Aircraft Serious Incident Investigation Report

KNKT/06.06/08.02.37

PT. Adam SkyConnection Airline

B 737-329

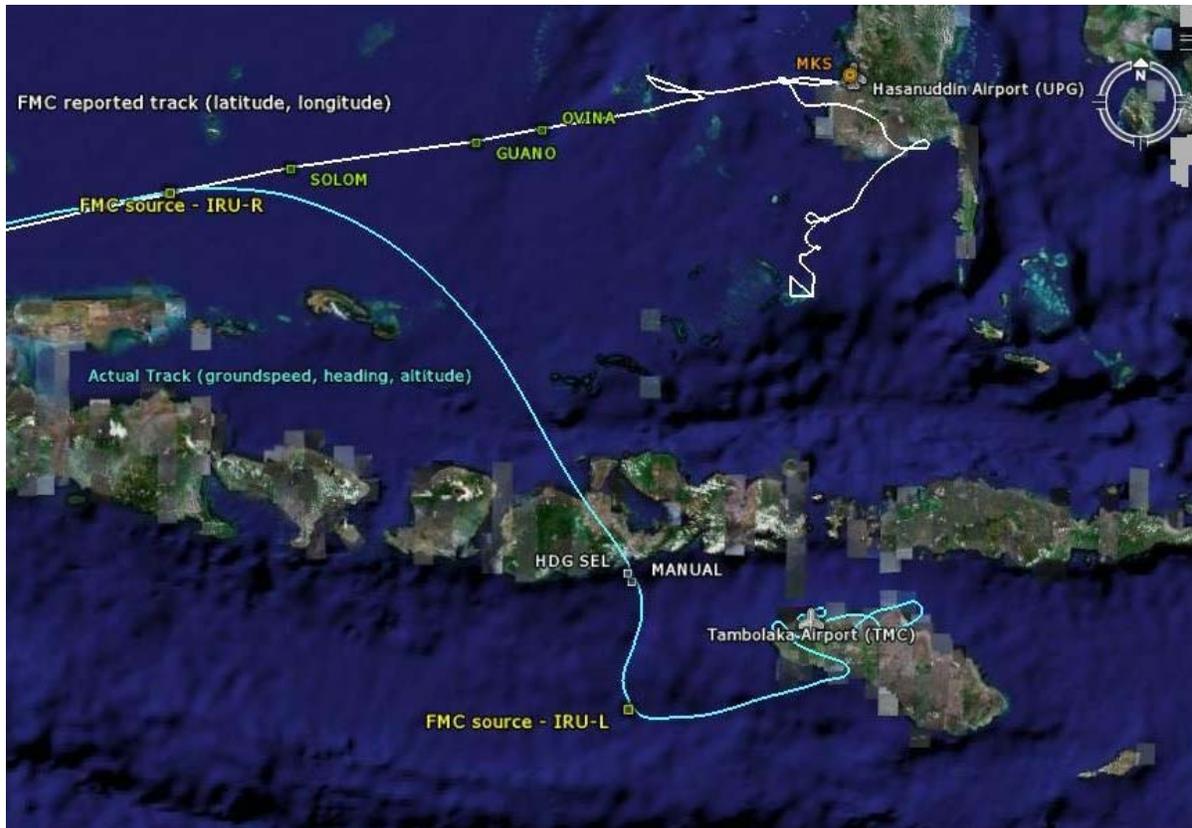
Figure 3 : Flight paths (FMC and actual) following switch to IRU - R

The FMC utilised the right IRU for approximately 52 minutes during which time the aircraft was on a south-easterly heading with the FMC believing it was travelling in a north-easterly direction. The FMC switched back to using the left IRU at 01:25:53. At this time the aircraft was being flown manually on the required heading for ANY to Makassar. The recorded FMC position when the FMC was switched to the left IRU was also erroneous for the remainder of the flight.

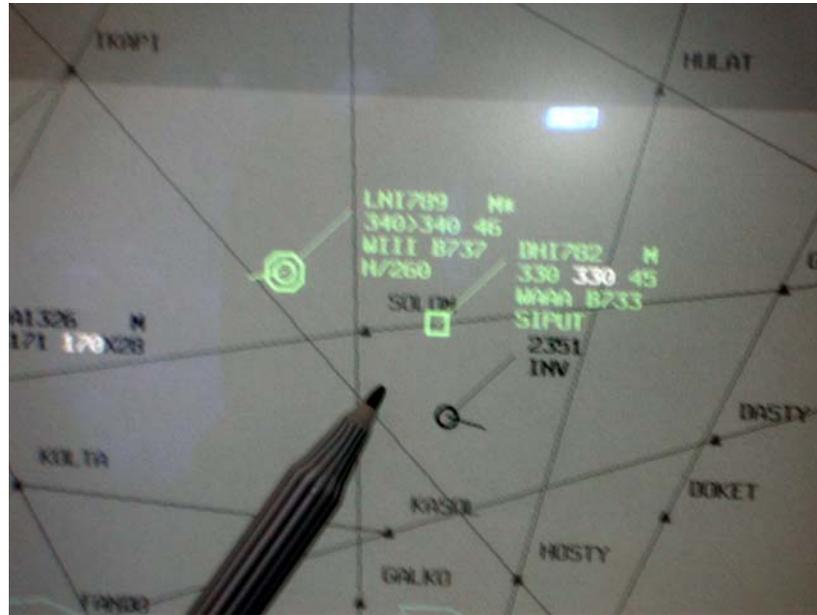
Figure 8: Flight plan track target (square with label, green color) was separated from radar track (circle with squawk number label, black color)

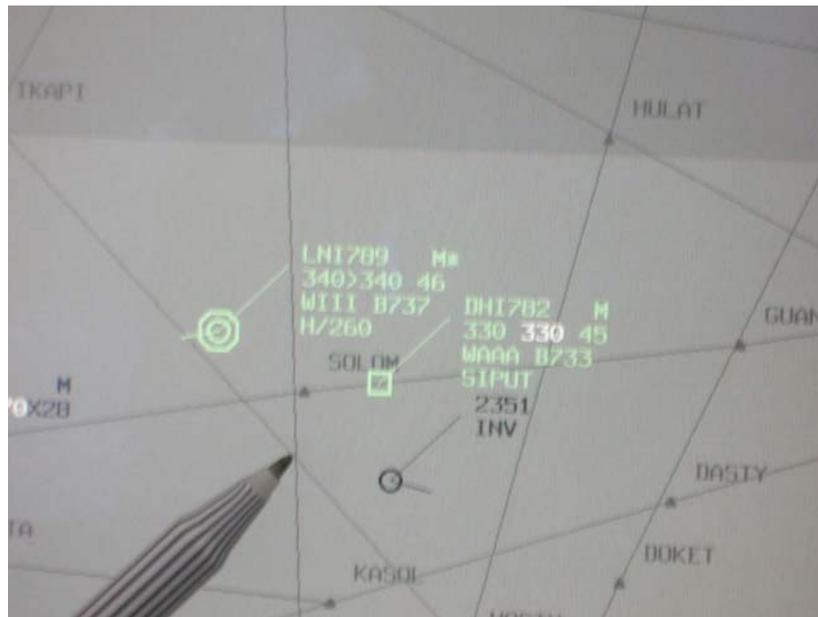
Figure 9: The aircraft was in between waypoints *SOLOM* and *GUANO* and off track about 15 miles

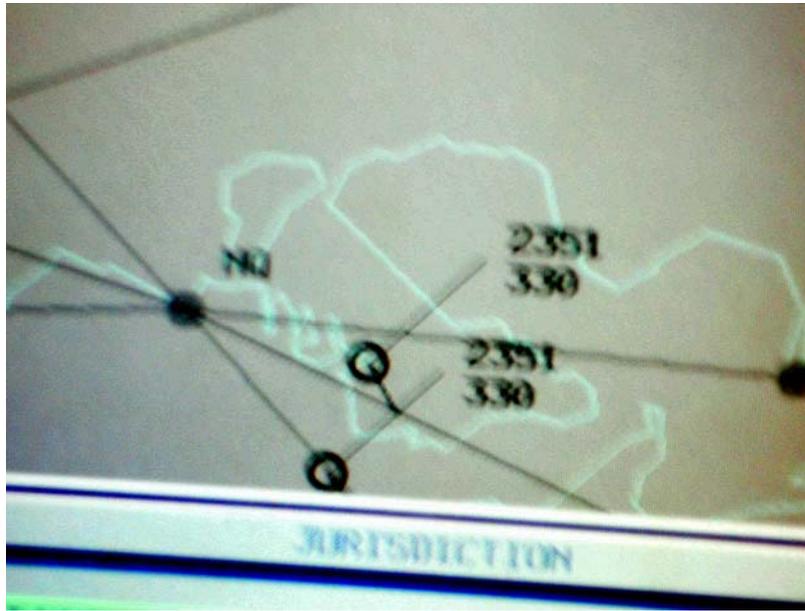
Figure 10: The aircraft's (radar track) at near waypoint *NQ* and captured by two radar heads (dupe) Ngurah Rai and Waingapu radars

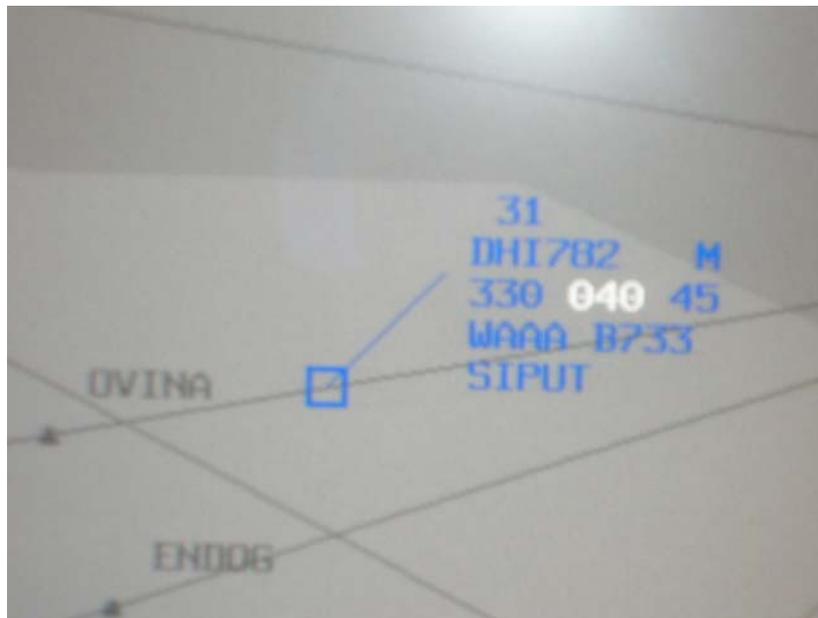
Figure 11: The aircraft's flight plan track (not actual target) coming to Ujung Lower area, but the target was square; the primary radar did not capture the target

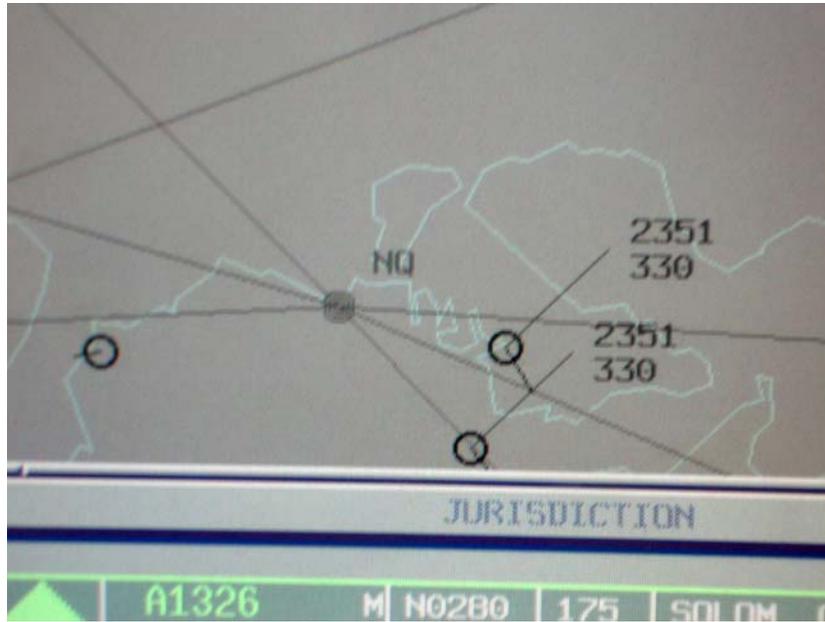
Figure 12: The aircraft at 01:06:51, was still at FL 330 (altitude 33,000 feet) and captured by two radar heads

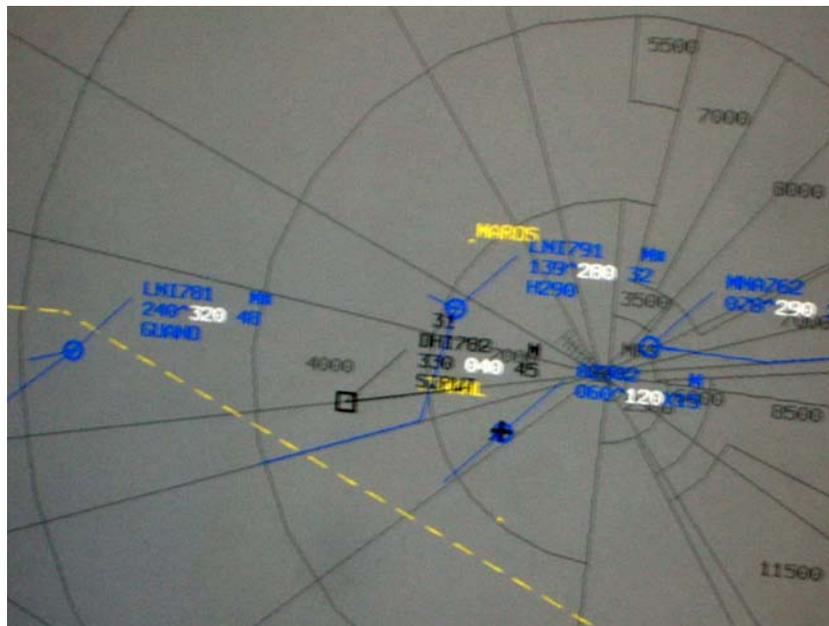
Figure 13: The flight plan track close to MKS (about 20 miles) showing the icon square and black colour; the primary radar did not capture the target
