AIRCRAFT ACCIDENT INVESTIGATION REPORT

ASIANA AIRLINES INC.

H L 8 2 5 8

**PASSENGER INJURY BY THE SHAKING OF THE AIRCRAFT
ASIANA AIRLINES INC.
AIRBUS A330-300, HL8258 (THE REPUBLIC OF KOREA)
AT AN ALTITUDE OF APPROX. 40,000 FT, OVER MATSUE CITY,
SHIMANE PREFECTURE, JAPAN
AT AROUND 15:17 LOCAL TIME, AUGUST 21, 2012**

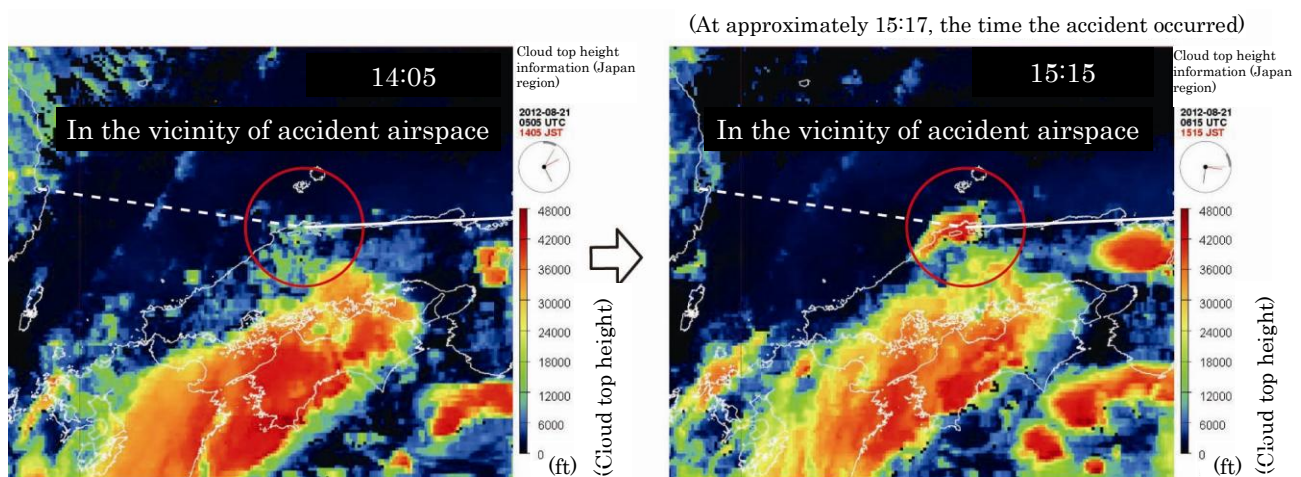
According to Rapid Scan Observation imagery *⁷, at 14:05, clouds with a low cloud top height were scattered in the vicinity of the accident airspace, but as time passed, more clouds developed, and at 15:15, immediately before the accident, clouds reaching a high-altitude cloud top height were analyzed.

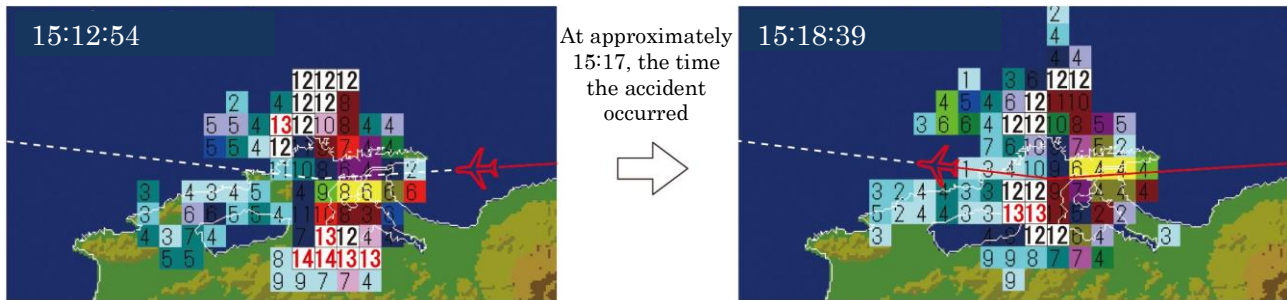
According to Doppler radar echo top distribution imagery from equipment installed at Miho Aerodrome adjacent to the accident occurrence point, within the time period of the accident multiple cumulonimbus were generated as a cluster in the vicinity of the accident airspace. The clouds were analyzed to be cumulonimbus with a cloud top height exceeding the Aircraft's flight altitude of 40,000 ft.

Numbers within frames indicate the maximum cloud top height (units: 1,000 m) within those frames.

- 12 Maximum cloud top height within frame: 39,400 ft
- 13 Maximum cloud top height within frame: 42,700 ft
- 14 Maximum cloud top height within frame: 46,000 ft

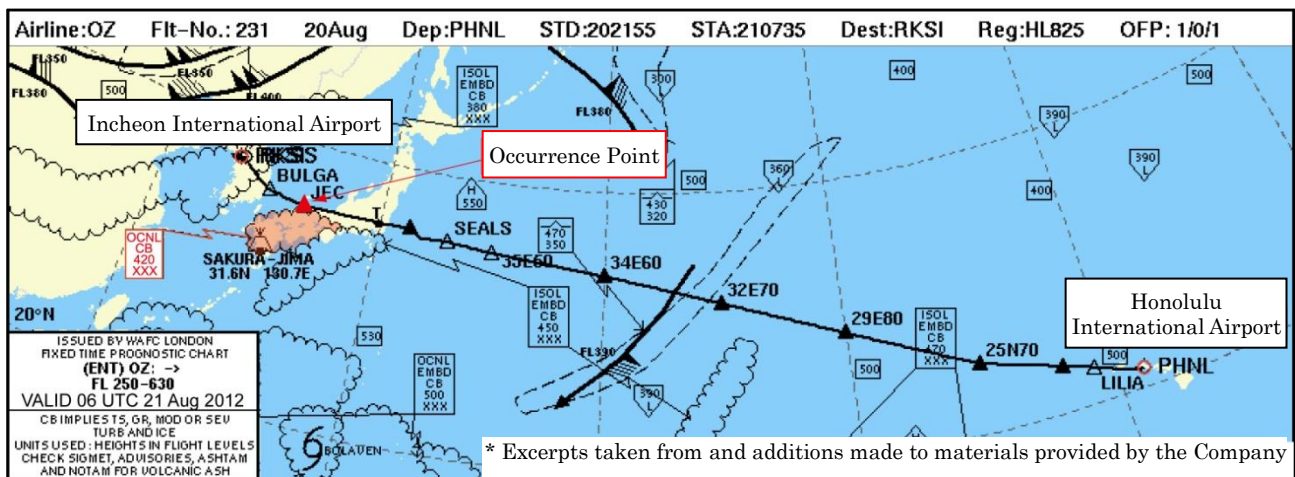
According to the Significant Weather Prognostic Chart for International Aviation^{*8} issued by the London WAFC and confirmed by the PIC in the pre-flight briefing, the weather on the flight route after takeoff was favorable up until the accident occurrence point, and no significant weather conditions that would hinder the flight, such as cumulonimbus, were forecast; however, cumulonimbus with a cloud top height of 42,000 ft were forecast from the vicinity of Kinki and Shikoku to the area immediately south of where the accident occurred.

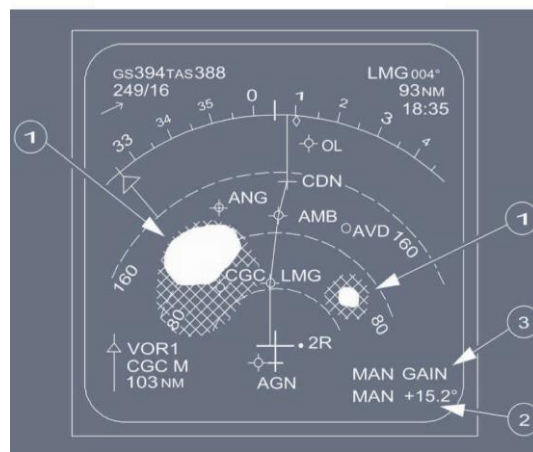
Example ND display

If the weather radar is turned on and the weather radar image of each ND is turned on, the weather radar information will be displayed on each ND (excluding PLAN Mode). Therefore, if the weather radar image on the ND is turned on, the operating status of the weather radar can be confirmed by the display (e.g., radar sweep, tilt angle) on ND even if there are no echoes.

According to the statements in 2.1.2, at the time when the accident occurred the PIC and the R Captain indicated that they were using the weather radar but that no echoes were displayed on the ND. As described in 2.1.1 and 2.8, however, the Aircraft's weather radar was off. Because there were no malfunctions found with the Aircraft's weather radar system, it is highly probable that if the weather radar image on the ND had been on, the operating status of the weather radar could have been confirmed even without echoes by using the ND display (e.g., radar sweep, tilt angle).

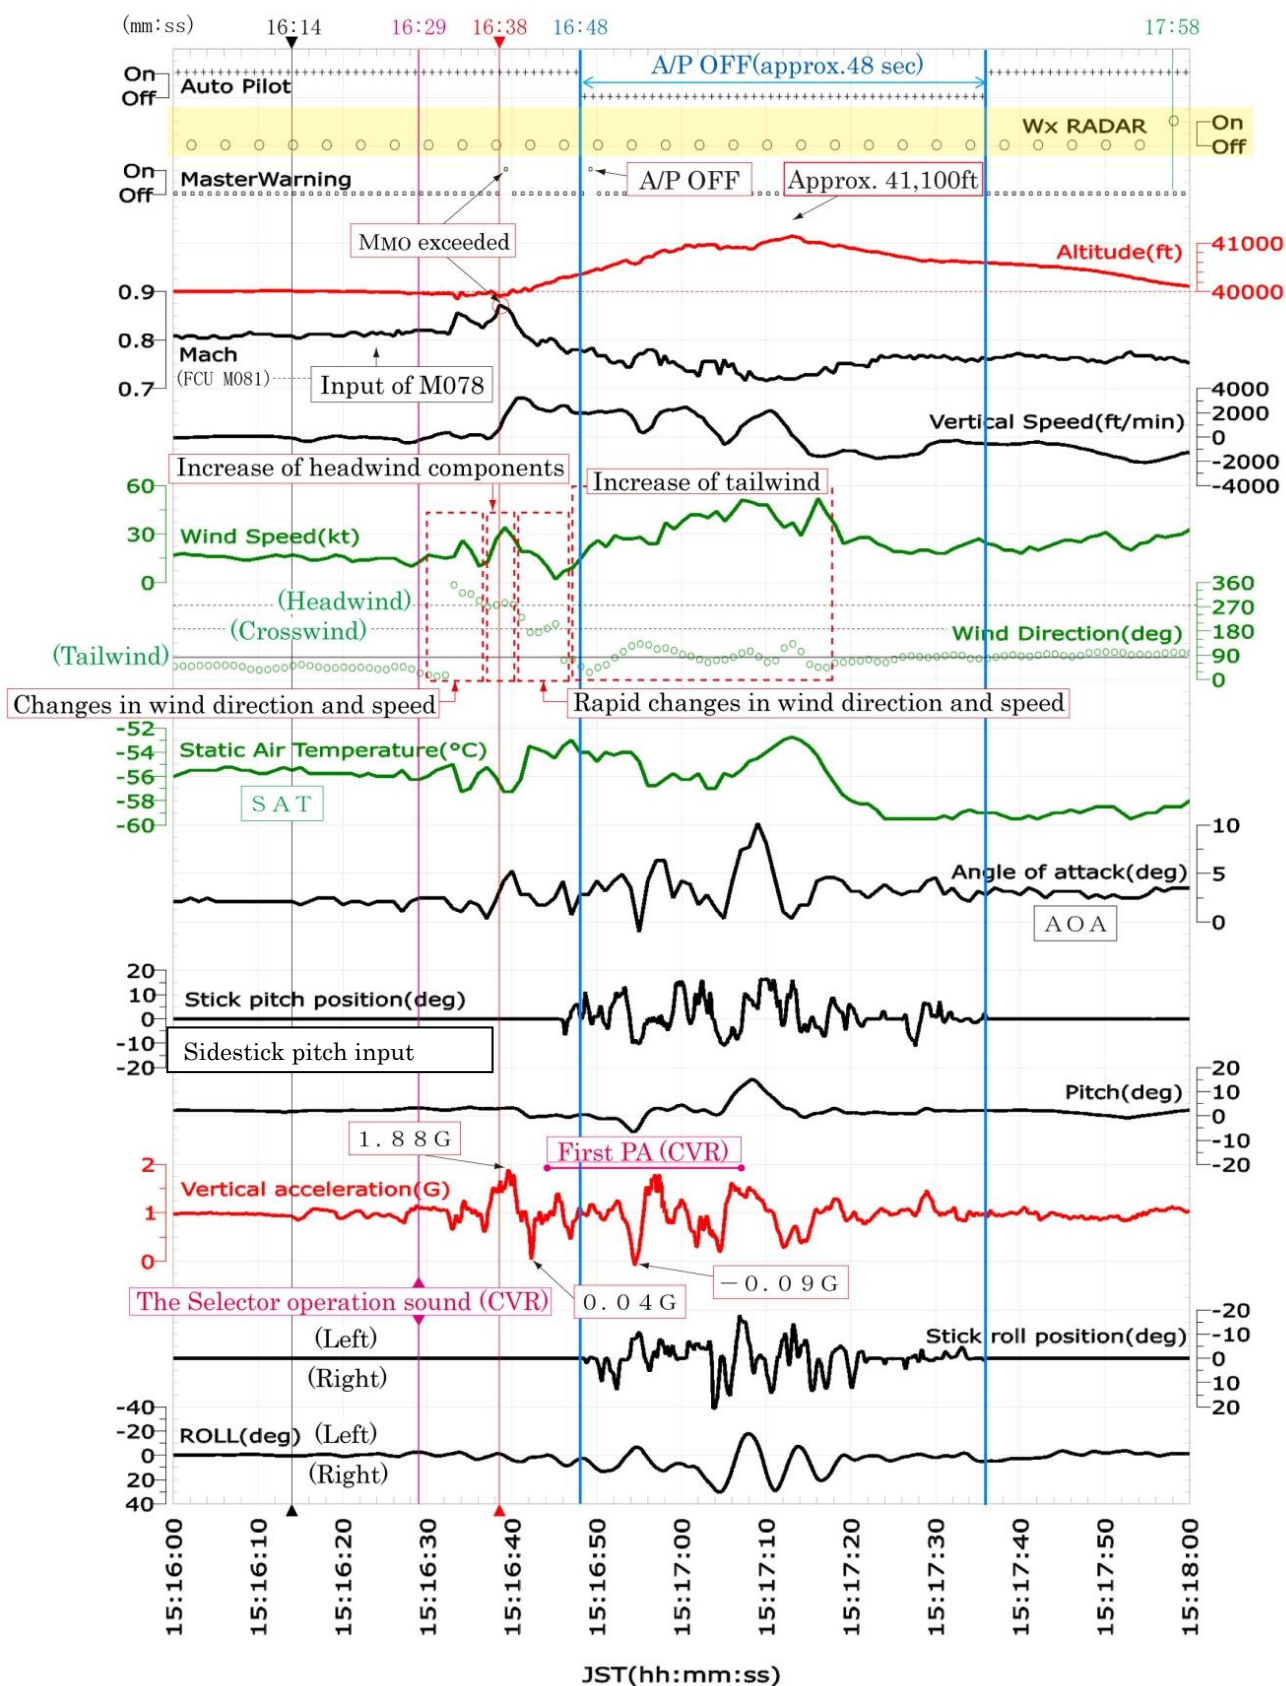
Figure 1: DFDR and CVR Records

15:16:14 A small change of the vertical acceleration started.

15:16:38 The wind speed became 34 kt. The speed of the Aircraft became M0.872, temporarily exceeding the M_{MO} (maximum operating speed limit: M0.86) and causing the over speed warning to sound.
The altitude of the Aircraft increased.

15:16:40 The SAT increased rapidly by 4°C, and this high value was maintained for approximately 15 seconds. The vertical acceleration became 1.88G, the highest value for this flight. The wind began to change in a counter-clockwise direction.

15:16:54 The sidestick on the PIC side was pushed forward. The pitch angle of the aircraft changed rapidly to -6.3°, while the vertical acceleration became -0.09G, the lowest value during this accident.

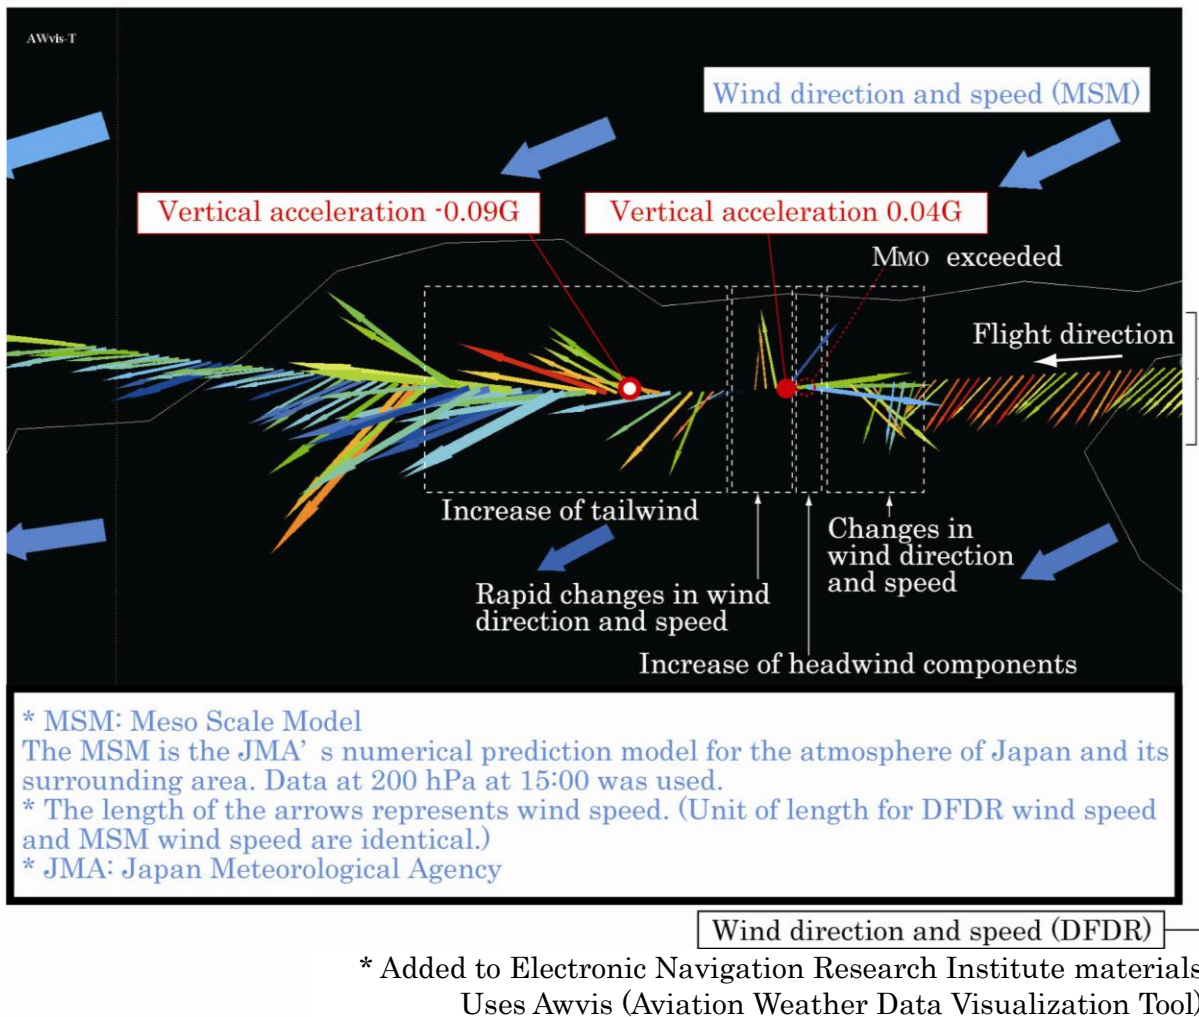
Figure 2: Status of Changes in Wind Direction and Wind Speed Recorded in DFDR

15:16:36 The wind direction changed to blow directly against the Aircraft. The Aircraft’s AOA*³ increased suddenly, but there was no change to the pitch angle.

15:16:42 The wind became a crosswind from the left, and the wind speed became 20 kt. The vertical acceleration became 0.04G, which was the greatest change during this flight.

15:16:55 While remaining as a tailwind, the wind speed increased to a maximum of 52 kt, and as the roll angle varied within the range from 30.2° on the right side to 17.9° on the left side, the pitch angle reached

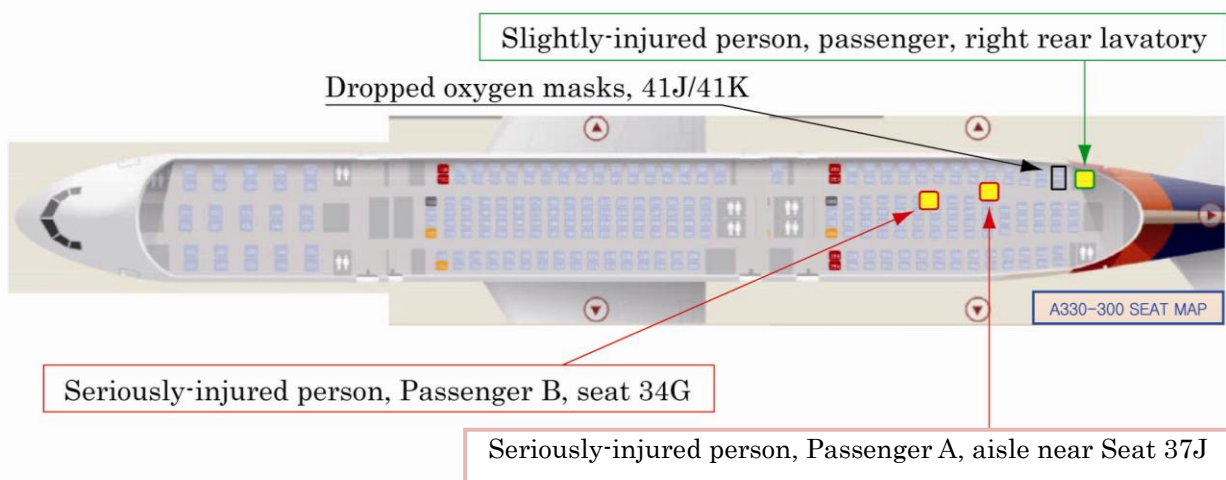
Figure 3: Locations of Injured Persons and others
At the Time when the Accident Occurred

Cabin Attendant A observed Passenger A being thrown into the air and falling due to this shaking. During the shaking, the passenger in seat 40G helped Passenger A to stand, sit in the empty seat 38J, and then fasten the seat belt there. Later, when Cabin Attendant A moved closer to Passenger A to check on her condition, Passenger A stated that her leg was broken. Because Passenger A complained of severe pain when Cabin Attendant A placed an ice pack on the injured part, Cabin Attendant A believed that her leg was broken.

According to the statements in 2.1.3 and 2.1.4(1), the initial shaking caused Passenger A to be thrown into the air and sustain serious injury when falling to the floor, a situation which was observed by Cabin Attendant A. Since the Aircraft was lifted and shaken as described in 3.4.1, it is probable that the serious injuries sustained by Passenger A occurred at the time of the change in vertical acceleration from 0.04G, recorded when the aircraft experienced shaking as a result of encountering severe atmospheric disturbances.
