**AIRCRAFT ACCIDENT
INVESTIGATION REPORT**

**JAPAN AIRLINES CO., LTD.
J A 6 5 4 J**

May 28, 2015

CABIN ATTENDANTS INJURIES
BY THE SHAKING OF THE AIRCRAFT
JAPAN AIRLINES CO., LTD., BOEING 767-300, JA654J
AT AN ALTITUDE OF APPROXIMATELY 16,000 FT
ABOUT 95 KM SOUTHEAST OF
GIMPO INTERNATIONAL AIRPORT (KOREA)
AT 17:33 JST, SEPTEMBER 12, 2014

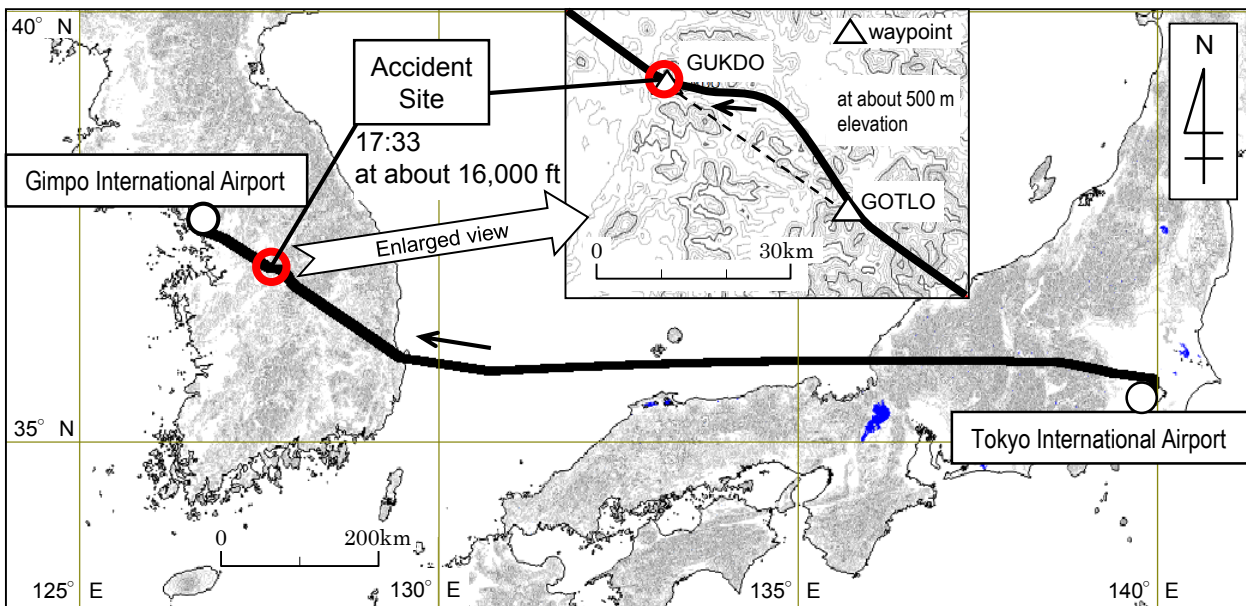
Figure 1 Estimated Flight Route

<p>preparing for landing. Since shaking of the aircraft gained its momentum from around 17:28, CAs and interpreters in the aft galley took their seats temporarily although the seatbelt sign was not lit on. When they resumed their work after the shaking subsided, they suddenly encountered a violent vertical shaking, by which cabin crewmembers were thrown into the air to hit the ceiling and one of them fell onto the floor on her back. As a result, she was seriously injured.</p> <p>The atmosphere being stabilized after clearing clouds, the PIC turned on the seatbelt sign at 10,000 ft as usual and continued descent. The aircraft landed at Gimpo International Airport at 17:51.</p> <p>The accident occurred at 17:33 on September 12, 2014, near GUKDO, about 95 km southeast of Gimpo International Airport (37°01'43" N, 127°38'05" E), at an altitude of approximately 16,000 ft.</p> <p>(See figure 1 and 2)</p>

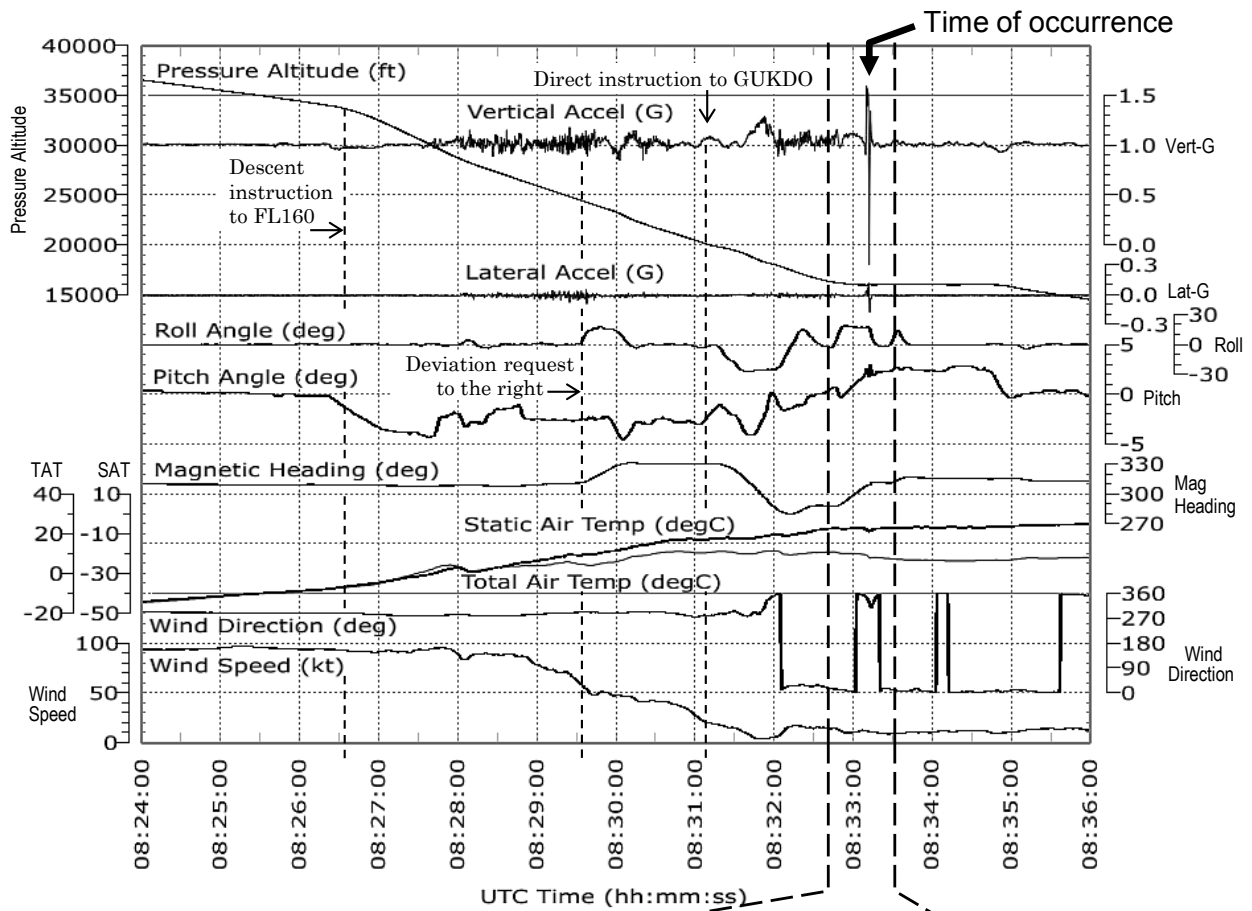
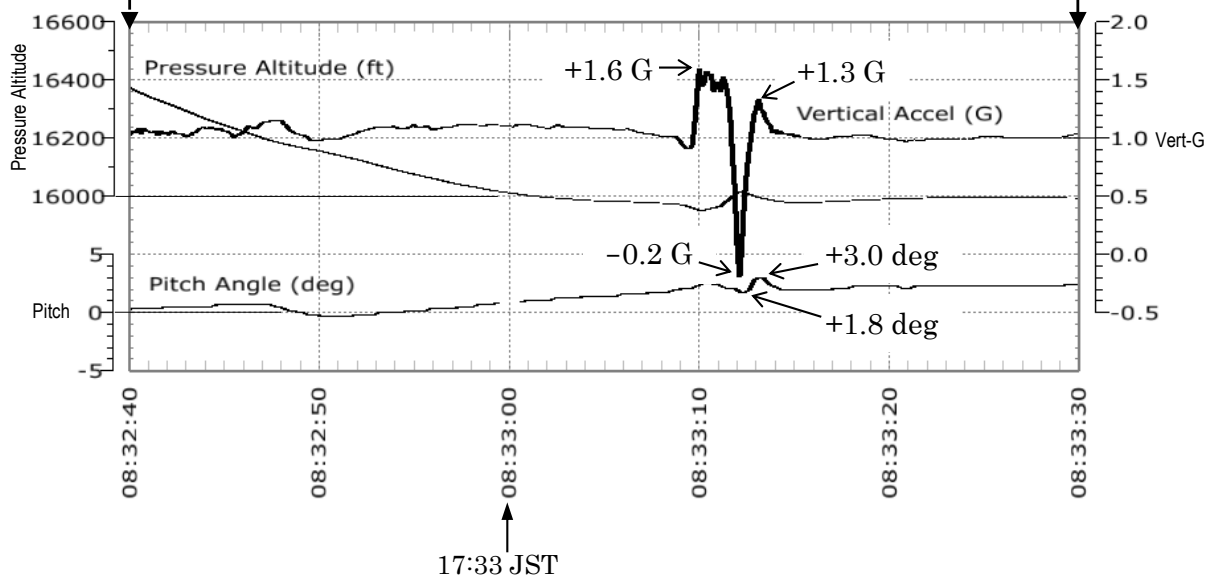
Figure 2 Records of the FDR

A vertical acceleration of approximately +1.5 G continued for around two seconds, and momentarily it changed to -0.2 G, then +1.3 G (+: moving upward) when the aircraft encountered strong shaking. There was a little change of pitch angle. The autopilot and autothrottle remained engaged during the shaking.

(2) Judging from the fact that significant change of vertical acceleration was observed at 17:33 when the aircraft was about to level off at FL160 around GUKDO after its descent, it is highly probable that the aircraft was strongly shaken as it encountered turbulence by the convective clouds, causing cabin crewmembers thrown into the air to hit the ceiling, and one of them fell onto the floor on her back to sustain a severe injury.

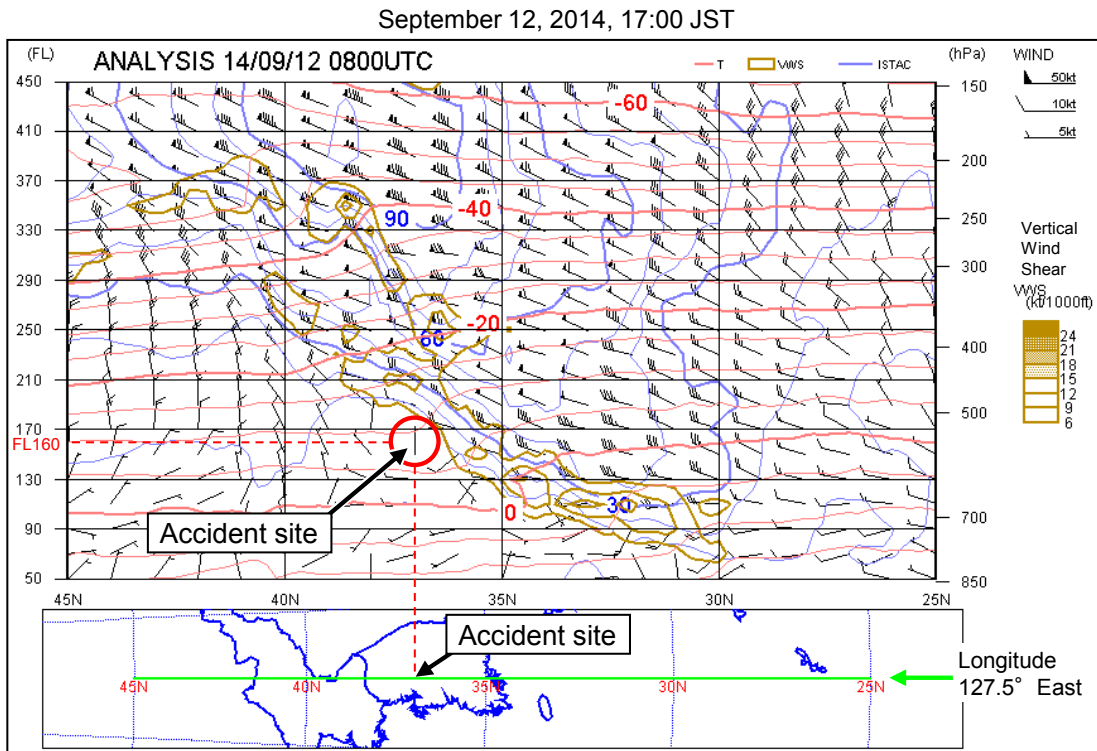
Figure 3 Hourly Analysis Chart (vertical cross section)

2.6 Meteorological Information	<p>(1) Weather conditions confirmed before the flight</p> <p>The Korean Peninsula area was covered by high pressure system from the north, and there were no low pressure system or fronts which might imply bad weather. Although jet stream of about 100 kt in FL390 was expected from the Korean Peninsula to the Kinki district of Japan, bad weather such as clear air turbulence or convective clouds were not expected around Seoul.</p> <p>According to the Pilot Report (PIREP) of the company's preceding flight, weak turbulences (TB2 *1) were reported at 13:25 in clouds the altitude of which were from 24,000 to 23,000 ft and from 7,000 to 5,000 ft during the descent towards Gimpo International Airport.</p> <p>(2) Weather information provided during the flight</p> <p>At 16:43, during cruising flight, cloud condition provided from the operation support staff at Gimpo International Airport was as below.</p> <p><i>Some isolated CB has been developed around west of GUKDO, over Seoul and over Gimpo Airport. But now it tends to go weak. No significant CB observed on your approach course and no need to deviate.</i></p> <p>(3) Weather conditions at the time of the accident</p> <p>According to the hourly analysis chart (127.5° East vertical cross section) of 17:00 and 18:00 of the Japan Meteorological Agency, weak Vertical Wind Shear (VWS) existed in the upper layer, however, it was not at the altitude of the accident.</p> <p>According to the upper-laid observation weather chart (500 hPa, 700 hPa and 850 hPa) of 09:00 and 21:00 of the Japan Meteorological Agency, the Korean Peninsula area had been covered with the rear surface of the cold air trough. Although the center of the cold air had moved to the east, it was under the condition that cold air stayed as about -10 °C at around 500 hPa.</p> <p>According to the images of the Terminal Doppler Weather Radar (TDWR) installed in Incheon International Airport (Korea), small echoes had been scattered to the west of GUKDO (123 km southeast of Incheon TDWR), these echoes attenuated once. However, they began to grow up near GUKDO from past 17:00.</p> <p>(See Figure 3 and 4)</p>

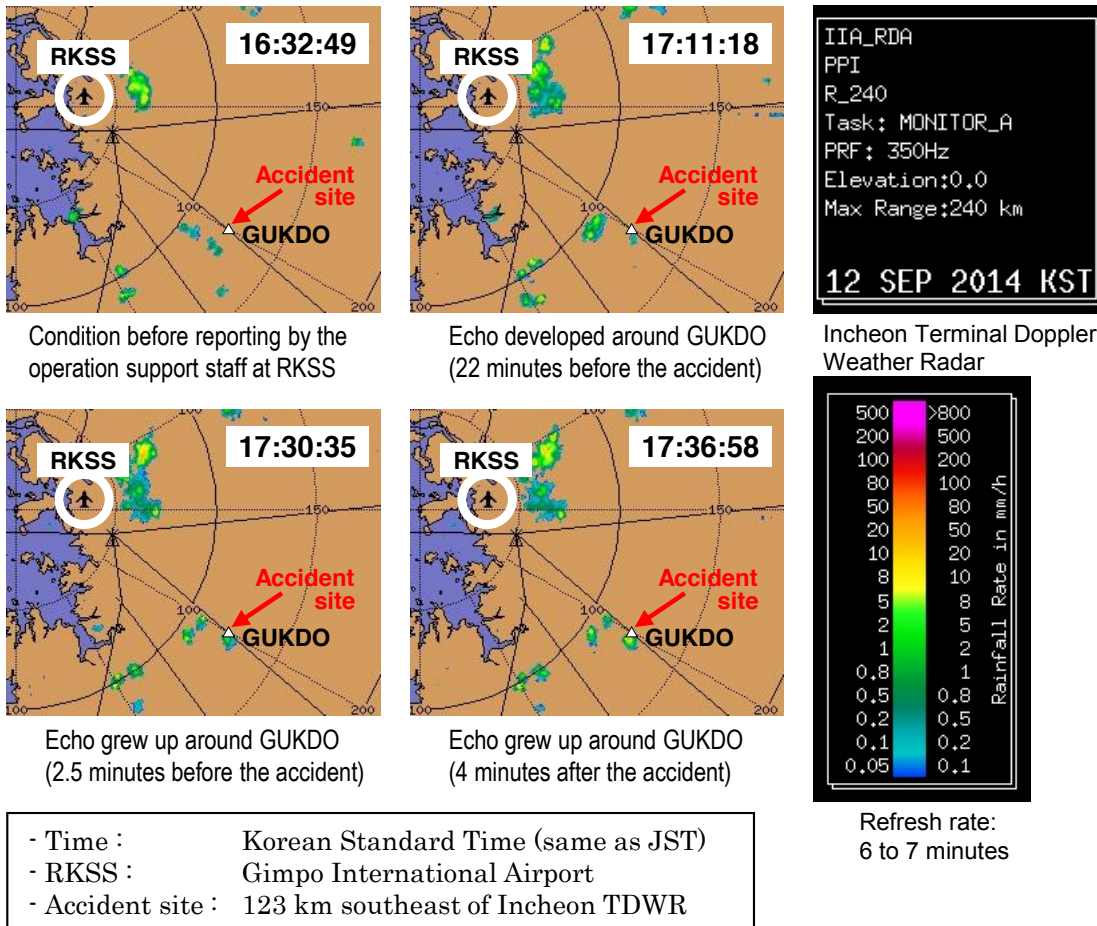
Figure 4 Radar Observation Data

(1) It is probable that the operation support staff of the company at Gimpo International Airport, based on the images of Incheon TDWR that scattered echoes of clouds shown in the east of GUKDO were attenuating, judged the aircraft would not need to deviate because no convective clouds which might give significant impact on the flight were observed along the approach course before 16:43 when the staff sent the information to the aircraft. However, convective clouds were redeveloping near GUKDO after 17:00.
