**AIRCRAFT SERIOUS INCIDENT
INVESTIGATION REPORT**

**ALL NIPPON AIRWAYS CO., LTD.
J A 8 6 7 4**

Operator: ALL NIPPON AIRWAYS CO., LTD.
Type: BOEING 767-300
Registration number: JA8674
Type of serious incident: ENGINE INTERIOR DAMAGE
Time and date of outbreak: AT 09:19 , JULY 8, 2011
Occurrence Point: AT AN ALTITUDE OF APPROX. 8,500M
ABOUT 79KM TO THE NORTHWEST
OF TOKYO INTERNATIONAL AIRPORT

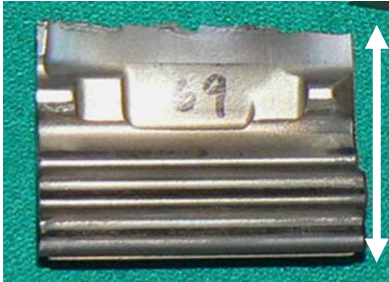
<p>Blade 69 (side view)</p> </div> <div style="text-align: center;">

<p>2.2 Injuries to Persons</p>	<p>None</p>
<p>2.3 Damage</p>	<p>(1) Extent of Damage: Minor damage (major damage to inside of the engine)</p> <p>(2) Damage to inside of the Engine</p> <p>The High Pressure Turbine (hereinafter referred to as “HPT”) is composed of two stages. Out of 74 second stage HPT blades, the blade 69 (hereinafter referred to as “the Blade”) was separated at a distance of 1.3 inches (1 inch = about 25.4mm) from the bottom in the shank and lost. Other blades exhibited damage on the blade tips.</p> <p>The Low Pressure Turbine (hereinafter referred to as “LPT”) is composed of five stages. The LPT blades exhibited damage along the full axial length of the LPT module.</p> <div style="text-align: center;">

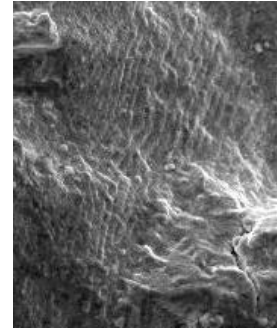
Fracture surface

Traces of fatigue propagation were observed on the fracture surface of the Blade.

The shank wall thickness was thinner than the minimum design value of 0.055 inches.

High-temperature corrosion was observed on the internal surface of the fracture part, but it was limited within the outermost aluminide coating and did not penetrate into the base material. The component material analysis of the Blade showed no abnormality.
