Investigation Report

AX002-0/05
November 2010

Type of occurrence:	Serious Incident
Date:	23 April 2005
Location:	Stuttgart
Aircraft:	Commercial Aircraft
Manufacturer / Type:	Boeing / B737-800
Injuries to persons:	One person slightly injured
Damage:	Major damage to aircraft
Other damage:	None
Information source:	Investigation by BFU

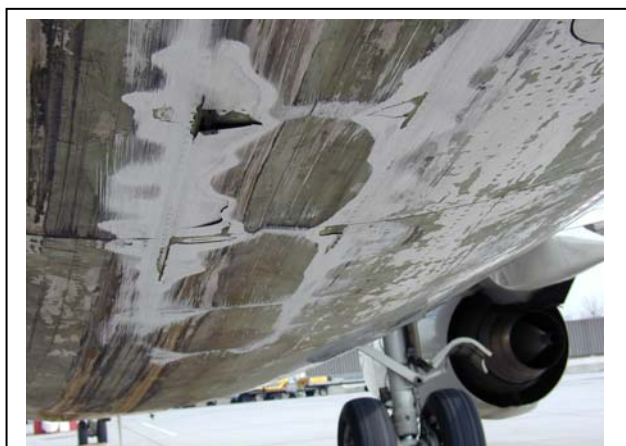
Damage on the lower side of the fuselage

The tail strike caused severe structural damage in the aft fuselage area.

The cause of the tail strike was the extreme tail-heavy aircraft balance, caused by the remaining passengers and their luggage in the aft part of the aircraft.
