Investigation Report

Type of Occurrence:	Accident
Date:	4 October 2007
Location:	Düsseldorf
Aircraft:	Airplane
Manufacturer / Model:	Airbus / A330-322
Injuries to Persons:	None
Damage:	Aircraft severely damaged
Other Damage:	Minor damage to buildings and outdoor facilities
Information Source:	Investigation by BFU
State File Number:	BFU 1X002-07

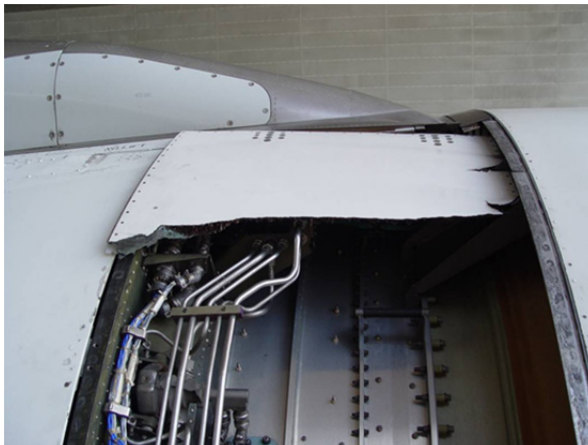
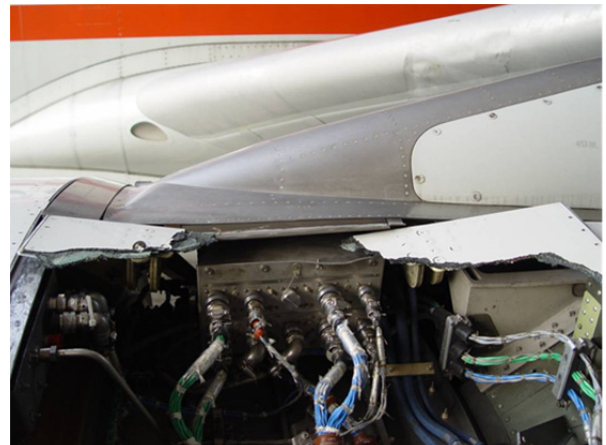
Each of the two cowling doors had fractured directly below the hinges. The fragment of the right (inner) cowling door got jammed below the cowling. On the left (outer) door a front and an aft fragment were found. The aft fragment was jammed below the fixed cowling part. The front fragment was movable.

Residual fracture, right and left side

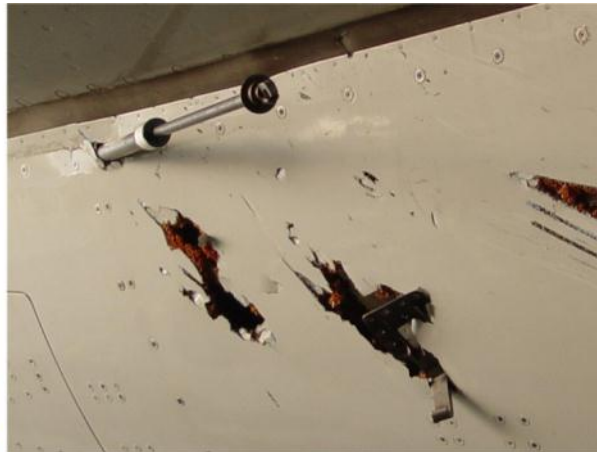
8 mm. Other parts of the cowling had damaged the belly fairing. One of the telescope bars had penetrated the fairing. Once the belly fairing was removed, damages to the structure and hydraulic pipes were determined. Only lines of the blue system were affected which had the following functions:

- Blue system reservoir air pressurisation
- Return line engine #1 thrust reverser
- Engine Driven Pump (EDP) case drain line
- EDP suction line (blue system),

Furthermore, parts of the cowling latches were found in this zone.

Damages to the belly fairing

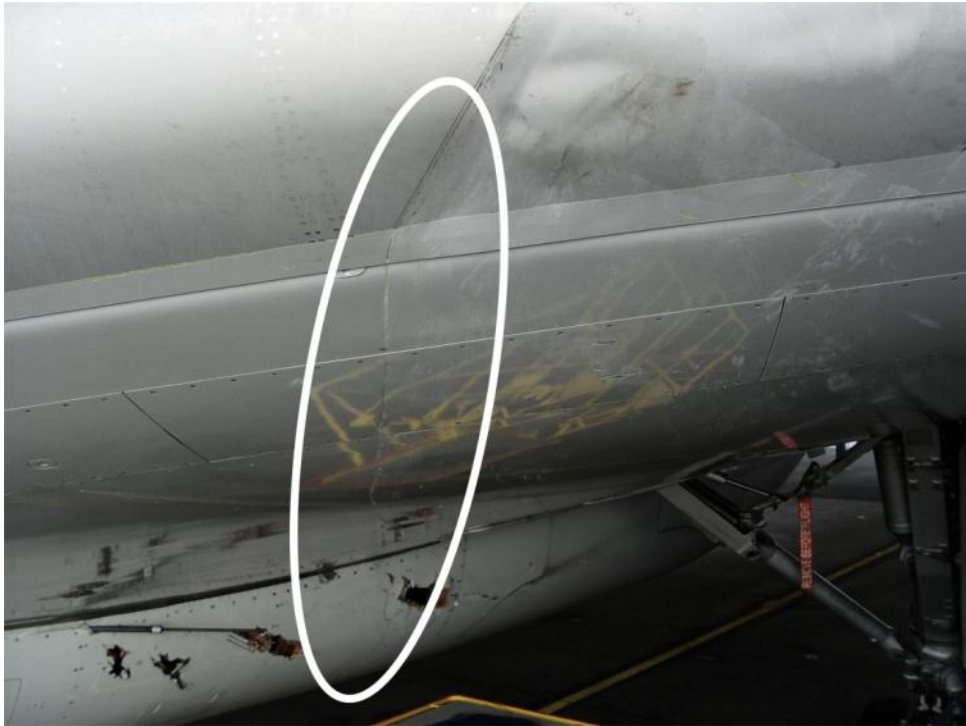
Additional damages were found on the slats, the flap fairing and on two passenger windows. A continuous scratch mark ran from the initial impact mark on the slats to the belly fairing.

Continuous scratch mark on the lower surface of the wing

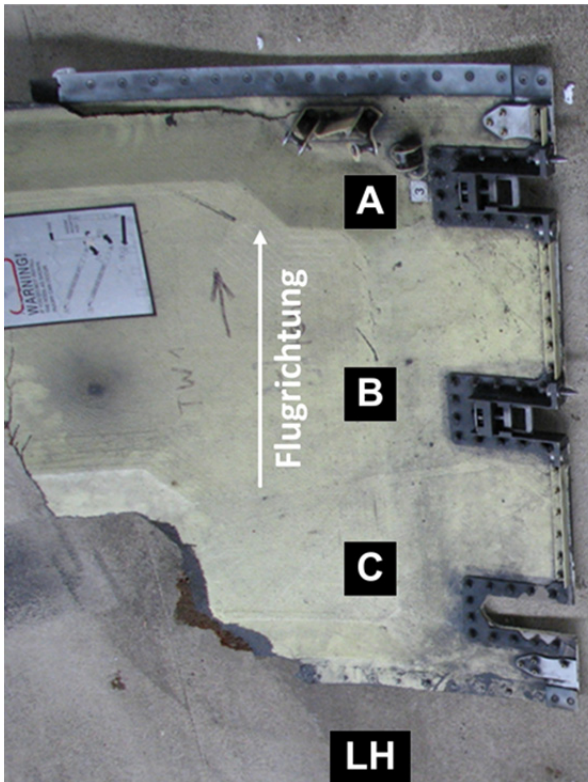
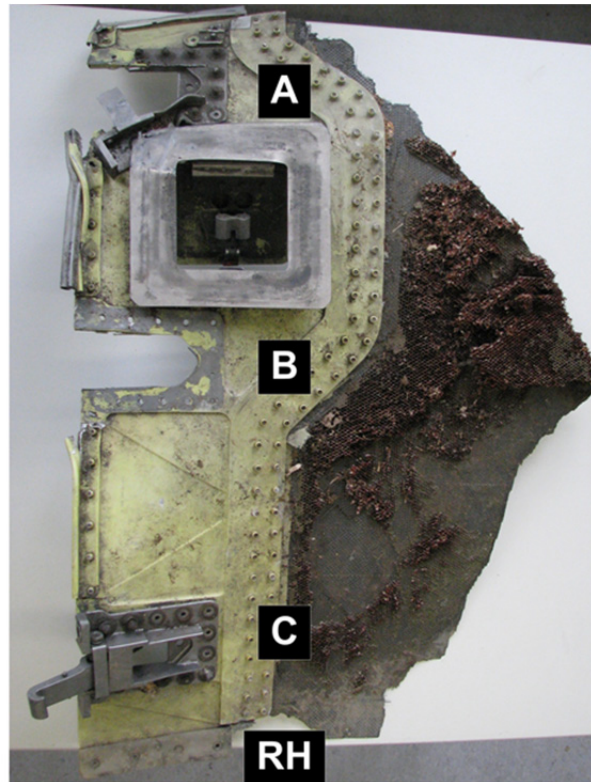
The lower section of the cowling doors showed different damages. On the left door the front two keeper housings (A and B) did not show any damages or impact marks, the aft clevis (C) was torn out. On the left door the front hook (A) was severely damaged, the centre hook (B) was torn out and the aft hook was damaged. The pieces found on the ground and in the belly fairing, respectively, could be matched with latches A and B, respectively (Appendix 1). The outer edge (in the area of the engine centre line) of the left cowling door was straight and did not show any damages. The outer edge of the right cowling door, however, showed an arch-shaped deformation.

Damages to the latches

The latches showed the damages described in Appendix 2. The engine manufacturer, who was also responsible for the cowling, examined all latch parts as well. It was determined, among other things, that on the front hooks of latches A and B white paint residue was present which matched the paint of the cowling.

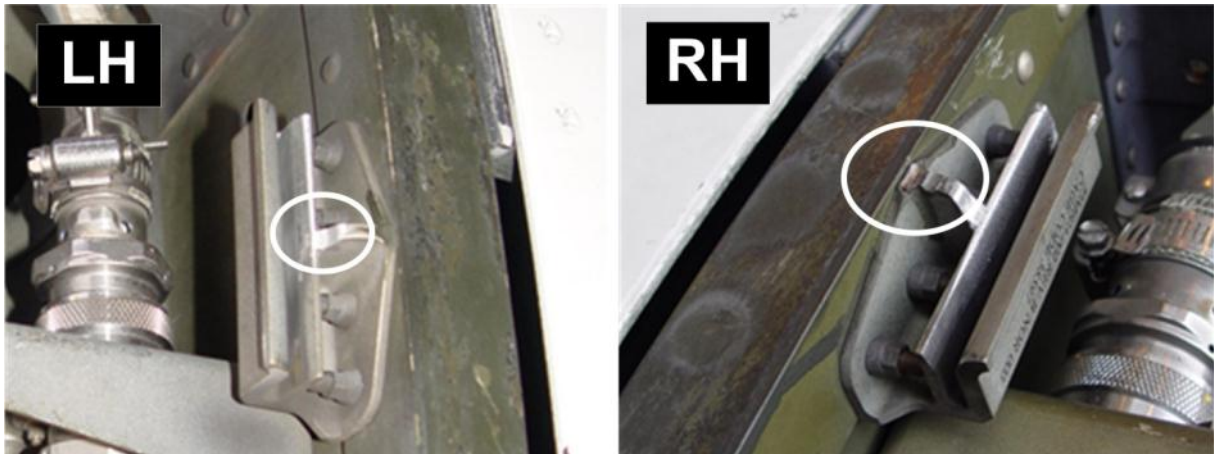
The receptacles (PN 73M603-001) were partially worn. Immediately after the accident they were replaced.

Wear on the receptacles for the axial locators

The outer area of the receptacle for the axial locator showed wear at the outer area. It could not be determined what caused the wear. If the wear had occurred with a locked cowling it would show that operation would still be possible without immediate damage to the cowling. The tests conducted by the BFU and the engine manufacturer show that locking the cowling is extremely difficult if receptacle and axial locator are not correctly aligned. The maintenance personnel stated, however, that they did not notice the need to increase force to lock the cowling.

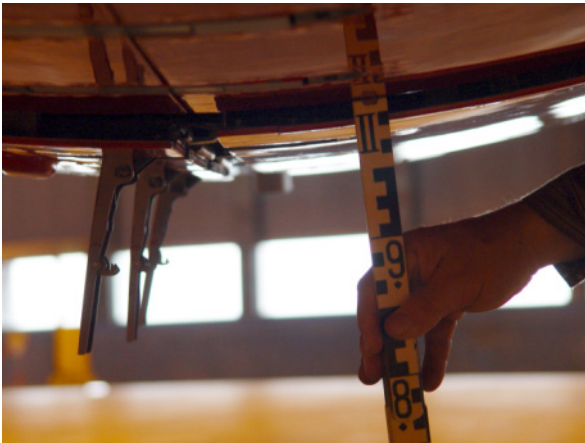
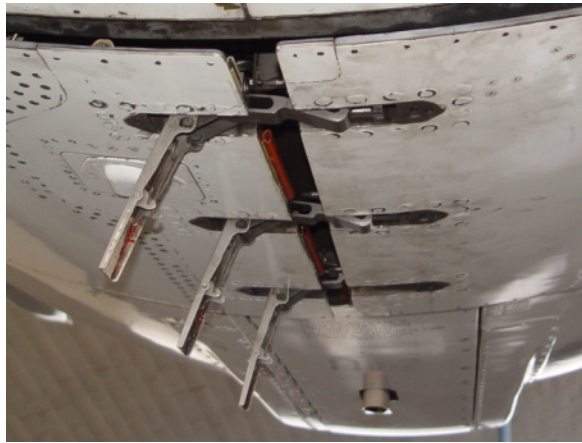
Closed and clasped cowling.

Closed cowling with one clasped latch (aft)
Photos (2): BFU

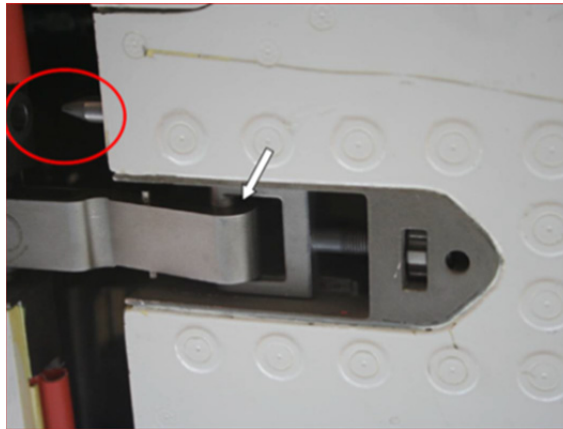
Tests were conducted to simulate the bearing of the axial locator on the worn receptacle. The range of axial locator and receptacle were limited. In this case the cowling could only be closed by applying a significant force. One or more latches were outside of the contour of the cowling.

Locked hook / alignment pin unaligned

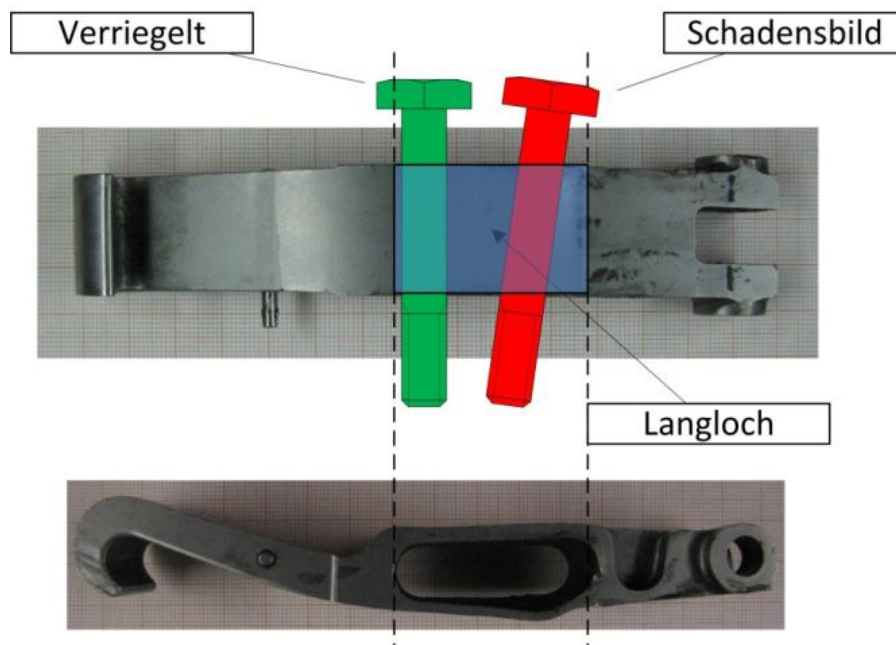
The deformation of the latch pin slots of latches A and B are about in the centre. Therefore, the deformation occurred with the hooks not in the locked position (red bolt); in the locked position the bolt would be at the outer end of the hook (green bolt). Since the deformation line does not run perpendicular to the longitudinal axis of the hook, the damage must have occurred when the hook was not locked otherwise the clevis and the bolt would have caused a perpendicular deformation.

Position of the bolt in a locked latch versus the damage (latch A)

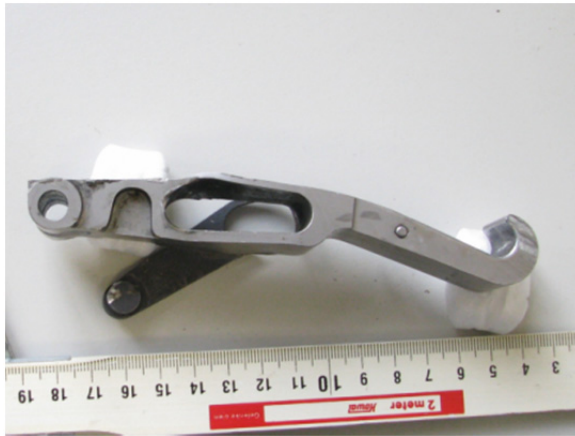
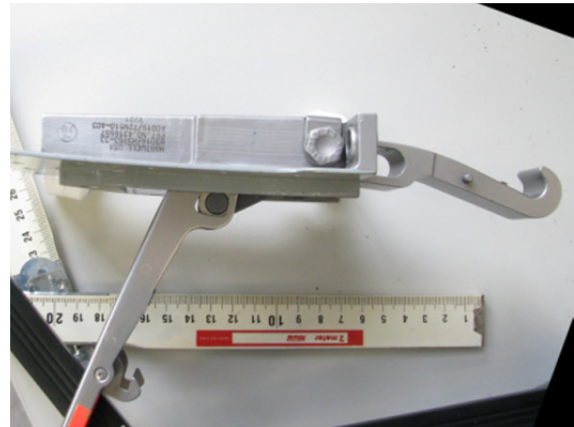
The position of the impact mark on the link (#3) also indicates that the hook and the handle of latch B were not closed when the damage occurred.

The approximate position of the link versus an undamaged latch

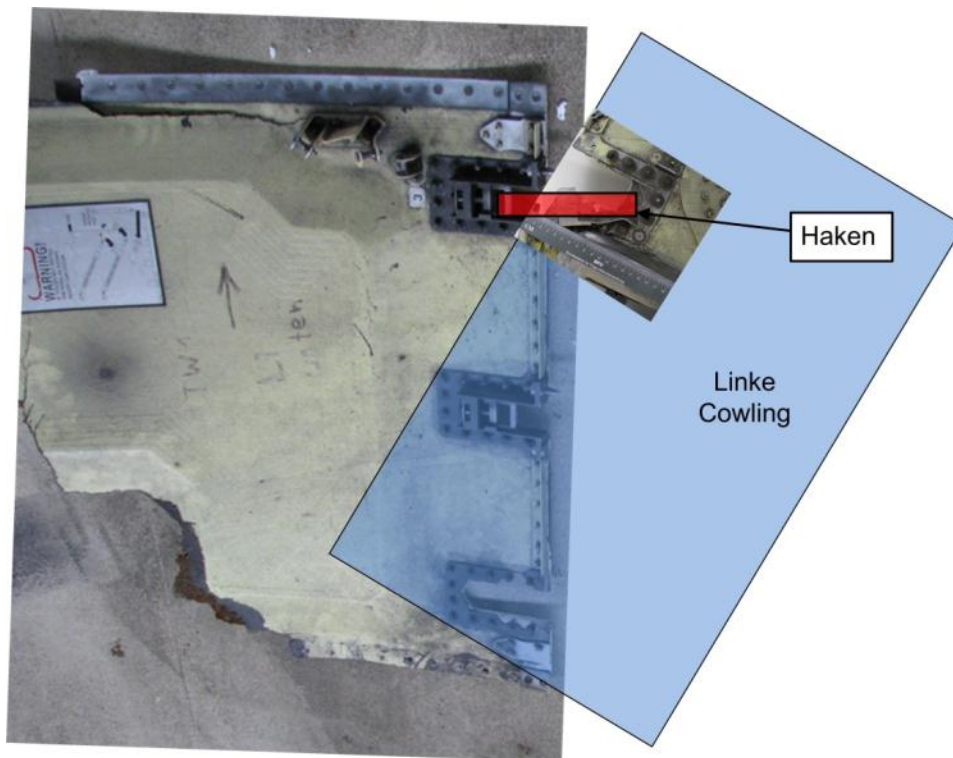
The deformation of the aft flank of latch housing A, the indentation of the latch hook (#4) and the deflection of the bolt (#2) show that the hook was deflected by about 30° at the time. Geometrically it is not possible that at that time all latches were aligned because the left aft part of the cowling door would have overlapped with the right. Therefore, the conclusion can be drawn that the aft flanks of the latches were unlocked when the deflection occurred.

Position of the left cowling (if latch A was locked)

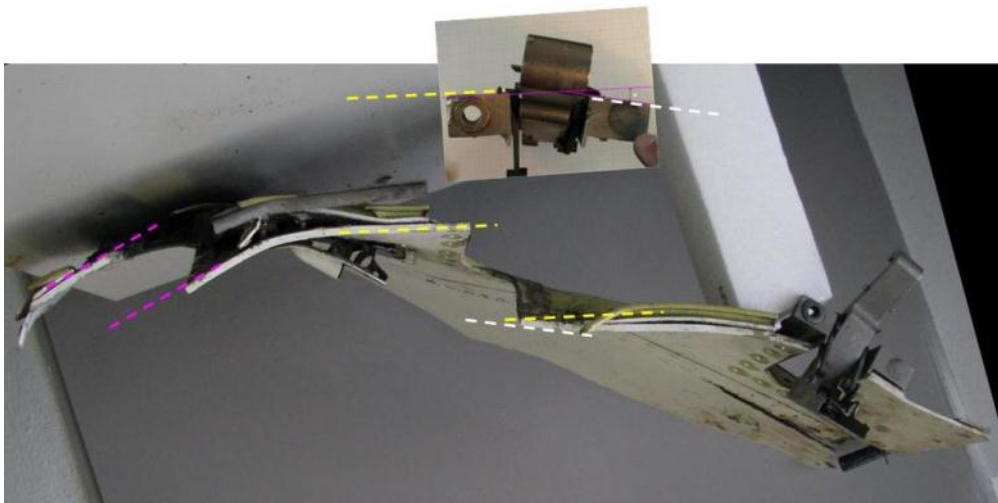
The arch-shaped deformation on the outer edge of the right cowling door could not have occurred with a properly locked cowling latch otherwise a similar damage could be found on the left door. The left door, however, is mainly undamaged and straight. Due to this fact, the deformation has occurred as individual latches were not properly connected with the opposing part of the right cowling. The arch-shaped bends match the deformation of the cowling latches. Therefore, it is highly likely that the latches were peeled from the cowling one by one.

Arch-shaped deformation on the outer edge of the right cowling door

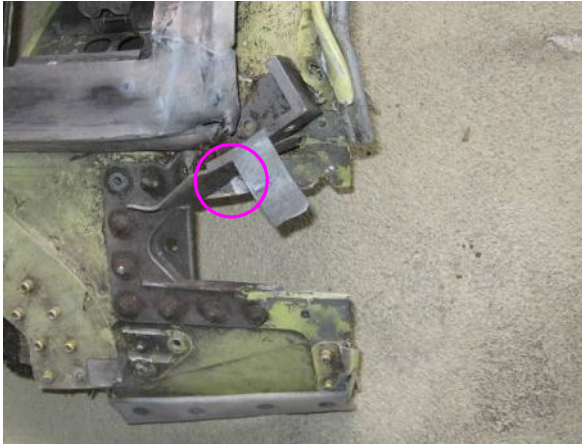
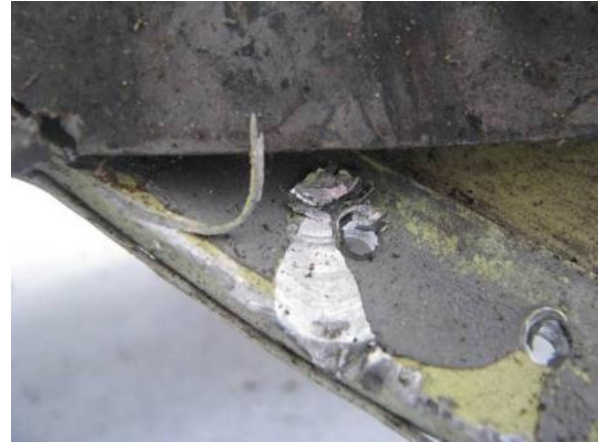
Latch A:

The aft flange of the housing was torn out and bent backward by about 30°. A dent was found (about 70 mm from the outer end).

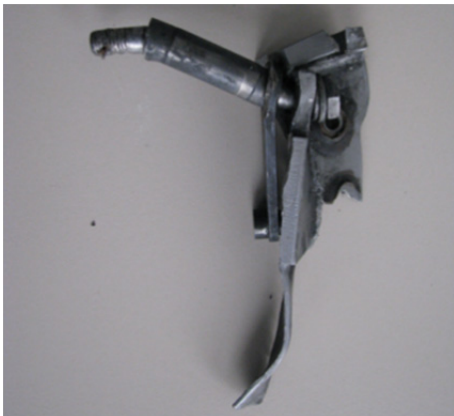
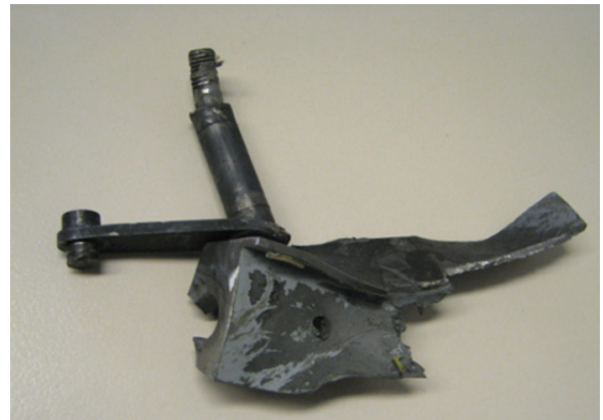
Latch housing part #2 (part of latch A):

The bolt was bent by about 30°. The thread end was twisted by about 30° (about parallel to the screw head). The receiving hole of the bushing was torn and showed an oval-shaped deformation.

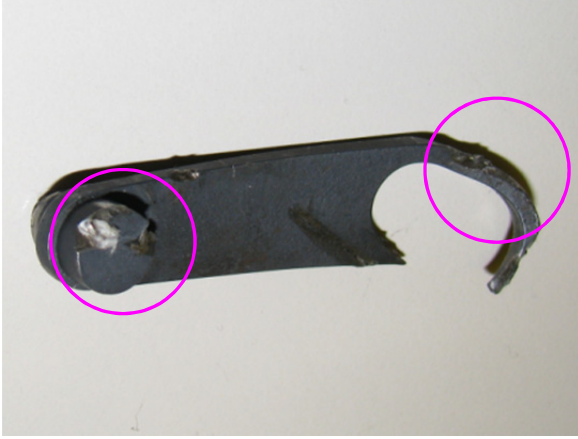
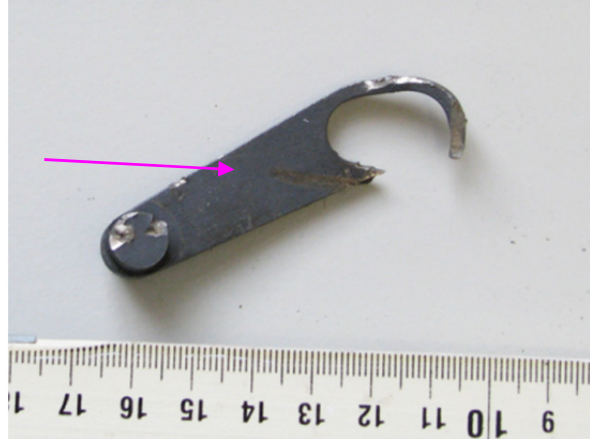
Link #3

The link showed a line-shaped impact mark which was slanted by about 30° in relation to the longitudinal axis

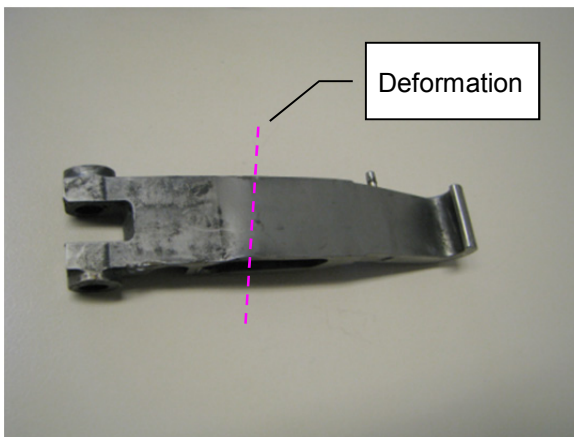
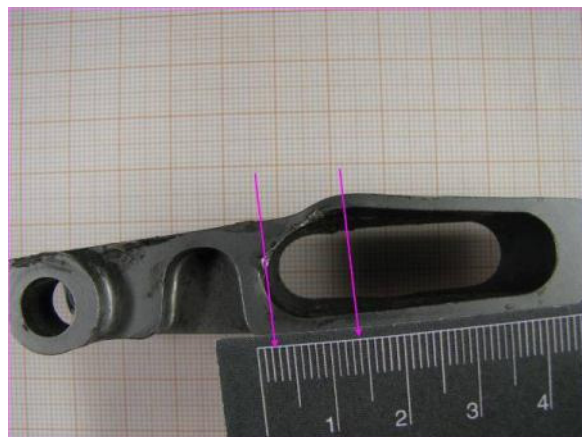
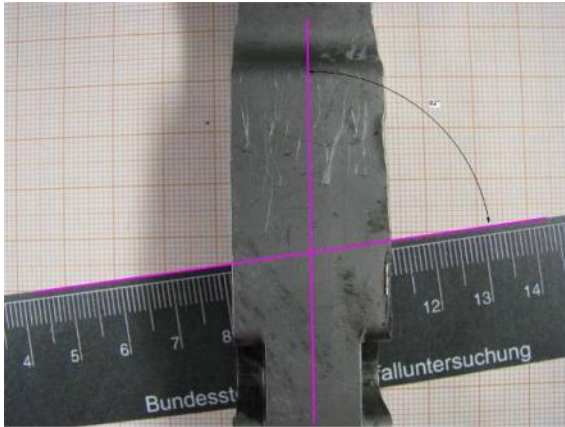
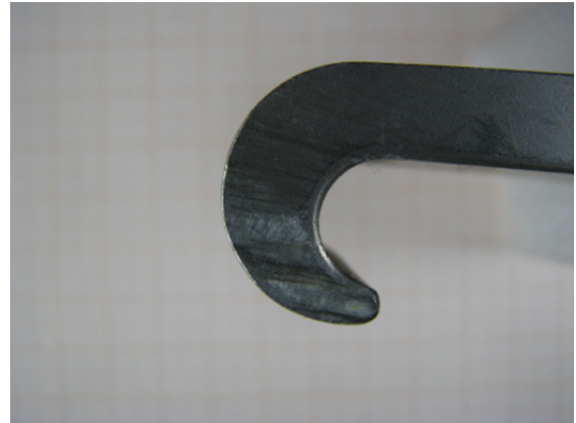
Hook #4 (part of latch A):

The hook showed a line-shaped deformation which was more pronounced at the front end. The line did not run perpendicular to the longitudinal axis of the hook (deviation about 7°). The housing of the hook was twisted. White paint residue was found on the front end.

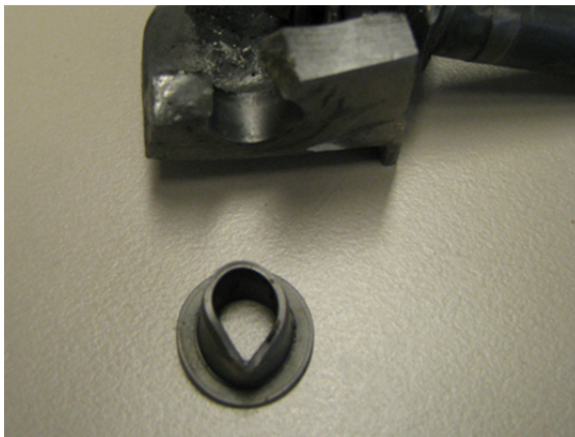
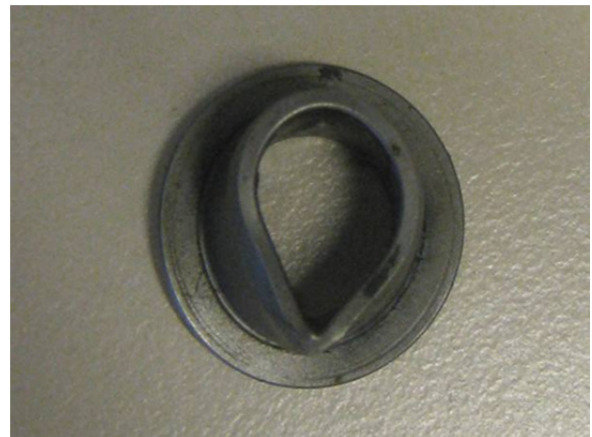
Shear Pin Receiving Bushing #6 (part of latch A):

The bushing showed an oval-shaped deformation and fit into the similar shaped receiving hole of housing #2.

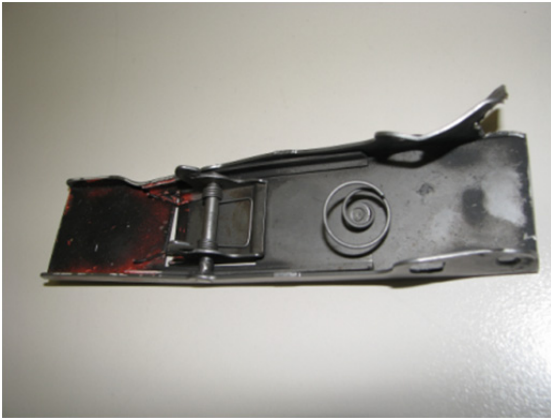
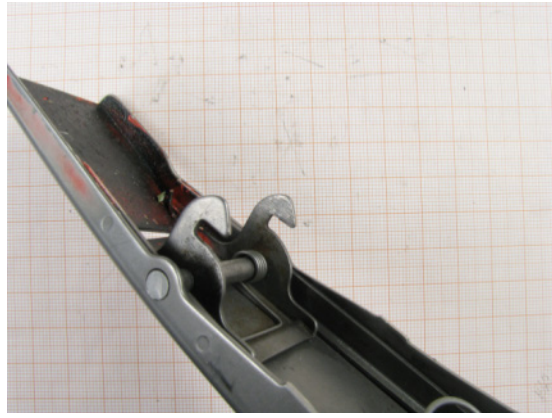
Handle #5:

The handle was slightly twisted and one of the aft receiving holes was torn. The two locking hooks were undamaged. The orange alarm colour was worn and covered by grime. It could not be unambiguously matched with latch A or B.

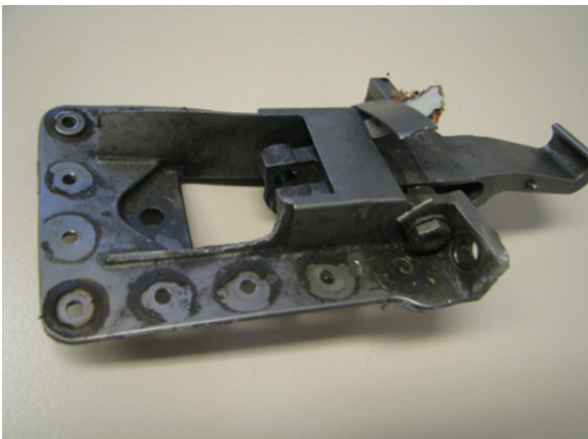
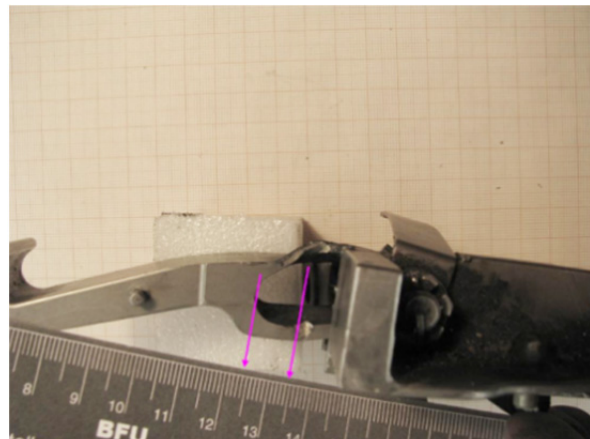
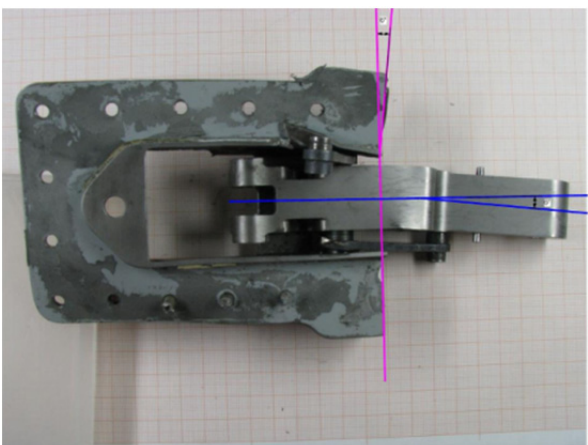
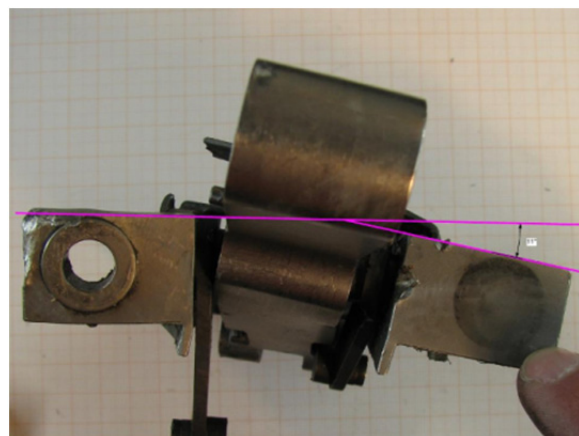
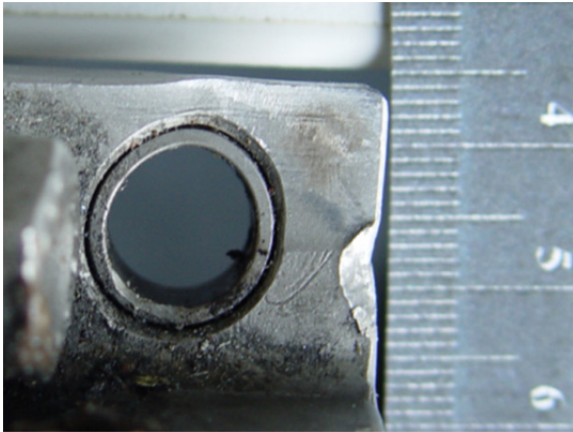
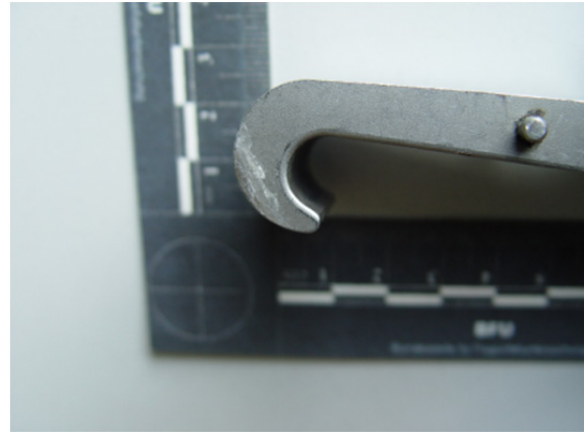
Latch B

The housing was twisted. The hook showed a line-shaped deformation which was more pronounced at the front end. The line did not run perpendicular to the longitudinal axis of the hook. The bushing showed an oval deformation on its inner end.

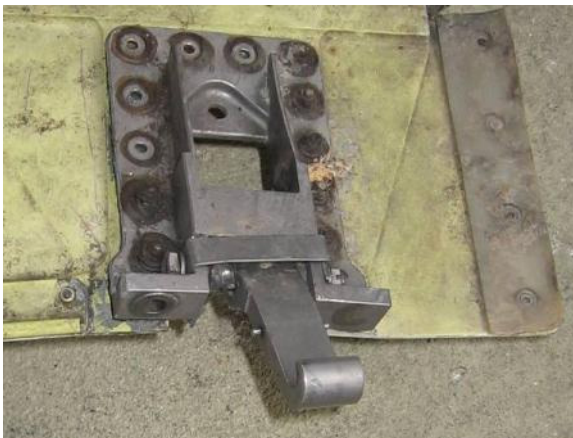
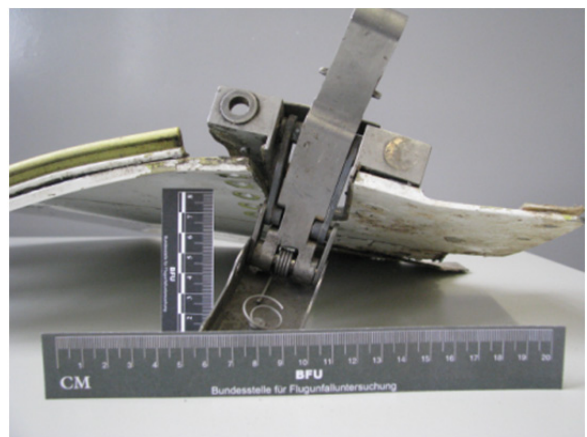
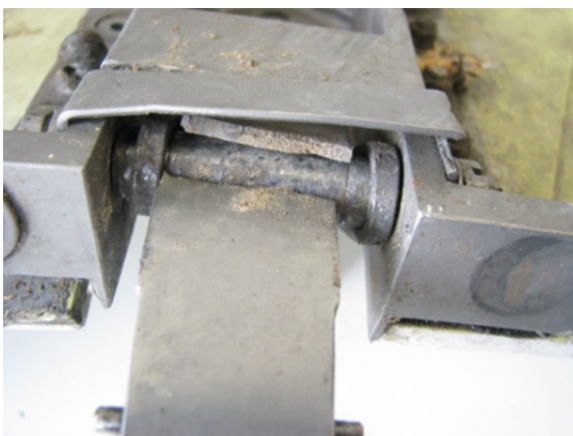
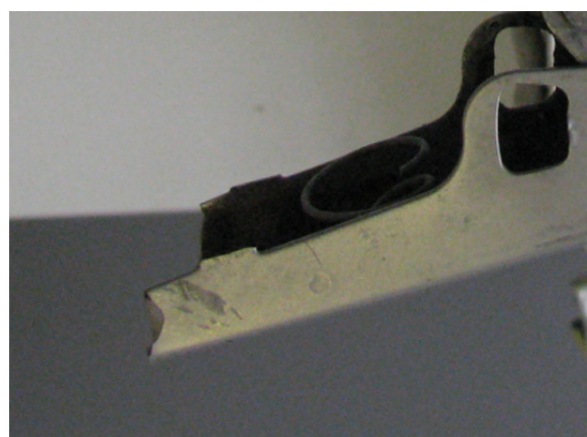
Latch C

The housing was not twisted. The hook of the latch was bent backward and had fractured in a straight line. The handle was fractured and both locking hooks were torn off.

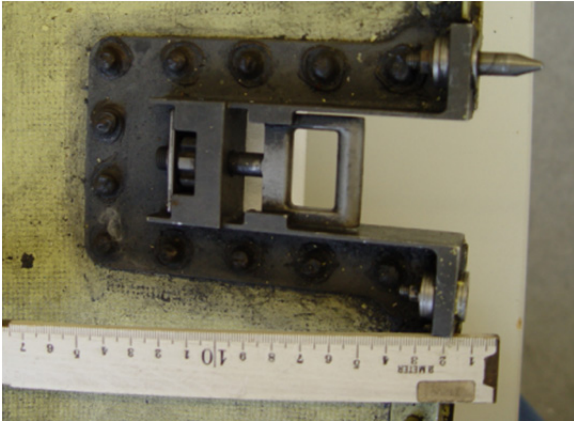
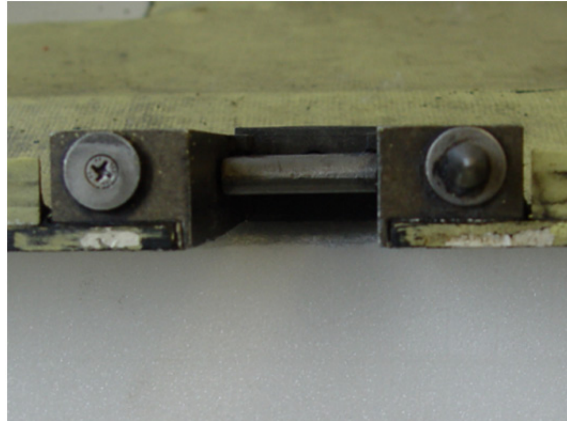
The keeper housing assembly did not show any visible damage.

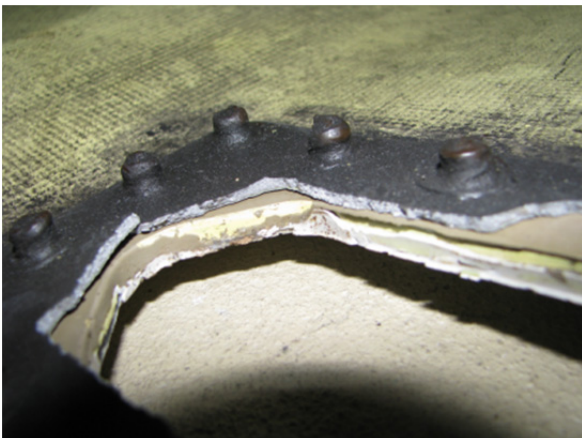
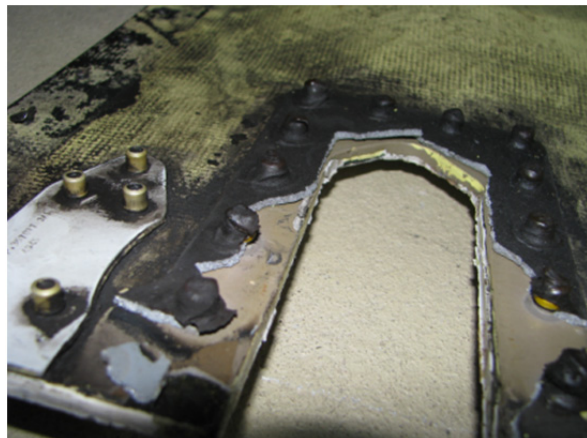
Keeper housing assembly C

The keeper housing assembly in the area of the mounting flange was destroyed.
