# Investigation Report

Type of Occurrence:	Serious incident
Date:	15 August 2011
Location:	Düsseldorf
Aircraft:	Airplane
Manufacturer / Model:	Airbus Industrie / A330-322
Injuries to Persons:	None
Damage:	Minor damage to aircraft
Other Damage:	None
Information Source:	Investigation by BFU
State File Number:	BFU 5X007-11

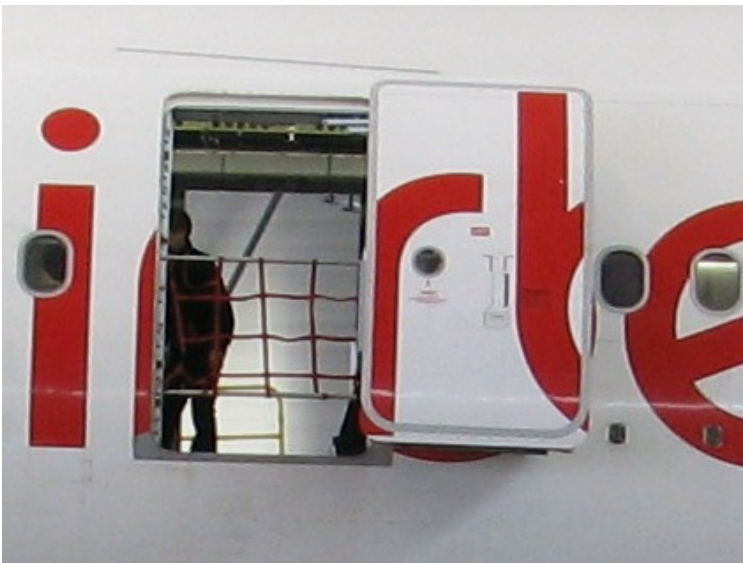
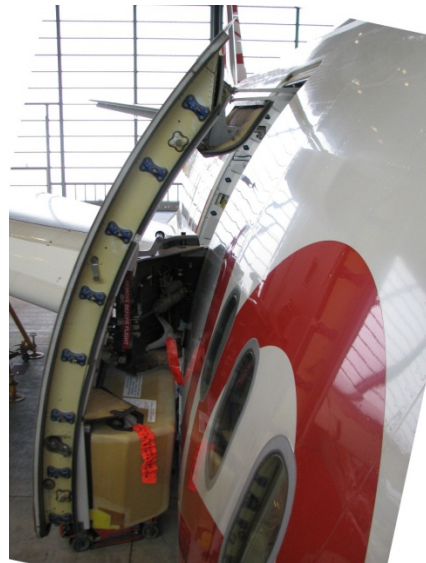
Door R2, in which the work light was installed, is opened almost always whenever the airplane is on the ground since it is used as a service door. The door is pushed outward when it is opened and all sides are exposed to the weather. The examination of an aircraft of the same type showed that the upper side of the door has openings through which water can flow unhindered into the door. Between the door structure and the inner lining there are no seals which would prevent the water from penetrating. When the door panel of this airplane was removed it was determined that the insulation mats had partially collected substantial amounts of water.

Open door R2

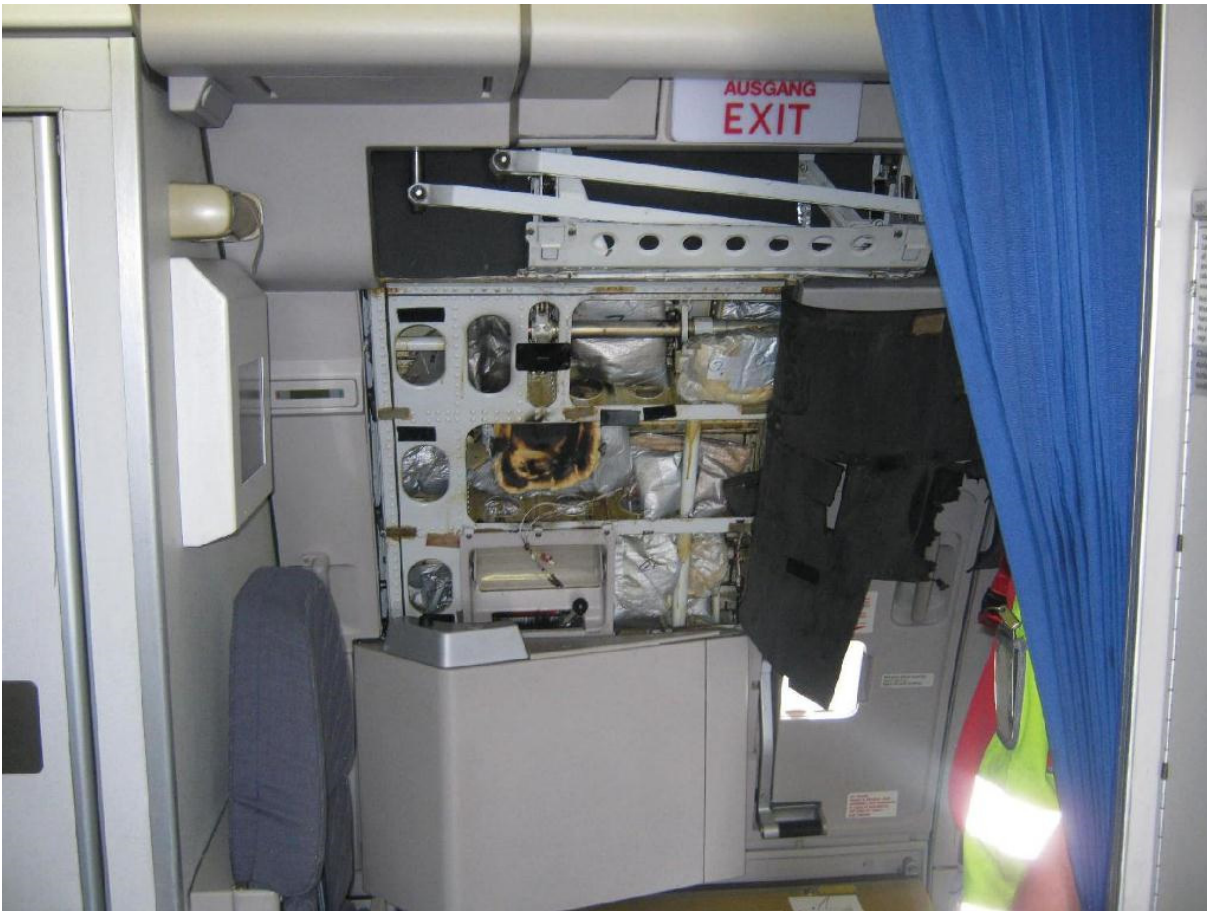
After the landing the interior panel of door 2R showed slight scorch marks in the area of the work light. After the lamp unit (P/N F925-90046-012-00-C) was removed it was determined that especially in the area of the power unit (P/N 8ES004692-10) heavy fire and heat traces were visible. The interior of the door showed fire and scorch marks on the insulation and the structure once the panel was removed.

Fire area on door R2 after the panelling was removed

The traces of high current flow on the circuit board of the power unit, the heat and fire traces on the lamp unit and on the insulation and the door panelling allow the conclusion that the short circuit in the power unit caused a fire which spread to the surrounding area. The fire was limited to a few square decimetres. The BFU is of the opinion that it cannot be determined conclusively if this was owed to the properties of the material used or the immediate use of the fire extinguisher. It is doubtful, however, that enough extinguishing agent could penetrate through the available openings to extinguish the fire. This is even more important because the fire extinguisher was

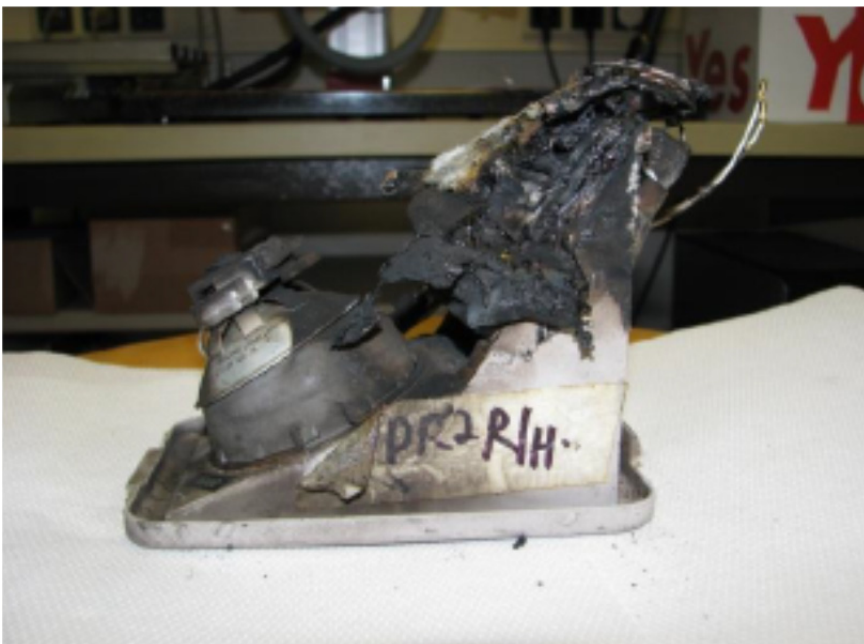
Lamp unit with fire and heat traces

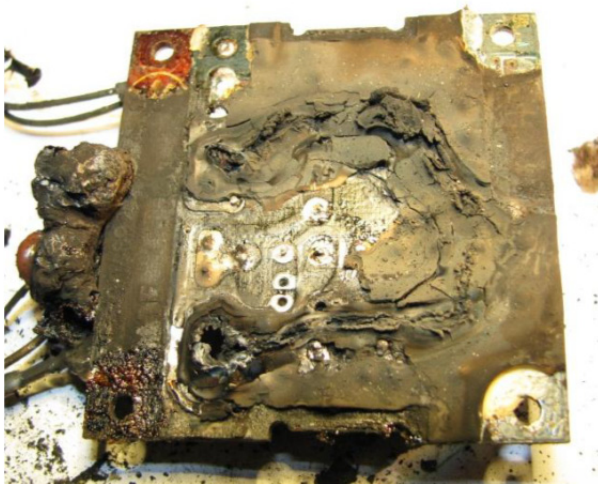
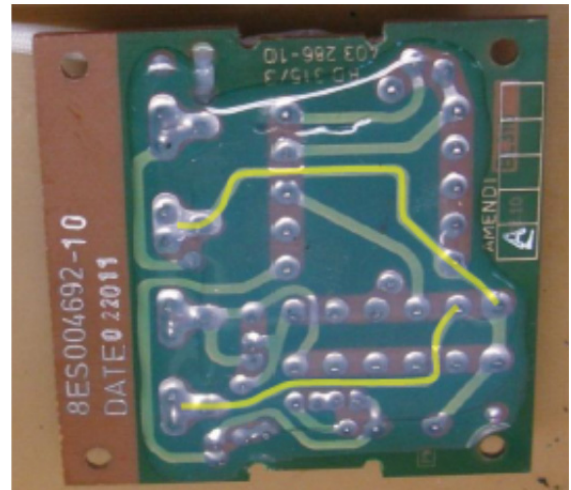
The lamp unit was examined in the BFU laboratory. The circuit board of the power unit showed signs of high current flow along two circuit paths. These circuit paths were directly connected with 115 VAC/400 Hz and AC Return/GND.

Comparison of damaged and new power unit

The BFU is of the opinion that the short circuit was definitely caused by water ingress in combination with a power unit coating insufficient for this particular environment since

In combination with the water the insulation resistance of the circuit board was reduced and resulted in a short circuit.

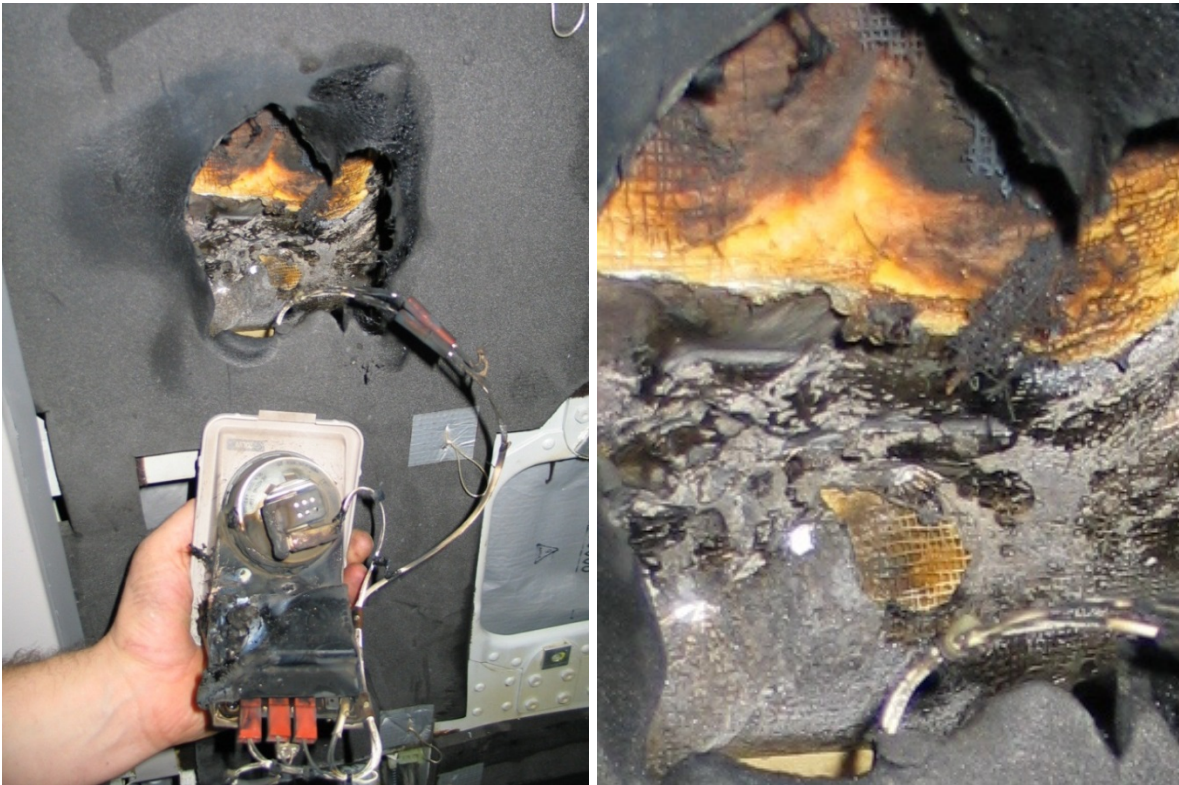
In January 2005 there was smoke development aboard an Airbus A340 in the area of the work light which was installed in a door. The smoke development ended after five minutes. The airplane returned and landed safely. The investigation on the ground conducted by technicians determined that the insulation mats in the vicinity of the lamp were very wet. The photo below shows that the insulation material of the door was partially pyrolyzed.

Traces behind the door panelling (overview and detail)
