*Accident
on 24 March 2001
at Saint-Barthélemy (971)
to the DHC-6-300
registered F-OGES
operated by Caraïbes Air Transport*

REPORT
f-es010324a

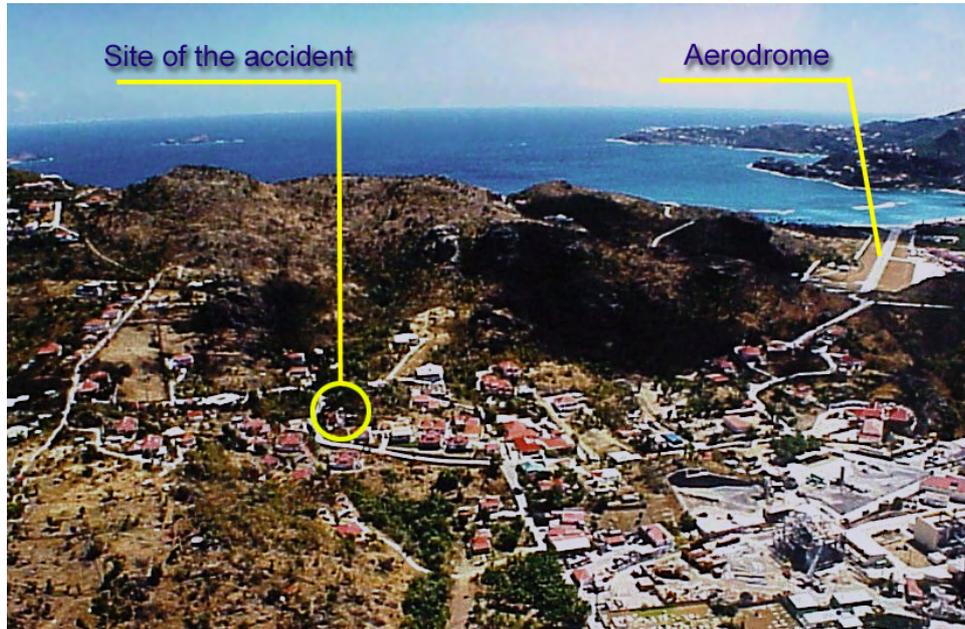
Aerial view of the site and the aerodrome

The accident occurred north-west of the aerodrome, on the west slope of the La Tourmente pass, at around six hundred metres from the threshold of runway 10.

The aircraft struck the ground right next to a dwelling located along the Corossil road, on a steep, hard piece of land planted with trees and bushes. The wreckage was spread over an area of around nine hundred square metres.

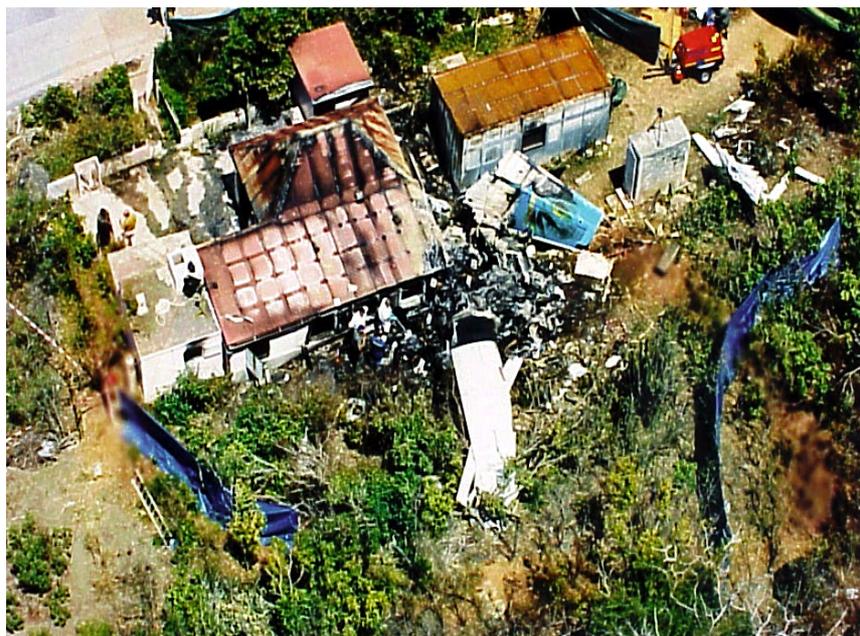
On either side, and in immediate proximity to the area of fire, the main wreckage found was the aircraft's two wings and tail assembly. Not much affected by the fire, they were separated from the fuselage and exhibited significant compression deformations. There were no traces of a bird strike. The rupture marks on the flaps show a symmetrical extension of 37.5% on impact.

No signs of anomalies in relation to the integrity of the controls and mechanical linkages were found.

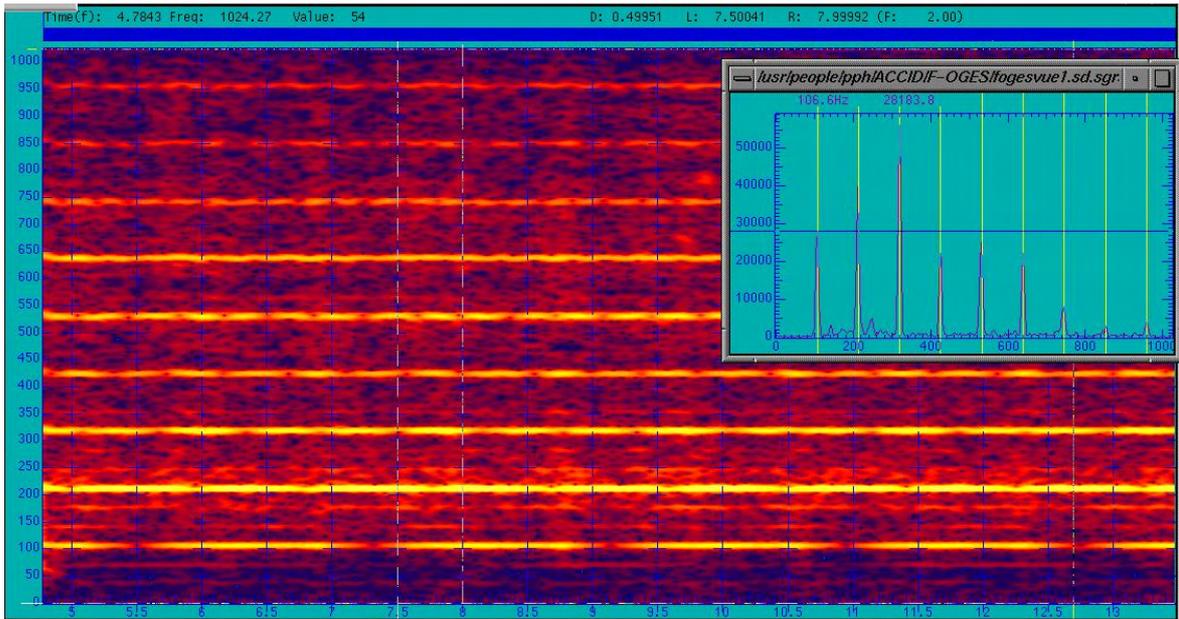
Spectral analysis of the soundtrack on take-off

Take-off: the fundamental frequency measured on the soundtrack was 106 Hz with eight to ten visible harmonics. The propeller rotation speed deduced from this was 2,120 RPM (in this phase of flight the manufacturer specifies a rotation speed of around 2,110 RPM). The absence of a double peak shows that the propellers were turning at the same airspeed.

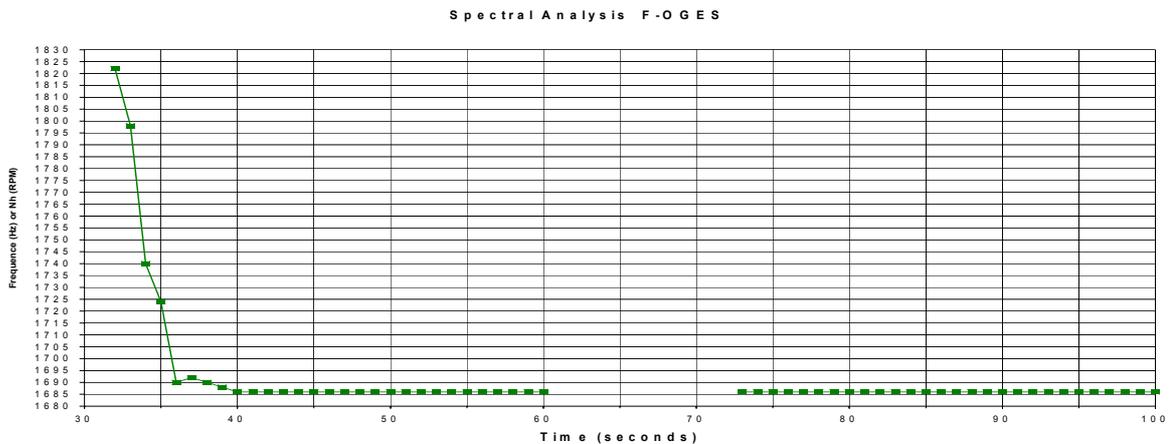
Propeller speed in cruise

Cruise: the sound signal indicates a slowing down of the propeller rotation speed from 1,825 to 1,690 RPM in five seconds, then stabilization at 1,685 RPM. This figure corresponds to the cruising speed specified by the manufacturer. Again, the absence of a double peak shows that the propellers were synchronized.

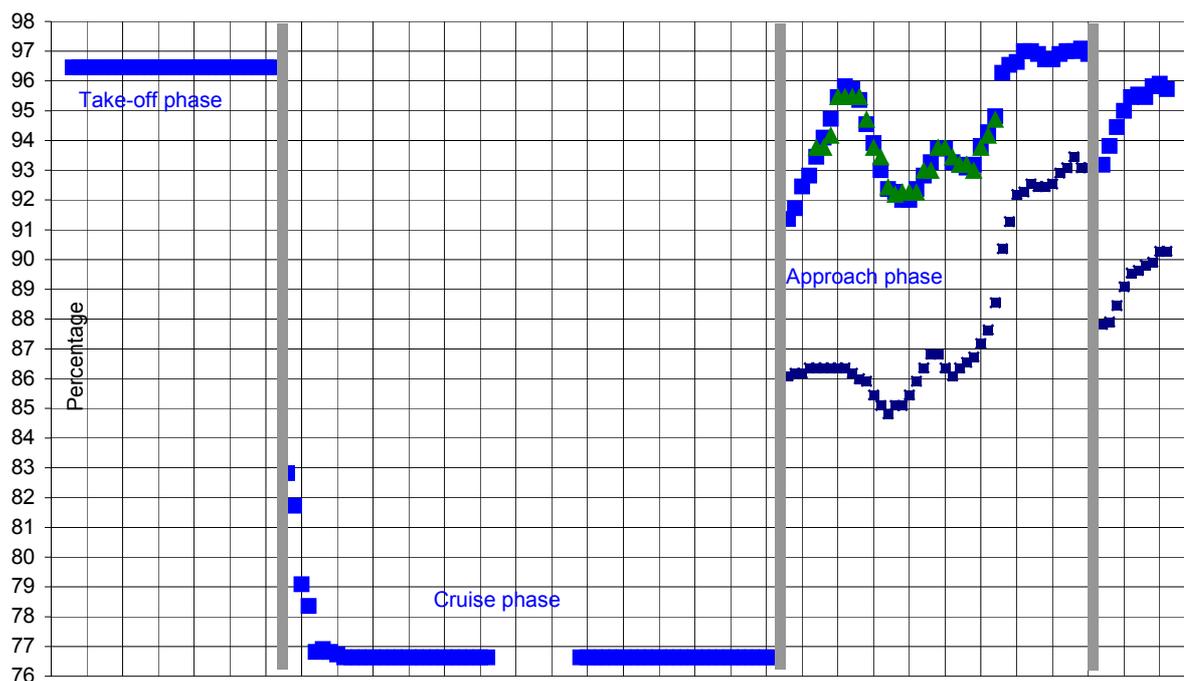
The rotation speeds of the propellers during flight TX 1501, expressed as a percentage of the reference rotation speed as defined by the manufacturer, are represented on the following graph. The discontinuities between the points correspond to the ends of each recording.

The asymmetry between the two propellers during the approach phase was around 9%, which is consistent with normal use (see following). An increase in RPM of the order of 6% to 8% was also noted.

In conclusion, examination of the film found in the wreckage did not bring to light any malfunctions or anomalies for that part of the flight which was recorded.

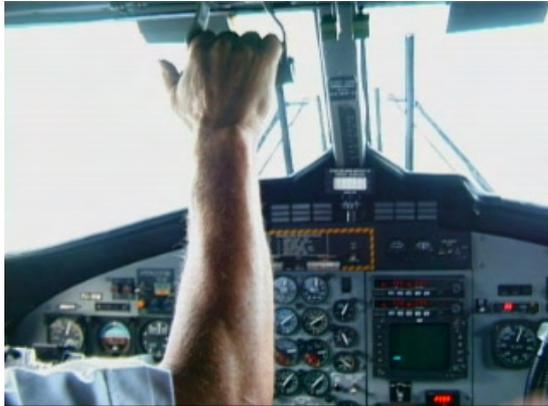
When the PF is seated in the left position, his right forearm is located in the extended vertical axis of the levers, a position which is favorable to symmetric handling.

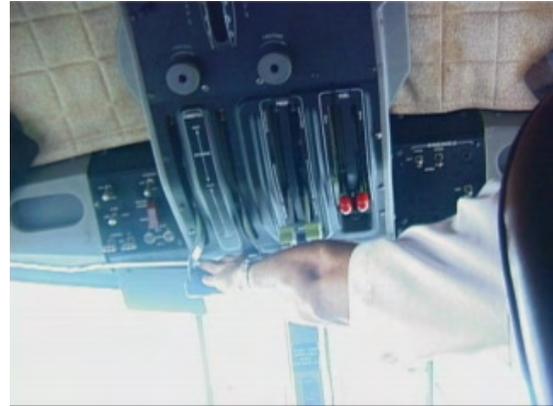
When the PF is seated in the right position, his left forearm is not vertical; he stretches slightly to the left and is thus not aligned with the axis of the levers, this “angle” being compensated by wrist movement.

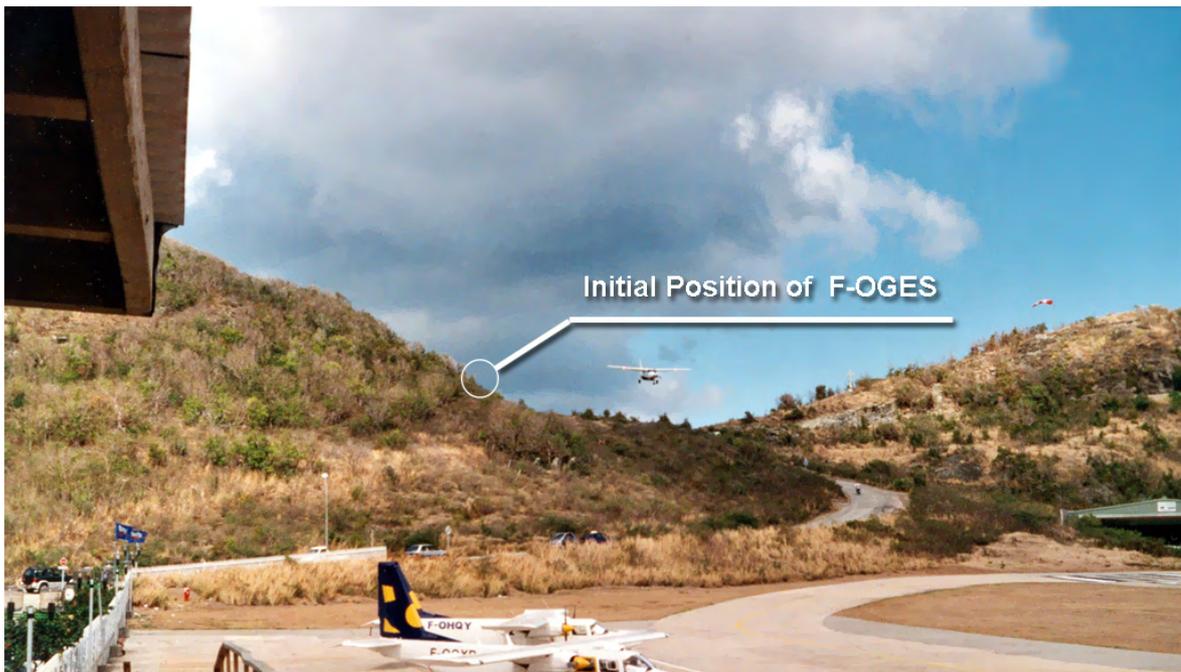
The photo shows an airplane belonging to another airline on passing the pass. The circle indicates the initial position of F-OGES during its turn to the left.
