Air Accidents Investigation Branch

**Report on the serious incident to
Airbus A319-111, registration G-EZAC
near Nantes, France
on 15 September 2006**

This investigation was carried out in accordance with
The Civil Aviation (Investigation of Air Accidents and Incidents) Regulations 1996

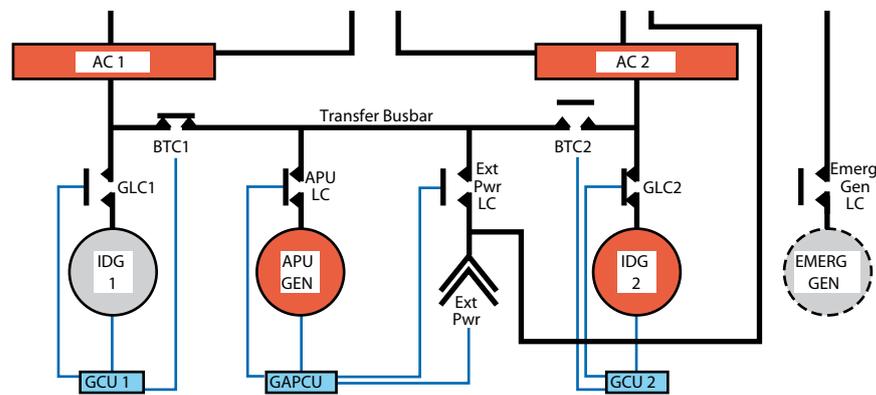
Figure 6

However, if the APU generator output is available on the Transfer busbar it automatically supplies the AC Main busbar associated with the lost IDG output, via the respective BTC (Figure 6). In this situation the other BTC remains open, segregating the on-line IDG and APU outputs from each other. Monitoring and control of the APU generator output is by a combined Ground and Auxiliary Power Control Unit (GAPCU).

EPGS in G-EZAC dispatch configuration for incident flight

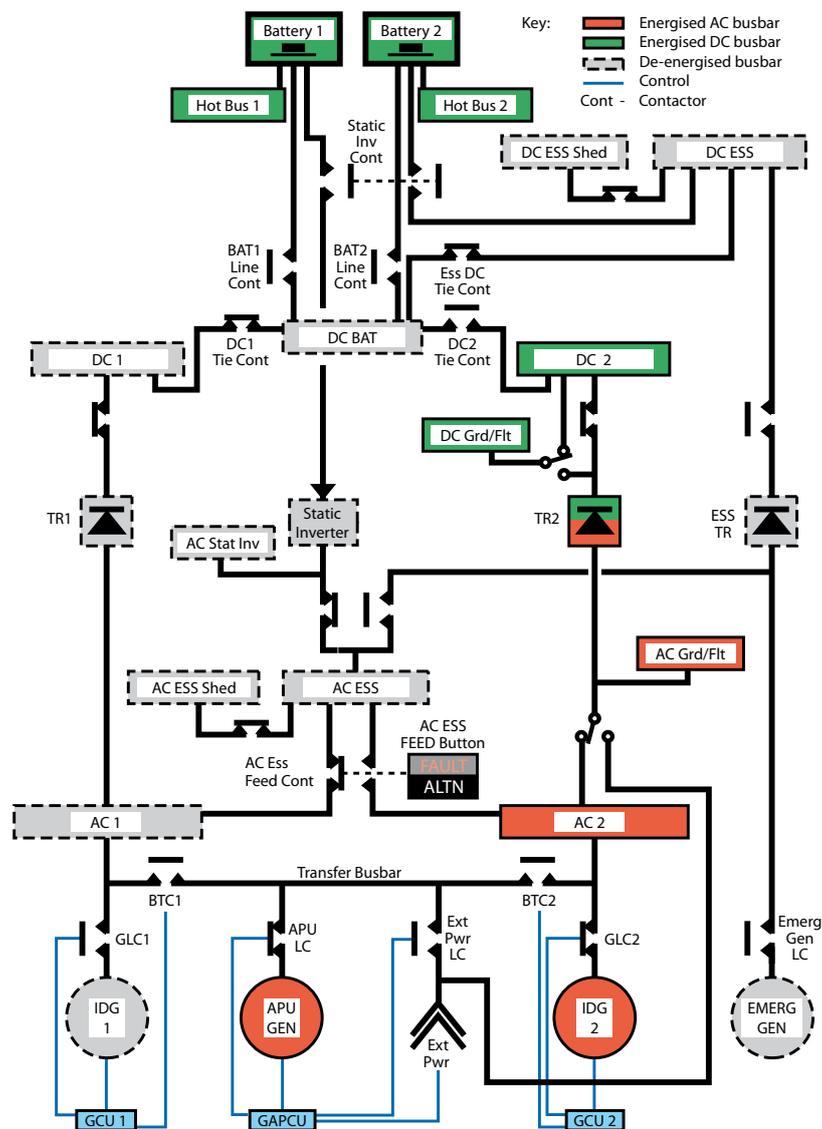
Figure 8

Thus, loss of AC BUS 1 results in loss of the AC ESS busbar, and also the loss of the AC ESS SHED busbar. As loss of AC BUS 1 de-powers TR 1, it also causes loss of the DC BUS 1 as well as loss of the DC ESS and DC ESS SHED busbars (Figure 8). After five seconds DC BUS 1 is automatically transferred to feed from DC BUS 2 via the DC BAT busbar, but it does not supply the DC ESS busbar.

EPGS Distribution System – Immediately After Failure

action item following an electrical failure. Loss of the AC ESS busbar should cause the Master Caution to trigger, an 'AC ESS FAULT' warning message to appear on the ECAM DU and an amber 'FAULT' caption to illuminate in the 'AC ESS FEED' push-button selector switch on the EPGS control panel. Data from Airbus suggests that, following AC BUS 1 failure, a flight crew will typically take, on average, about one minute to restore power to the AC ESS busbar by selecting the AC ESS FEED switch. The crew of G-EZAC reported that they performed this action a number of times, but it did not result in power being restored to the AC ESS busbar.

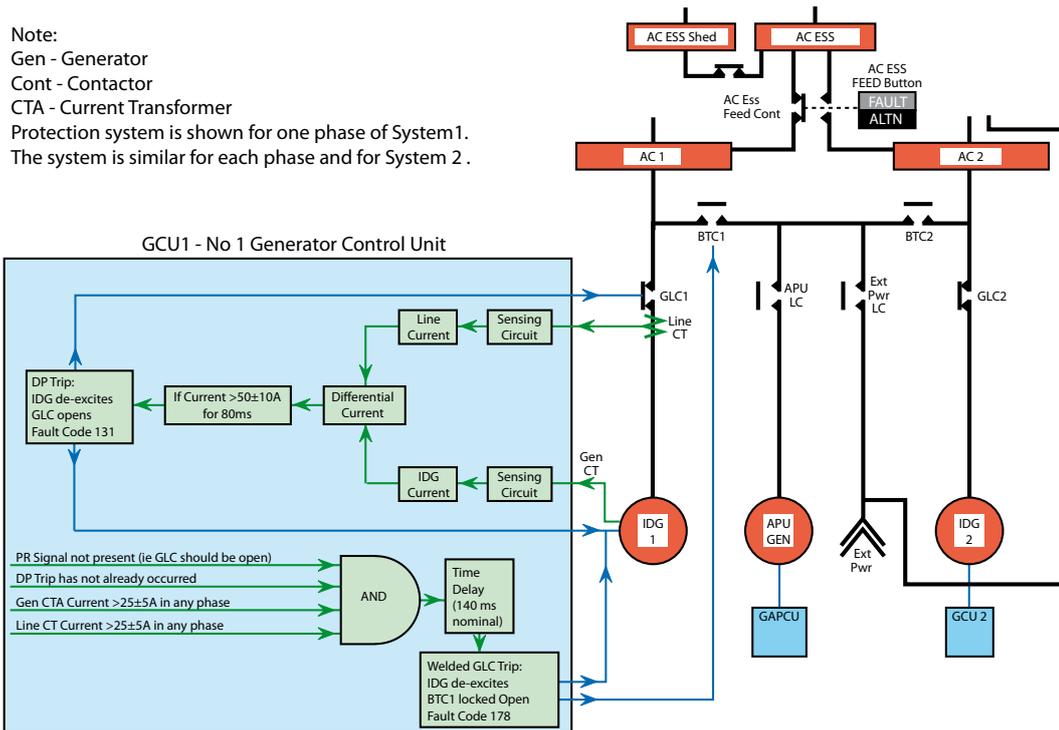
Figure 9

For one of its protection functions, known as 'Differential Protection' (DP), the GCU compares the IDG current with the line current in each phase, as sensed by the CTs. An excessive difference is assumed to be due to a short circuit, either between phases or to earth. The threshold is 50 ± 10 A difference persisting for at least 80 milliseconds (ms).

If the threshold is exceeded, the GCU reacts by de-exciting the IDG and tripping the PRR, thus causing the GLC to open. A Built-In Test Equipment (BITE) message 'FC [Fault Code] 131 IDG GEN CT/GCU' is generated, signifying that a DP trip has occurred. In the normal situation with the electrical networks
