Final report RL 2016:11e

Accident in Oajevágge, Norrbotten County, Sweden on 8 January 2016 involving the aeroplane SE-DUX of the model CL-600-2B19, operated by West Atlantic Sweden AB.

File no. L-01/16

12/12/2016

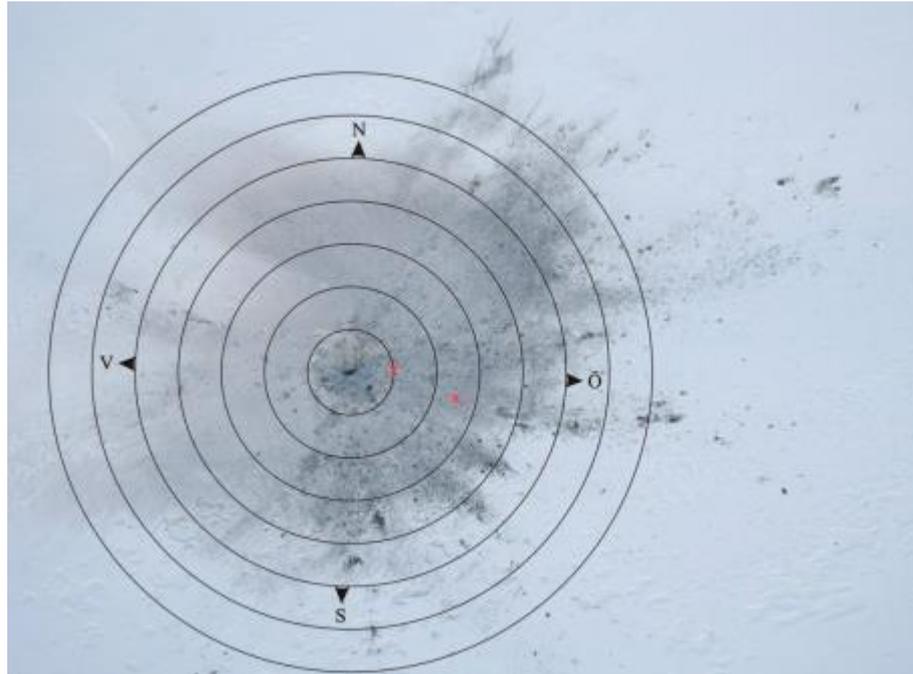
The accident site is located in an almost flat part of a valley in mountainous terrain. In connection with the accident, a crater was formed. The crater was approximately 6 meters deep and 20 meters in diameter. The bottom of the crater was filled with about 1.5 cubic meters of fluid consisting of aviation fuel and water.

Figure 17. Accident site with 10 meter distance circles. CVR was found at the red cross closest to the center, DFDR at the second cross (Photo: Swedish Police).

The aircraft was destroyed. Debris was found up to a distance of about 150 meters from the crater. Most parts were found in the crater and to the northeast of it (figure 17 above). Mapping of the debris was made according to the polar method, which means that one starts from the centre of the accident site and specify distance and direction.

The distribution of the debris shows that the aeroplane hit the ground approximately in an easterly direction. The main part of the right wing was found in the northern part of the crater, while the main part of the left wing was found in the southern part, which indicates that the aircraft collided with the ground in an inverted position.

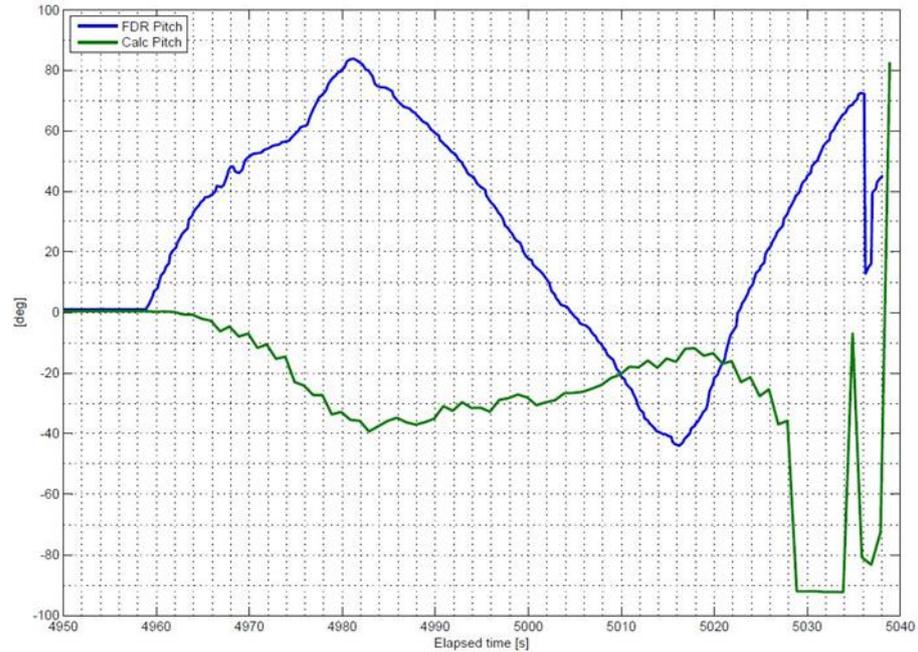
The chart below shows the physically probable values for the aircraft's real pitch angle and the DFDR recorded pitch angle (figure 22).

Figure 22. DFDR pitch angle (blue) and calculated pitch angle (green).

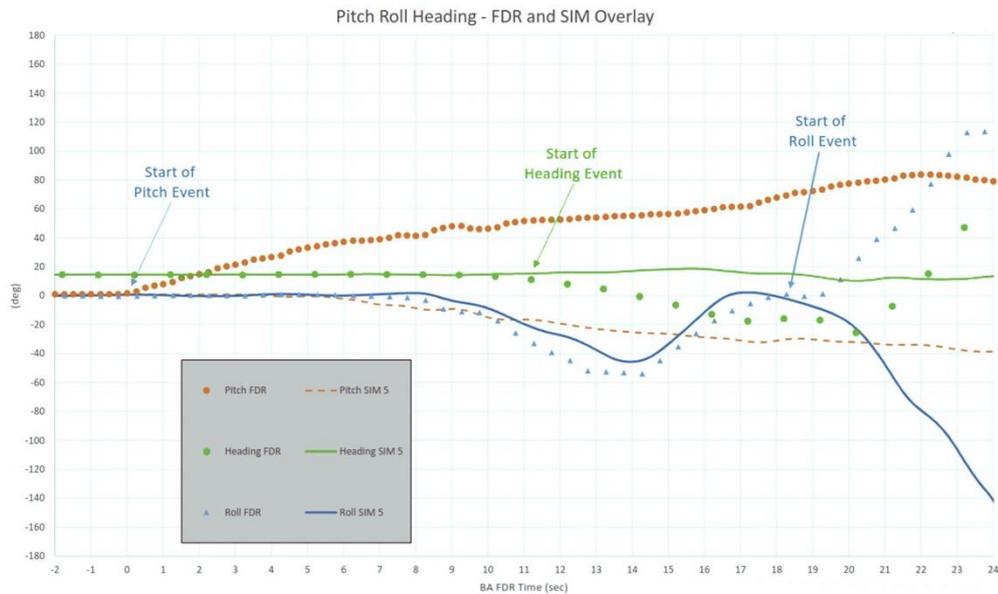
The calculations show that the DFDR-recorded roll angle started to deviate from the aeroplane’s calculated real roll angle about 6 seconds after the start of the event. The roll angles thereafter show a certain consistency and are definitely deviating after another 13 seconds.

Furthermore, the calculations show that the DFDR recorded magnetic heading started to deviate from the calculated magnetic heading after approximately 11 seconds (figure 23).

Figure 23. Discrepancy between DFDR recorded values and simulated real values.

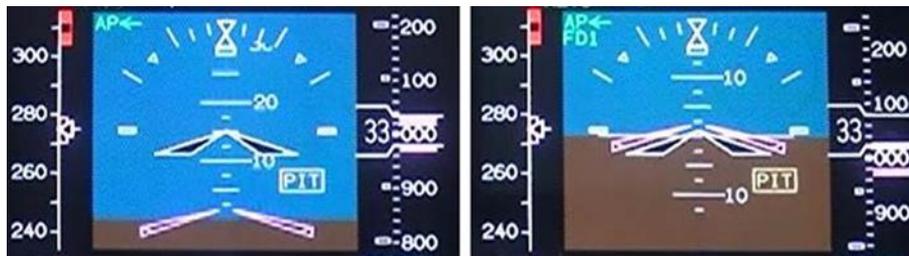
The figure 25 below shows the information that is believed to have been displayed on PFD 1 and 2. The Pitch angle on the left PFD was about 15 degrees but unchanged on the right PFD.

Since the difference between the units exceeded 4 degrees, the PIT symbol was displayed flashing in yellow. No audible warning (Master Caution) had yet been recorded which is likely due to the delay which is built into the system. The activation of the PIT display shall coincide by design with an EFIS COMP MON caution on the EICAS display. The flight director indicator went down to give control commands to lower the nose of the aircraft as the autopilot was in the altitude hold mode called Altitude Track.

Figure 25. Left and right PFD at t2.

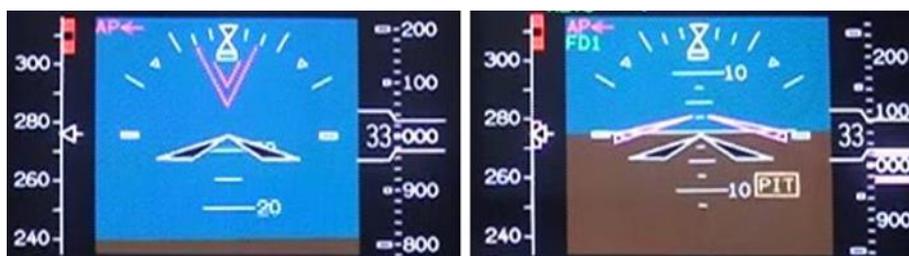
At t4 the pitch angle on the left PFD reached 30 degrees and the unit went into declutter mode which means that the PIT caution and the Flight Director symbol disappeared and that a red chevron appeared. The right unit was still displaying information without declutter as before (see figure 26 below).

Figure 26. Declutter on left PFD at t4.

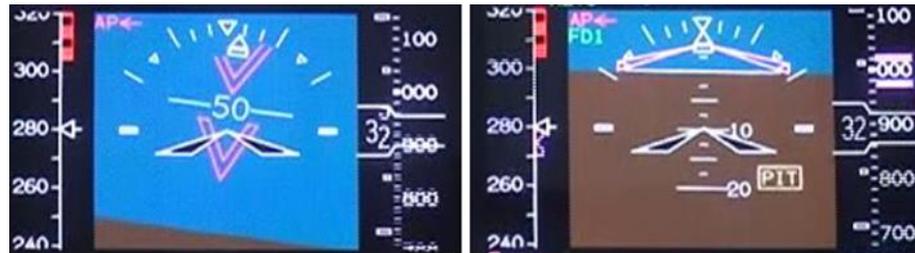
A few seconds after the negative G-load onset, between **t9** and **t12**, the co-pilot's trim switch was activated while an unexplained roll to the left occurs. The reason for this might have been the co-pilot's grabbing on the control wheel during negative G-load.

Figure 27. Start of diverging Roll Angle at **t9**.

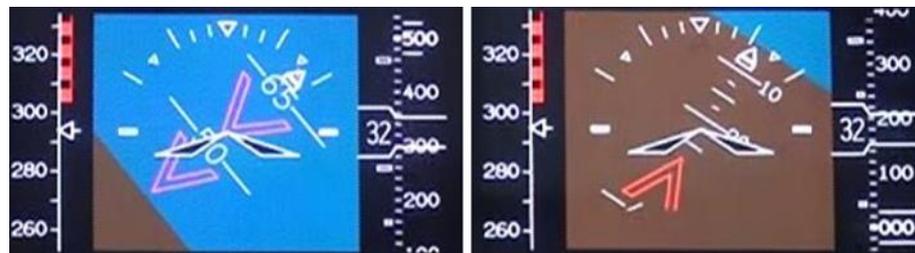
At approximately **t13** the Pitch Angle on the right side PFD reached minus 20 degrees which meant that the declutter mode now was activated on this side (see figure 28 below). The co-pilot exclaimed the first operational callout “Come up”. At about the same time the warning for stabilizer movement, Stab Trim Clacker, was activated and another Triple Chime sounded which was cut-out by two Bank Angle warnings.

Figure 28. Declutter mode on right PFD at **t13**.

The situation at this time meant that the crew were presented with two contradictory attitude indicators with red chevrons pointing in opposite directions. At the same time none of the instruments displayed any comparator caution.

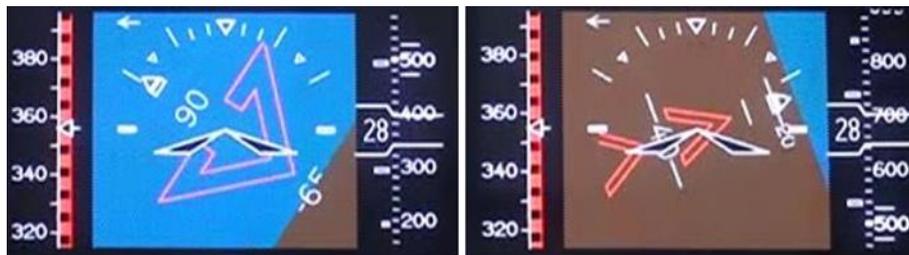
The speed and attitude in combination with the spatial disorientation of the flight crew at this point meant that the possibilities to recover from the loss of control of the aeroplane now were minor.

Figure 29. Display of the simulation at **t22**.
