PRELIMINARY REPORT

ACCIDENT
aircraft B737-400 registration marks HA-FAX,
Orio al Serio Airport,
5th of August 2016

Boeing 737/400 registration marks HA-FAX

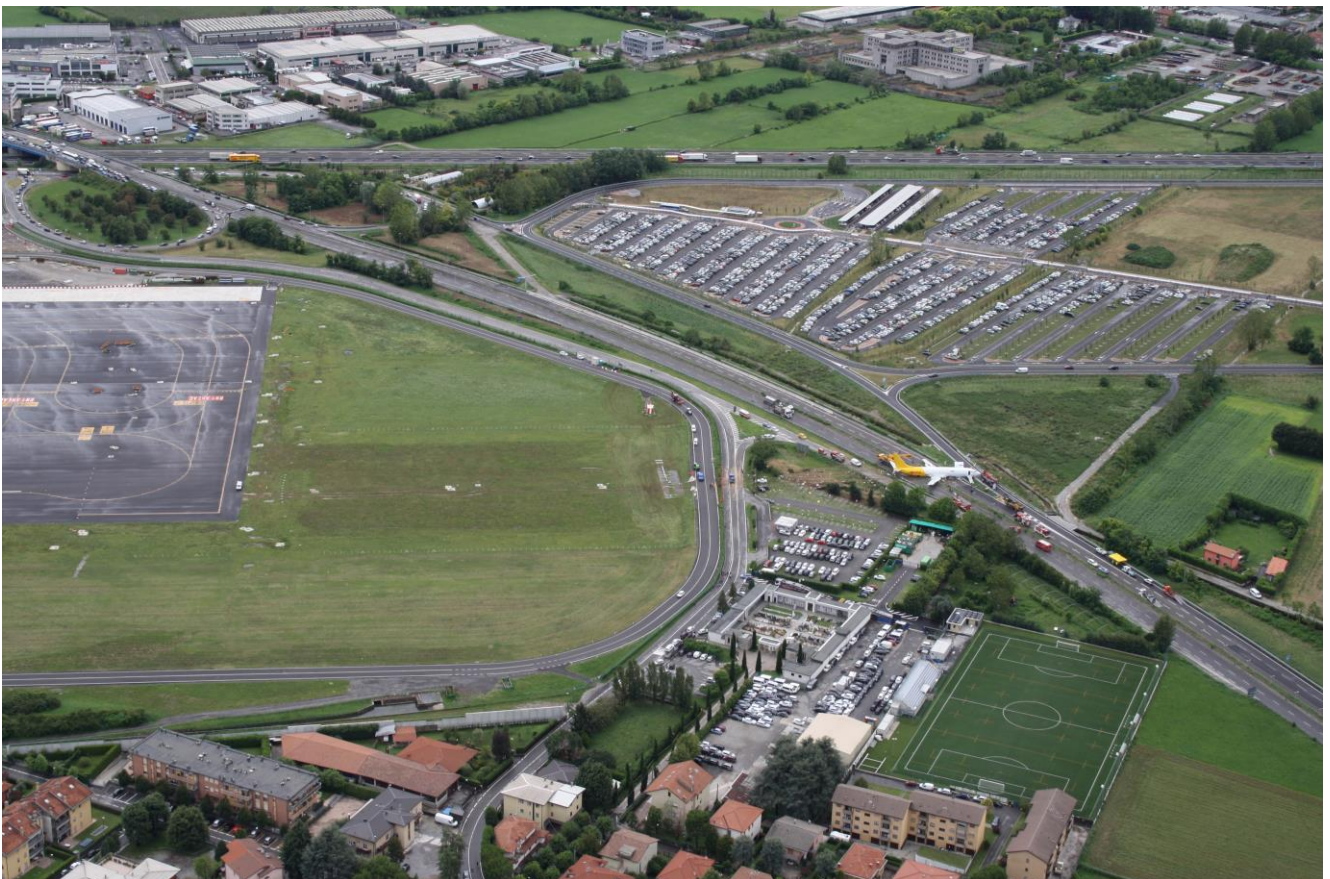
The aircraft touched down at approximately 2000 meters from the threshold RWY 28 and during deceleration broke through the localizer antennas and the airport fence. The landing gear and both engines separated from the main body and the aircraft came to a complete rest at about 520 meters beyond the runway end. The crew deployed the emergency slide and evacuated the aircraft using the right front door. They were assisted by the medical team and carried to the hospital for further treatment. Firefighting rescue team reached the accident site within three minutes from the emergency call.

Picture 1: the accident site (aerial view from Carabinieri Corps).

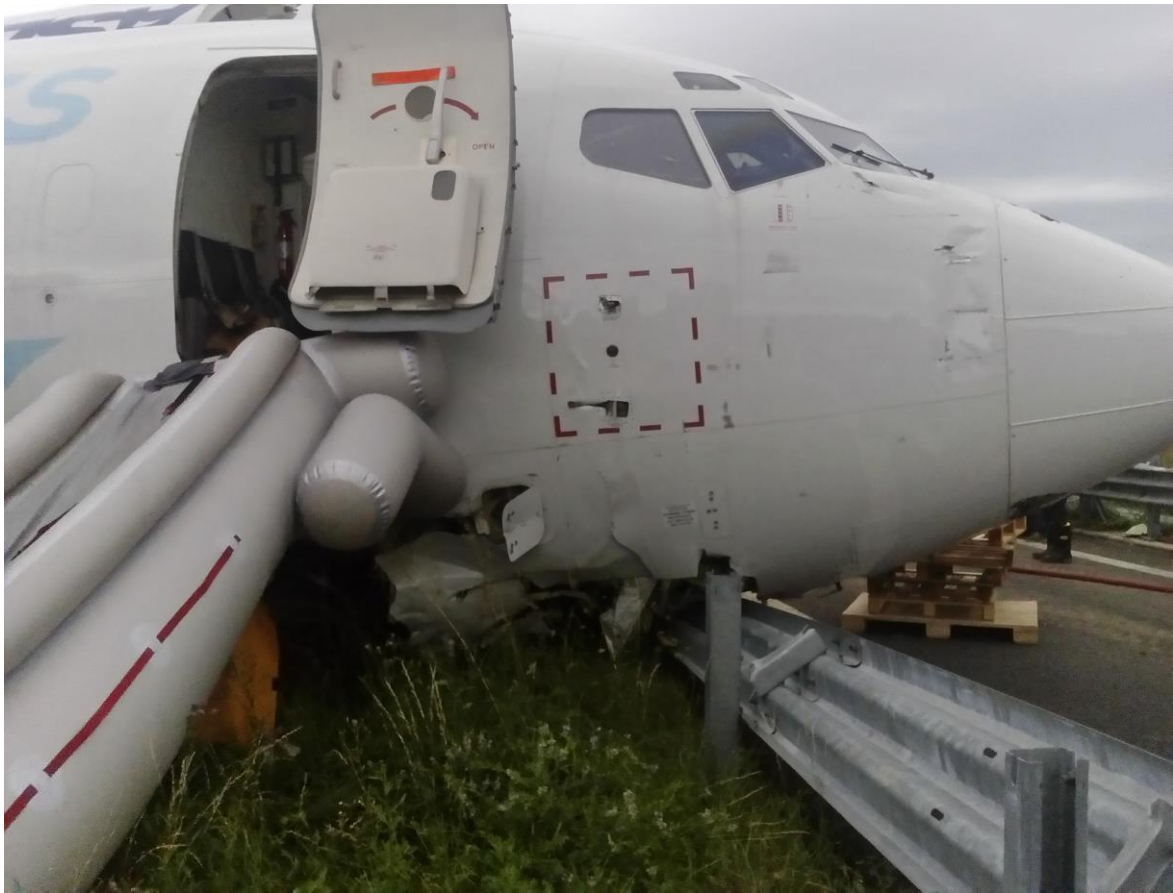
Picture 2: aircraft damage.

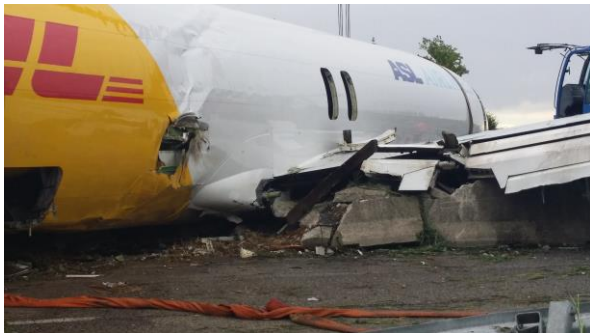
Picture 3: aircraft damage.

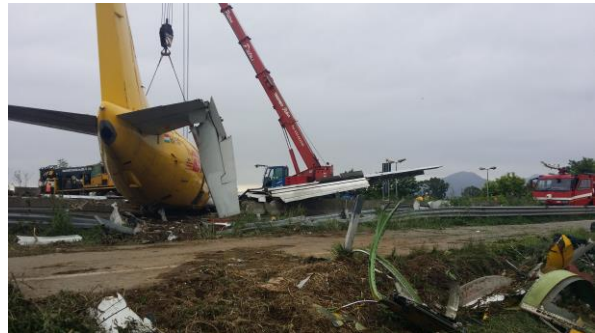
Picture 4: aircraft recovery operations.
