ACCIDENT REPORT

occurred to the Boeing B737-800AS aircraft
registration marks EI-DYG
Rome Ciampino airport
November 10th 2008

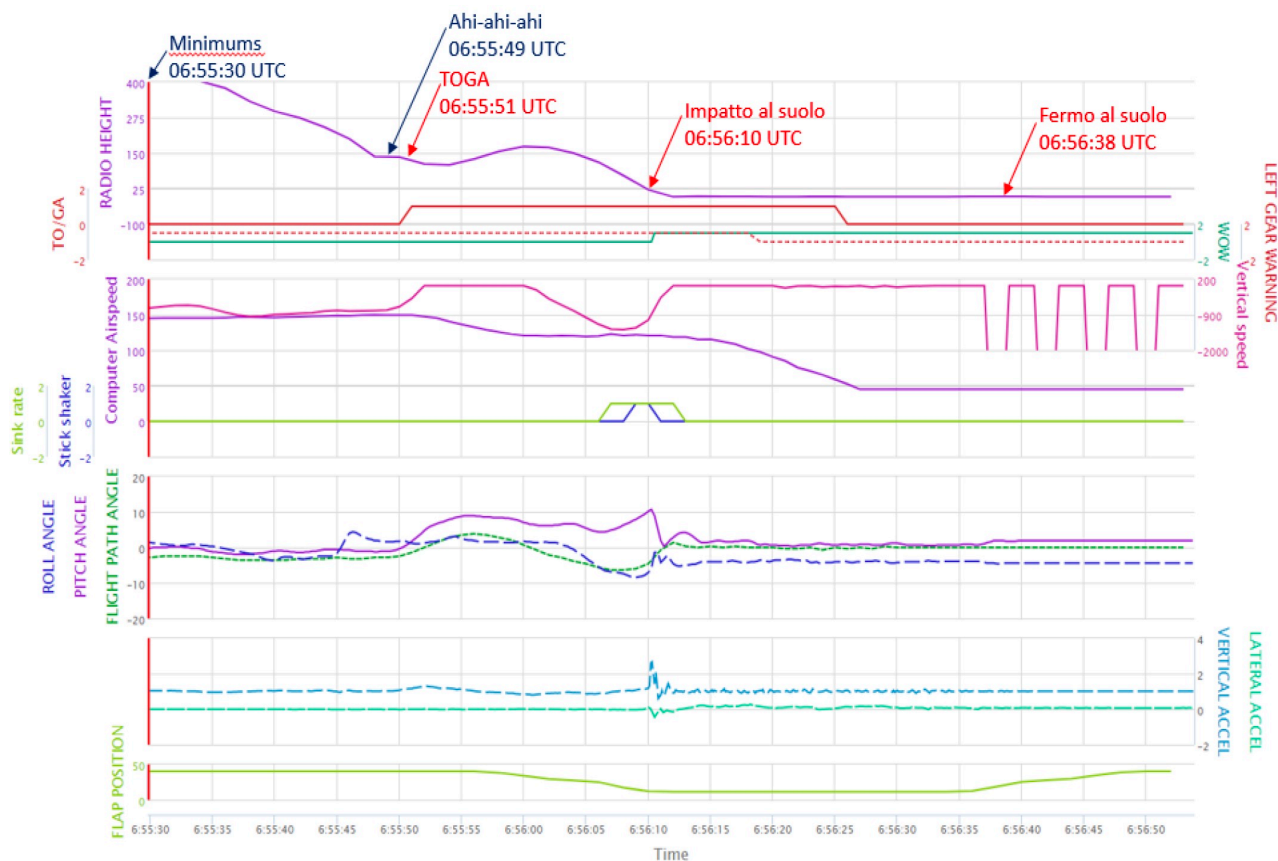
At 06.56'10", the aircraft touched the ground (switching of WOW) with a pitch of 10° and roll -6°, indicated a speed of 120.75 knots, vario metric airspeed of -1064 feet/minute, vertical acceleration of 2.66 g and a side one of -0.45 g.

Picture 19 : sink rate, aerodynamic data, and acceleration on impact

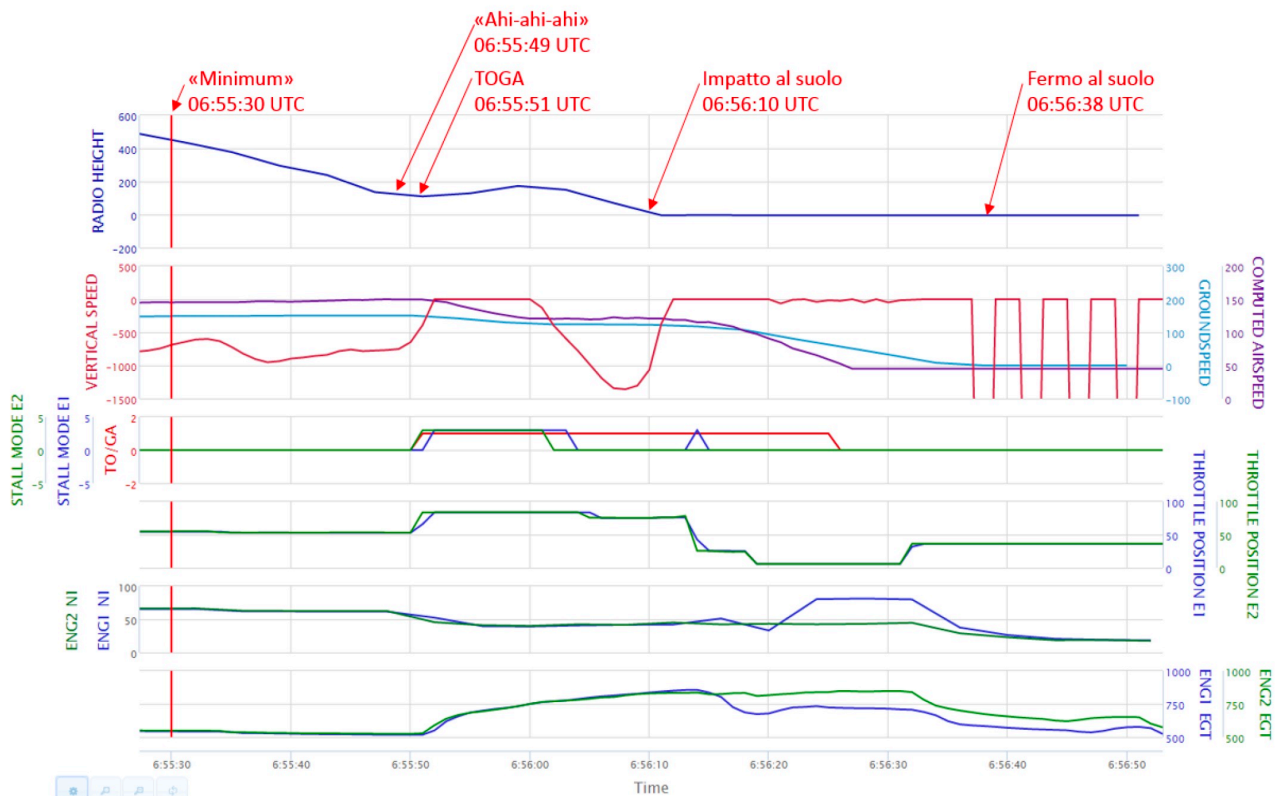
Together with the lowering of the N1, there was a sudden increase EGT of both engines.

Picture 25 : behavior of engines

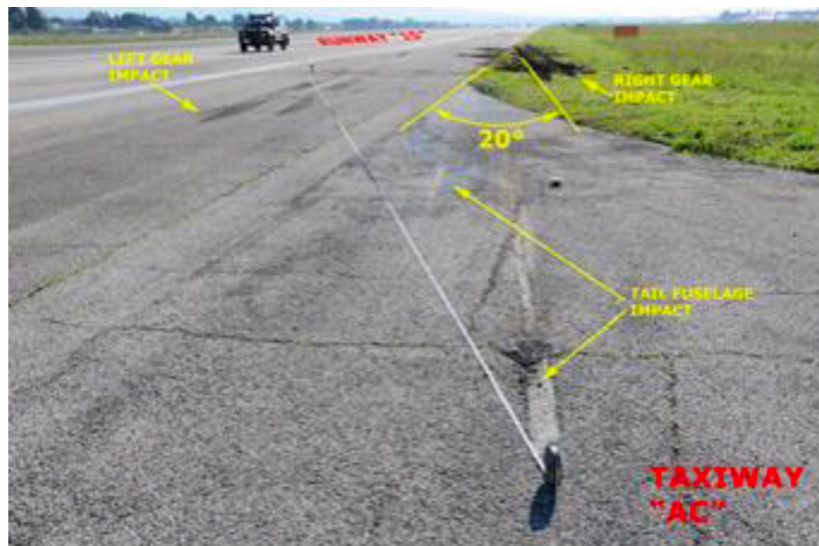
- Impact trace of the lower part of the tail against the asphalt surface of the "AC" taxiway;
- Impact of the left landing gear against the asphalt surface of the runway;
- Impact of the right landing gear on the lawn adjacent to the right edge of the runway;
- A Continuous trail of the left engine and left landing gear from the first point of contact until the aircraft's final stop point.

Photo 5 : runways on the ground of the landing gear and tail

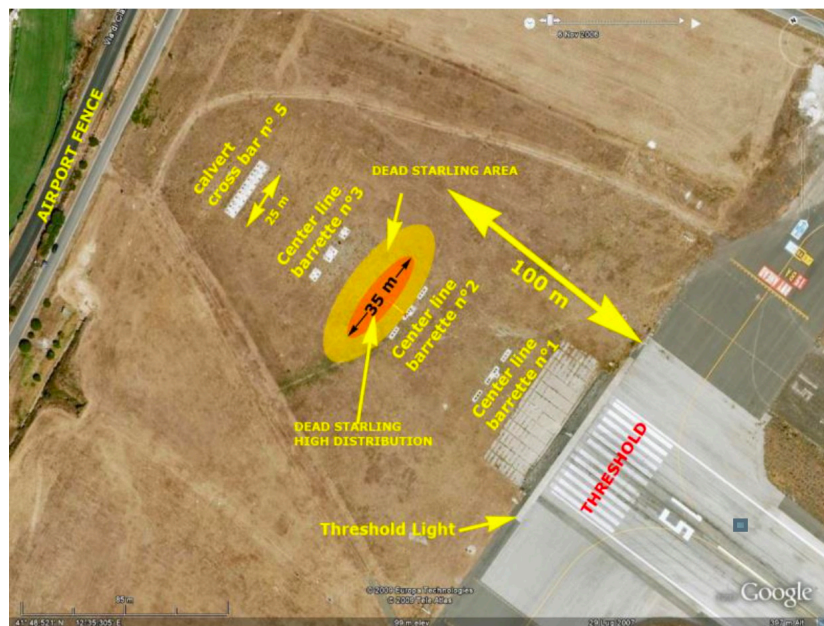
Most of the organic remains were concentrated within an ellipsoidal zone, closer to the pylon "Centerline bars n°2", whose major axis was about 35 m, while the smaller one was about 10 m.

Photo 7 : distribution of bird remains

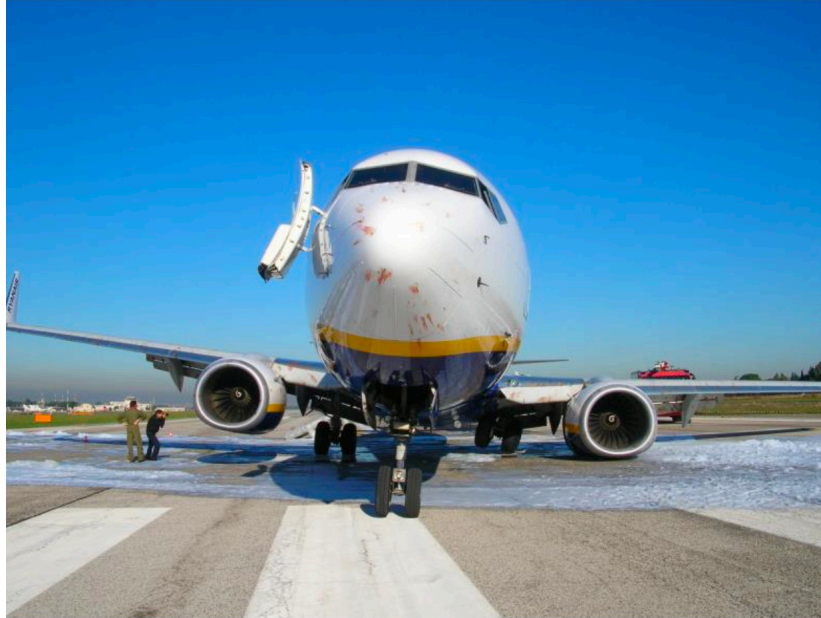
The aircraft stopped at the end of the runway, corresponding to the RWY 33 threshold, resting on the main right-hand landing gear, the nose gear, and the left-hand fan cowl.

Photo 8 : airplane on the runway

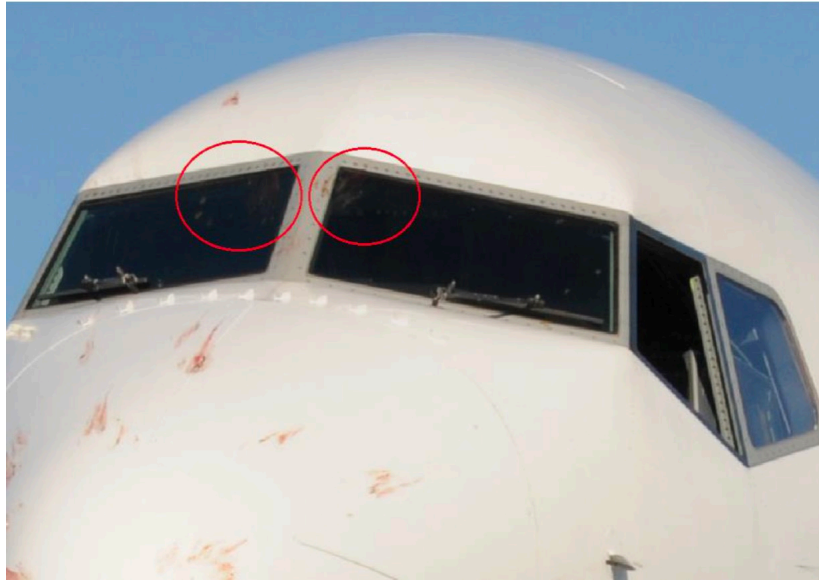
The fuselage has multiple signs of impact with birds (not less than 86), visible in the subsequent images. Windshields have some impacts with birds in the upper part and the central one.

Photo 10 : bird impacts on the windshield

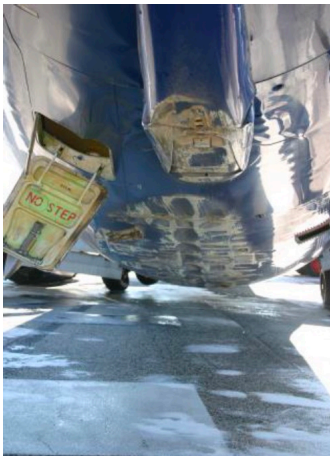
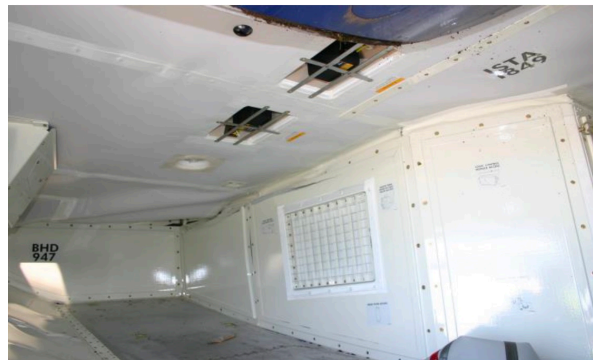
On the lower back of the fuselage, there are evident damages due impact and sliding against the asphalt of the runway.

The lower part of the passenger cabin floor structure presents extensive deformations.

Photo 11 and Photo 12 : damage to tail and cabin floor

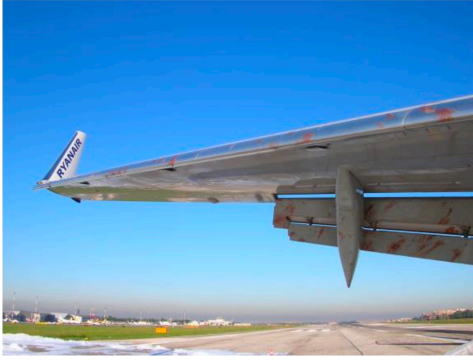
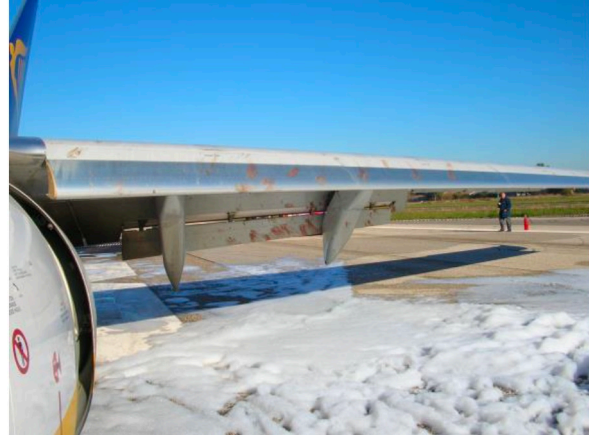
On the left wing, there are many points of damage and embossing, both on the upper, and on the lower part of the wing. The flaps have dents.

Photo 13 and Photo 14 : impact of birds on wings

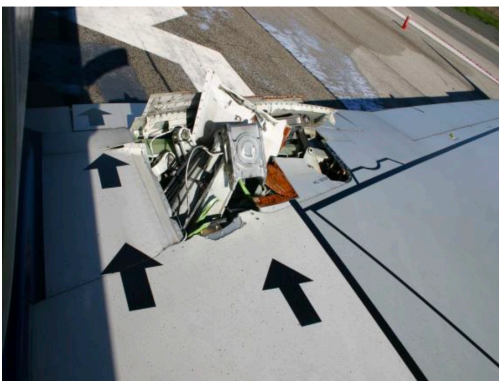
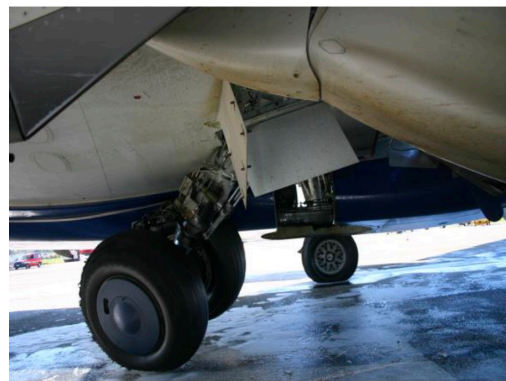
The left main landing gear is severely damaged, the shock absorber passed through the wing.

The landing gear doors of the left main landing gear are severely damaged.

Photo 15 and Photo 16 : left side, damage to main landing gear and wing

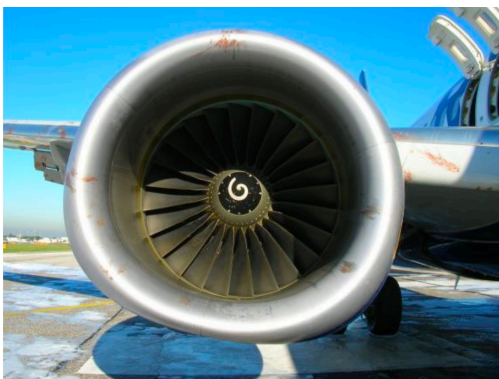
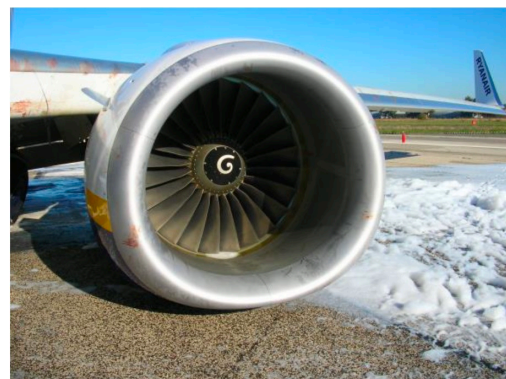
The engines have many traces of impact with birds on their respective air intakes.

Photo 17 and Photo 18 : bird strikes on engine intakes

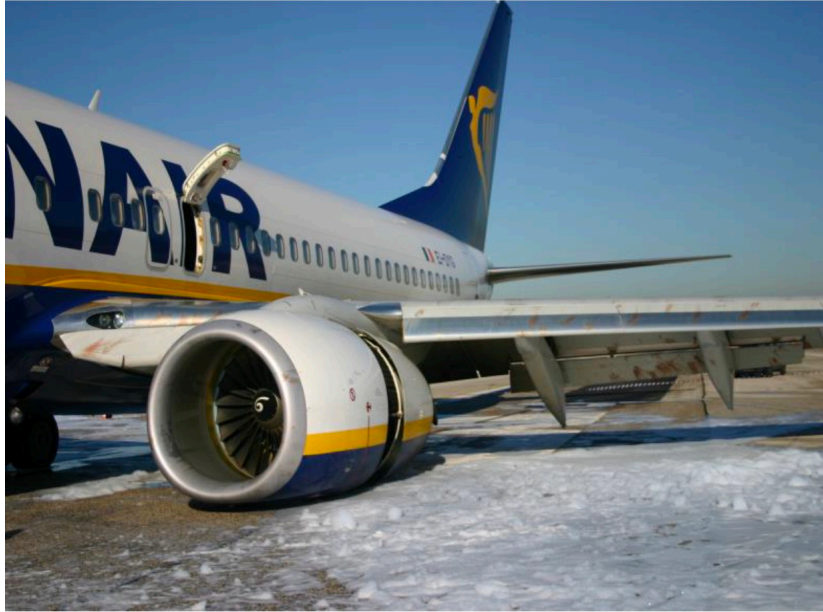
On the fan cowl of the left engine, there are damages from swiping on the asphalt, thrust reverser doors are locked in a partially open position.

Photo 19 : thrust reverser locked in a partially opened position

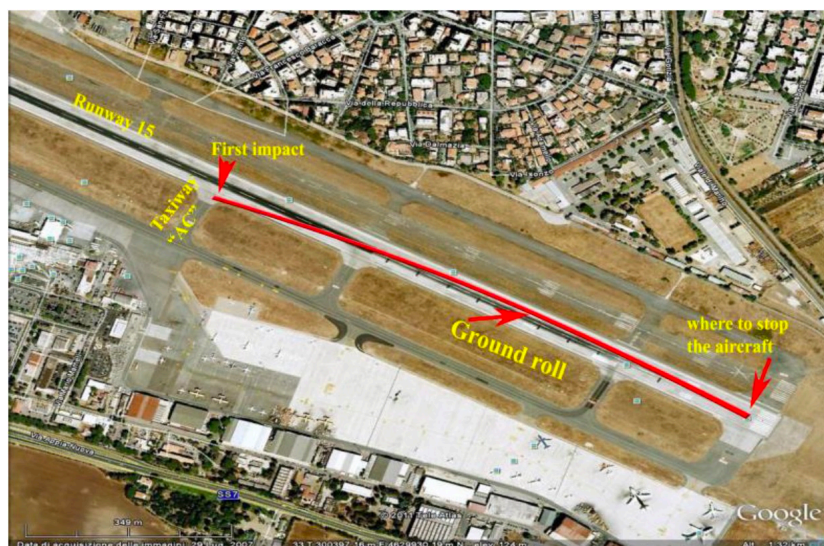
The damages found on the aircraft have allowed confirming that there was a contact of the tail of the aircraft with the runway, contact that caused a plastic deformation of the structure. The traces on the ground have allowed us to precisely determine the point and the mode of initial contact of the aircraft with the ground. It was also possible, on the base of the traces detected on the ground, to reconstruct the trajectory of the aircraft from the first contact with the runway, up to the stop point.

Photo 20 : the ground roll of the airplane

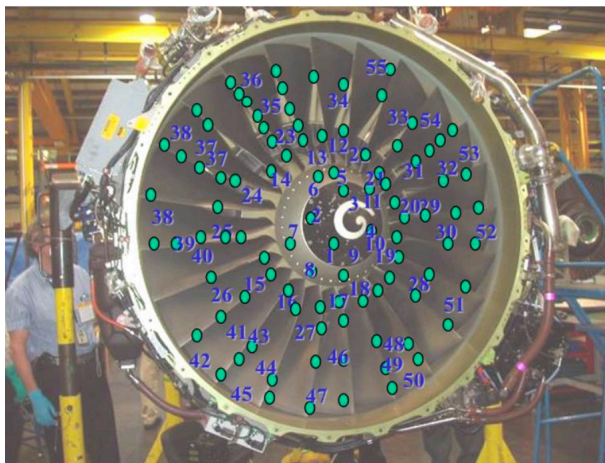
The external visual inspection of the fans highlighted 55 points of impact with birds on the fan of the left engine and 30 points on the right engine fan; on both fans there were no apparent damage and deformation of the aerodynamic profile of the blades; has been found a slight deformation of the engine case fan # 1, due to contact and subsequent creep with the runway of its fan cowl¹.

Photo 24 : bird impacts on engine fan #1

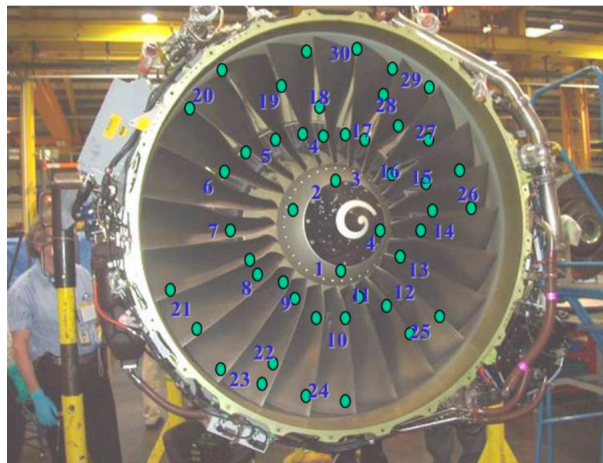
Photo 25 : bird impacts on engine fan #2

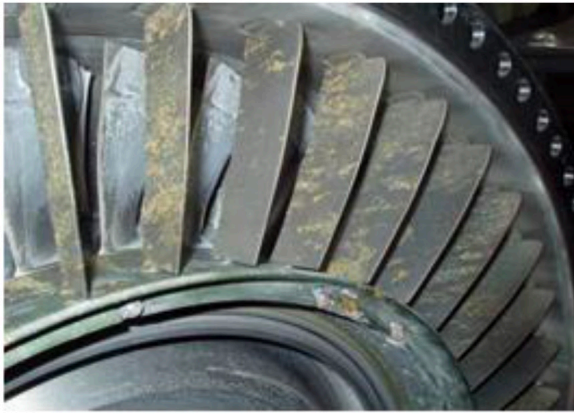
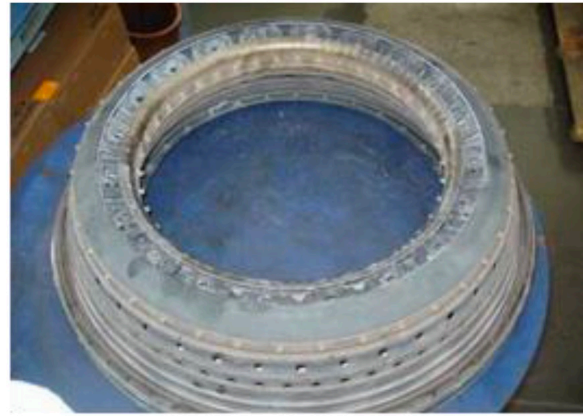
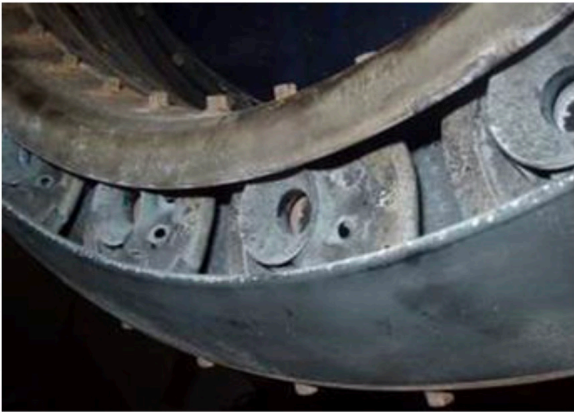
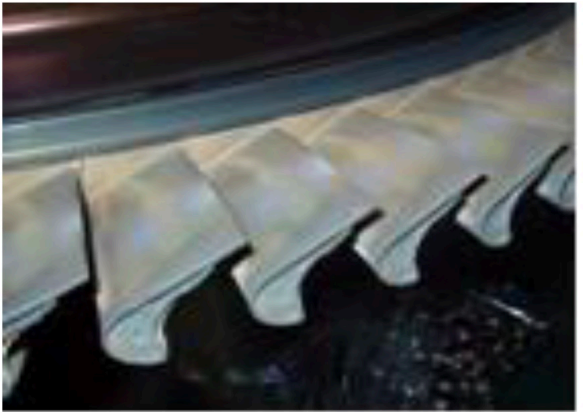
No defects that occurred prior to the ingestion of the engines were found on both engines.

Photo 26, 27, 28 and 29: engine # 1, disassembly conditions in modules.

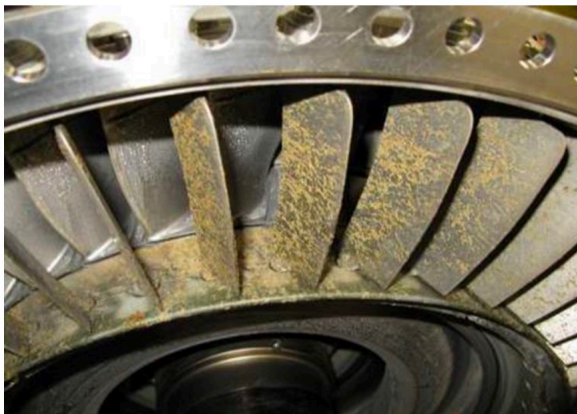
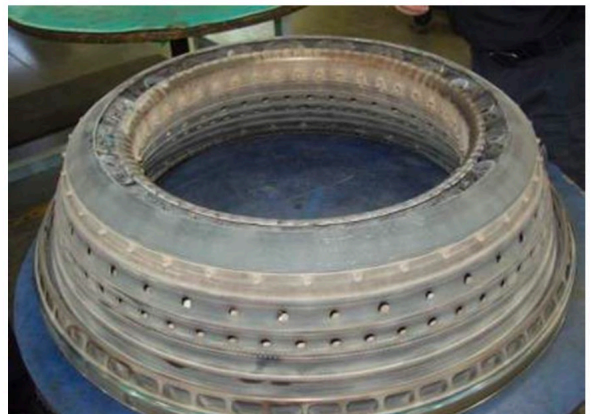
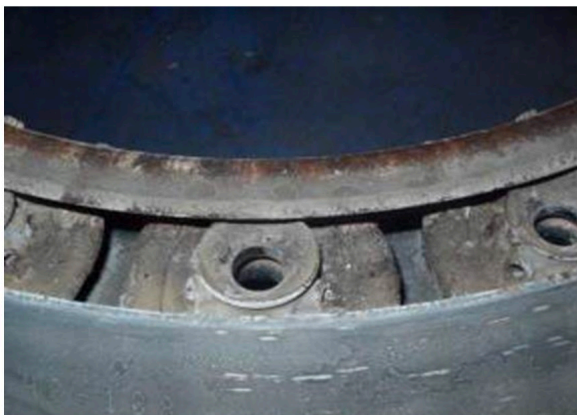
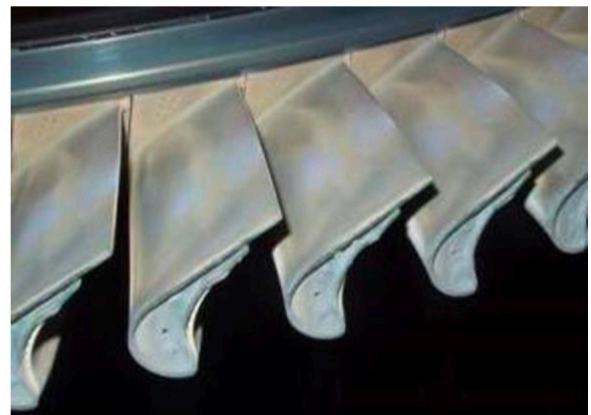
Photos 30, 31, 32 and 33: engine # 2, disassembly conditions in modules.

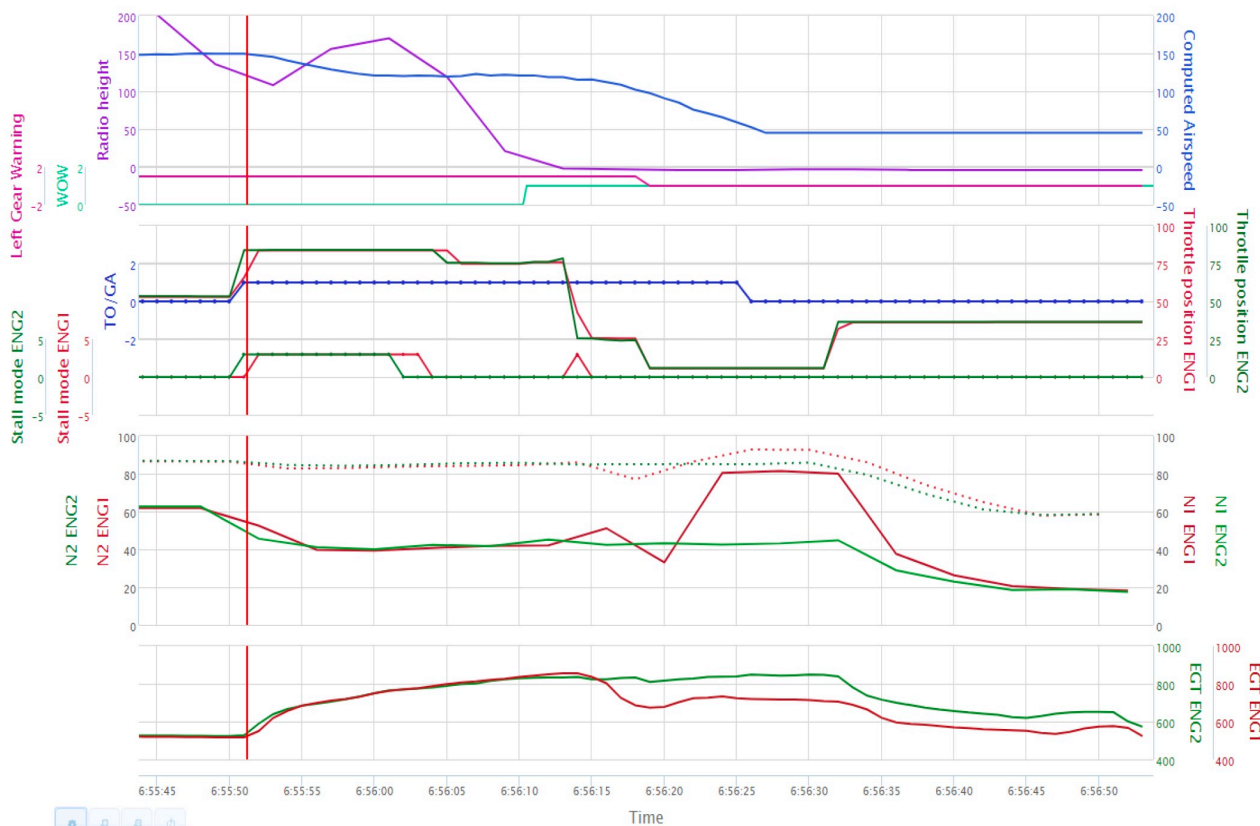
in the next 24 seconds. The fall of N1 and the rise in EGT occurred together with a series of "surge²" tested by both the compressors and indicative of a severe aerodynamic disturbance of the flow of air inside the HPC.

Picture 31 : behavior of N1, N2, EGT, stall mode at TOGA throttle selection
