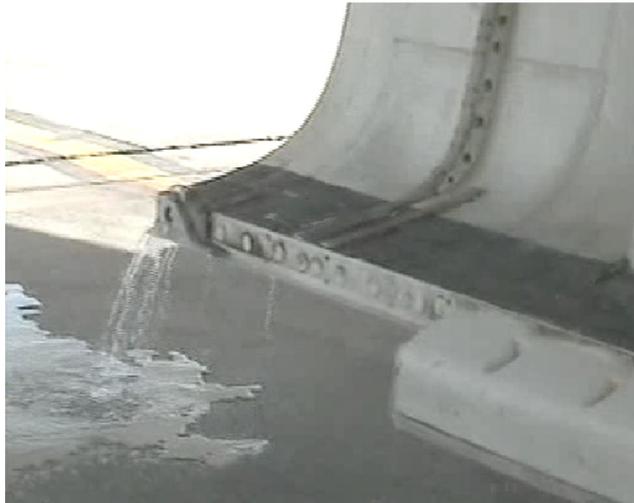
Fuel leak detected on opening a landing gear door

- ❑ A serious fuel leak outside of safety limits under the right wing. The liquid was flowing onto the brake block of the right L/G. A service bulletin had been issued for this fuel circuit and this seems to have been applied. Damage to the paintwork on the starboard wing seemed to indicate that this leak was not recent ⁽⁸⁾.

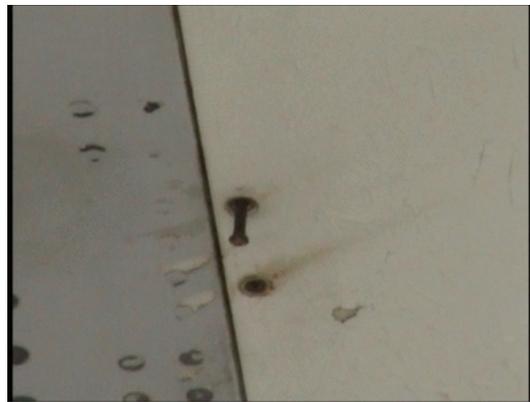
Example of a loose screw on a lower wing panel

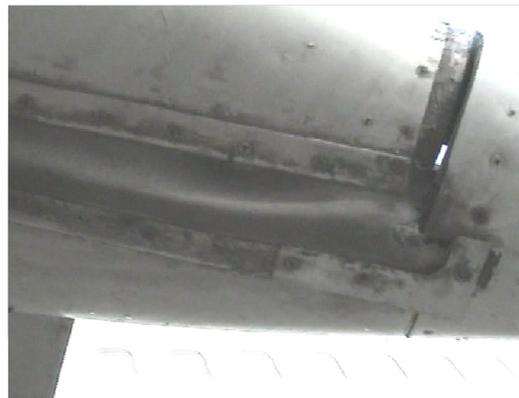
There was serious corrosion on several mechanisms, in particular on the flaps and slats (flap guide rails). Several rivets were missing from the lower left wing. A seal had been added in accordance with a service bulletin, but had been fitted in a makeshift way.

Example of the fairing of a flap guide rail that had come loose because certain rivets were missing

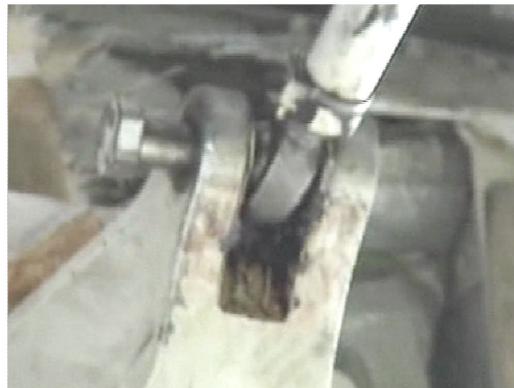
The cargo door actuator was ripped off and the support provided for opening did not ensure the safety of the personnel handling the door. The lower nut on the actuator was missing and the screw was almost out of its fitting. An electric cable had been crushed by the closing of the door. The electric motor actuating the door was no longer attached to the airframe. The pressure seal fitted on the door frame was rotten and part of the upper door frame was broken. In view of the condition of this door, the specialists were sceptical as to the potential consequences of performing any new pressurisation cycles.

Off-centre cargo door actuator

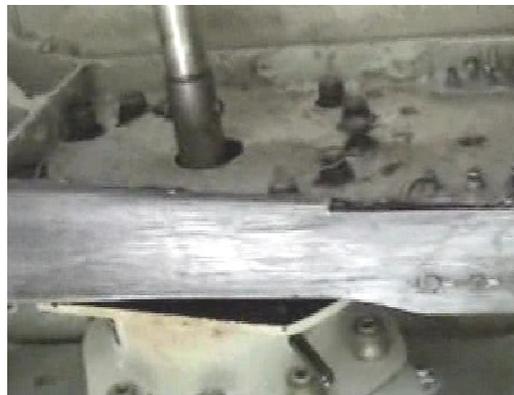
Actuator motor separated from the airframe

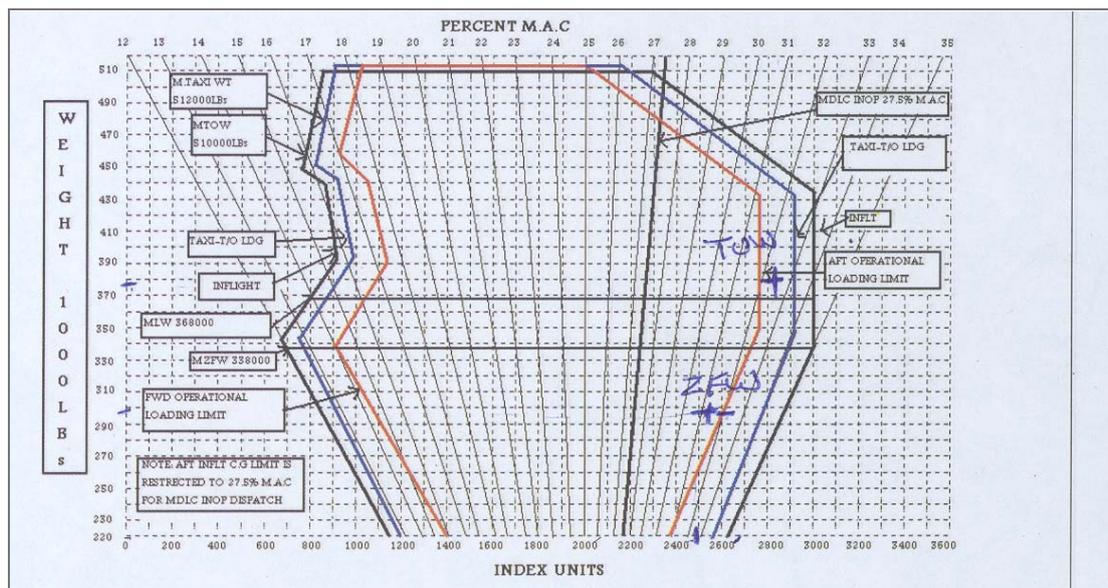
These three different empty weight equipped indices had been used randomly by the crews on the weight and balance sheets found on board.

Note: The maximum permitted index range calculated for loading is 2,300. This must be compared with the range of uncertainty of 621 between the indices used.

Excerpt from the load sheet filled in for a CDG-ATH flight on 2 July 2005 (using the index given on the weight report issued by GAMCO, i.e. 2,161). The index of 2,782 given in the table provided by the operator for airplane 9L-LED made takeoff impossible.
