*Accident
on 25 May 2000
at Paris Charles de Gaulle (95)
to aircraft
F-GHED operated by Air Liberté
and
G-SSWN operated by Streamline Aviation*

REPORT

**f-ed000525
g-wn000525**

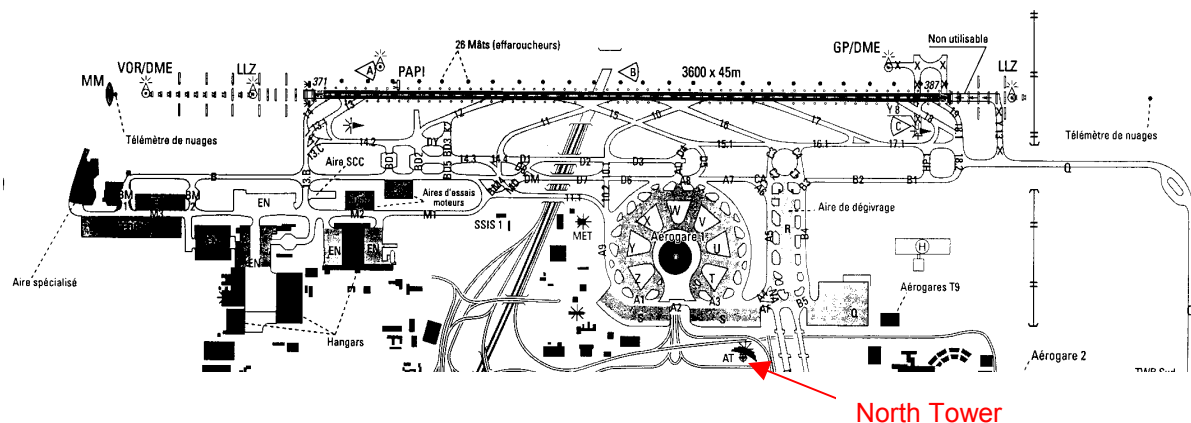
Observations made by the accident investigators showed that, at a height corresponding to that of the Shorts 330 cockpit, there were no fixed obstacles blocking visibility of the runway threshold from taxiway 16.

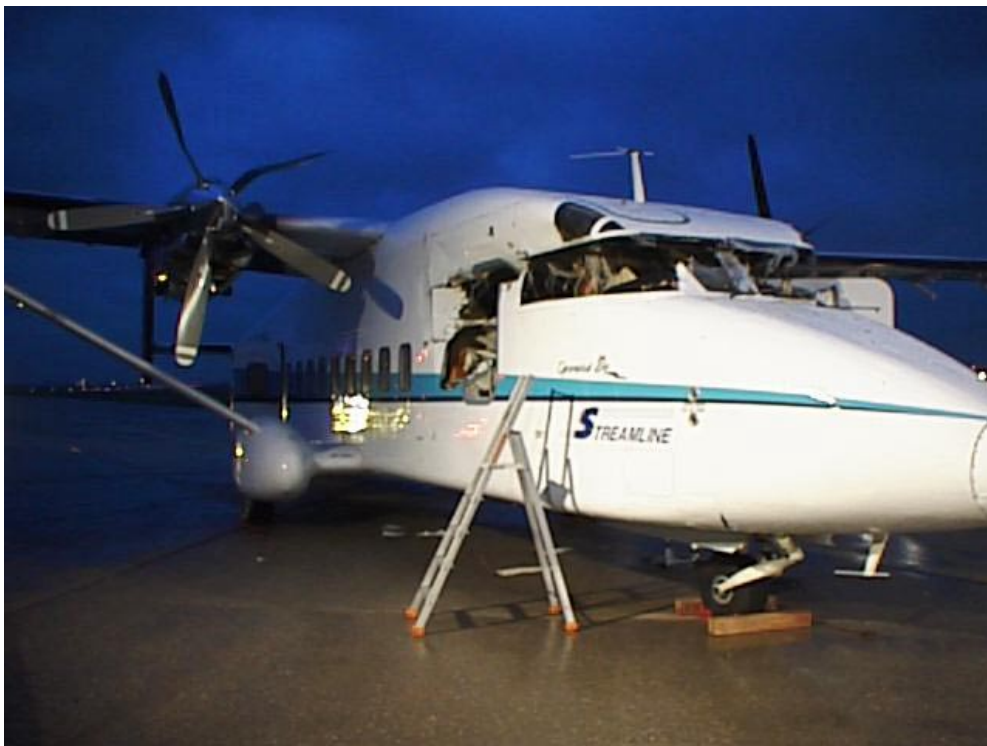
The right-hand wing brace bore friction marks which were caused by the right wing tip of the MD 83. These marks are located on the lower surface of the brace, approximately 70 cm from the junction with the wing spar, and approximately three meters up. They are straight and clearly show the direction of the friction movement.

The wing was not struck directly. A slight folding of the covering at the front of the junction with the fuselage indicated it was pushed in to the front.

On the starboard engine nacelle, the lower part of the cowlings was damaged, and the air inlet situated 2.8 meter from the ground was torn and pushed upwards. Two of the propeller blades were damaged. The propeller cone was undamaged.

The point of impact with the cockpit was situated above the window line, approximately fifty centimetres to the rear of the right-hand forward door frame. This door was torn off and pushed to the inside of the fuselage. The opening

created by the MD 83 wing is practically horizontal.

Inside the cockpit, the seat backs were not damaged. The MD 83 wing cut through the central column located between the two seats. It then cut into the left-hand side approximately fifty centimetres into the back of the rear left side window. The windscreen was broken and its uprights cut through.

The damage on the instrument panel was relatively slight. Some of the protective glass on the instruments was pushed in and broken. The elevator and rudder trims were on neutral. The six engine control throttles were in maximum rear position. The two fuel cut-off levers, situated on the upper panel, were in the rear position. The brake cables were broken.

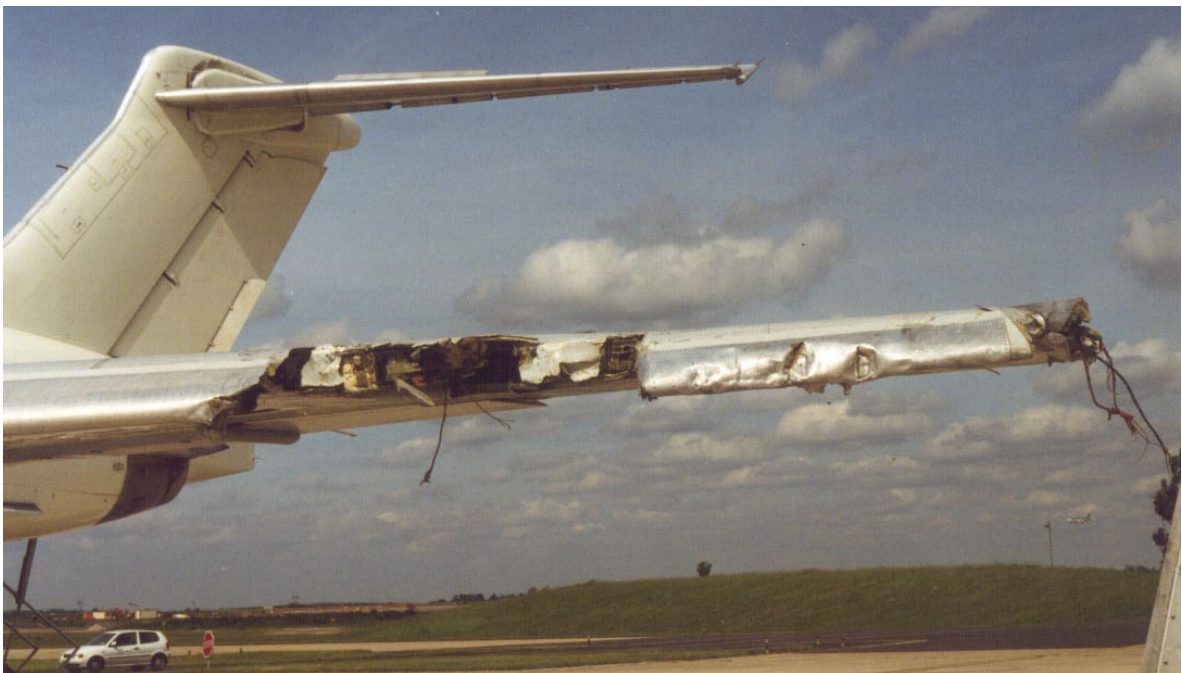
The tip of the left wing was missing and the last rib was almost completely in place. The wing tip, found on the ground, bears traces of white paint and marks from the rivet heads on the brace of the Shorts 330.

The wing leading edge is equipped with five slats. The outside slat was damaged: it was torn and the section situated 1.30 to 2.35 m from the last rib was missing. A large piece of this slat was found on the runway. Under the damaged slat, there were two pulleys with two cables broken under load, and shearing due to the impact. The two cables were connected to the leading edge slat control.

The end of the upper wing surface bore the mark of a propeller blade impact. The trailing edge was slightly damaged in the wing sweep area. This section of the wing does not have any flight control surfaces.

At the impact point, the wing structure forming the end of the wing centre box is not used as a fuel tank. Moreover, no fuel leakage was observed on the rest of the wing, even after the aircraft had stood in the parking area for several days. Low power electrical wires were cut off at the end of the left wing. These were used mainly to supply the navigation lights. No trace of electric arc or electrical fire could be found on these wires.

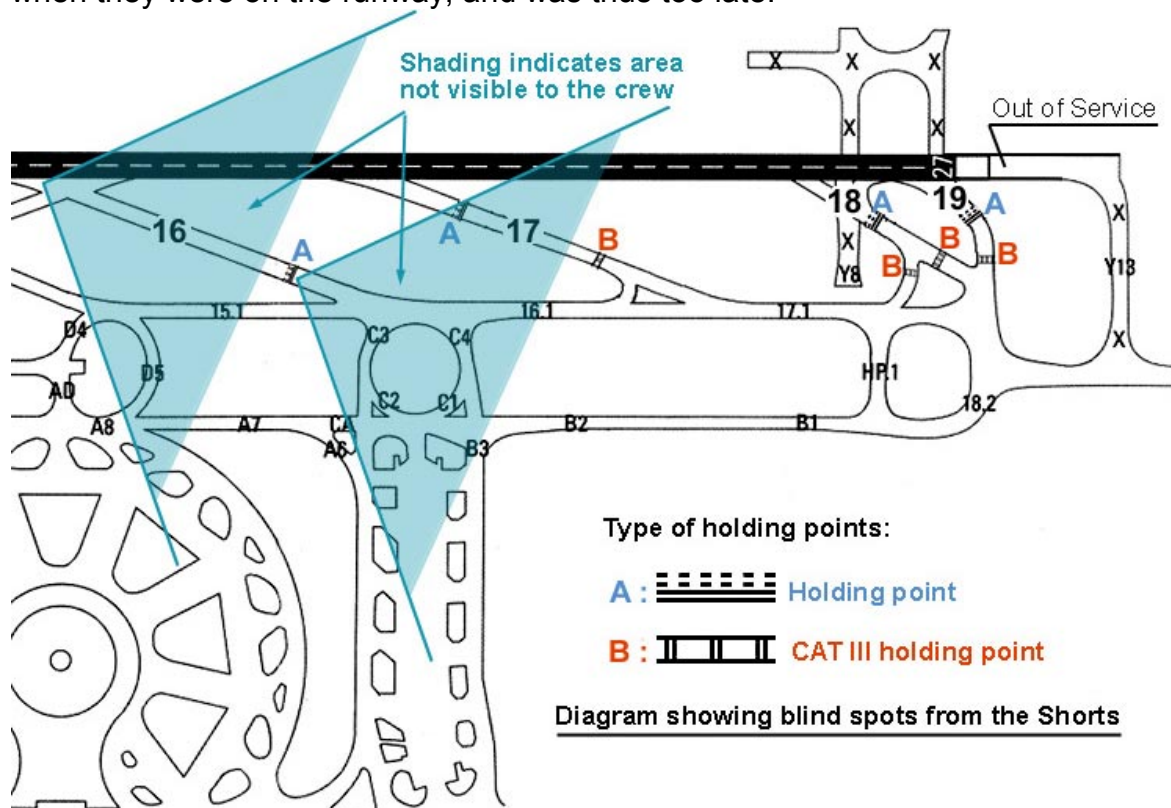
Before lining up it is usual for a pilot to perform a visual check to ensure the absence of any traffic on final or on the runway. However, taking into account the vision angles and the orientation of taxiway 16, the crew of the Shorts could not at any time have been in visual contact with the aircraft taking off. They could only have seen it after a right turn of at least 60°. Because of this, they could not check for the absence of aircraft before entering the runway. While looking for aircraft “number one”, they nevertheless tried to carry out a final check, but this was done when they were on the runway, and was thus too late.

Lining up from a high speed exit does not allow a crew to observe the upper end of the runway. Since they cannot, as a result, note the possible presence of an

aircraft landing or on the takeoff roll, a safety factor is eliminated.
