COMANDO DA AERONÁUTICA
CENTRO DE INVESTIGAÇÃO E PREVENÇÃO DE
ACIDENTES AERONÁUTICOS

FINAL REPORT
IG - 057/CENIPA/2015

SERIOUS INCIDENT

A320-214

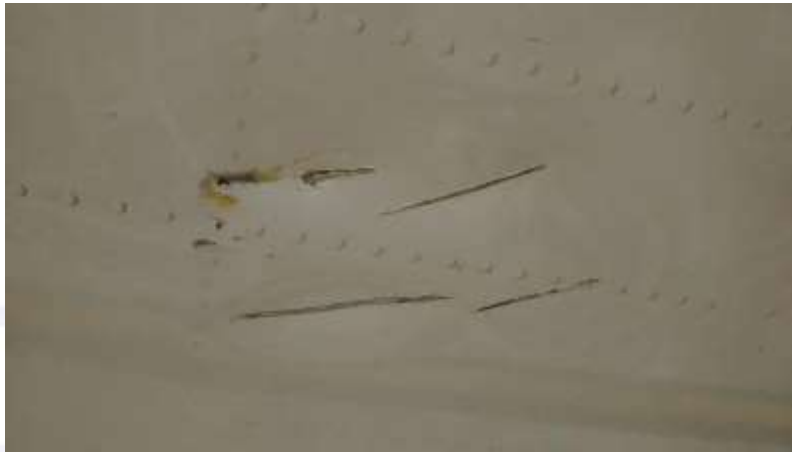
The aircraft suffered damage to the right main landing gear tires, and minor damage to the fuselage due to the shrapnel created by hitting the light.

Figure 1 – Damage to the PR-MHV fuselage.

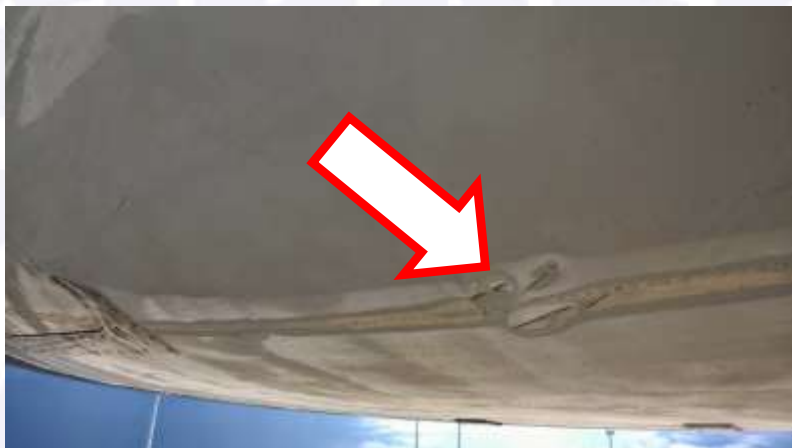
Figure 2 – Other sight of the damage to the PR-MHV fuselage.

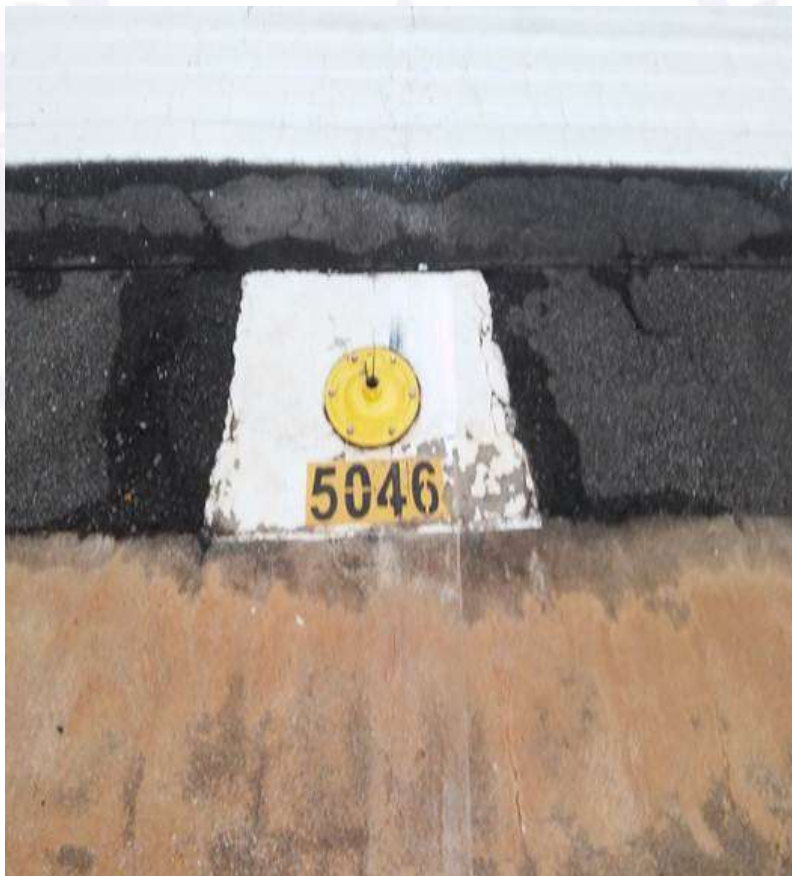
The pilot initiated the reject landing procedure, but lost height, and the aircraft touched down prior to the start of the runway. Shortly after it touched down, the right landing gear struck one of the runway threshold lights.

Figure 3 – Place where the struck threshold light was installed. (THR RWY29R)

A threshold light of the runway 29R was damaged, and it was necessary to be switched.

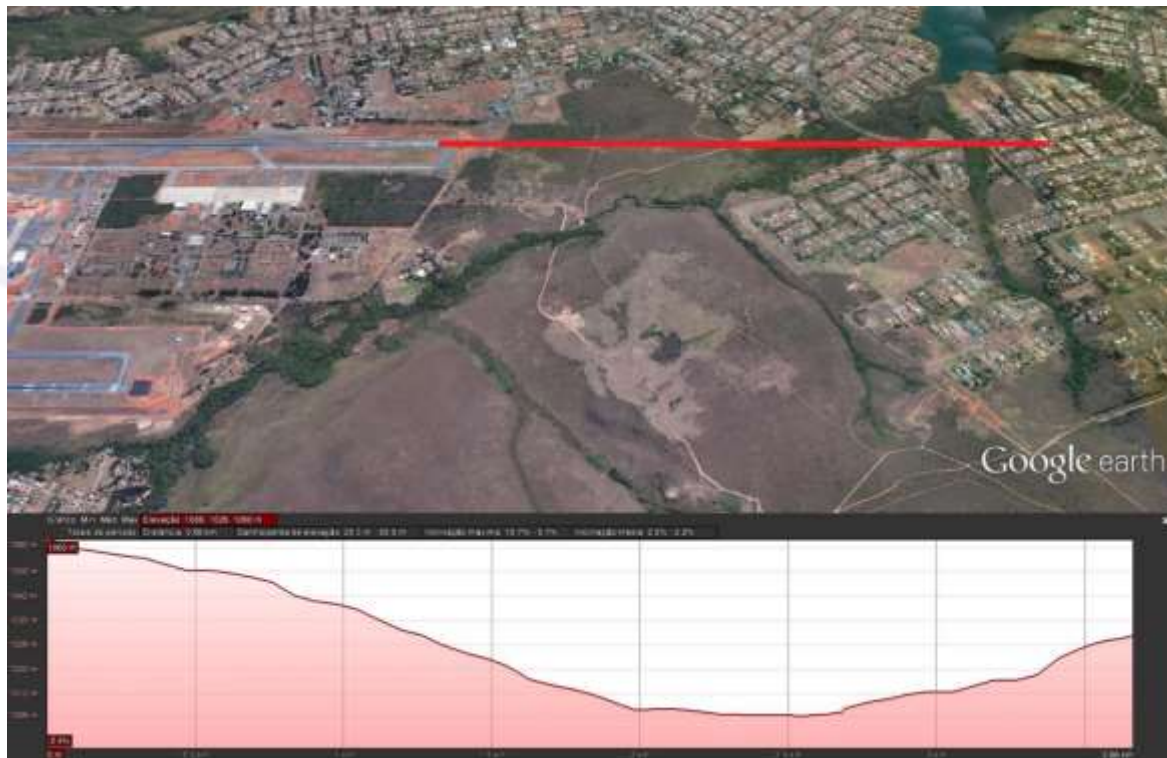
Although the runway was on a flat area, the terrain prior to the RWY 29R was an uphill slope (Figure 13).

Figure 13 – Vertical section along the red line, prior to the RWY 29R of SBRR.
Credit: Google Earth.

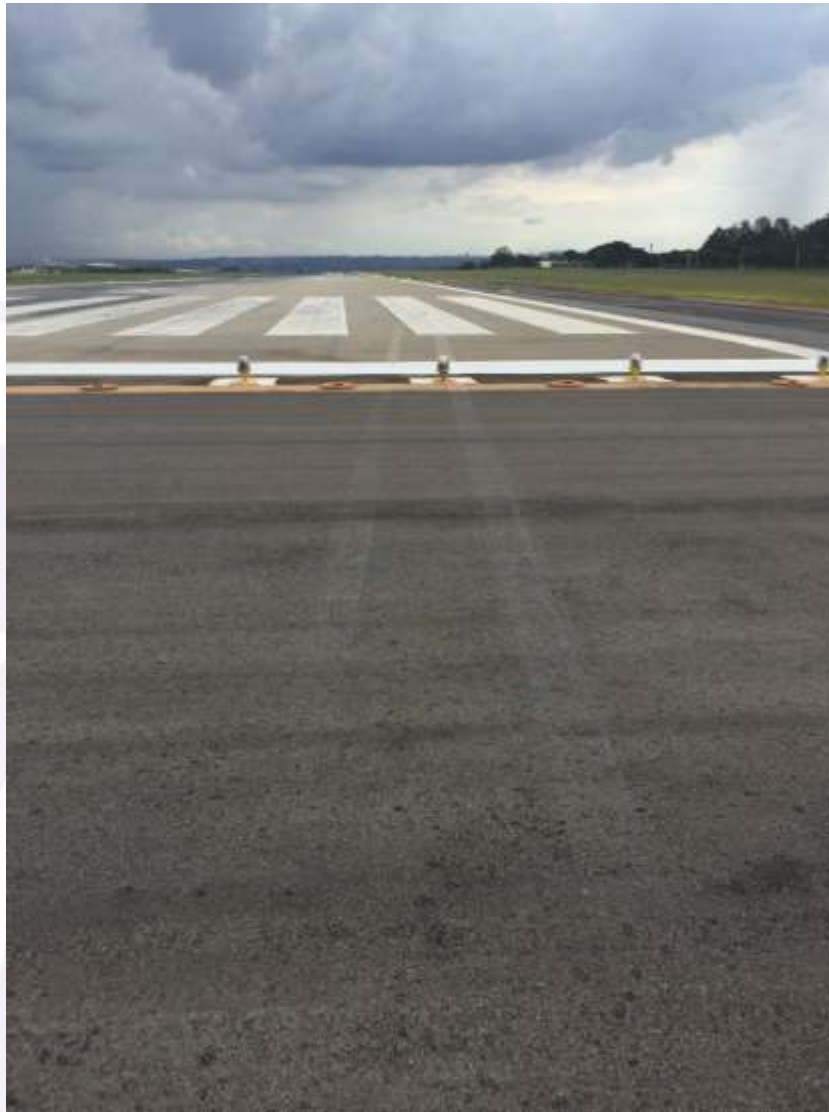
The airplane right landing gear initially touched down at RESA, 13,3m prior to the runway threshold. The left landing gear touched down within the runway limits.

The aircraft rolled a total of 31,5m with the landing gear on the ground.

Figure 14 – Right main landing gear marks on RESA.

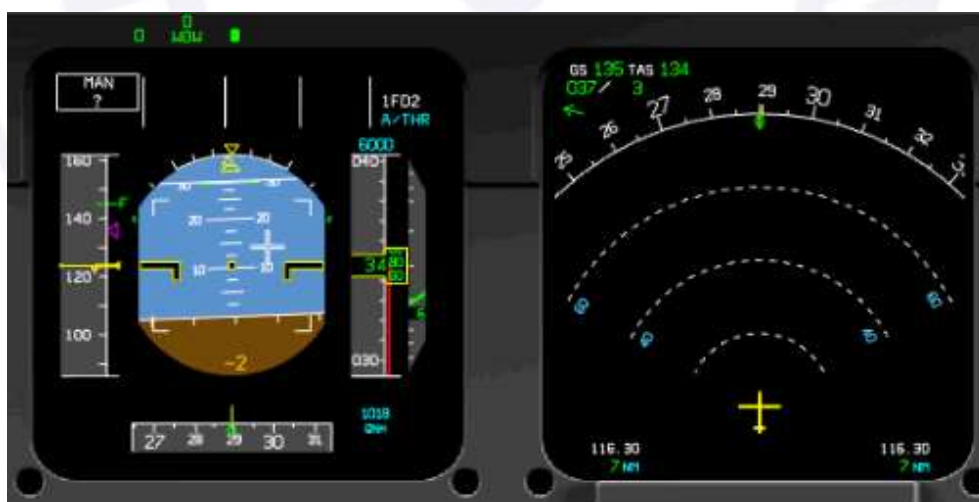
The final phase of the approach (since 150 ft AGL) and go-around procedure (until 130 ft AGL) lasted about 20 seconds. According to FDM data, during this part of the flight, the wind direction varied about 197° , and its intensity varied from 16 kt headwind to 13 kt tailwind.

Figure 19 - FDM data on PFD and ND at the moment the right main landing gear touches the ground.
