Incident

AAIS Case N° AIFN/0011/2018

Inadvertent Opening of Emergency Exit Hatch and Deployment of Slide Ramp

Operator:	Saudia Airlines
Make and Model:	Airbus A320
Nationality and Registration:	Saudi Arabia, HZ-AS55
Place of Occurrence:	Dubai International Airport
State of Occurrence:	The United Arab Emirates
Date of Occurrence:	20 September 2018

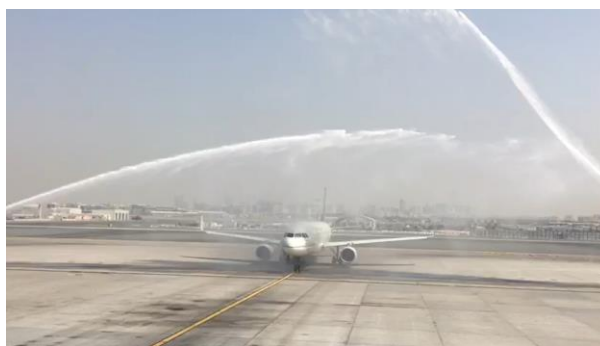
After turning towards the terminal, two fire-fighting vehicles, which were located on either side of the taxiway, started spraying jets of water to welcome the Aircraft with a water salute in celebration of the Saudi Arabia National Day (figure 1). The vehicle turret operators selected a water jet with a high kinetic energy to form a far-reaching arc.

The fire-fighting vehicle positioned on the left side of the Aircraft, FIRE 8, experienced a problem with the roof turret, which ceased to follow the operator's input from the hand controller. The high pressure water jet was suddenly sprayed upwards and then downwards, as the Aircraft passed underneath (figure 2). The Aircraft was struck by the water jet causing the left forward over-wing emergency exit hatch to open. The hatch fell into the cabin. This resulted in the deployment of the left over-wing emergency slide ramp.

Figure 1. Aircraft arrival at gate (start of water turret malfunction)

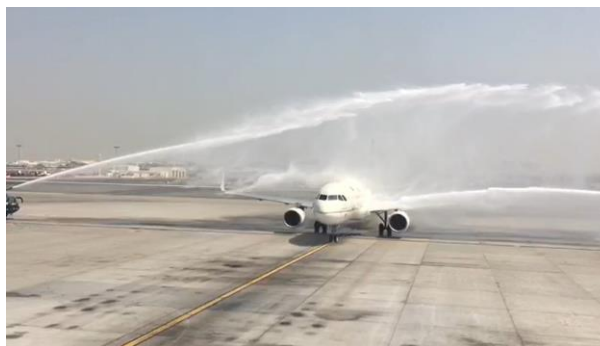
Figure 2. Water jet strikes the over-wing emergency exit hatch

turret mechanism. An AAIS investigator attended the maintenance activity, which identified that the loss of vertical turret control was caused by a fault in the elevation control potentiometer on the control handle.

The Air Accident Investigation Sector determines that the cause of the Incident was the erratic directional movement of the water jet onto the push panel of the left forward over-wing emergency exit hatch, which, when pushed inwards, resulted in the emergency exit hatch opening and falling into the cabin, slightly injuring the passenger seated in the window seat.

The potentiometer was replaced and the turret movement re-calibrated before FIRE 8 returned to service.

Introduce a routine "dry" turret check procedure, to ensure that malfunctioning turrets are identified during maintenance, or prior to their operation with water or foam.

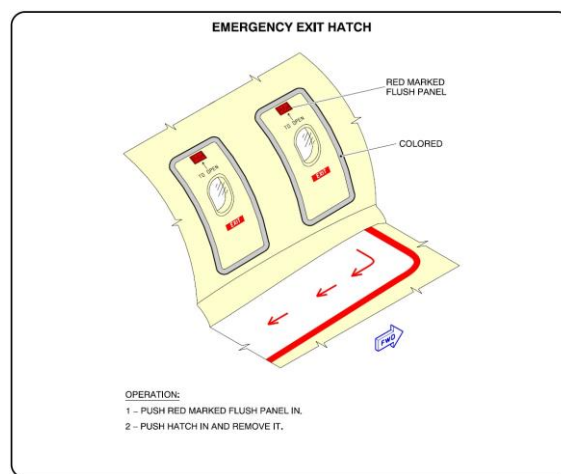
The type III emergency exits are opened from inside the cabin by removing a cover and operating a pull handle. These exits are accessible from the outside via the upper surface of the wing, and they are opened by pushing a red push panel, as shown in figure 4. Applying force to the push

The exit hatches are not hinged and when operated they open inwards into the cabin, from where they are picked up and then thrown outside by the passenger seated nearest to the hatch.

Figure 4. Over-wing emergency exit hatches
[Source: Airbus]
