Havarikommisjonen
Accident Investigation Board Denmark

FINAL REPORT

ATR72 200

OY-LHA

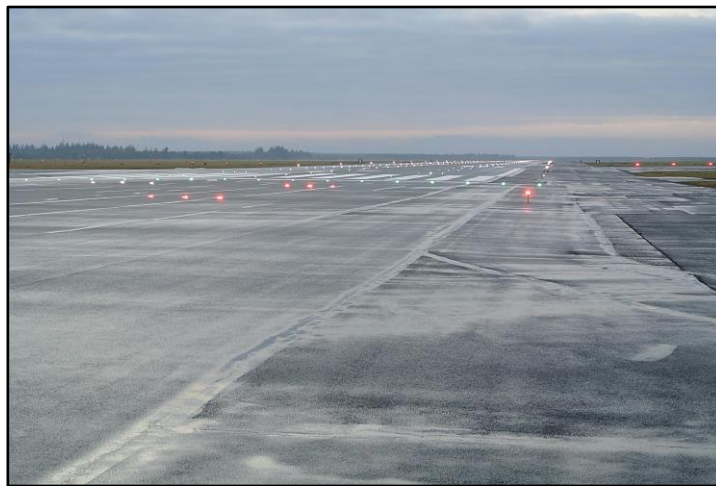
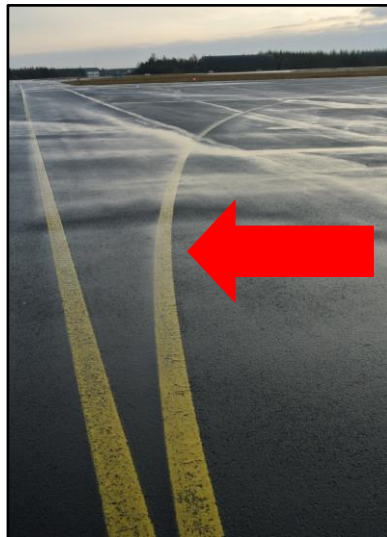
1.10.6 Intersection E at runway 27L

Runway 27L had an extra tarmac width (paved runway shoulder area) at intersection E, where the aircraft entered the runway. At the time of the serious incident, the area directly north of runway 27L was in darkness. The paved runway shoulder areas were not marked.

A taxiway lead-in line painted yellow lead from taxiway E to the center of the underrun of runway 27L.

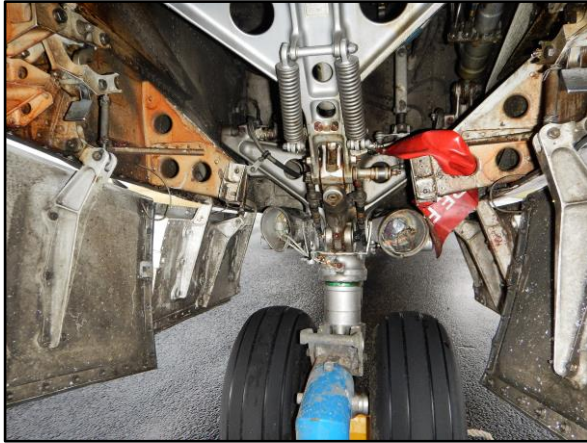
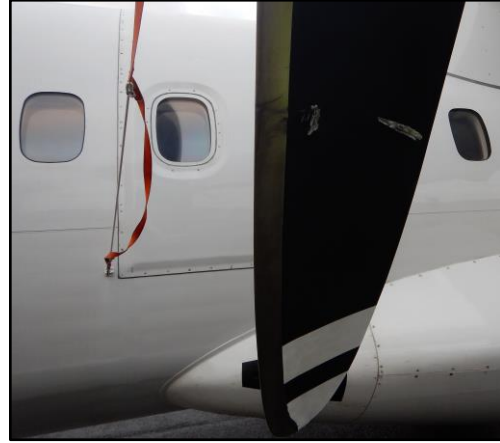
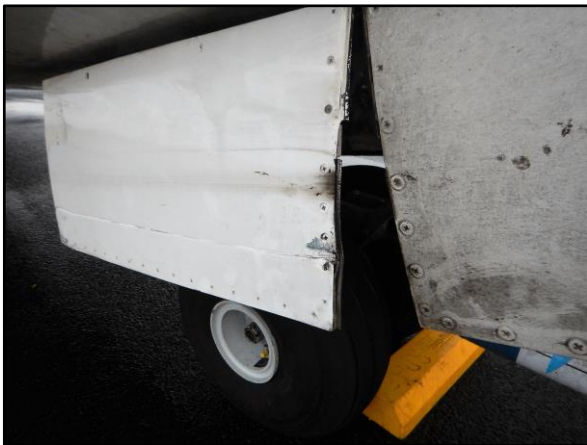
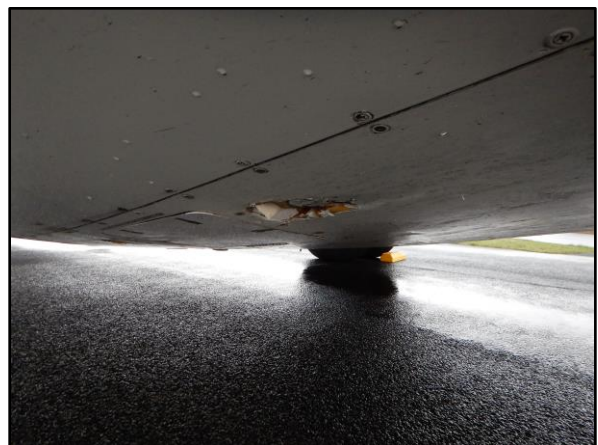
1.12.1 Damages to the aircraft

There were damages to and several cuts on:

- The nose landing gear taxi lights
- Both right hand nose landing gear doors
- Two of the propeller blades on the left hand propeller
- The lower fuselage skin in front of the air conditioning ground connection panel
- The tyres of the nose landing gear and the right main landing gear

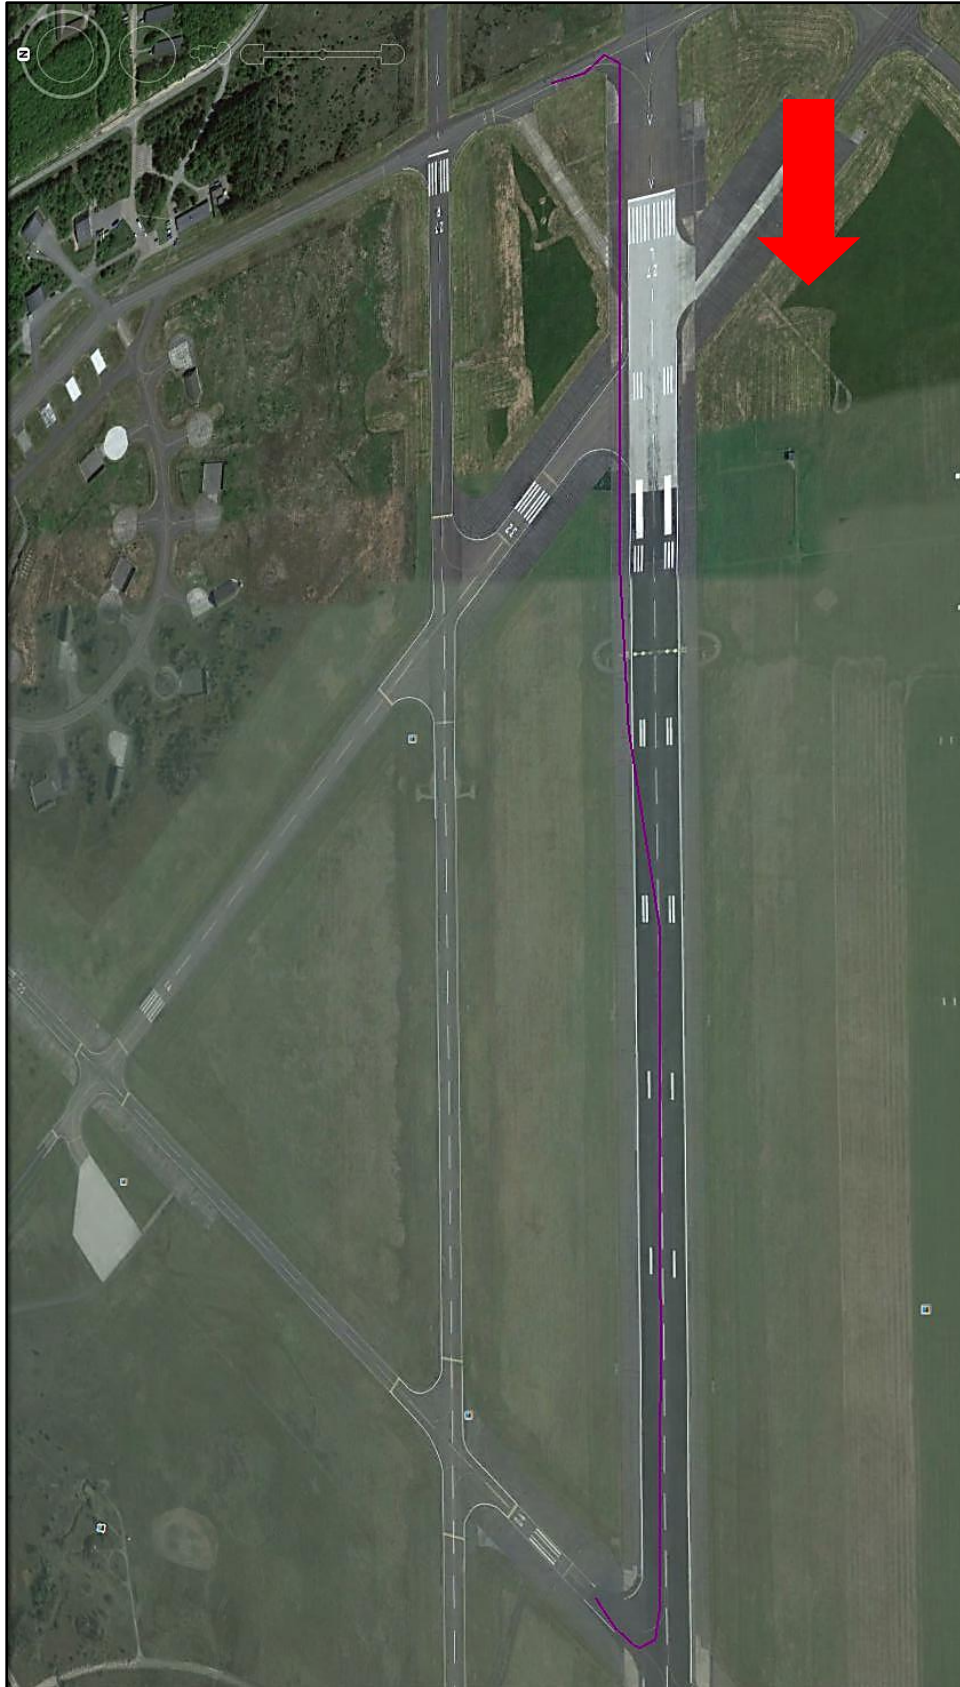
5.6 The take-off roll sequence - FDR plot

During the initial take-off roll, the flight crew observed a thumping noise from the nose gear, and the commander realigned the nose gear slightly to the left, which was done to avoid the thumping noises caused by the nose gear hitting, what the flight crew thought, were the recessed runway centre line lights.

The right main gear hit elevated runway edge lights along the right-hand side of runway 27L.

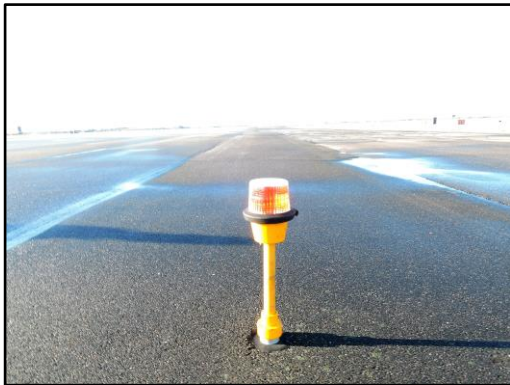
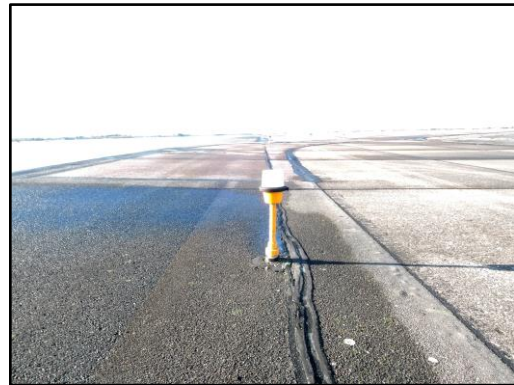
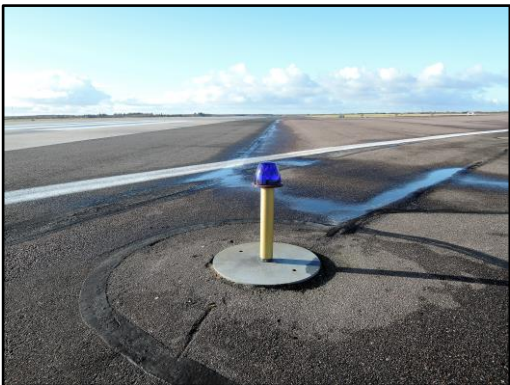
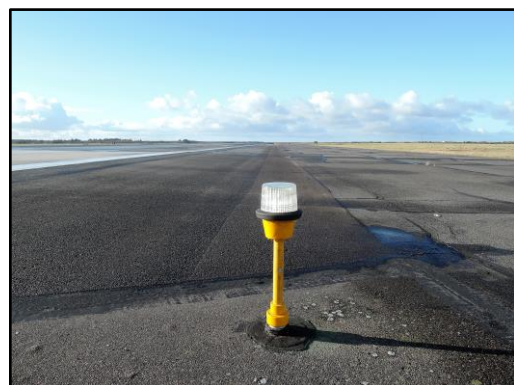
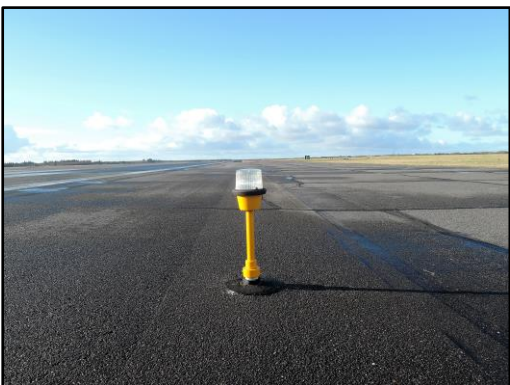
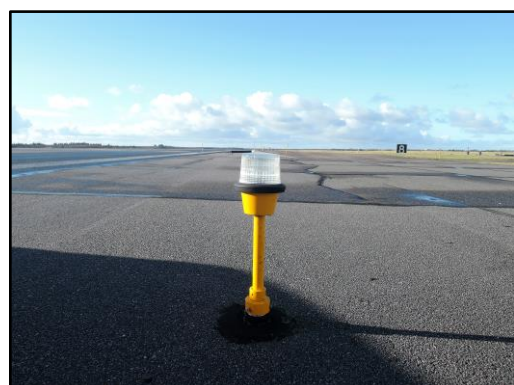
5.12 Runway edge lighting system

During the sequence of events, the aircraft hit six elevated runway edge lights and two obstacle lights on top of the military arrester cable mechanism along the right-hand side of runway 27L.

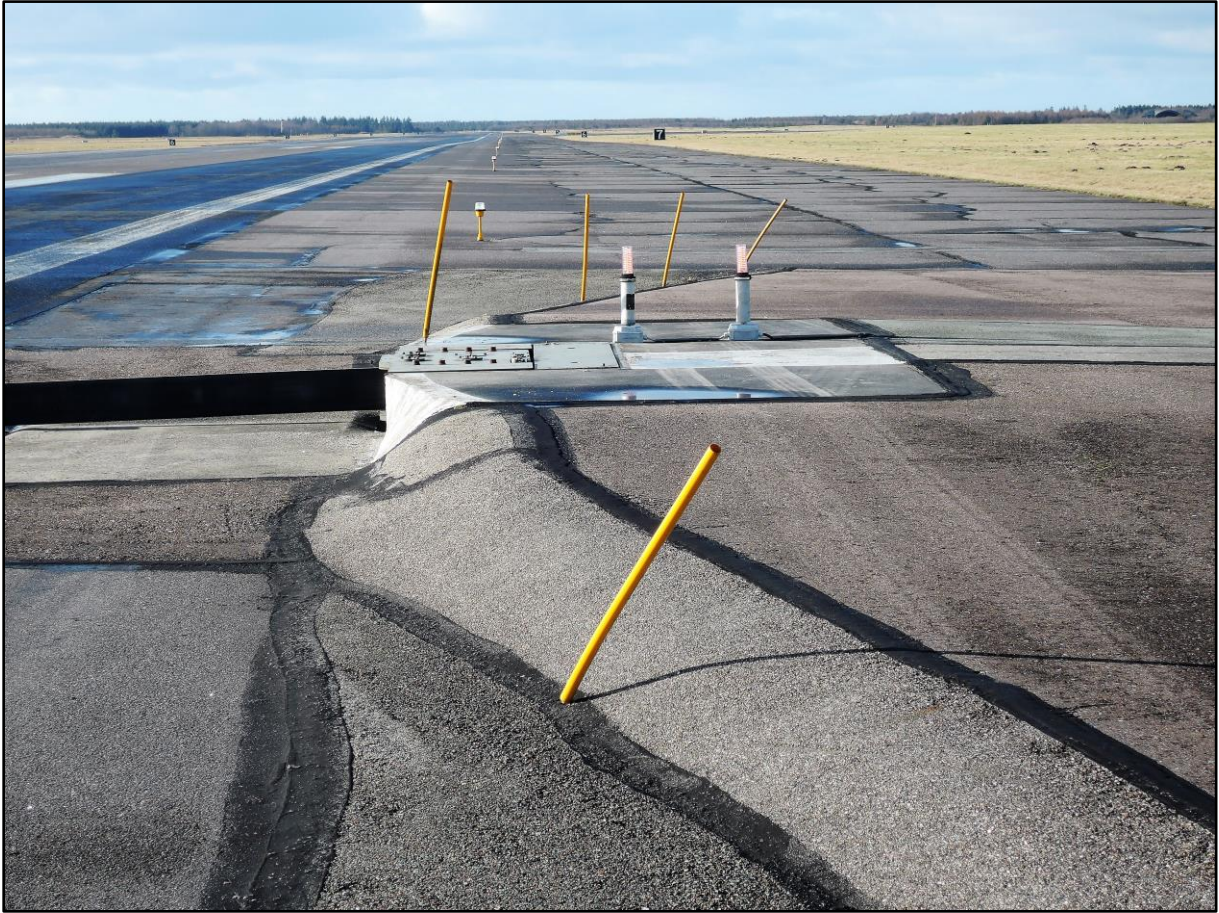
5.13 Military arrester cable mechanism

When approaching the military arrester cable mechanism on the right-hand side of runway 27L, the commander realized that the aircraft was lined up on the runway edge lights along the right-hand side of runway 27L instead of the runway centreline lights of runway 27L.
