# Undetected engine thrust reverser deactivation involving Airbus A320, VH-VQG

Gold Coast Airport, Queensland on 18 December 2017

**ATSB Transport Safety Report**  
Aviation Occurrence Investigation  
AO-2017-117  
Final – 5 September 2019

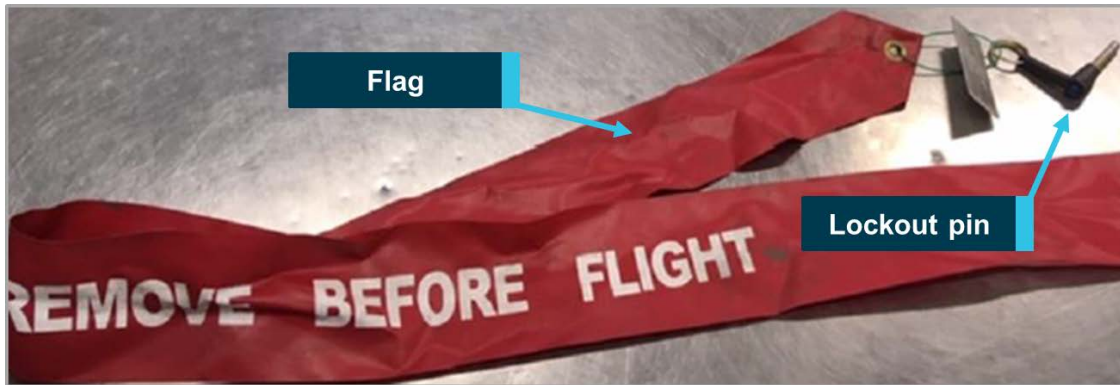
A couple of hours later, the engineers completed investigating the bleed air issue. By this time, it had started raining. Engineer 1 made a visual inspection around the engine in preparation to close the cowling. The available lighting had reduced as half the tarmac lights automatically turn off at midnight. Engineer 1 missed seeing the lockout pin and its 1 m long red warning flag, and closed

the cowling (Figure 1). The flag was shorter than those on the pins in the hangar tool store at Adelaide, which had been lengthened to 4 m after a previous incident to make them more obvious. Additionally, the stand that engineer 1 had used to install the pin, and which may have reminded him about it, had been removed for another task.

**Figure 1: Photograph of a thrust reverser lockout pin and warning flag (non-reflective)**

The red colour of the flag was also harder to see in the artificial lighting,<sup>4</sup> and the flag was not fitted with reflective material. The lockout pin was located at the top of the engine, where its 1 m flag was not as conspicuous as other longer flags, which would have hung below the engine to the tarmac. Further, the stand used to install the pin, which might have served as a reminder, had been removed. The combination of these factors probably led to the pin not being removed.

- Lengthening all thrust reverser lockout pin flags to hang past the closed cowls. The pin will also have a warning notice attached for placement on the engine thrust reverser controls during maintenance.
- Focused audits on work practices for tooling and documenting maintenance activities.
- Reiterating the responsibilities of engineers to those involved in this incident.
