Air Accident Investigation Sector

Accident - Final Report -

AAIS Case N°: AIFN/0008/2016

Runway Impact during Attempted Go-Around

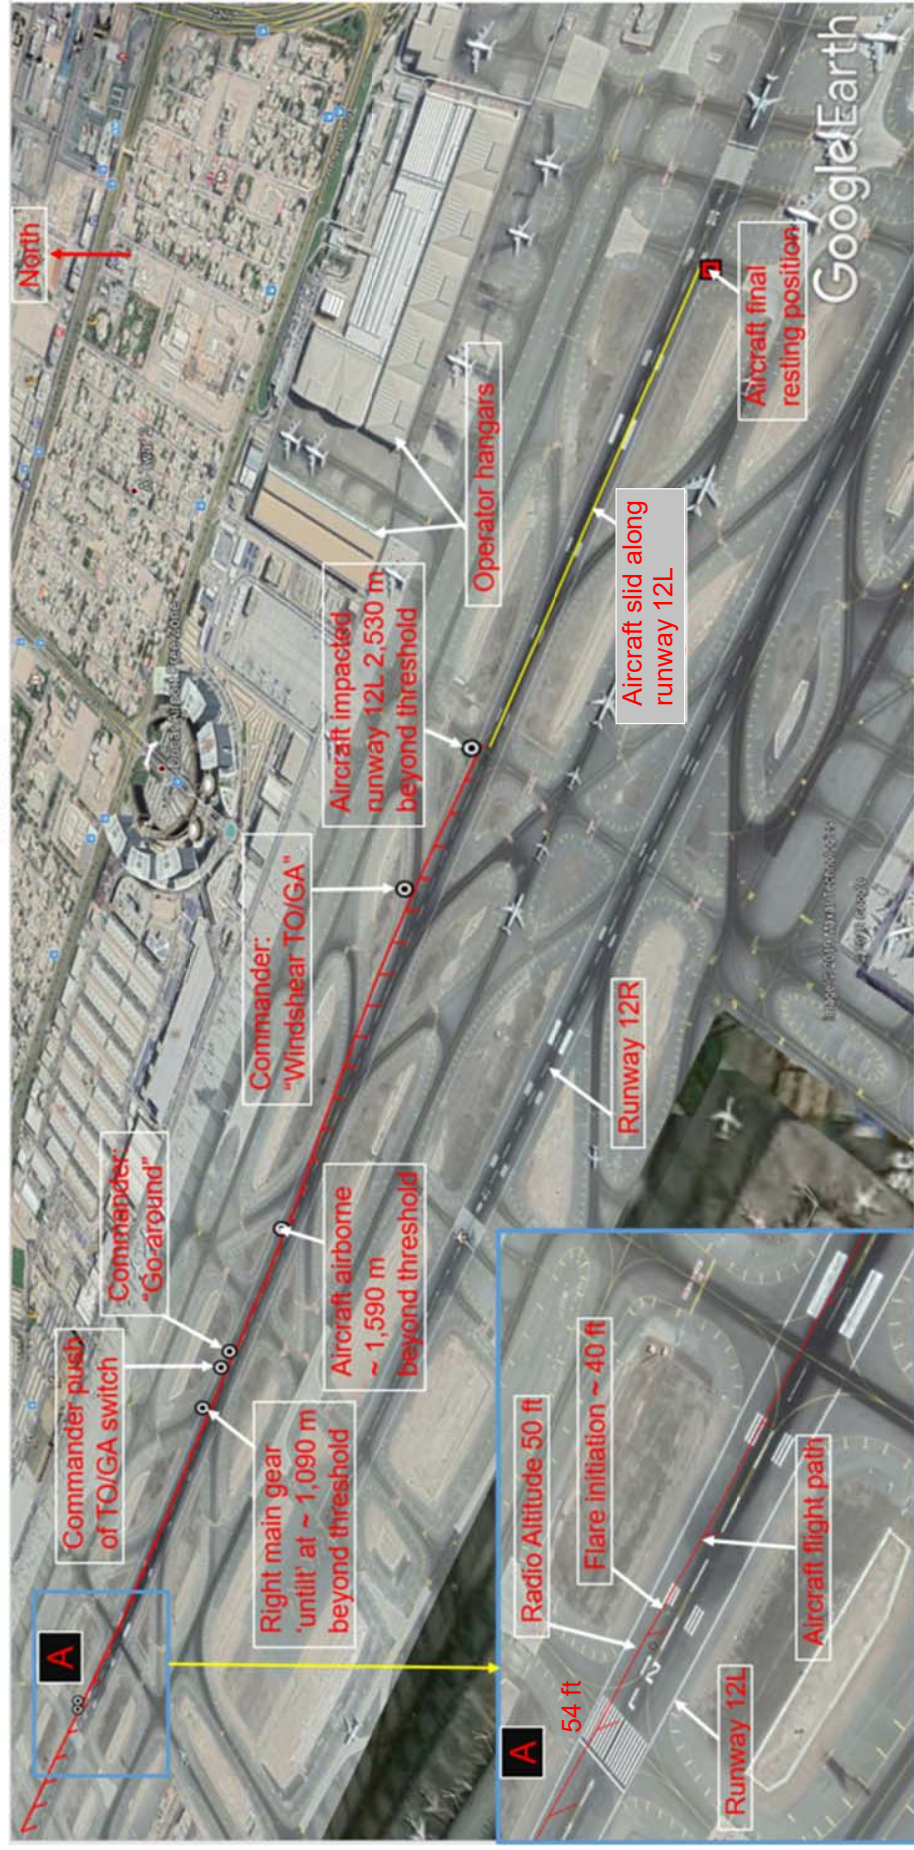
Figure 1. UAE521 flightpath and impact along runway 12L

At 0837:16, the Aircraft rolled 3 degrees to the left due to the wind effect and the Commander corrected with right control wheel input of 30 degrees. In response to this input, the resulting right bank of 7.4 degrees caused the right main landing gear to contact the runway approximately 1,090 m beyond the threshold.

Approximately 9 minutes and 40 seconds after the Aircraft came to rest, the center wing tank exploded which caused a large section of the right wing upper skin to be liberated. As the panel fell to the ground, it struck and fatally injured a firefighter.

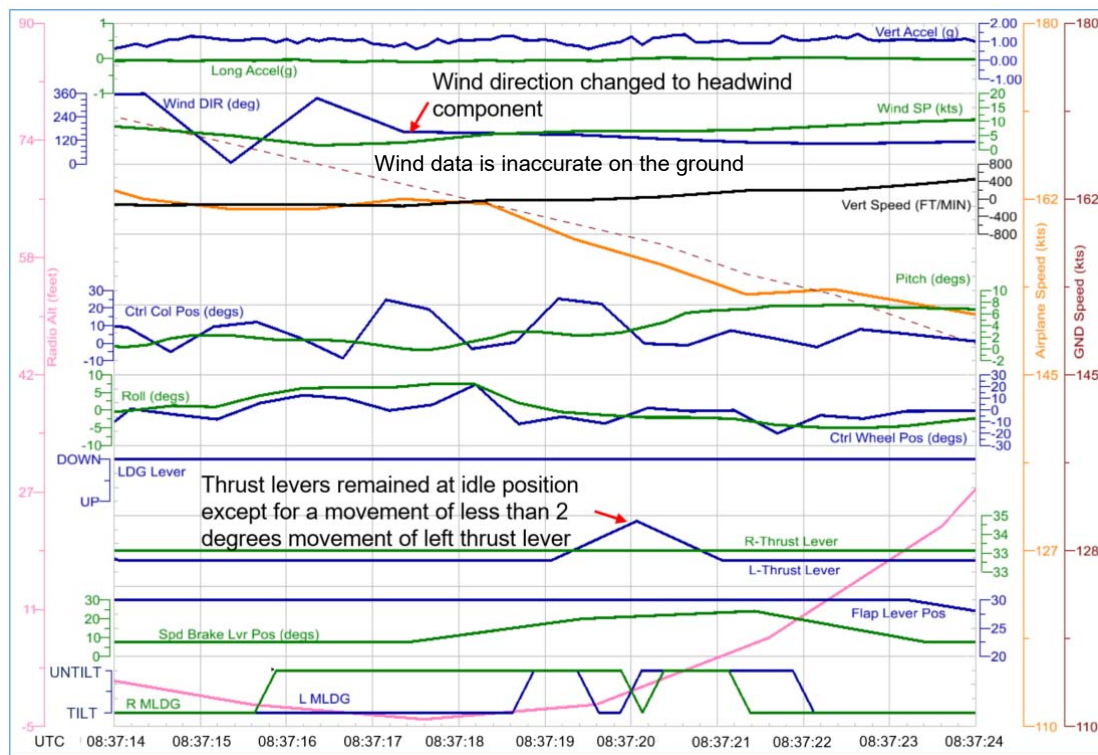
Figure 14. Main landing gear over six seconds of 'tilt' and 'untilt'

At 0837:18, the FDR indicated the pitch-up angle increasing from 0.8 to 3 degrees. The increase in pitch angle occurred shortly before the Commander called for a go-around, at about 161 kt IAS. The pitch angle oscillated between 3 and 2.3 degrees over the next one second before it continued to increase at a positive rate towards 7.4 degrees, at about 153 kt IAS, with both main landing gear being 'untilted'. The landing gear lever was selected to 'up' at 0837:29 and the Aircraft then continued in 'air' mode with the landing gear being in transit to the up position until impact.

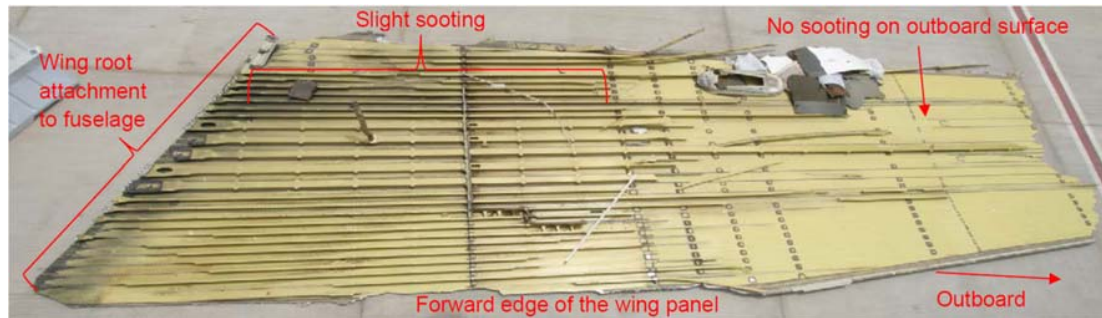
Figure 16. Upper skin panel from right wing

landing gear heating and causing the ignition of the approximately 100 kg of residual fuel in the center wing tank. The explosion caused the right wing upper skin panel of the center wing fuel tank to violently separate (figure 16).

The direction of the explosion pressure wave was from the center wing tank towards the right main wing tank. This resulted in a large section of the upper wing skin from the inboard right wing, approximately 15 m in length and the width of the upper wing surface, being separated with such force that it landed behind the right wing on the tarmac approximately 5 m from the wingtip. The wing skin panel separated from wing buttock line station (WB) 123.124 to wing station (WS) 732 (Rib 21). In addition, the explosion also caused the cabin floor over the center tank area to lift which provided a path for fire and smoke to enter into the passenger cabin.

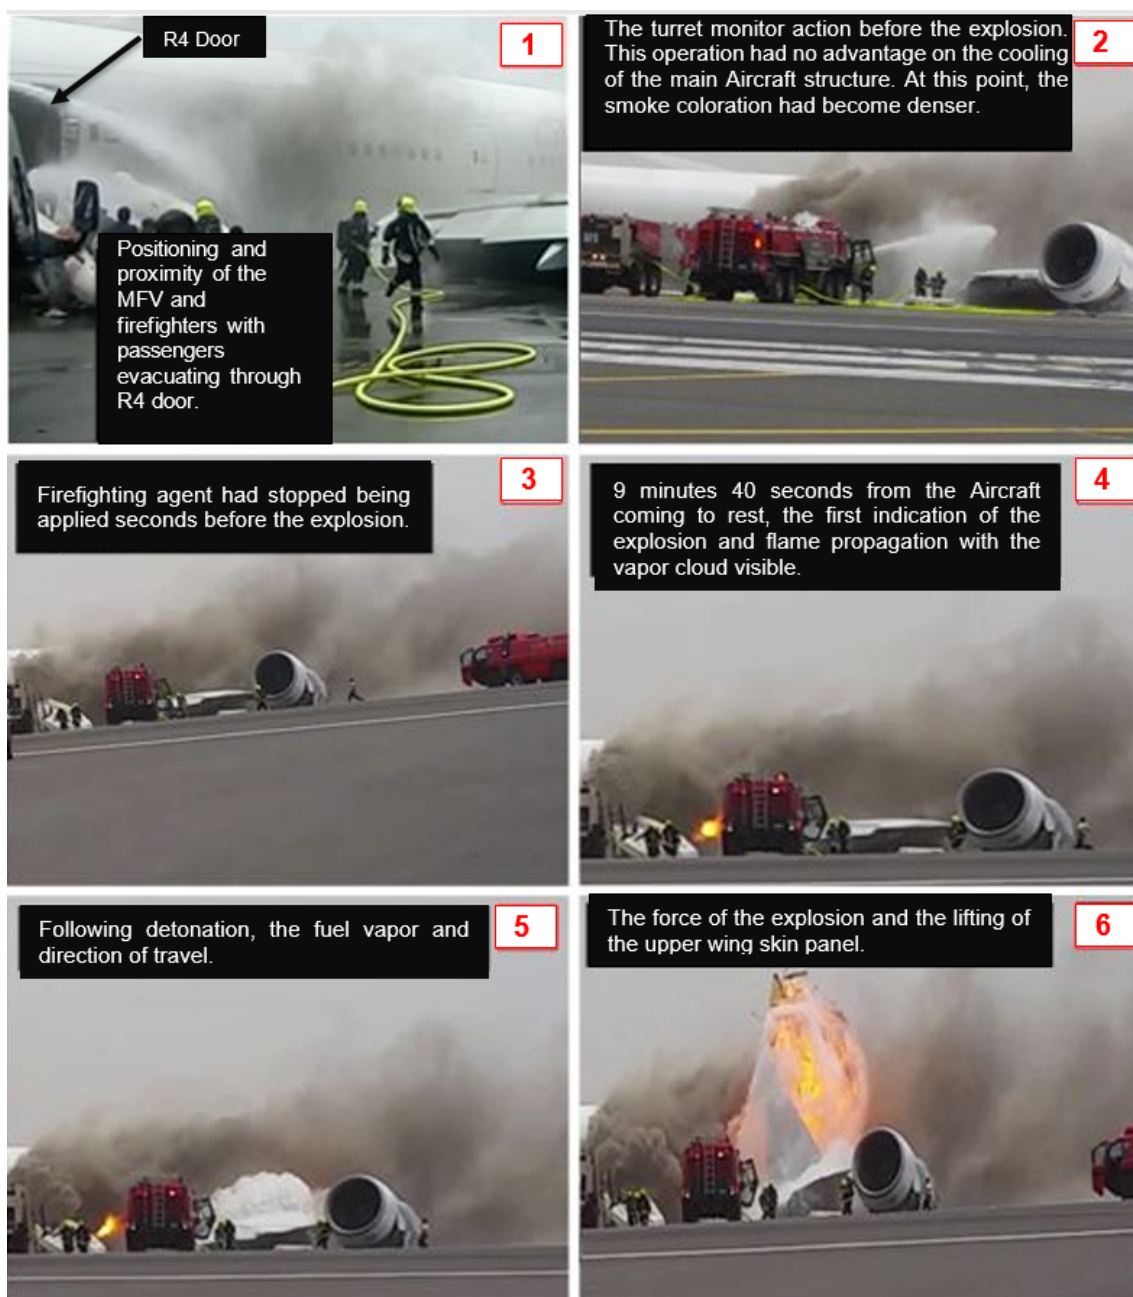
Figure 17. Center wing fuel tank explosion

Figure 17 illustrates the sequence of events before and after the explosion.

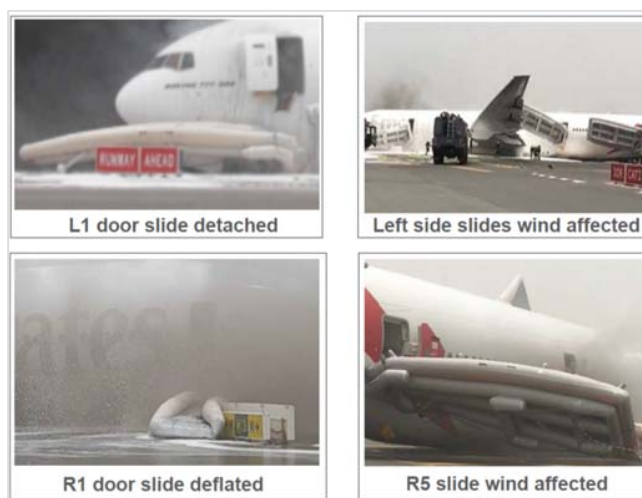
Figure 18. Door escape slides after deployment

All of the cabin crewmembers in the aft cabin evacuated via the R5 exit, approximately 25 seconds after the last passenger had been evacuated.

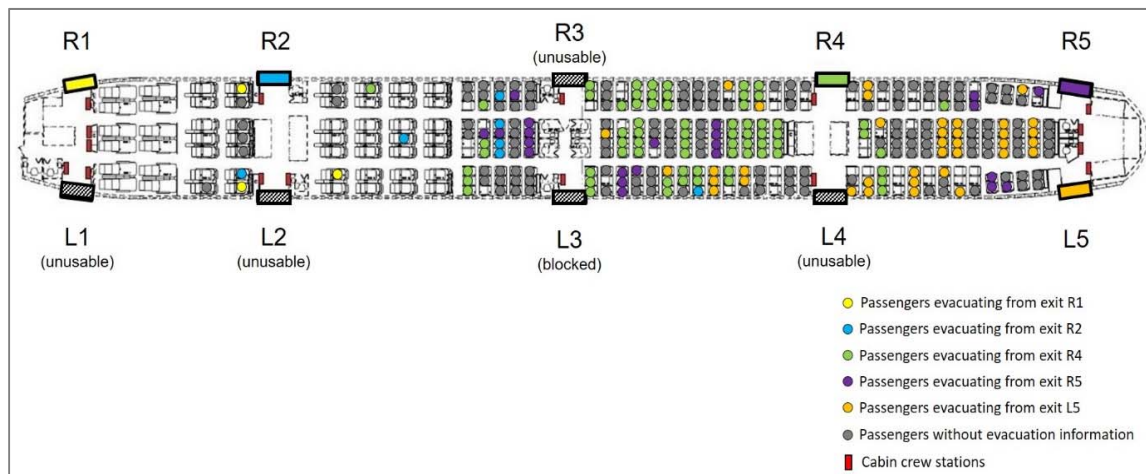
Figure 20. Passenger seating allocation and emergency exit status

Figure 20 shows the seat locations and exits used. Passengers who did not respond to the questionnaire are represented by grey dots.

One passenger, seated next to the right side over-wing exit (R3), stated that he was directed to the front of the cabin to evacuate from one of the forward exits, but he was then directed back because the forward exits were blocked. This passenger passed through dense smoke in the center cabin on his way to exit from the R4 door.

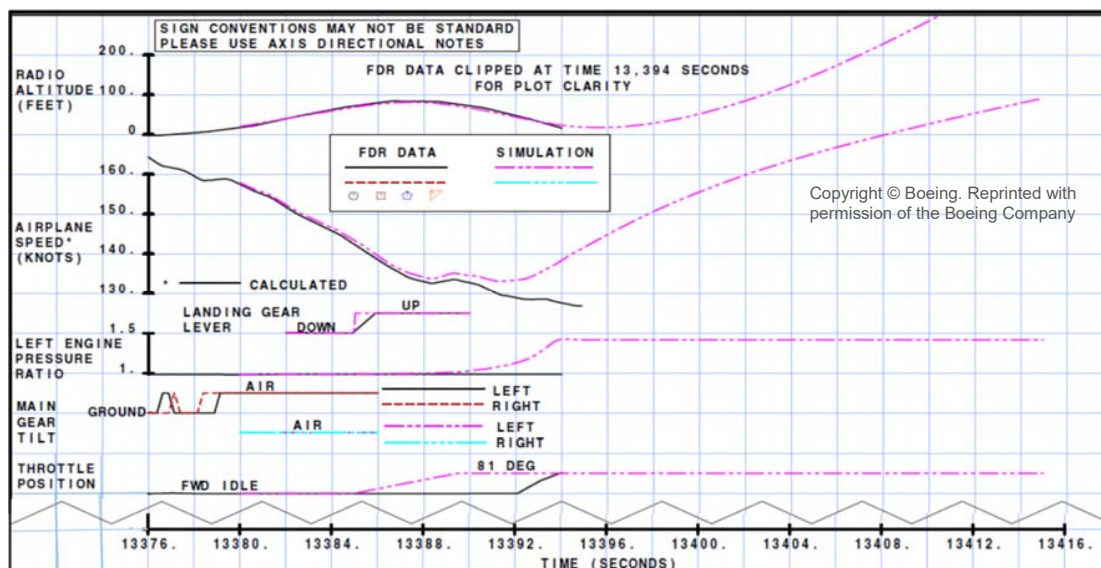
Figure 21. Calculated go-around after TO/GA switch push [source: Boeing]

For UAE521, the actual thrust lever increase, which was a manual advancement by the Commander at 13,392 seconds FDR time, was performed fifteen seconds after the Commander called for a 'go-around'.

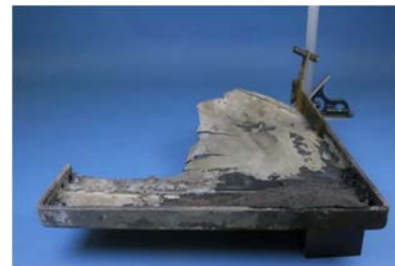
Figure 22. L1 cabin crew seat pan and left lever distortion [Source: NTSB]

The L1 cabin crew seat parts recovered from the Aircraft were sent to the NTSB materials laboratory in Washington, DC, the United States. The examination found that the left seat pan lever was twisted outwards at the attachment location of the seat pan lever stop and lower back pivot. The left lower back pivot stop bolt (figure 22), attached to this lever, was found bent. The lower back pivot stop bolt hole (figure 23) of the right seat pan lever was found elongated with a plastic deformation of base material.

From these findings, the Investigation concluded that the right lower back pivot stop bolt, most likely, fractured due to a force generated by the Aircraft impact. This caused the right seat pan base to be released, and the left lower back pivot stop to be extracted from its position, completely folding the seat base down.

Because the weight of the cabin crewmember was similar to that used for certification conformity test²⁴, the impact force most likely exceeded the cabin crew seat design limitations with its certified static 6g downward force, and 14g canted at 30 degrees dynamic downward force.
