Engine malfunction involving Airbus Industrie A330-323, registered 9M-MTM

37 km north of Curtin Airfield, Western Australia on 18 January 2018

ATSB Transport Safety Report
Aviation Occurrence Investigation
AO-2018-007
Final – 6 November 2019

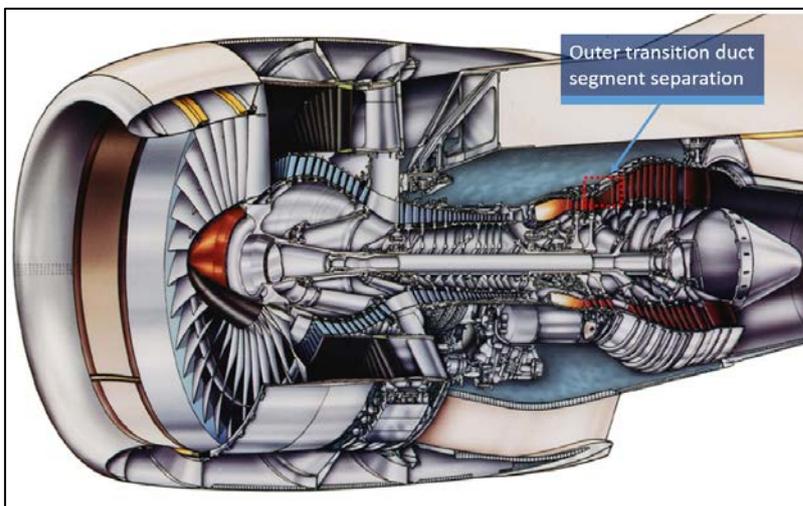
The engine disassembly and inspection identified that a third stage outer transition duct (OTD) segment had separated at the gas path entry point of the low pressure turbine. (Figure 1).

Figure 1: Cutaway view of the PW4170 showing outer transition duct location

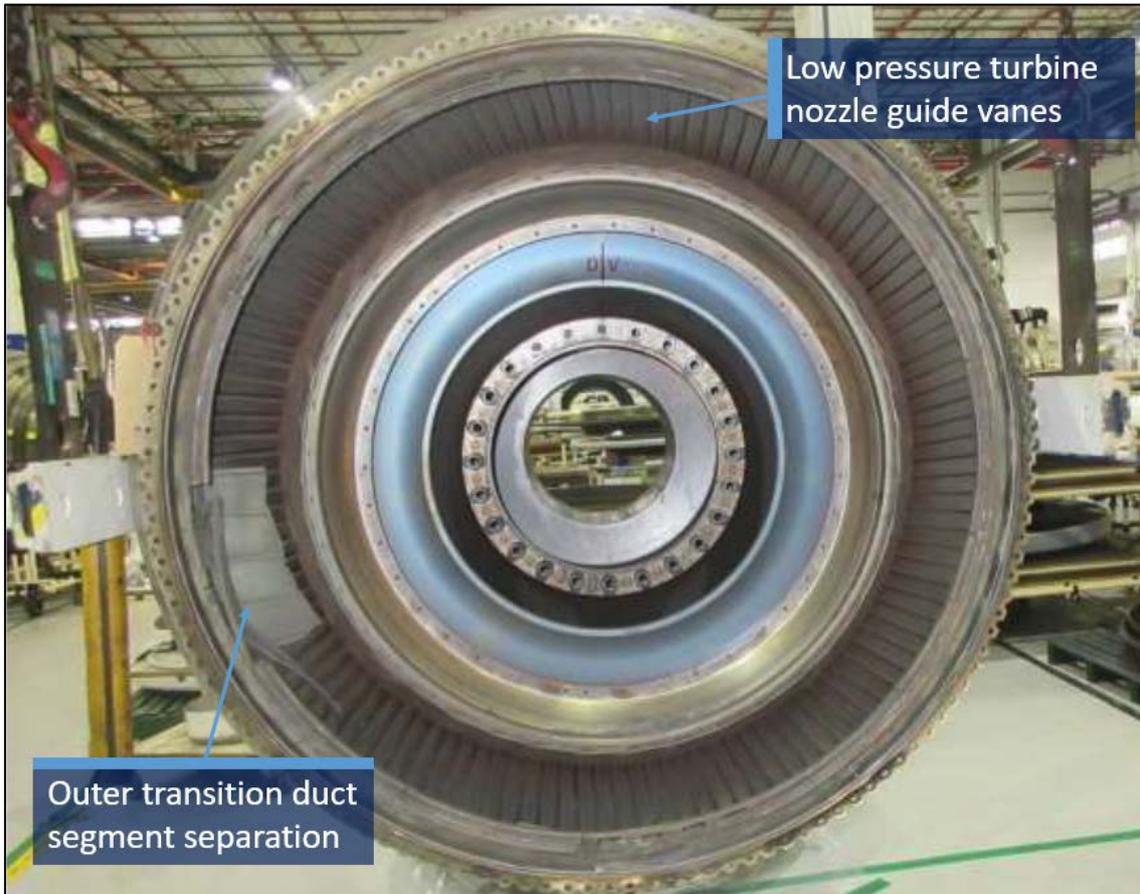
Specifically, the OTD at the number 5 position distorted, partially released from the front retaining hook and fractured so that a large section moved to a position that lay across the gas path of the low pressure turbine nozzle guide vanes (Figure 2). That partial blockage created turbulent airflow within the engine, and caused an increase in exhaust gas temperature. Downstream engine damage, including separation of some low pressure turbine blades, was attributed to the turbulent airflow and impact damage from sections of the OTD and released turbine blades.

Figure 2: Front view of low pressure turbine section showing the outer transition duct segment separation and movement into the low pressure turbine airflow path

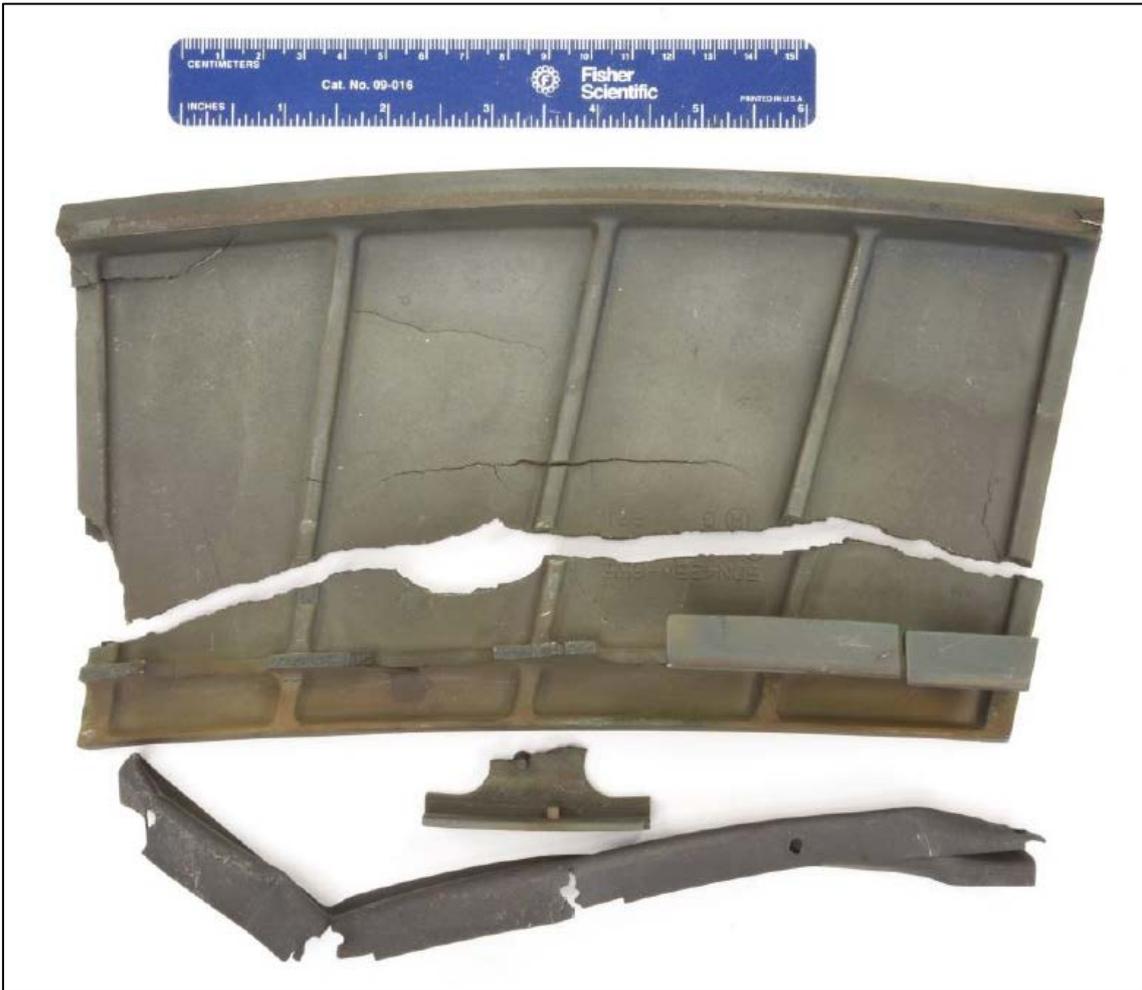
Review of the low pressure turbine outer transition duct segments found that the segment identified as #5 had fractured. Examination of the fracture surfaces found that the features appeared dendritic [microstructure affected by heat]; no evidence of fatigue was observed.

Metallographic sections were prepared through two outer transition duct segments selected based on the condition of the corresponding high pressure turbine 2nd stage blade outer air seals and dimensional inspection of the segments. Examination of the sections found evidence of microstructural changes indicative of exposure to elevated temperatures.

Figure 3: Non gas path side of the failed number 5 outer transition duct sections

The elevated temperature exposure of the OTD identified during the failure analysis activity is attributed to the OD [Outer Diameter] of the gas path being hotter in engines configured with the Talon IIB-combustor (includes all Advantage70 engines). Spallation of the 2nd Stage Blade Outer Air-seals (BOAS) immediately upstream of the OTD is an additional contributor.

P&W has processed an engineering change that revises OTD material with higher temperature capability. The redesigned hardware will be available from November 2019 and will be recommended for incorporation when the LPT [Low Pressure Turbine] module is disassembled at a minimum.

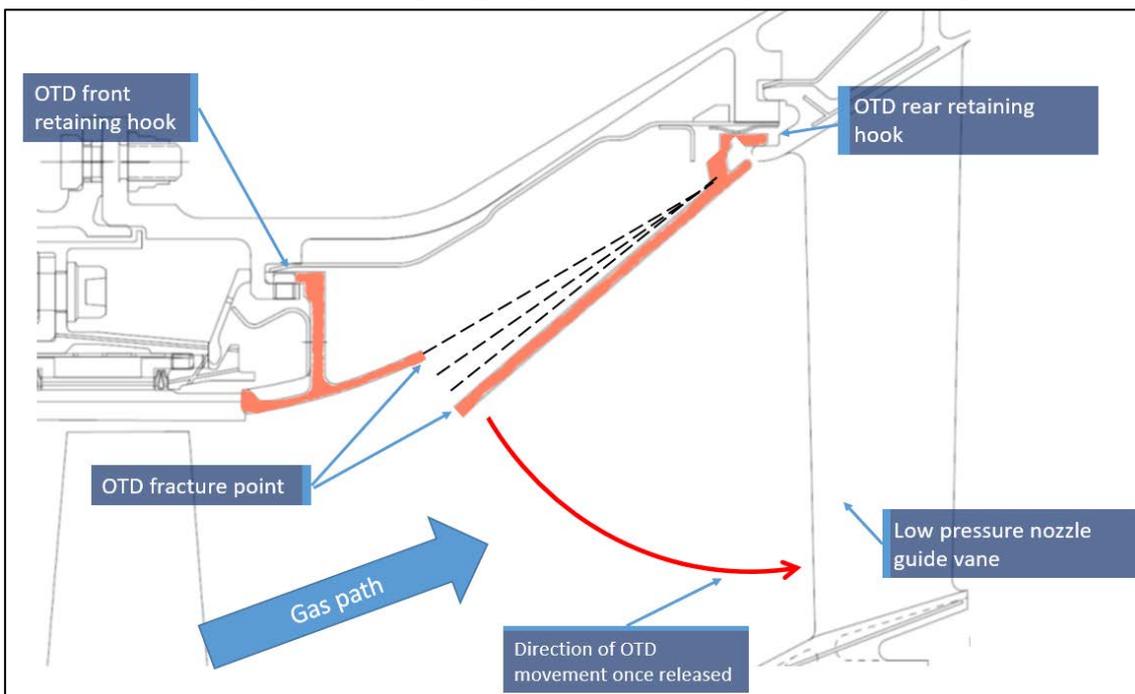
The engine manufacturer identified that the outer transition duct (OTD) distorted over a period of time to a point where the axial length was reduced enough for the front hook to disengage. Once disengaged, the OTD partially moved into the gas path which elevated its temperature. The temperature and gas path loads fractured the OTD, and the rear section rotated and came to rest on the low pressure nozzle guide vanes. That created significant turbulent airflow within the engine which led to low pressure turbine blade failure, high vibration and the compressor stall/surge events (Figure 4).

Figure 4: Plan view of the low pressure outer transition duct, front and rear attachment points, the fracture point, the engine gas path and the low pressure nozzle guide vane.
