Air Accident Investigation Sector

Serious Incident - Preliminary Report - AAIS Case N° AIFN/0016/2021

Shallow Initial Climb After Take-off

Operator: Emirates
Make and Model: Boeing 777-300ER
Nationality and Registration: The United Arab Emirates, A6-EQI
Place of Occurrence: Dubai International Airport and Dubai Airspace
State of Occurrence: The United Arab Emirates
Date of Occurrence: 19 December 2021

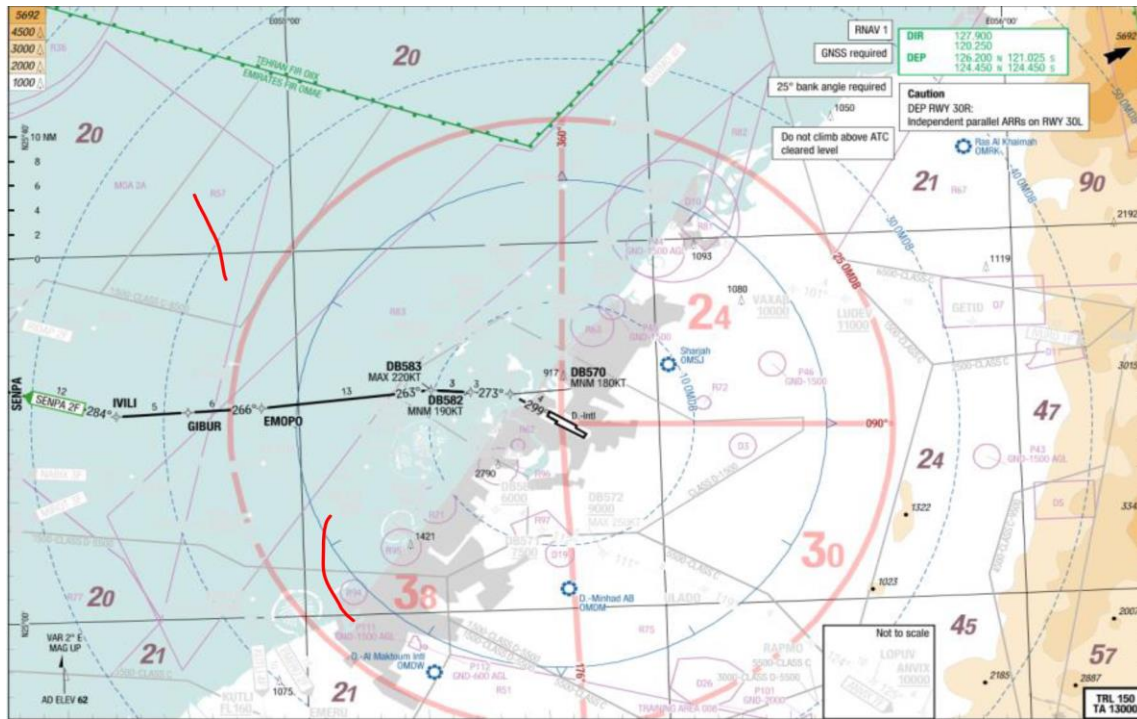
Figure 2. SENPA 2F SID

As per the operational flight plan (OFP), the SID was SENPA 2F (figure 2), which was flown by the flight crew for departure. As per the Commander's statement, the crew inserted the information of SENPA 2F SID in the Aircraft computer as planned.
