**The Aircraft Accident Investigation Board of the
Islamic Republic of Iran**

Flight PS752 Accident Investigation

Final Report

AAIB File Number:	A981018URPSR
Type of Occurrence:	Accident
Date of Occurrence:	Jan. 08, 2020
Place of Occurrence:	Near IKA Airport (OIIE) - I.R of Iran
Aircraft Type:	B737-800
Registration:	UR-PSR
Date of Issue:	Mar. 15, 2021

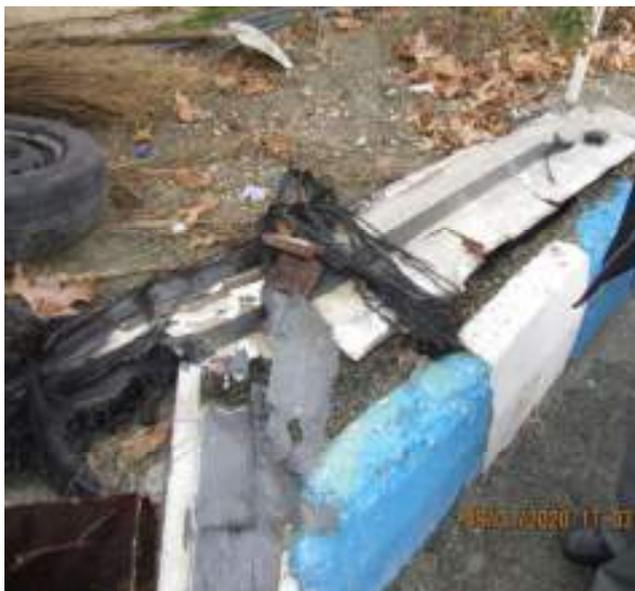
Figure 9- Part of the aircraft wing

While flying past a village called Boke near Shahriar, some skin pieces belonging to the aircraft wing back end surfaces (Figure 9) were detached and found on the ground at position $35^{\circ}35'55''\text{N}$, $50^{\circ}59'00''\text{E}$. Some small pieces and a piece of the air conditioning system (Figure 10) were found at position $35^{\circ}35'53''\text{N}$, $50^{\circ}59'43''\text{E}$, about 10 kilometers before the crash site, which was collected by the locals in residential complexes and delivered to the respective rural council.

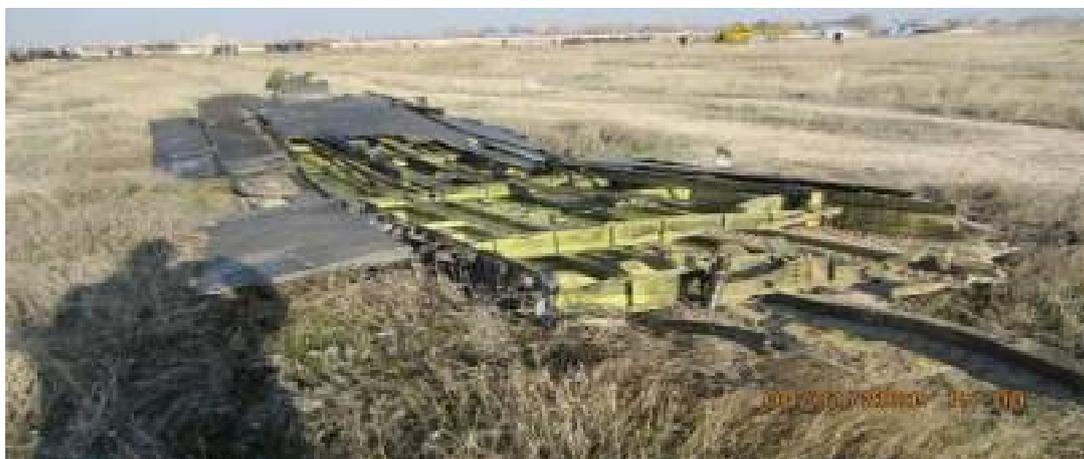
Figure 11- The aircraft left wing at the crash site

The outer skin of the left wing had signs of burning. There was no sign of fire at the place where the piece was found and the vegetation surrounding

it was undamaged. This showed the burn on the wing had occurred before the crash into the ground. The inner walls of the wing indicated that the fire had not broken out into the aircraft fuel tank. (Figure 11)

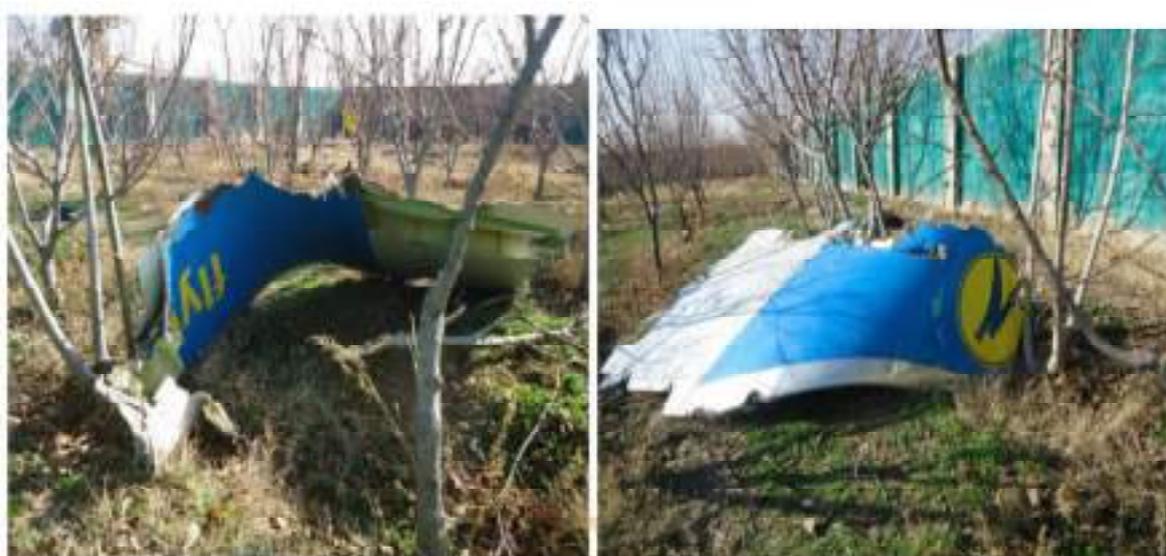
Figure 12- The aircraft right winglet

Some parts of the right wing together with the winglet indicated that the fire had not broken out into the right side of it (Figure 12).

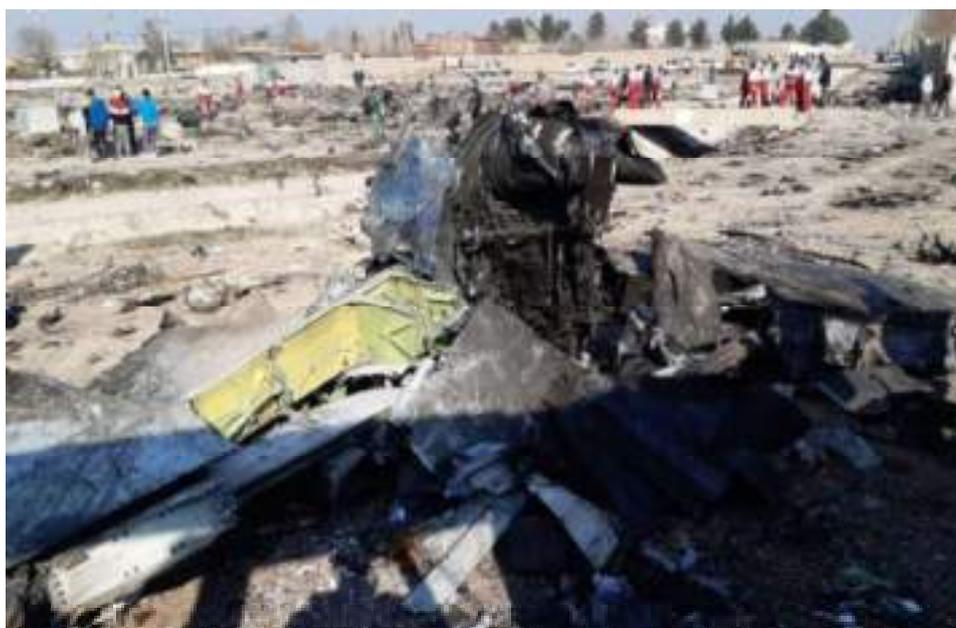
Figure 13- Auxiliary Power Unit

Smoke and burn were observed on the ground close to the Auxiliary Power Unit (APU) (Figure 13).

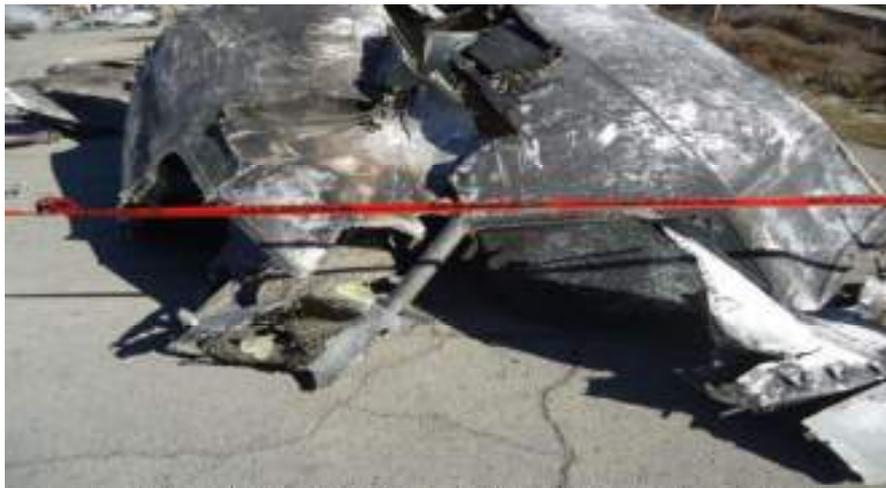
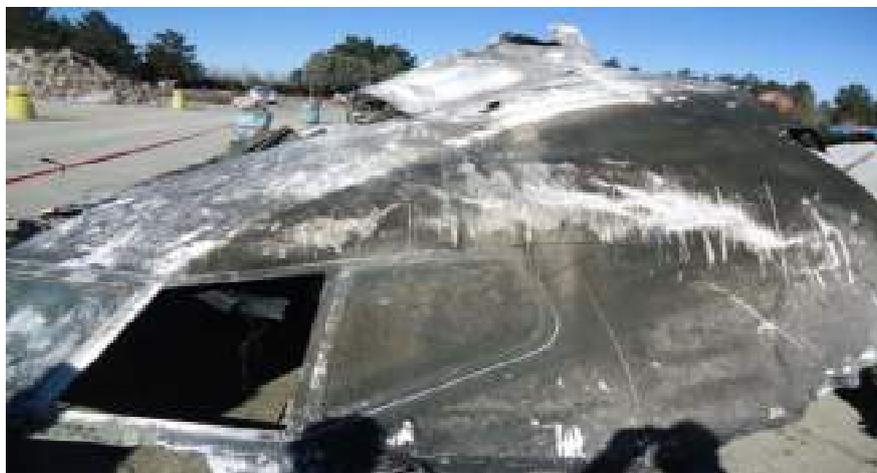
Figure 14 - Closer view of the cockpit

The traces of fire and smoke on the cockpit outer skin mark two situations: before and after the ground impact. In fact, it revealed that the fuselage had caught fire before the ground impact.

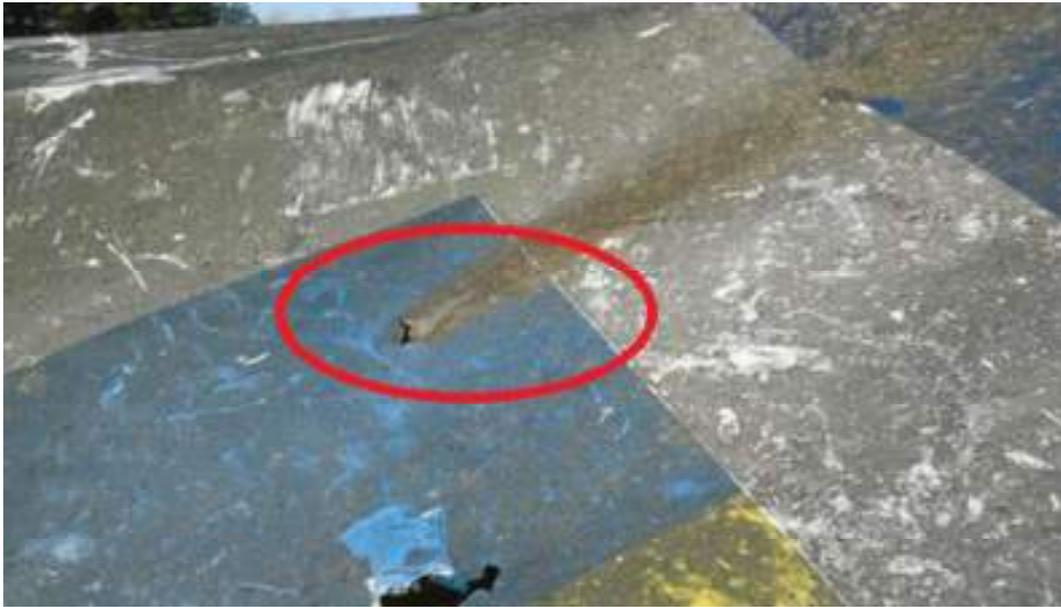
Laboratory results from the sample smoke layers around the holes show that the chemical base of the smoke was carbon, in which no traces of explosives were found.

Figure 16- Hole in the fuselage with a trace of a different color of smoke

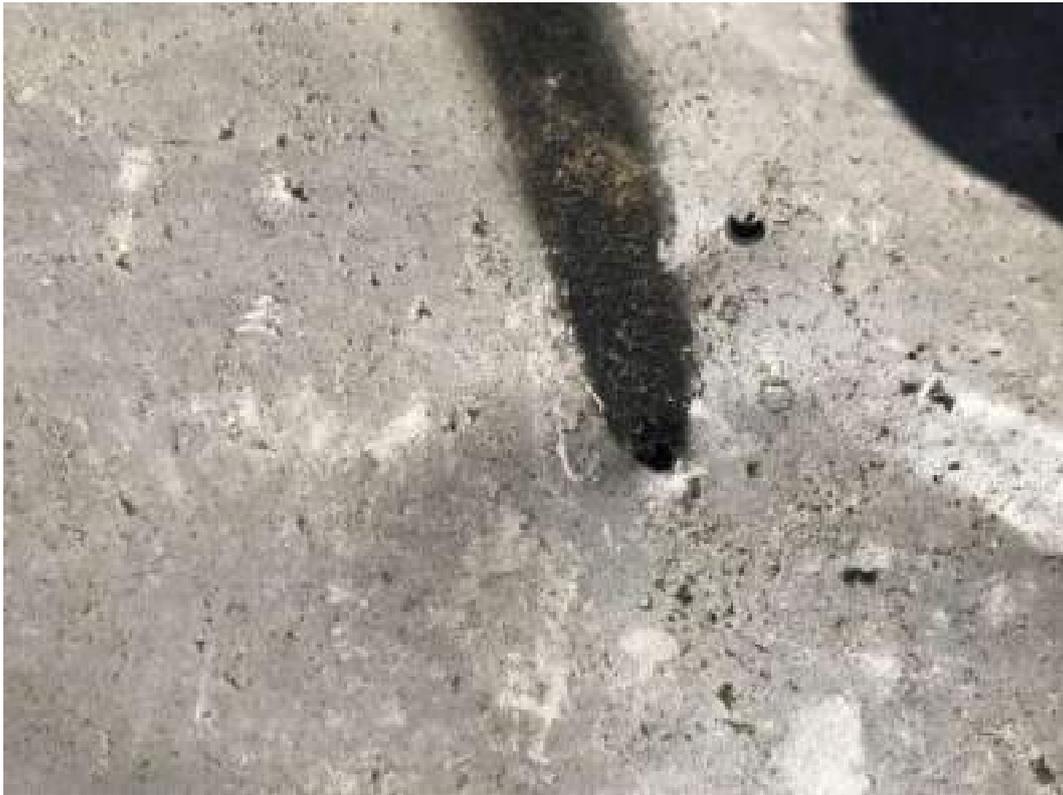
Figure 18- Hole on the fuselage near the cockpit and exhaust fumes

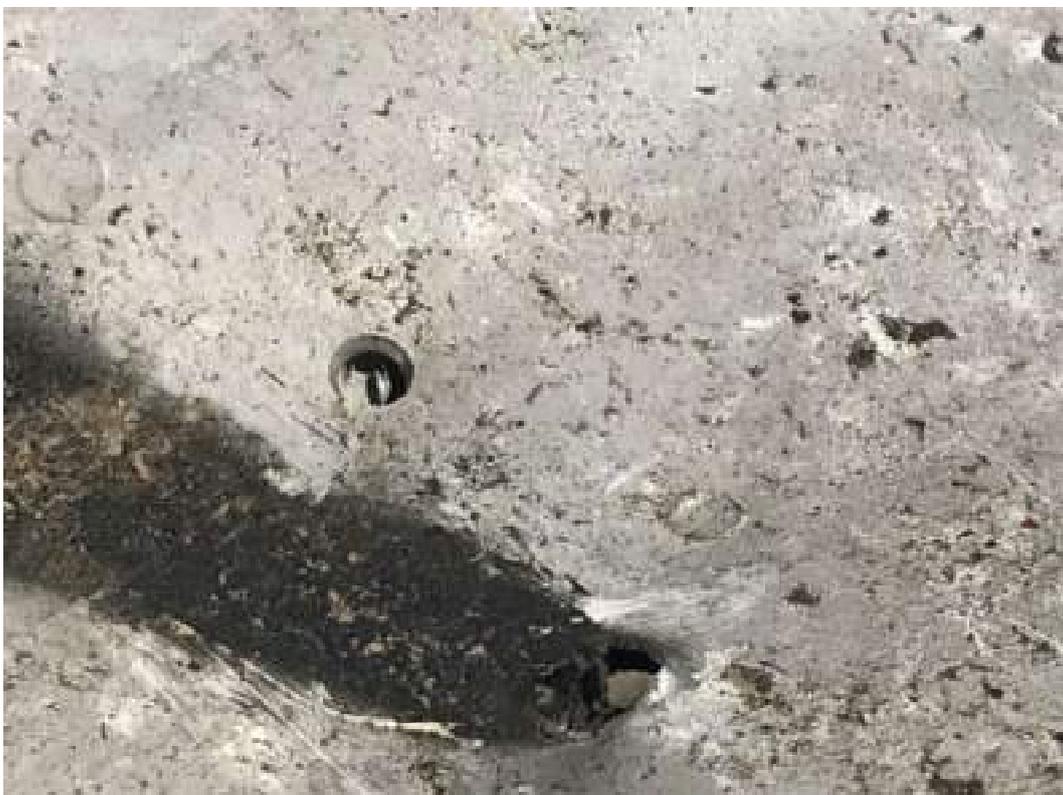
Figure 19- Closer view of the hole on the fuselage near the cockpit and burn signs in the hole area

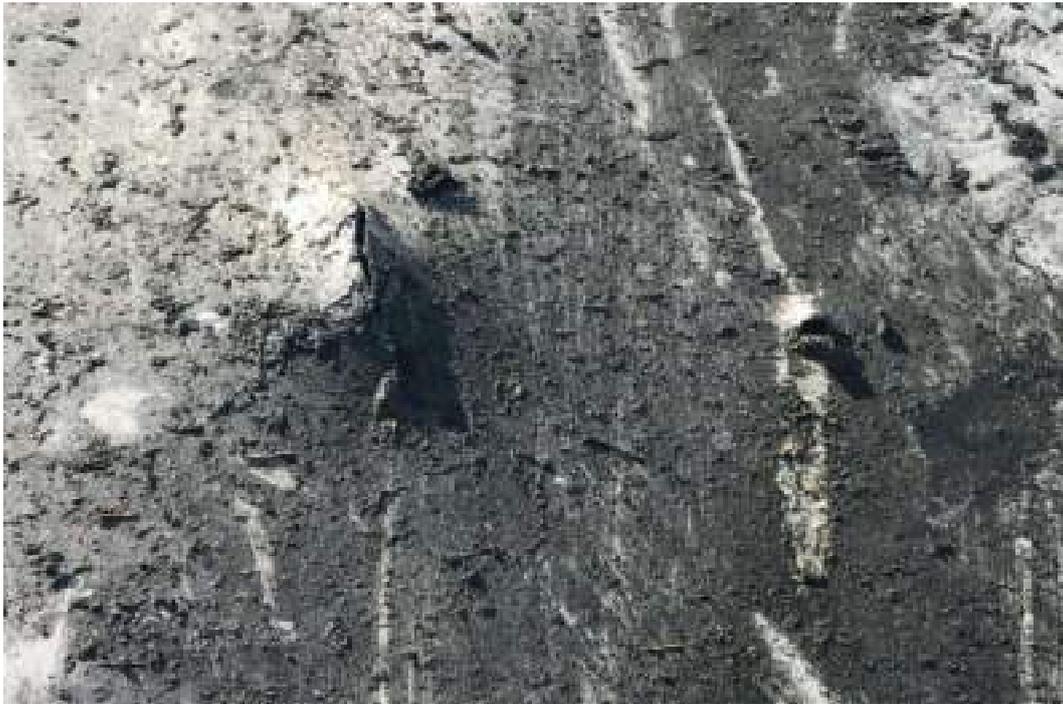
Figure 20- Crack with an outward hole in the skin of the structure near the cockpit

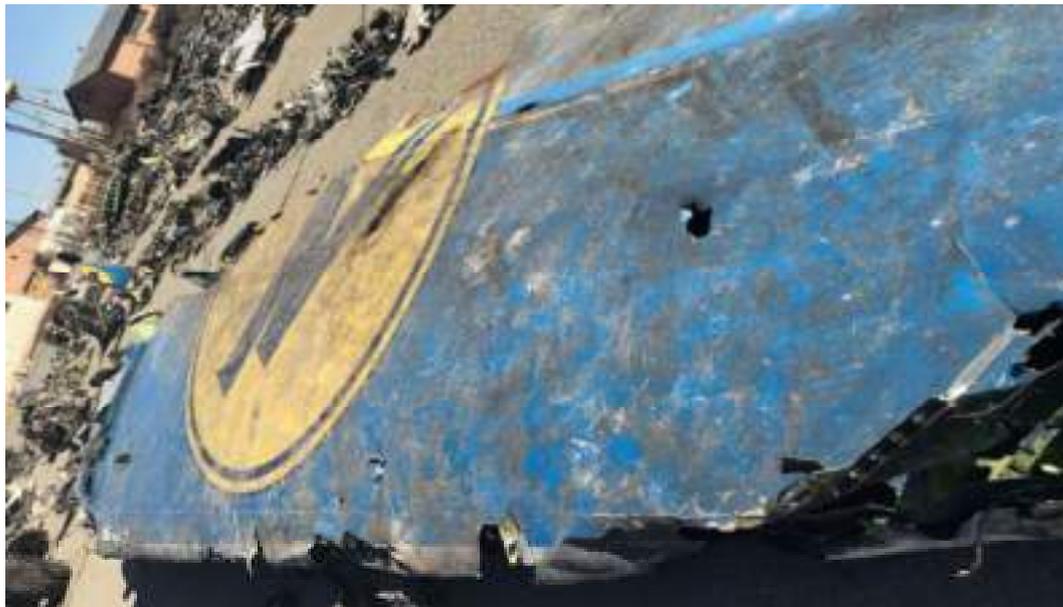
Figure 21- Holes and cracks on vertical stabilizer

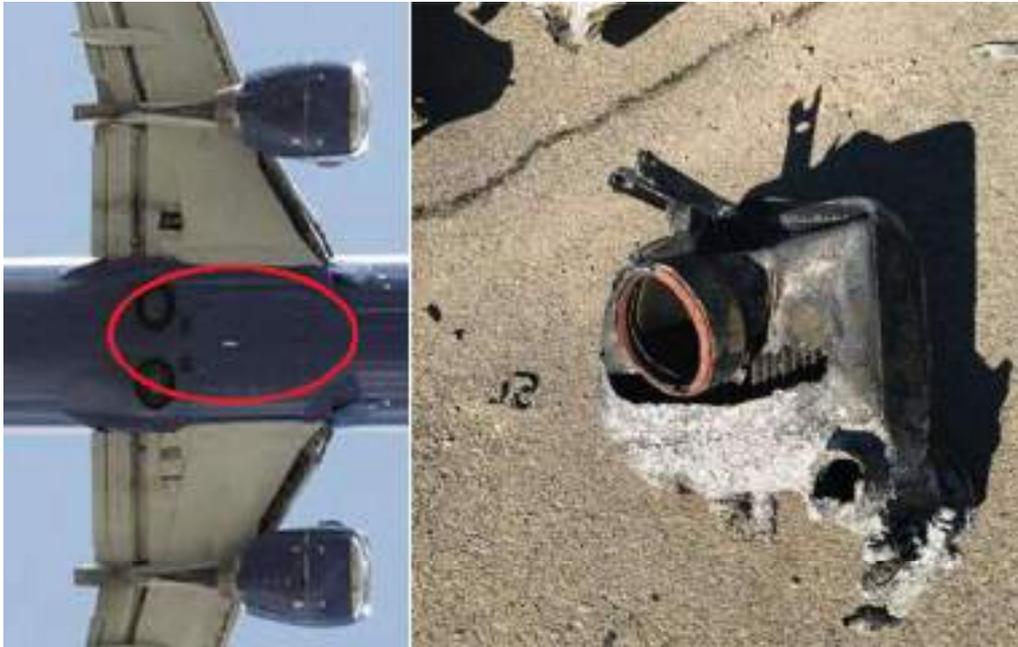
another heat exchanger found at the crash site, on which molten aluminum was observed, indicating a severe fire in this part.

Figure 22- The second heat exchanger found at the accident site and its installation point on the fuselage

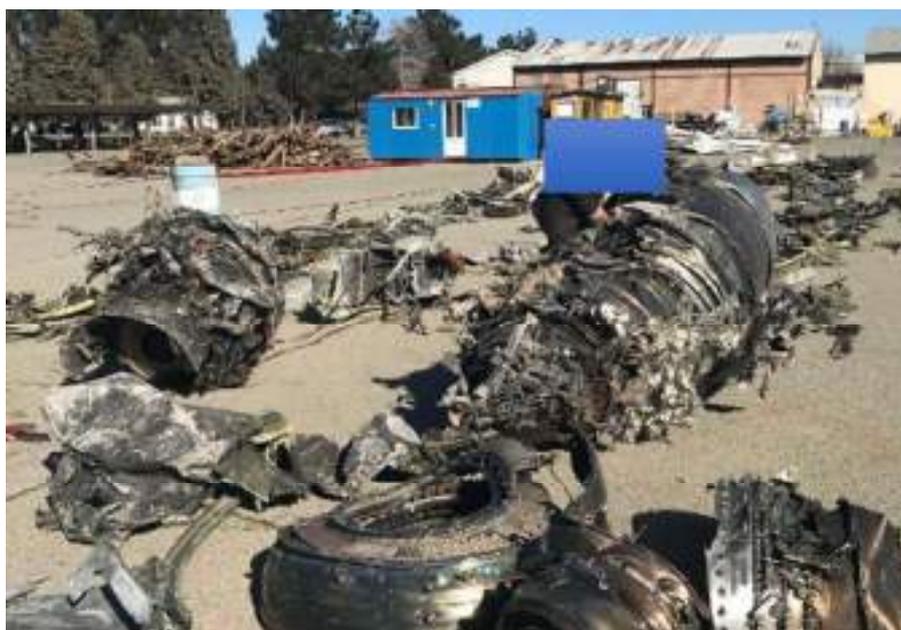
Figure 23- The two aircraft engines

Two aircraft engines were found at the accident site, which were totally destroyed (Figure 23). The damage observed on the rotating parts shows that the engines were working. The evidence revealed no explosion or severe fire on the engines and it seemed that most of the damage had been caused by deforming due to ground impact.

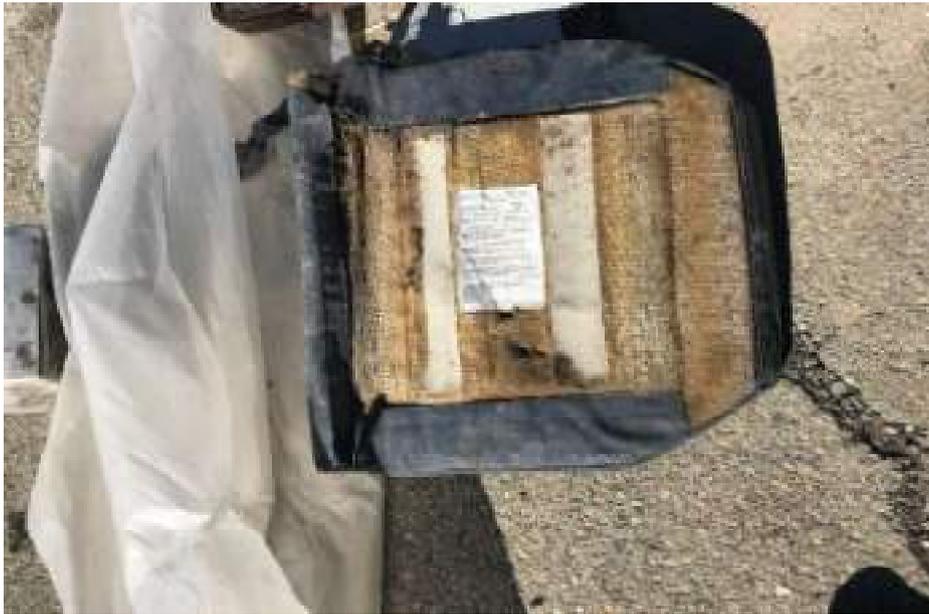
Figure 25- One of the remaining passenger seats with holes in it

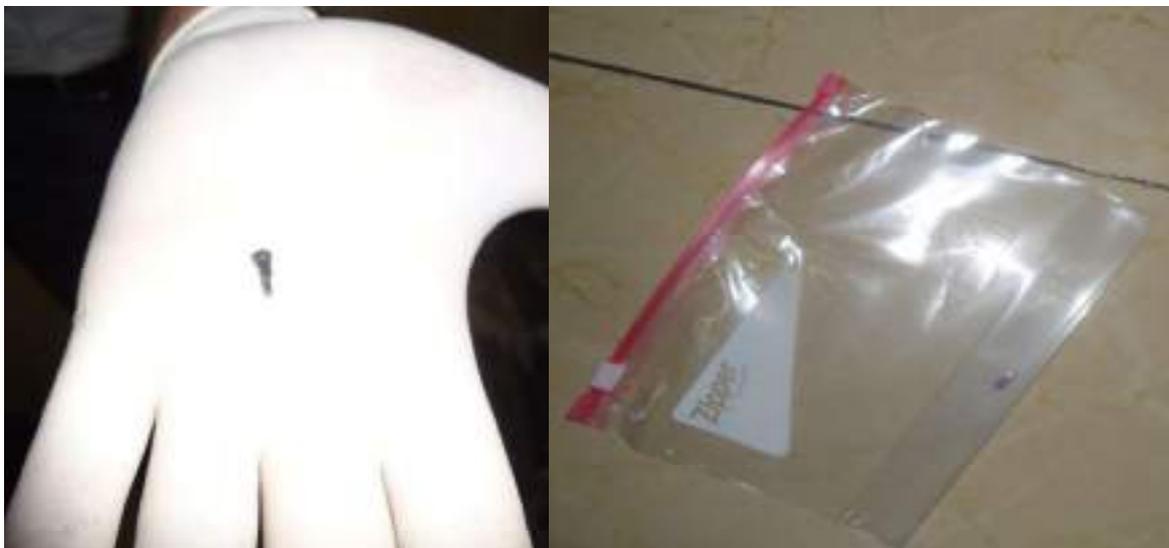
Figure 26- Metal objects found in the passenger seats

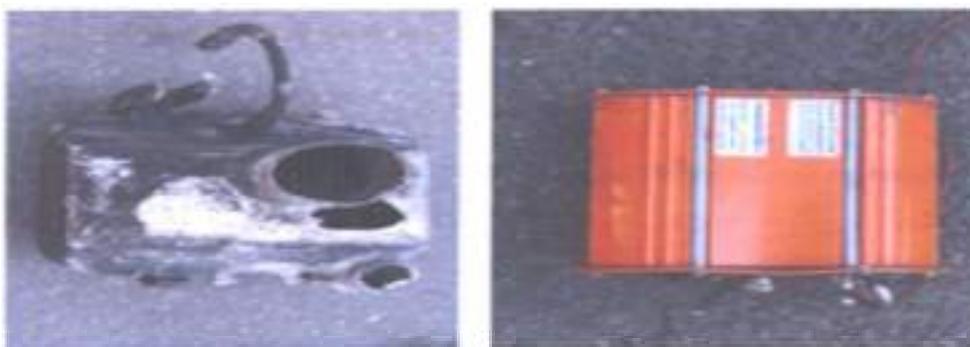
Figure 29- Pieces on which the explosive test was done

By sampling the air conditioning system and the two ELT pieces of the aircraft (Figure 29) and performing gas-chromatographic-mass spectrometry on each of the parts, the presence of negligible amounts of Dinitrotoluene (DNT) with the chemical formula $C_7H_6N_2O_4$ was proven.

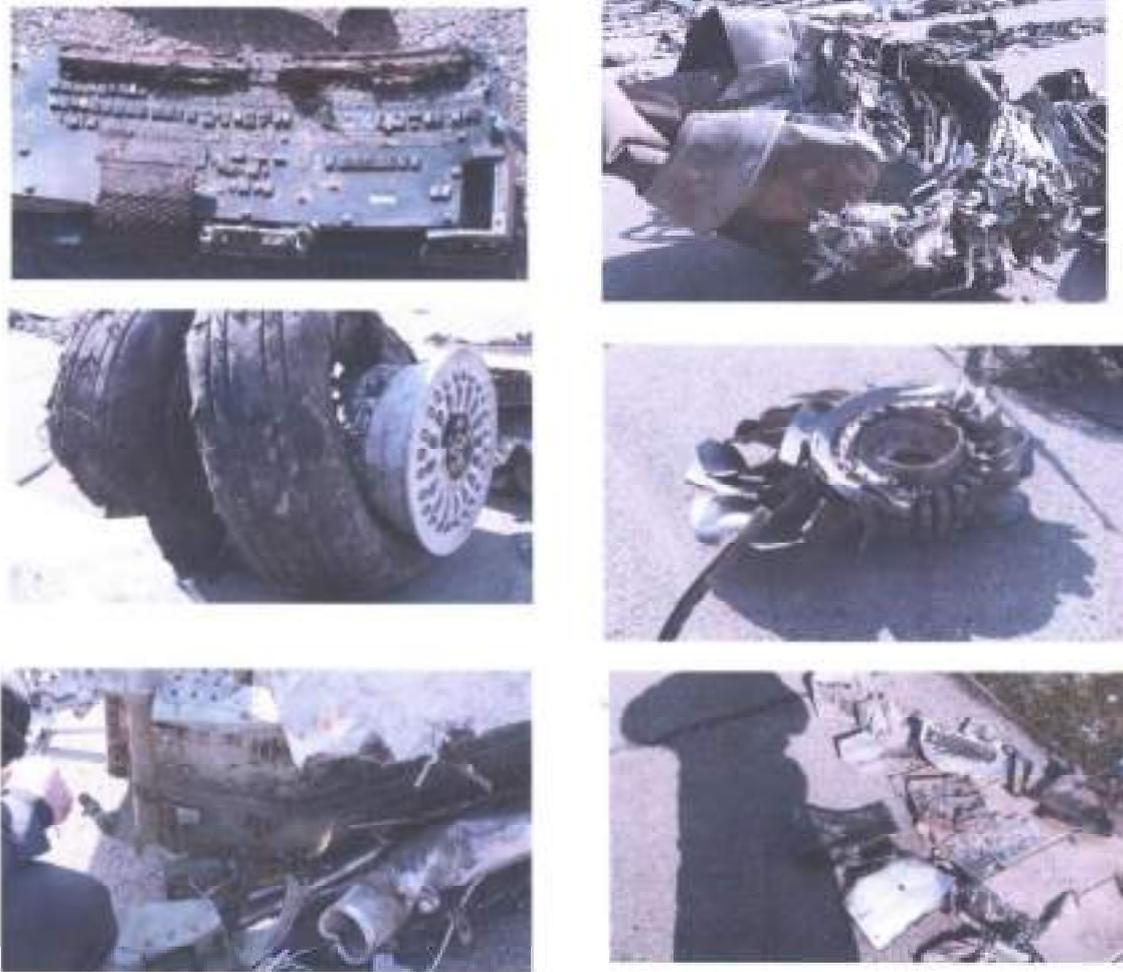
It should be noted that no explosive contamination was observed in the samples taken from the engines and other aircraft pieces or the objects inside the passenger cabin (Figure 33).

Figure 33 -Some of the aircraft parts free from explosives

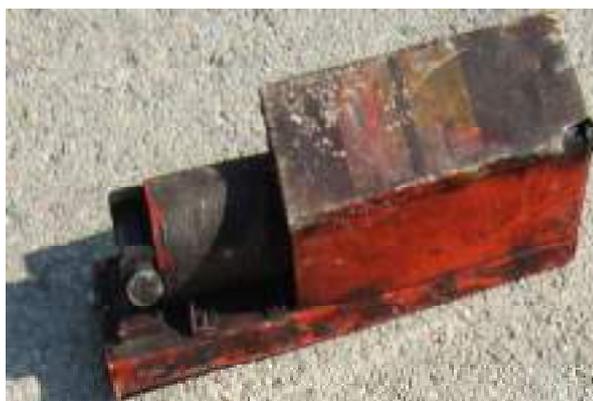
Figure 35- FDR physical appearance after the crash

Damage to CVR had been more serious, whose main memory (CSMU) was detached due to the impact severity. The condition of these recorders indicated that the CVR and FDR had not been exposed to the fire in the aircraft, and after the ground impact, they were damaged or exposed to fire. (Figure 35 and Figure 36)
