## Airliner Evacuation due to Smoke in the Cabin at Helsinki Airport on 3 August, 2018

## SYNOPSIS

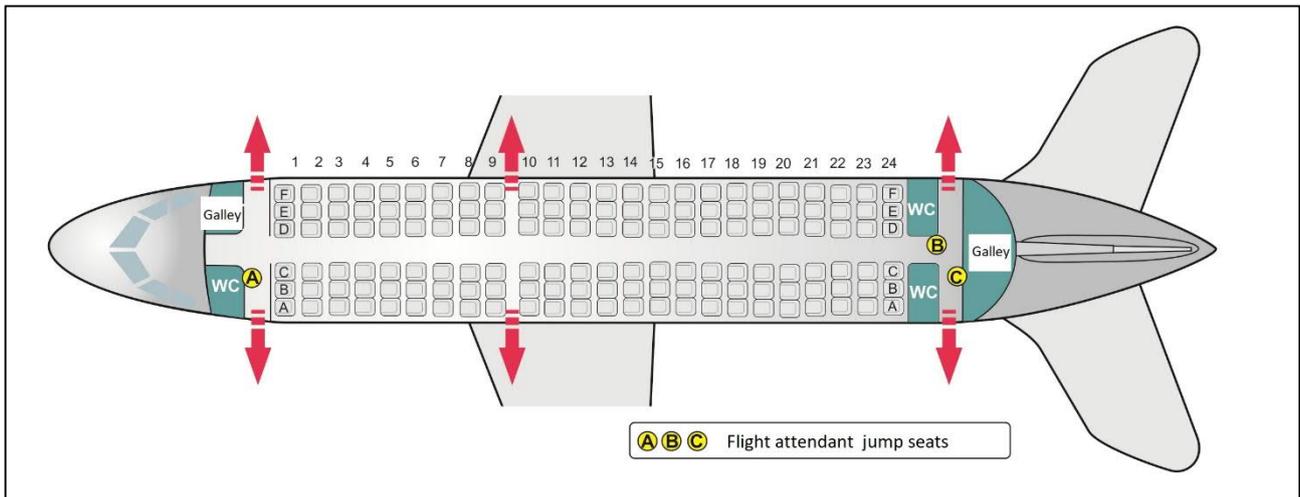
Figure 1. Cabin plan view. The red arrows indicate exits. (Image: SeatGuru, editing by SIAF)

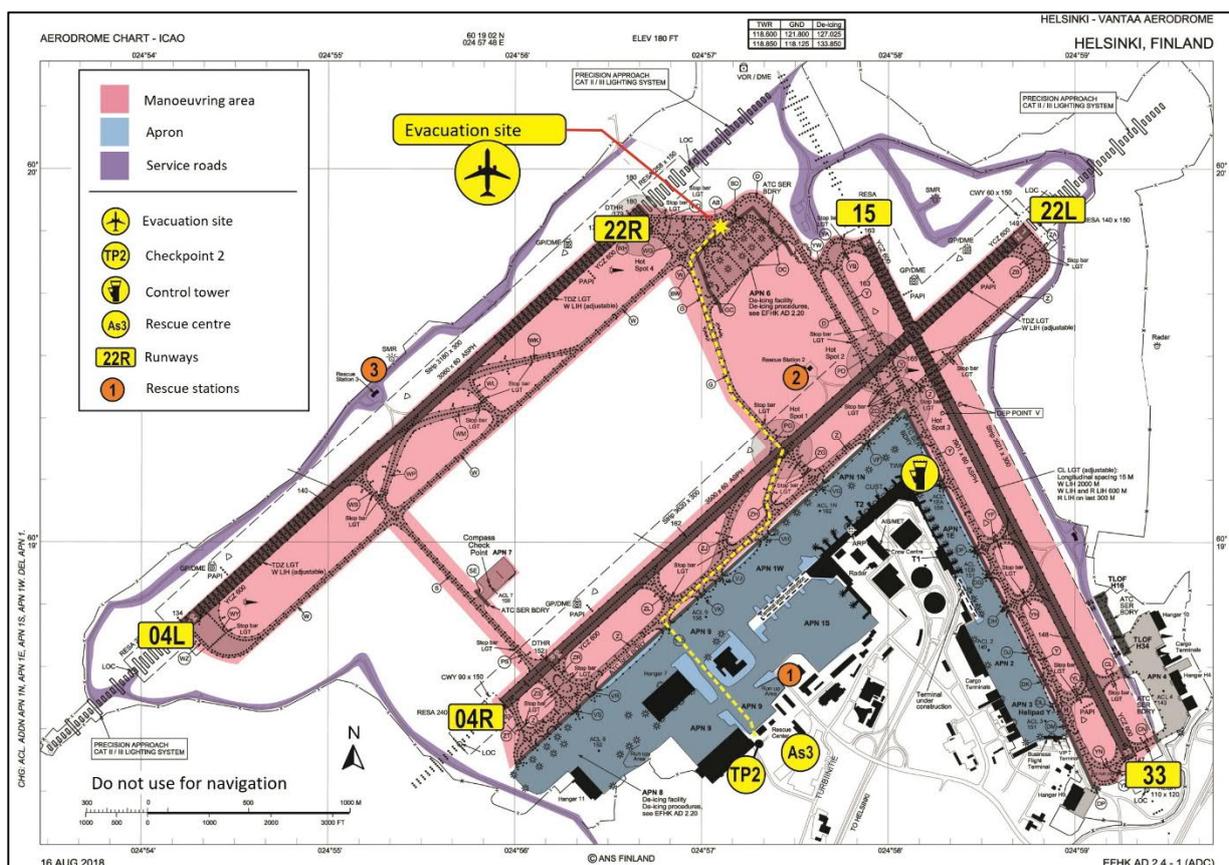
Figure 2. Aerodrome chart. The yellow dotted line is the shortest route (3.2 km) from checkpoint 2 (TP2) to the accident site. The length of the route using the service road is 11.1 km. (Image: © ANS Finland, added legends SIAF)

The shortest route from TP2 to the site was 3.2 km, via the apron, taxiway and the runway. The police units and rescue department units had to use the service road, which extended the distance to 11.1 km.
