Accident report occurred to the airplanes:

Airbus A321-231 reg. TC-JMM and

Airbus A330-300 reg. HL-7792

FINAL REPORT OF AIRCRAFT ACCIDENT INVESTIGATION AND INVESTIGATION

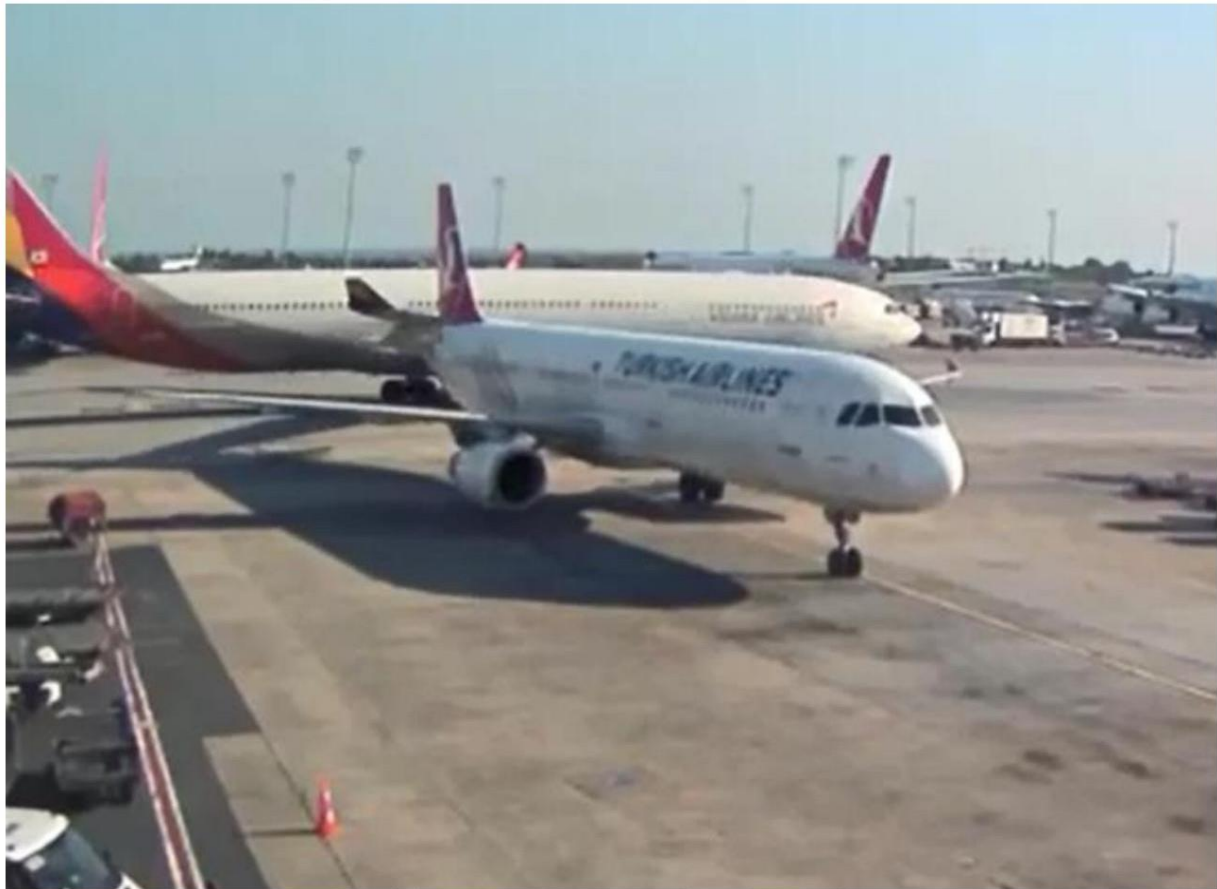
Picture-3: The Moment of the Accident

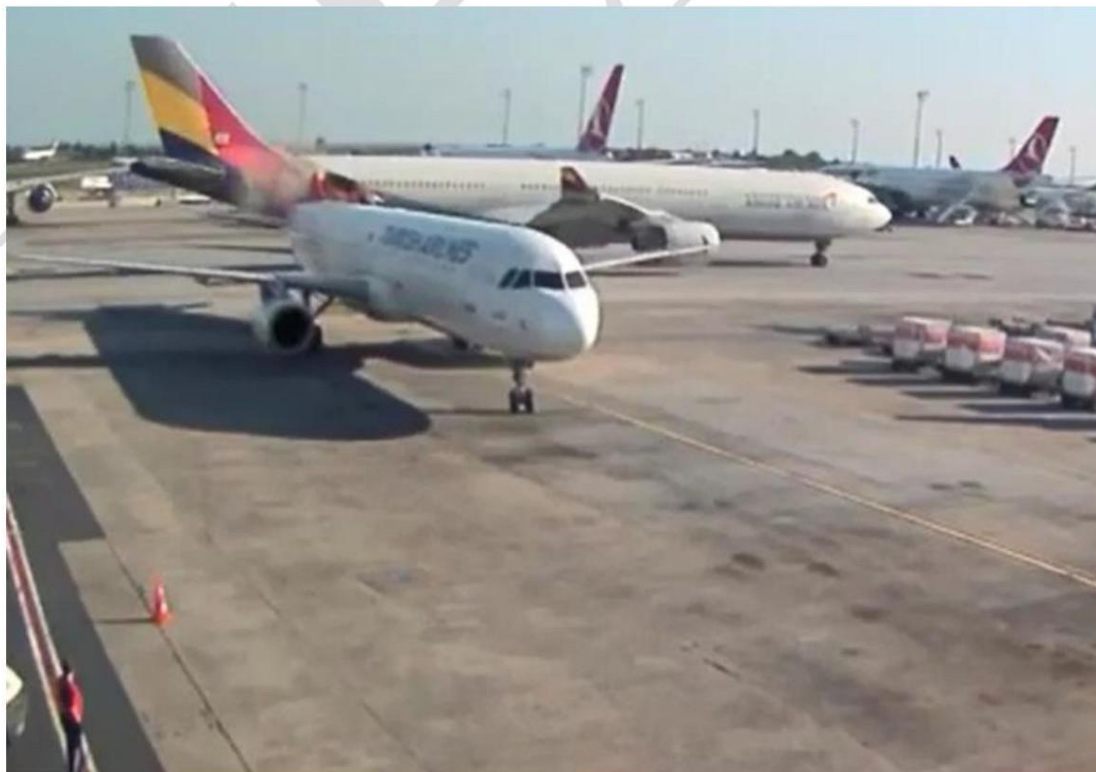
Picture-4: The Moment of the Accident

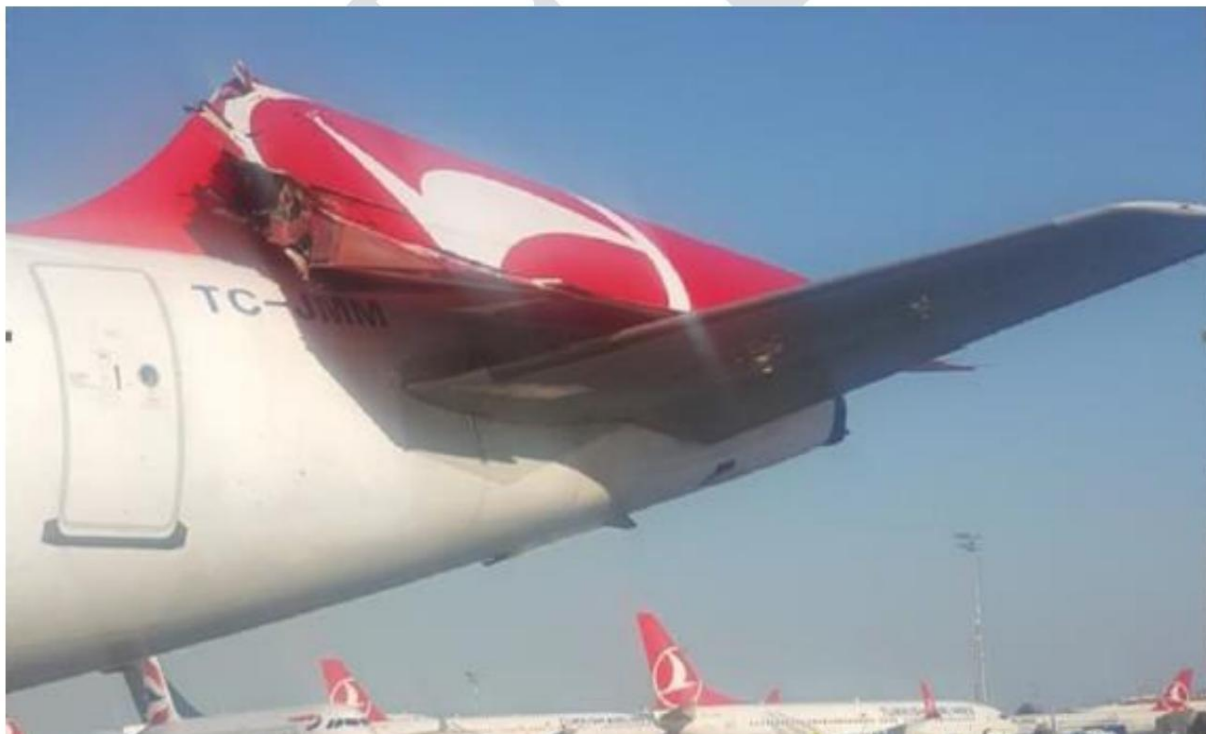
In the post-accident investigations, it has been determined that there are damages outside the damage and repair limits determined and published by the manufacturer in the tail gear components and structure of the aircraft with the TC-JMM registration mark.

The damage degree of the aircraft with the registration mark of TC-JMM is considered to be at the level of heavy damage within the framework of Article-37 of HKY-13 (Regulation on Investigation and Investigation of Civil Aircraft Accidents or Serious Incidents).

Picture-5: Tail Damage

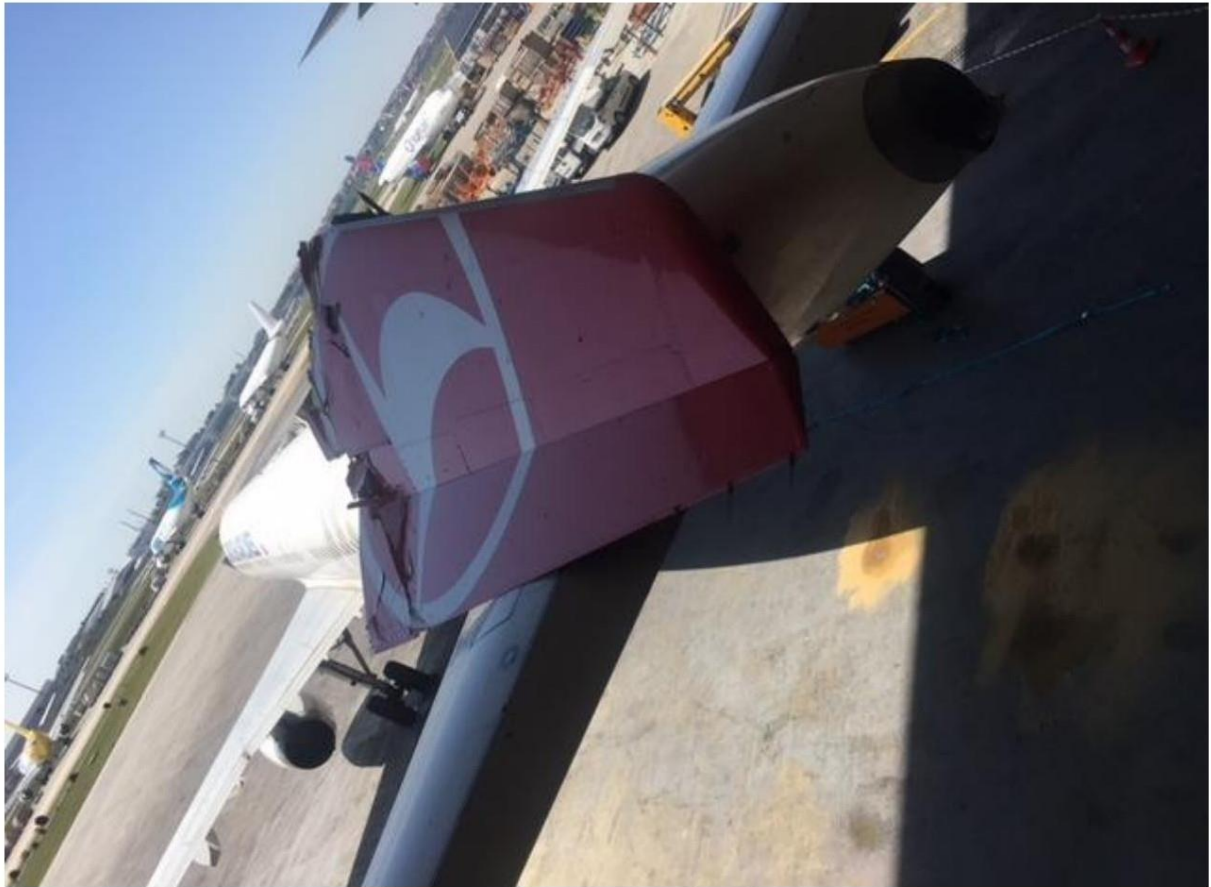
Picture-6: Tail Damage

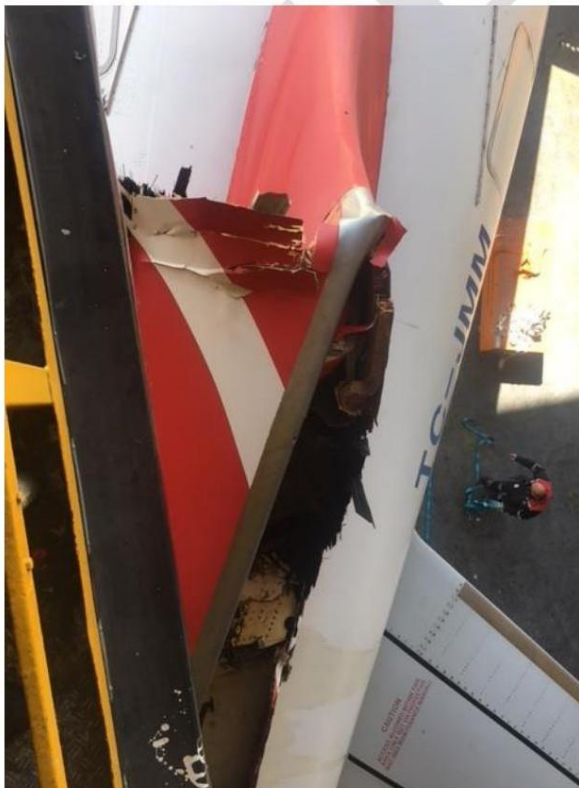
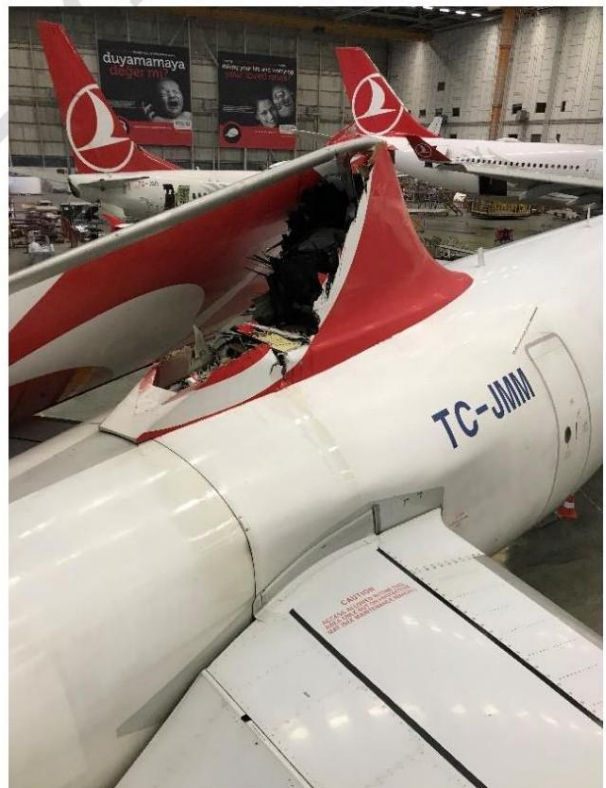
Picture-7: Tail Damage

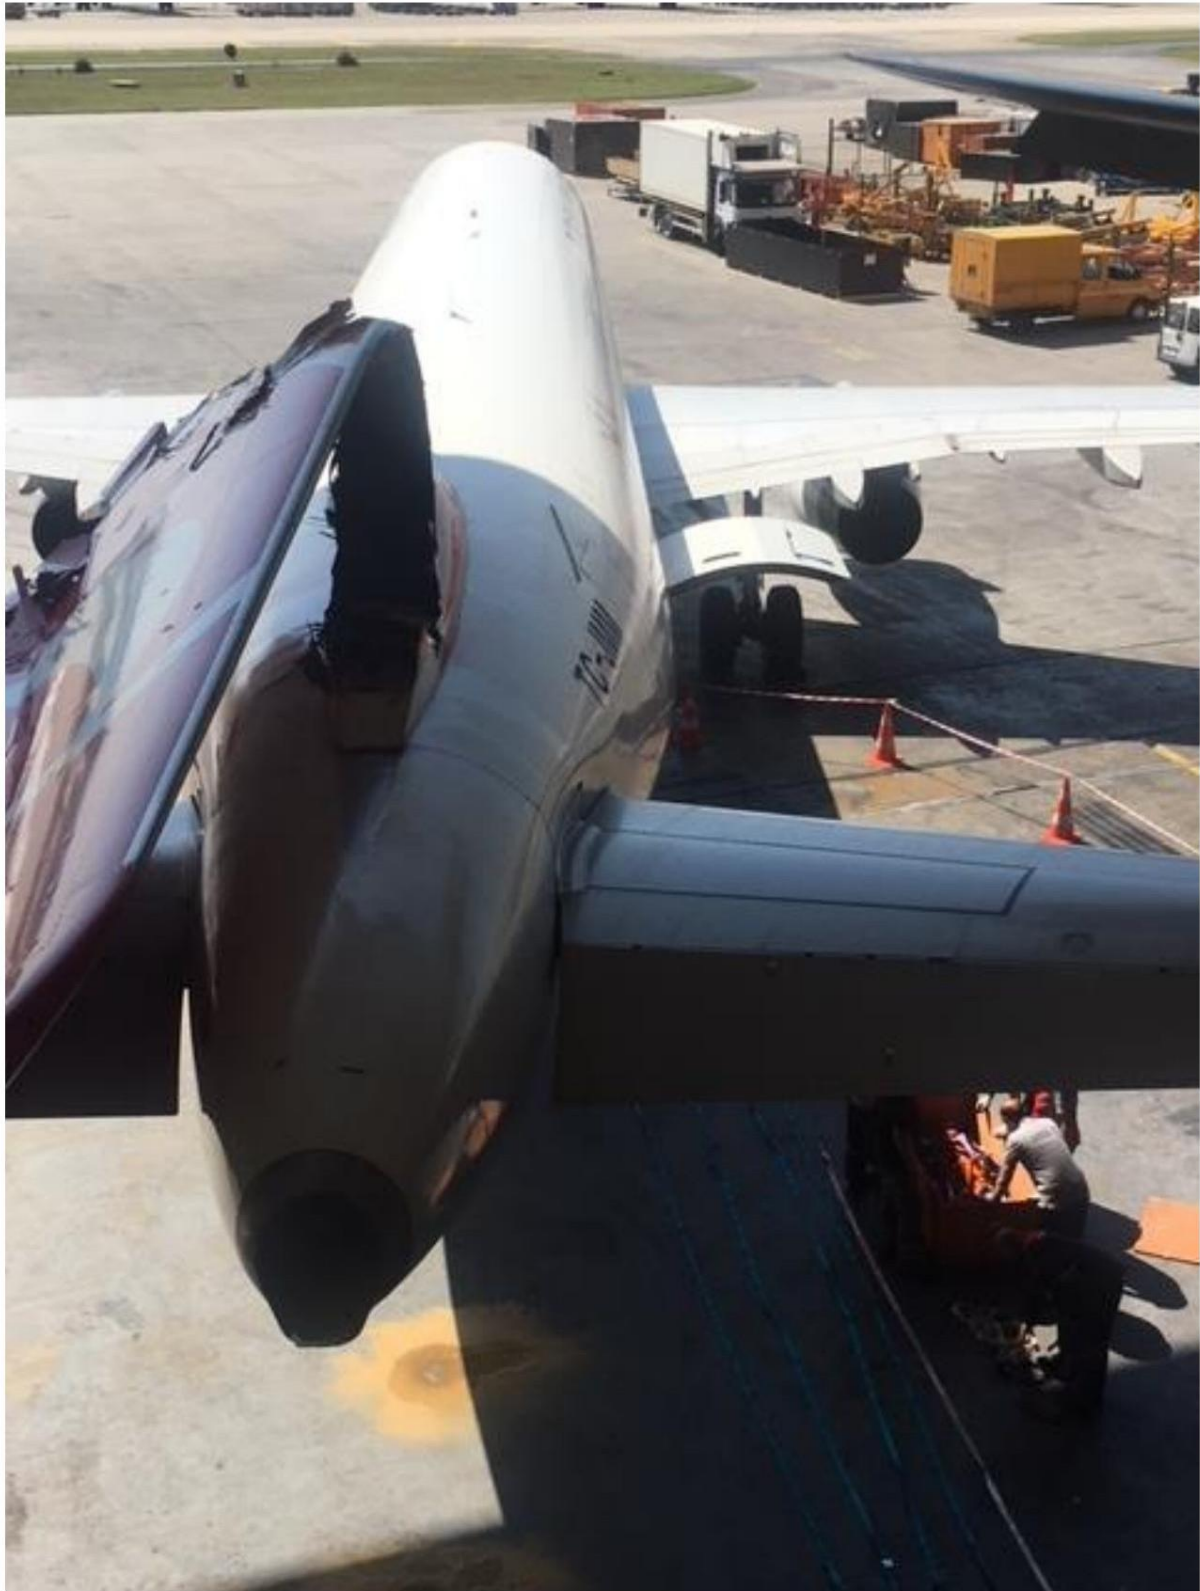
Picture-8: Tail Damage

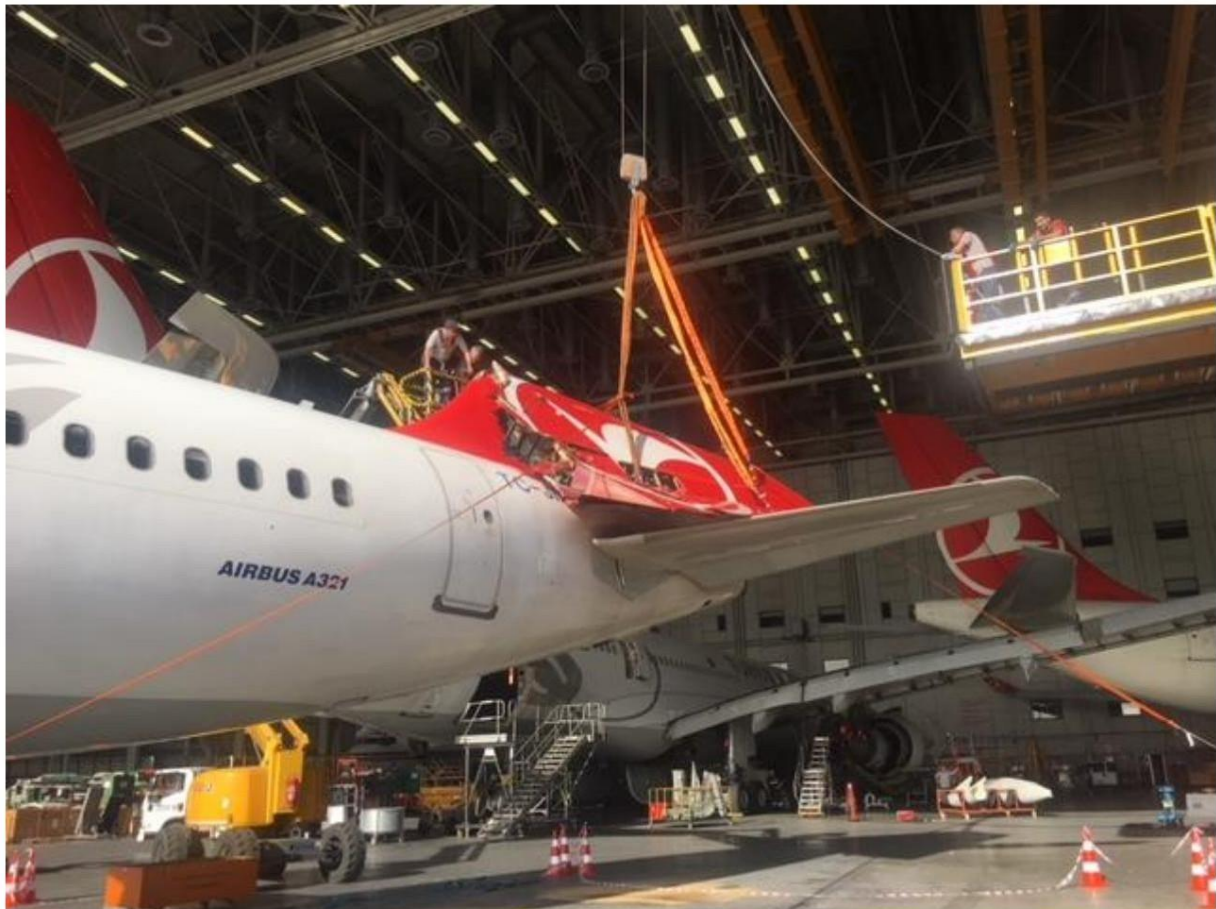
Picture-9: Tail Damage

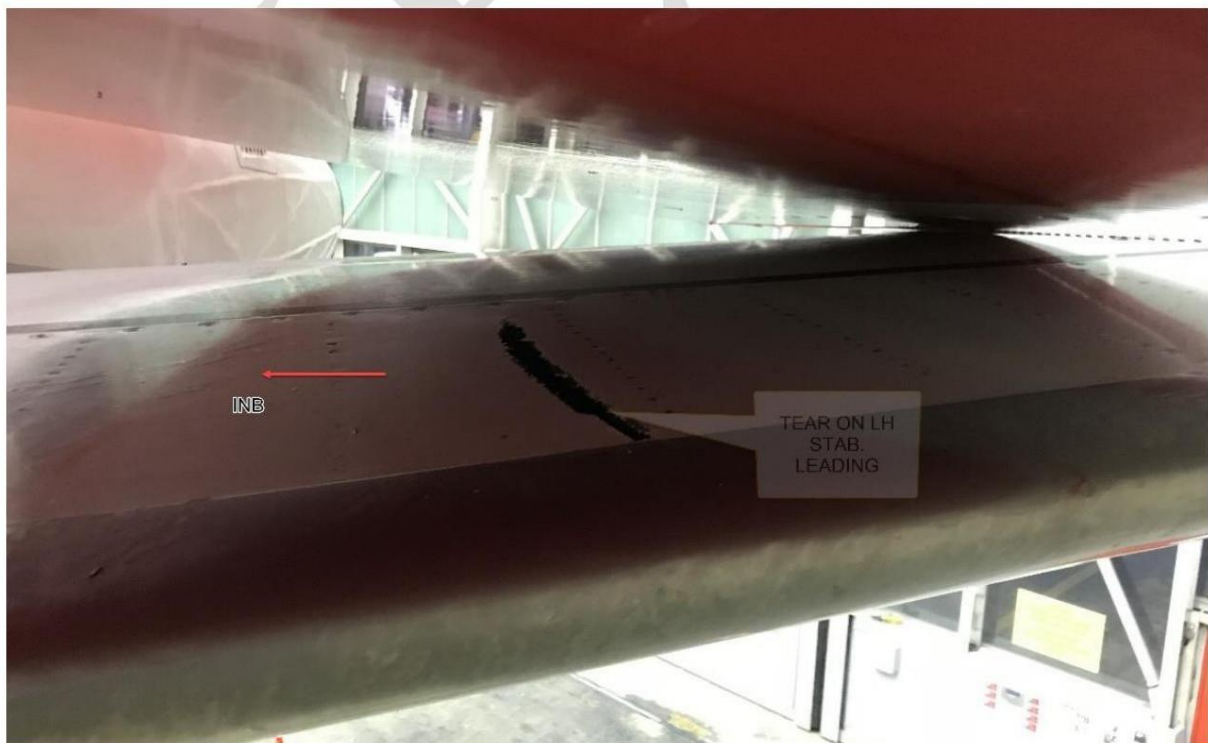
Picture-10: LH- Leading Edge Upper Part

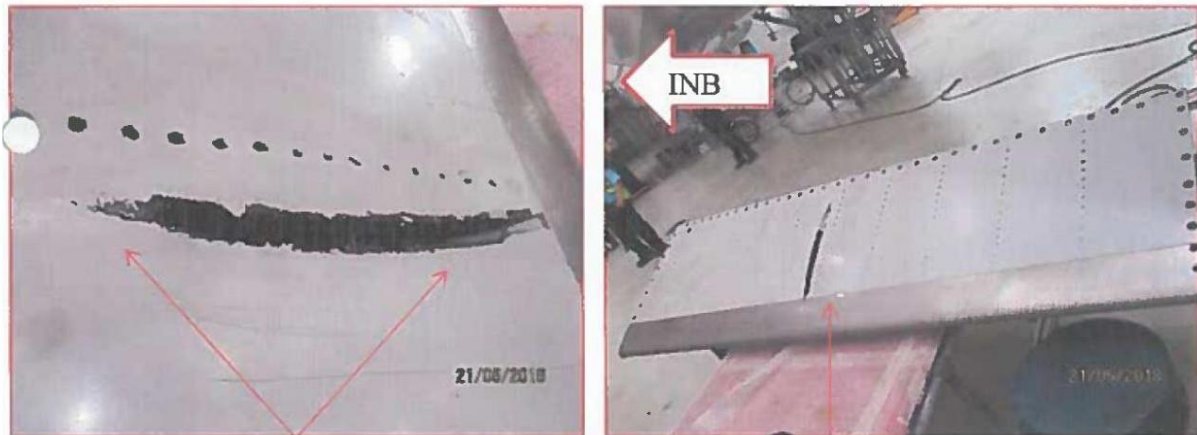
Picture-11: LH- Leading Edge Upper Part

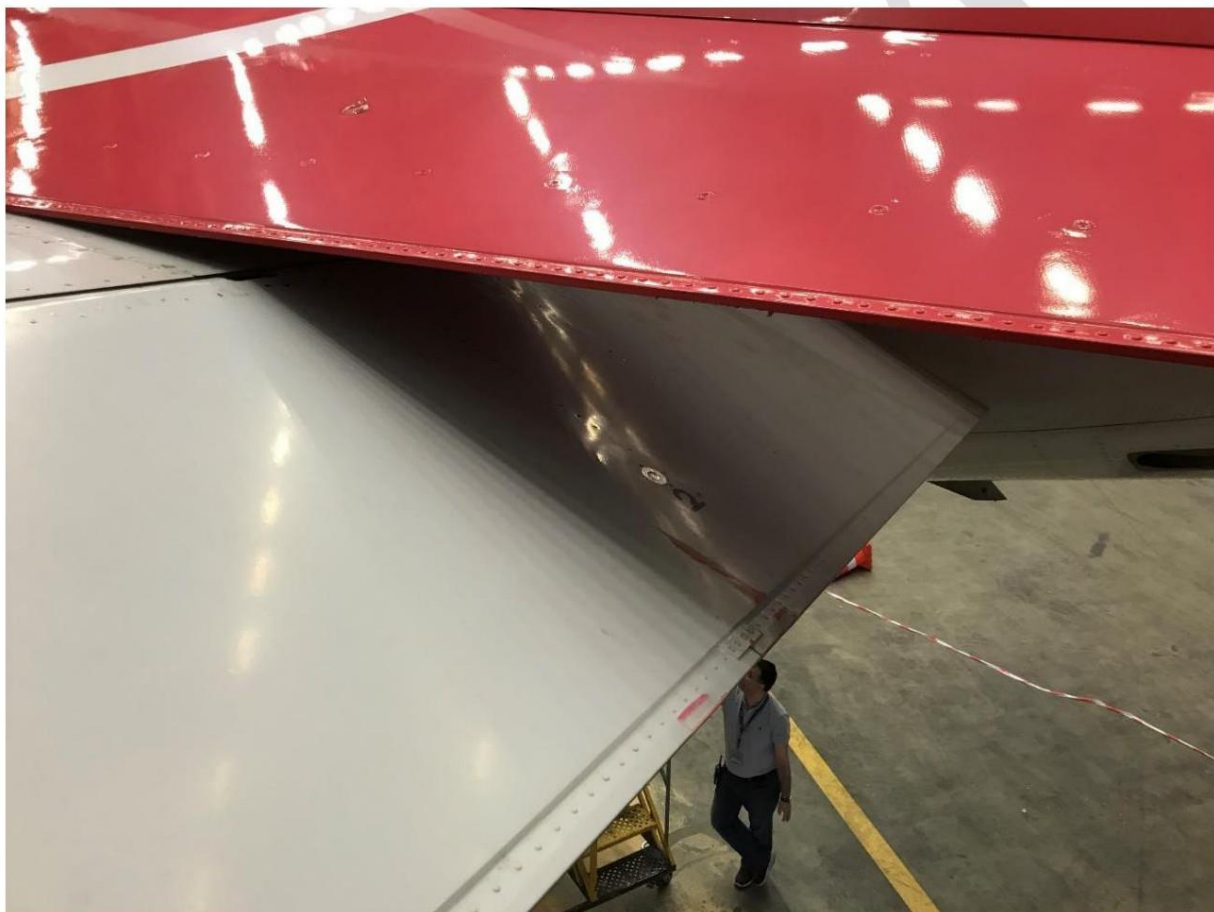
Picture-12: LH- Trailing Edge

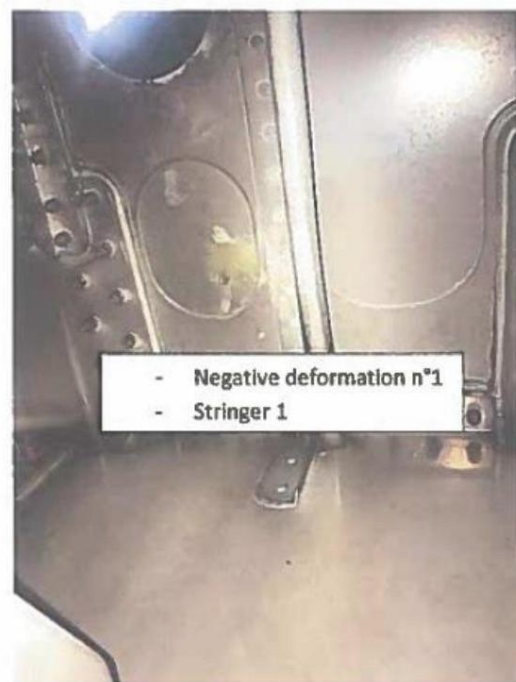
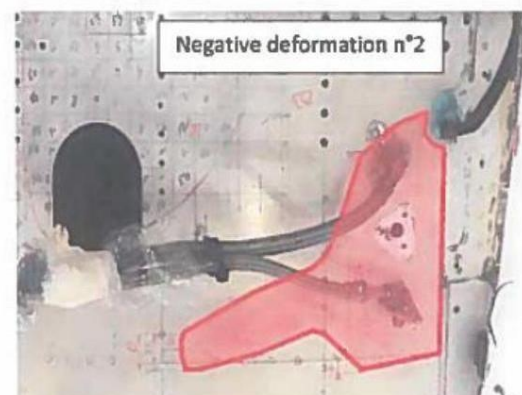
Picture-14: Body Surface Panel Stringer 1 / Frame 73

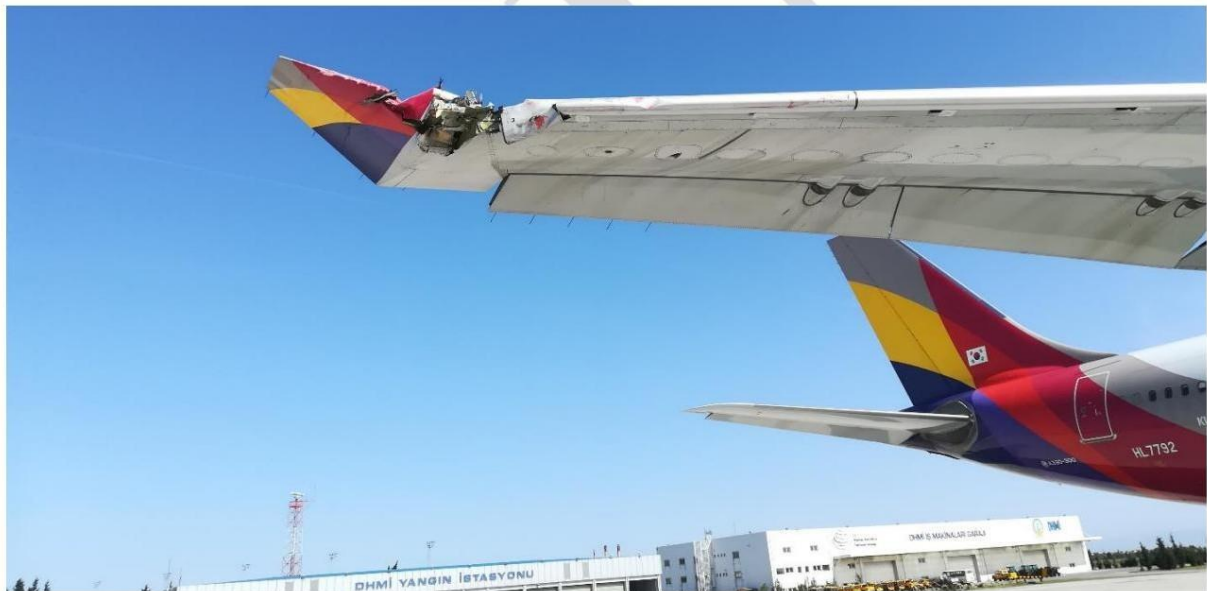
- Upper surface of the right wing,
- Right wing tip,
- Rightwing winglet,
- D-Nose structure,
- Right wing L/E 623NB panel,
- Crossing rib type,
- Right wing slat 7,
- Navigation lights, strobe lights were damaged.

The damage degree of the aircraft with registration mark HL7792 is considered to be at the level of light damage within the framework of Article-38 of HKY-13 (Civil Aircraft Accidents or Serious Incidents Investigation and Investigation Regulation).

Picture-15: Damaged Right Wing of HL7792

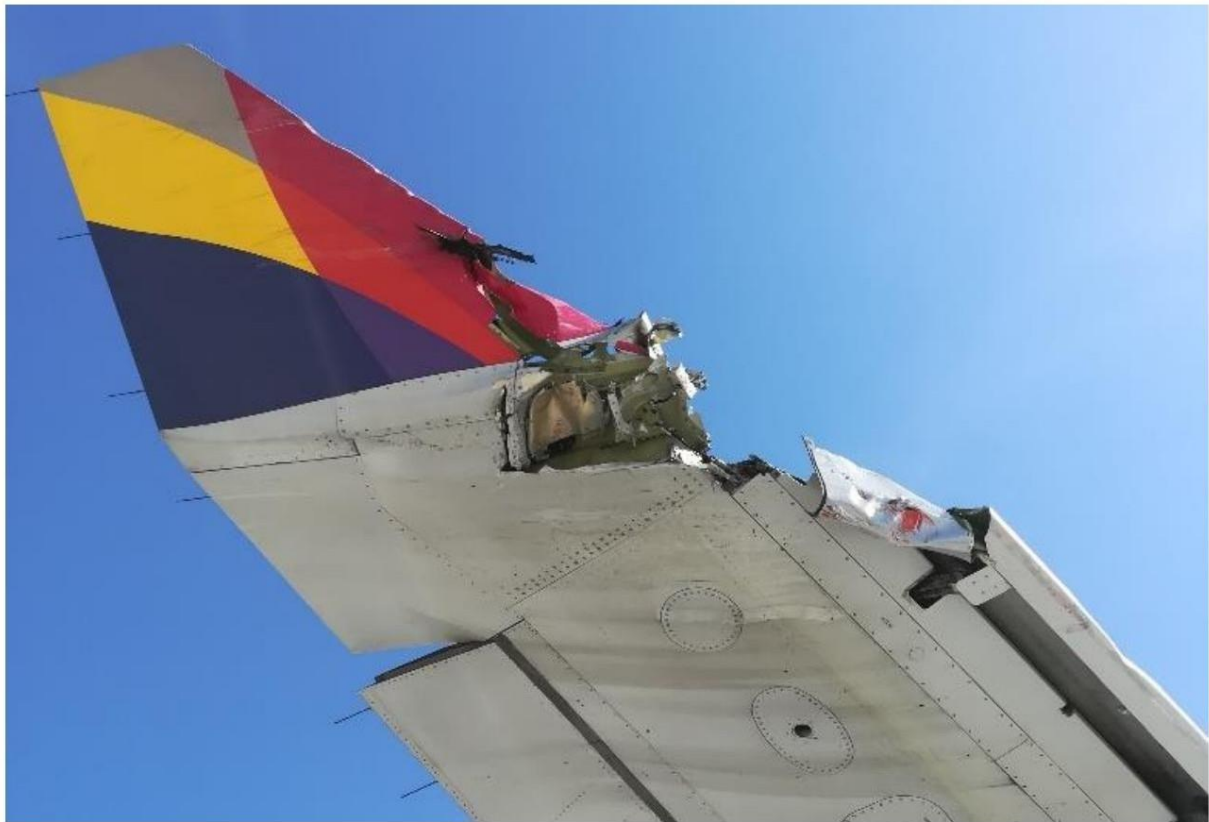
Picture-16: Right Wing Tip

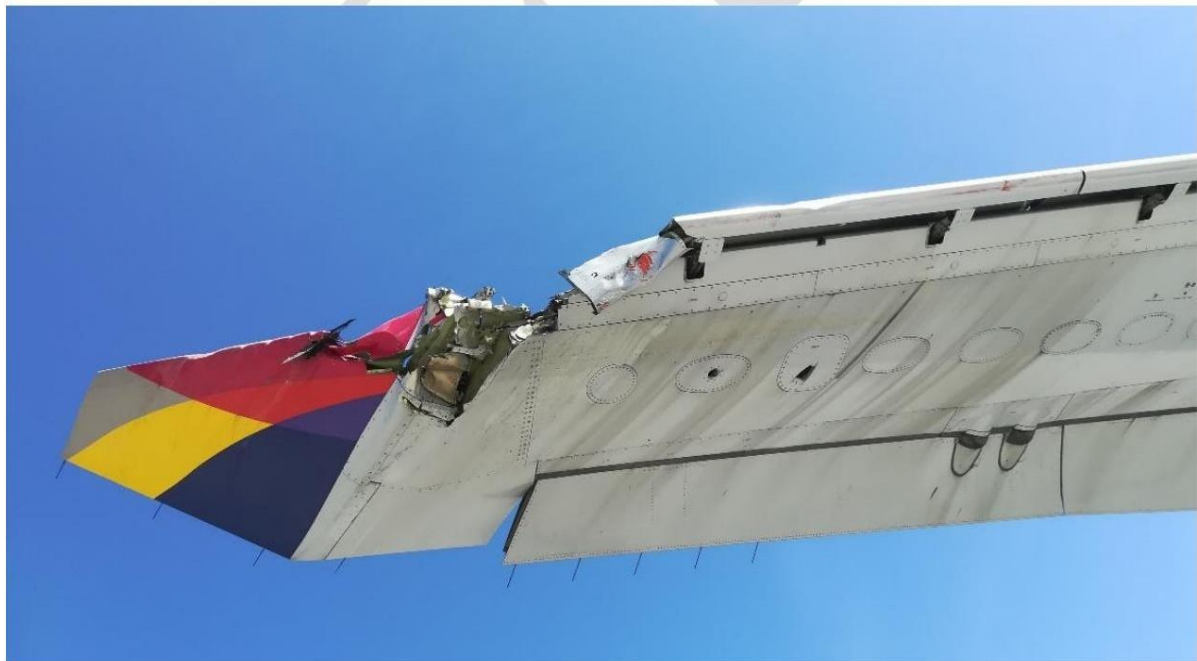
Picture-17: Right Wing Tip

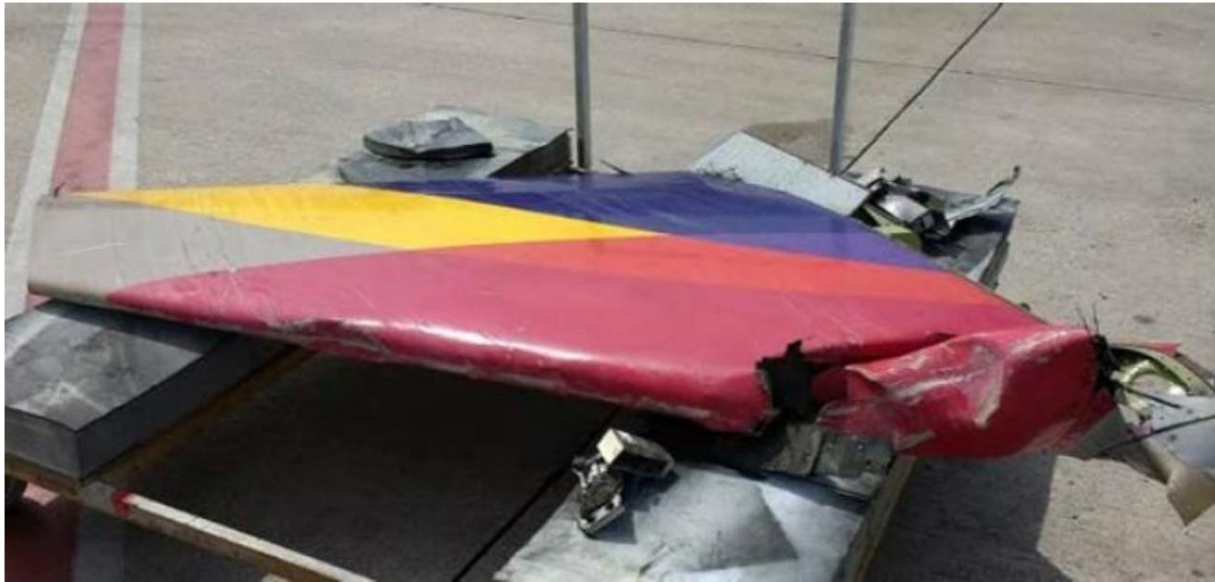
Picture-18: Right Winglet

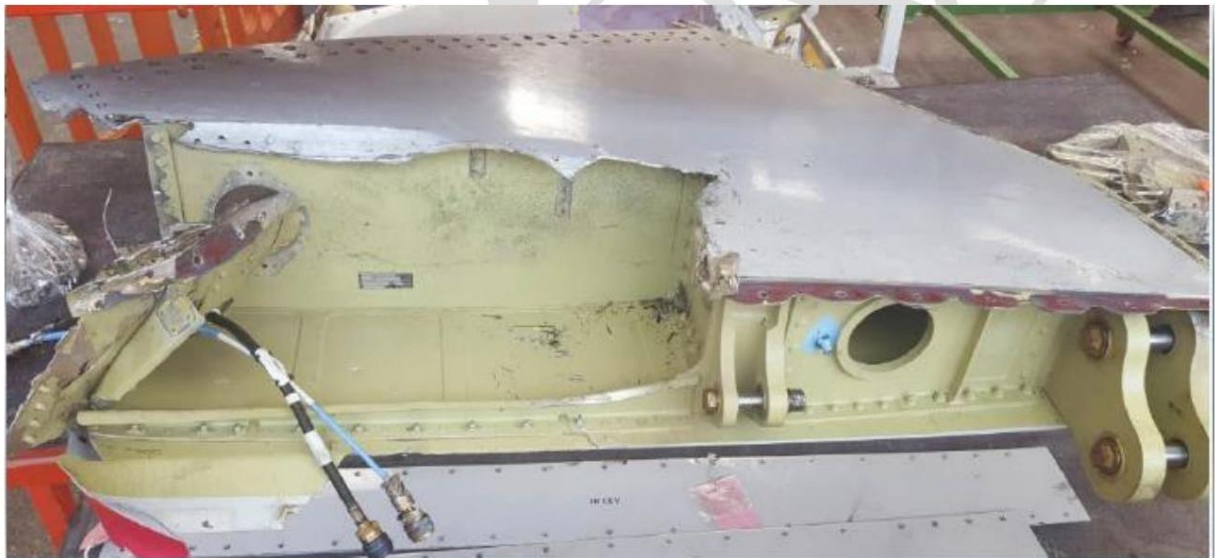
Picture-19: Wing Tip

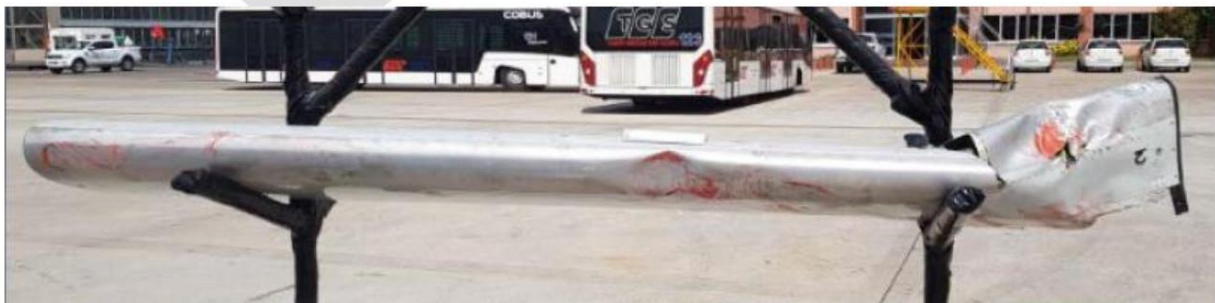
Picture-20: Slat #7

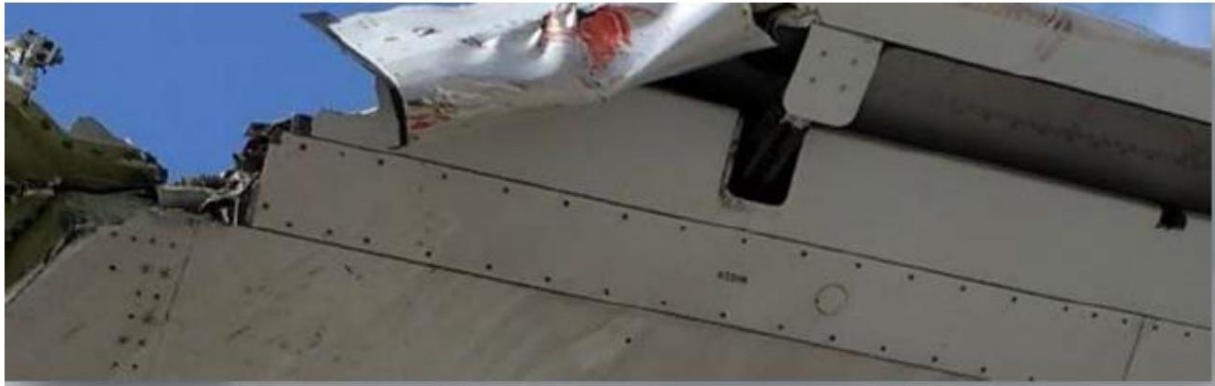
Picture-21: Access Panel

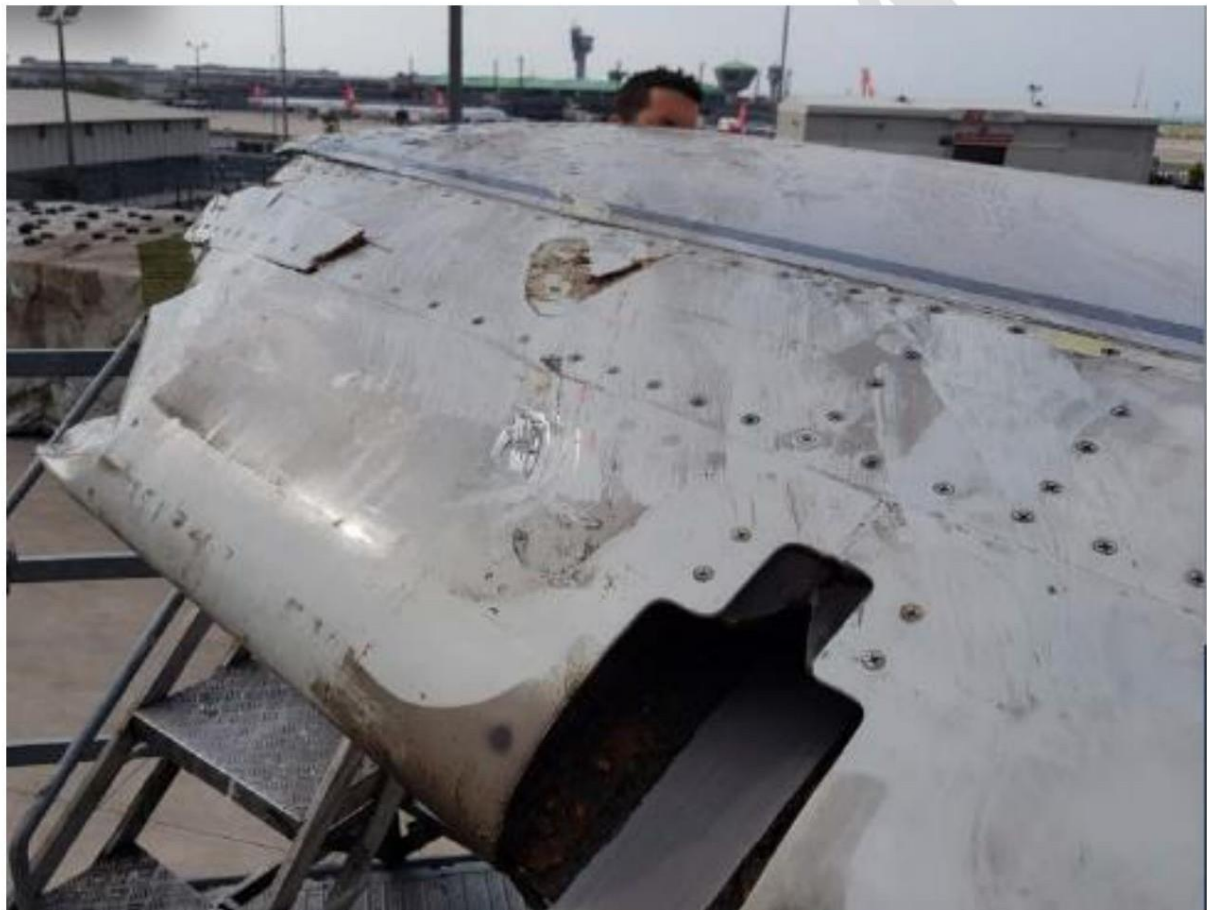
Picture-22: D-Nose

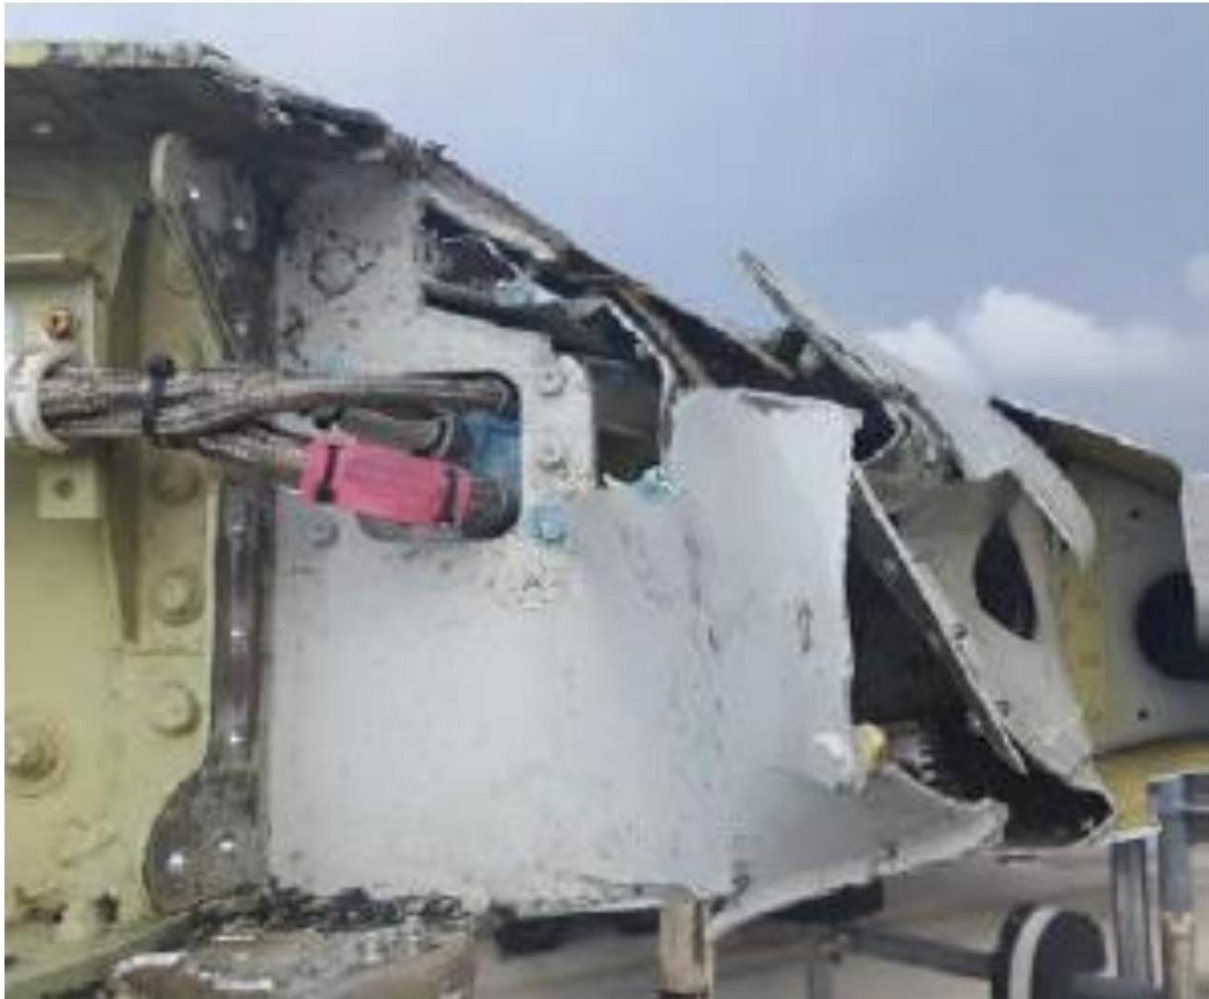
Picture-23: Closing Rib

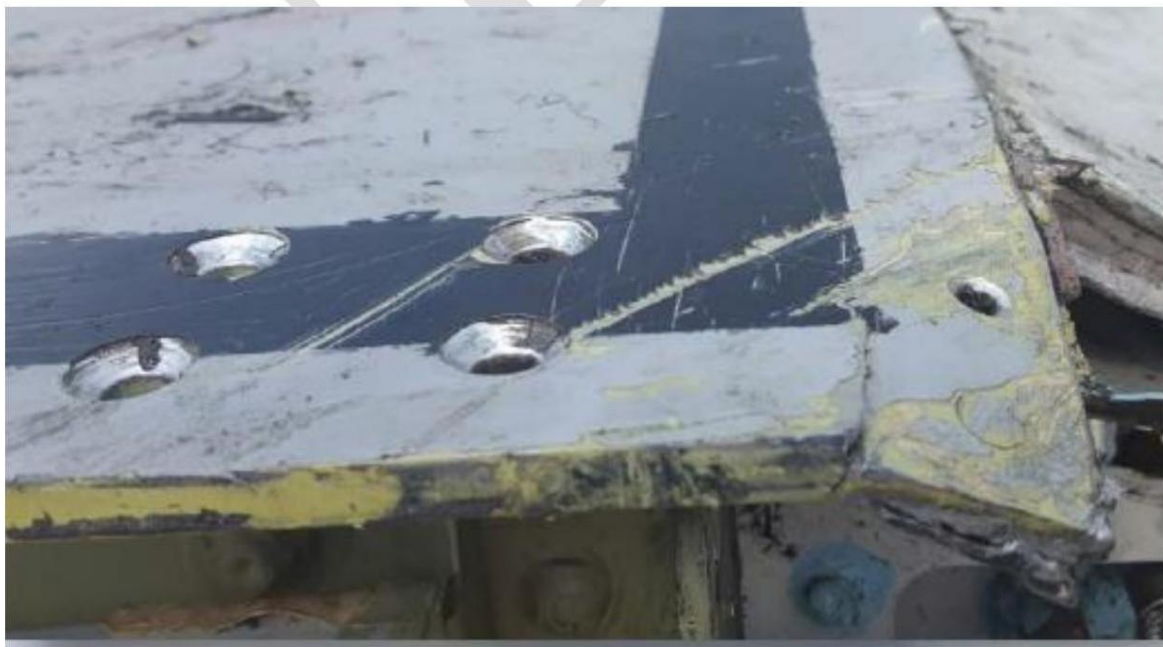
Picture-24: Wing Upper Surface

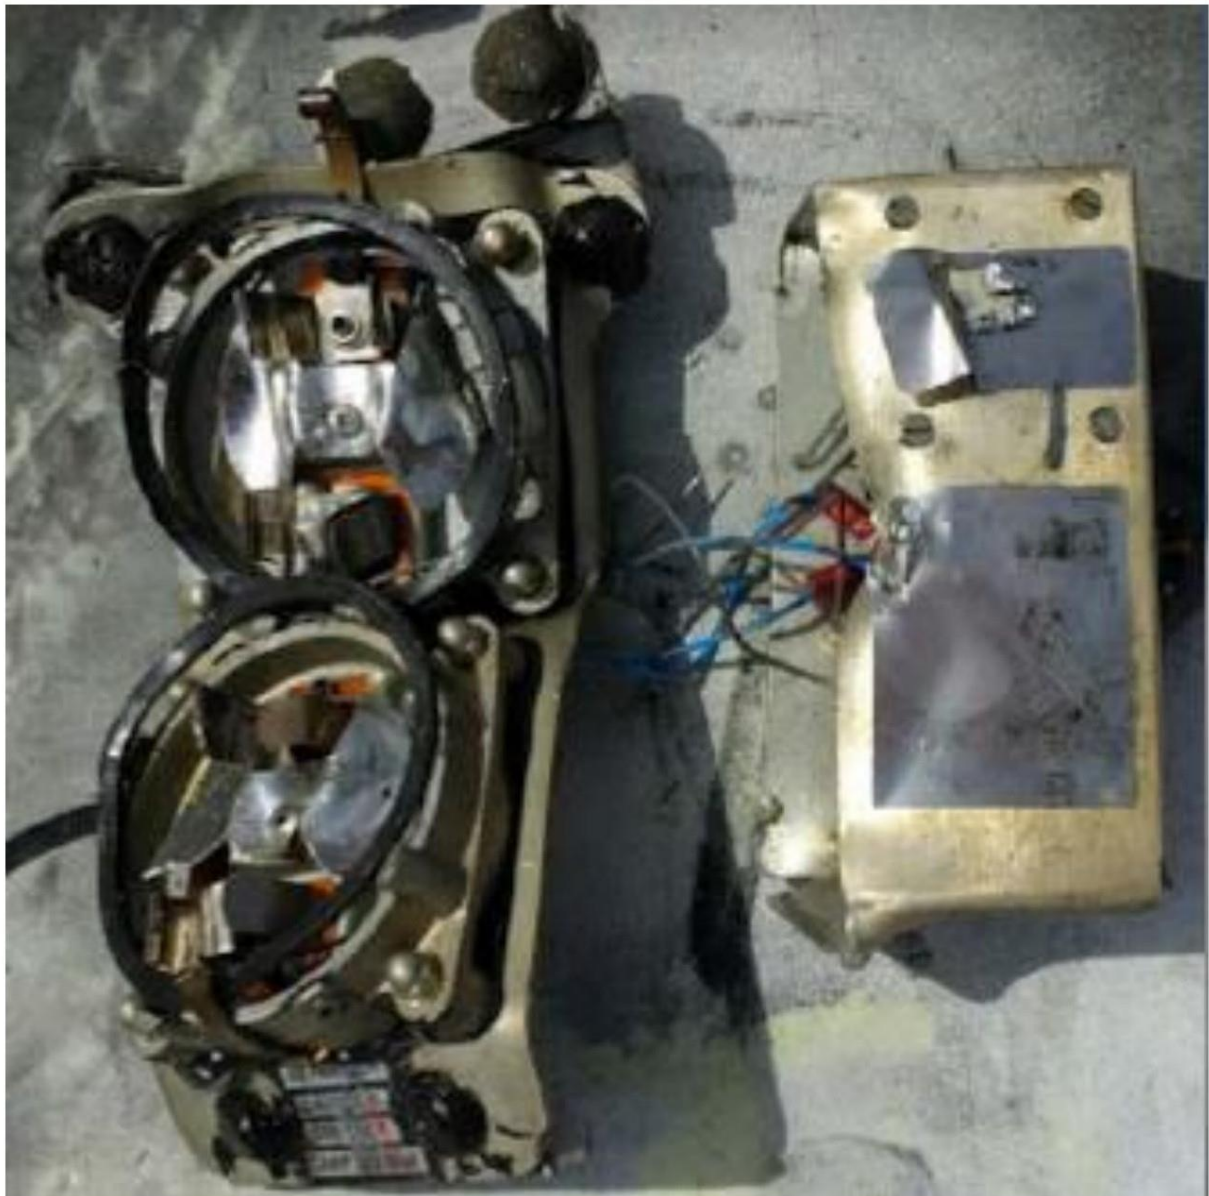
Picture-25: Navigation Illuminations

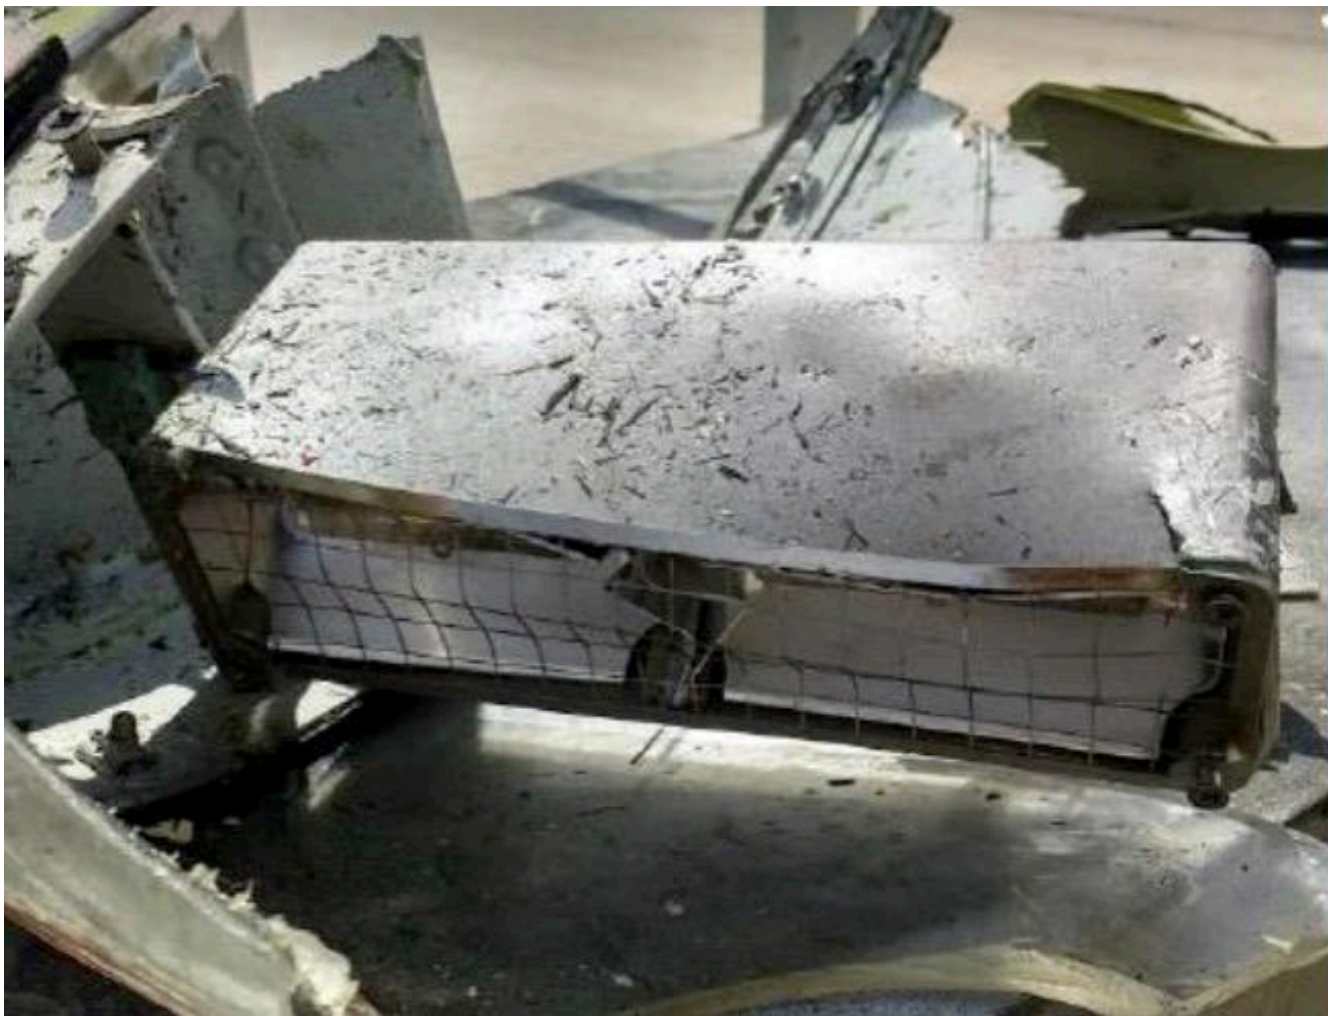
Picture-26: Strobe Lights

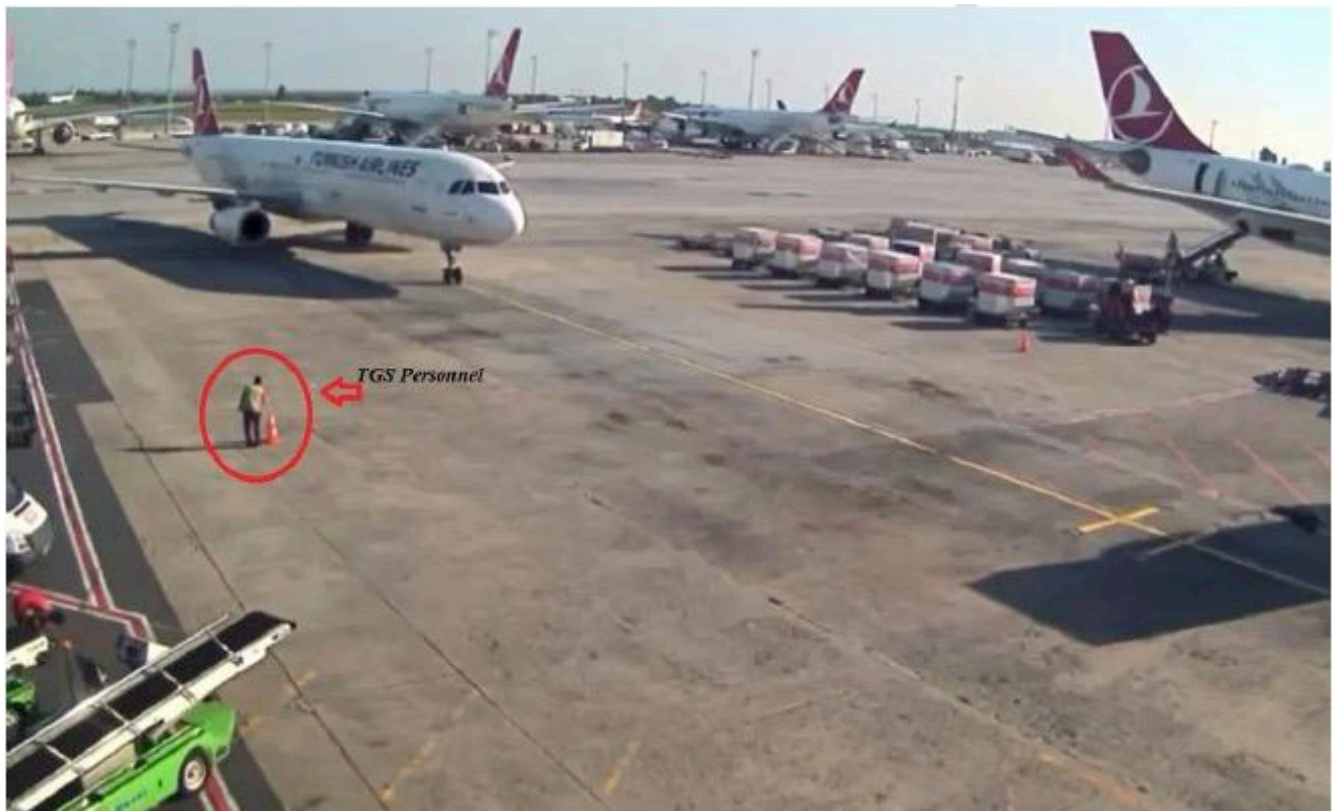
- As soon as the aircraft with the TC-JMM registration mark enters the parking position, a TGS
217 parking lot for staff to pick up the marking cone located in the parking area.
enters his position,
- It takes approximately 7 seconds for TGS personnel to pick up the marking cone.
noticing that the pilot slowed down and stopped,

Picture-28: The first TGS personnel to enter the Park Area
