Accident report occurred to the airplanes:

Airbus A321-231 reg. TC-JMM and

Airbus A330-300 reg. HL-7792

FINAL REPORT OF AIRCRAFT ACCIDENT INVESTIGATION AND INVESTIGATION

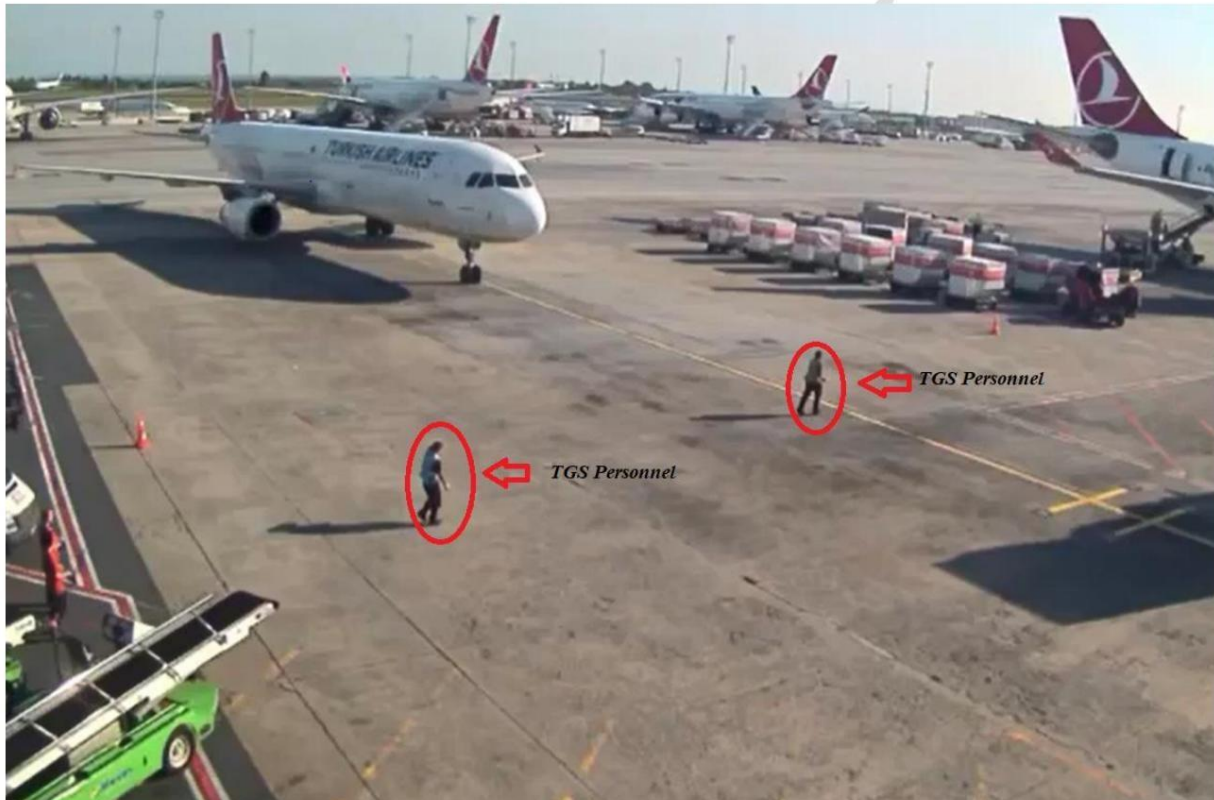
- TGS personnel pulling the cone aside and another TGS personnel without reason.
Entering the parking position number 217 on the ground, he ran to the opposite side with running steps,
- It takes approximately 21 seconds for TGS personnel to cross over to the opposite side,
- The aircraft with the TC-JMM registration mark is stationary for approximately 42 seconds.
stays,
- It has been determined from the CVR records that the pilots did not report this situation to the tower.

Picture-29: Second TGS Personnel Entering the Parking Area

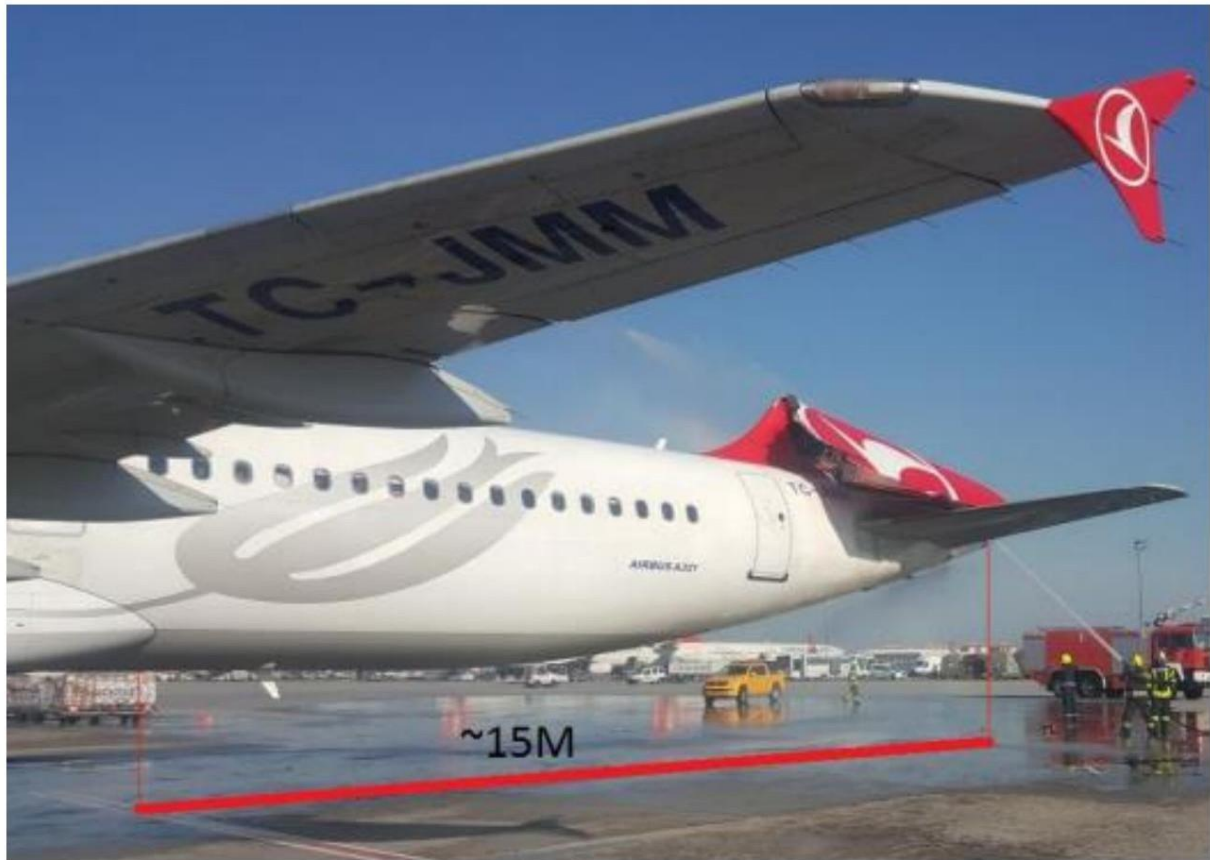
- Park the aircraft with the registration TC-KMM for approximately 42 seconds with the number 217 standing 15 meters outside the area,
- From the FDR analysis, 2 minutes after the aircraft with registration mark HL7792 took off. Seconds later, at 15 knots, the aircraft with registration mark TC-JMM hits the vertical stabilizer. hit,

Picture-30: The Part of the Aircraft Outside the Safe Area

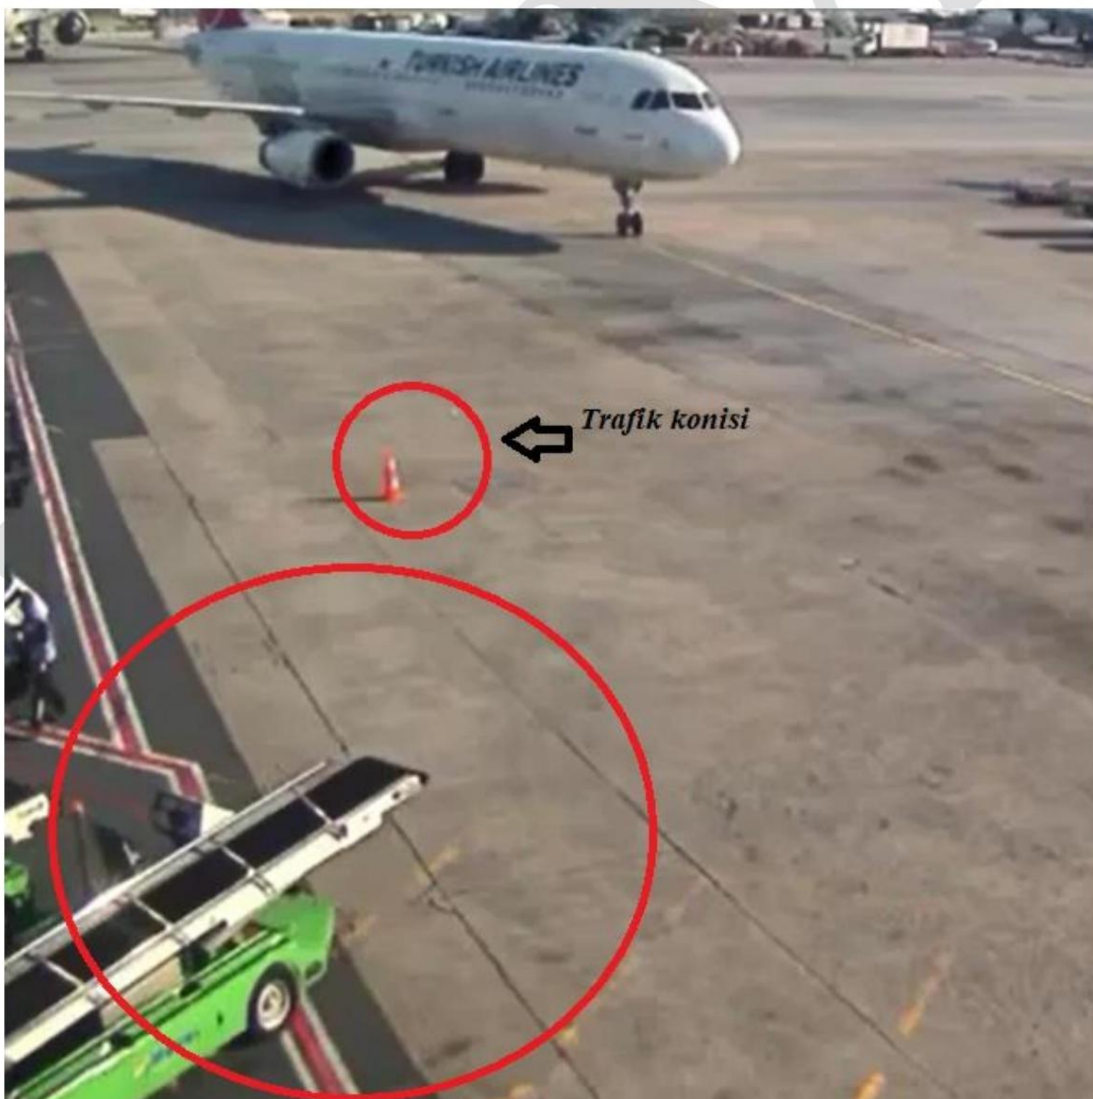
- Article-d : *“It should be ensured that there are no objects in the taxiway and ramp area used by the aircraft that may be hit by the aircraft or that may endanger others due to 'jet blast' effects.”*
 - Clause-e : *“All ground support equipment, vehicles and bridges must be parked in a safe position, clear from the taxiway used by the aircraft, outside the Equipment Restriction Area (ERA), except as applicable to the operation for the arrival of the aircraft in accordance with local regulations.”*
- As can be seen in the pictures below, it has been determined that the TGS personnel did not prepare the parking area 217 before the arrival of the aircraft, there was a marker cone in the parking area and a ground handling vehicle entered the parking area by crossing the red line.

Picture-31: Sign Cone and Luggage Loading Belt Vehicle in the Parking Area
