**The Malaysian ICAO Annex 13 Safety Investigation Team for MH370  
30<sup>th</sup> July 2018**

**SAFETY INVESTIGATION REPORT  
MALAYSIA AIRLINES BOEING B777-200ER (9M-MRO)  
8<sup>th</sup> March 2014**

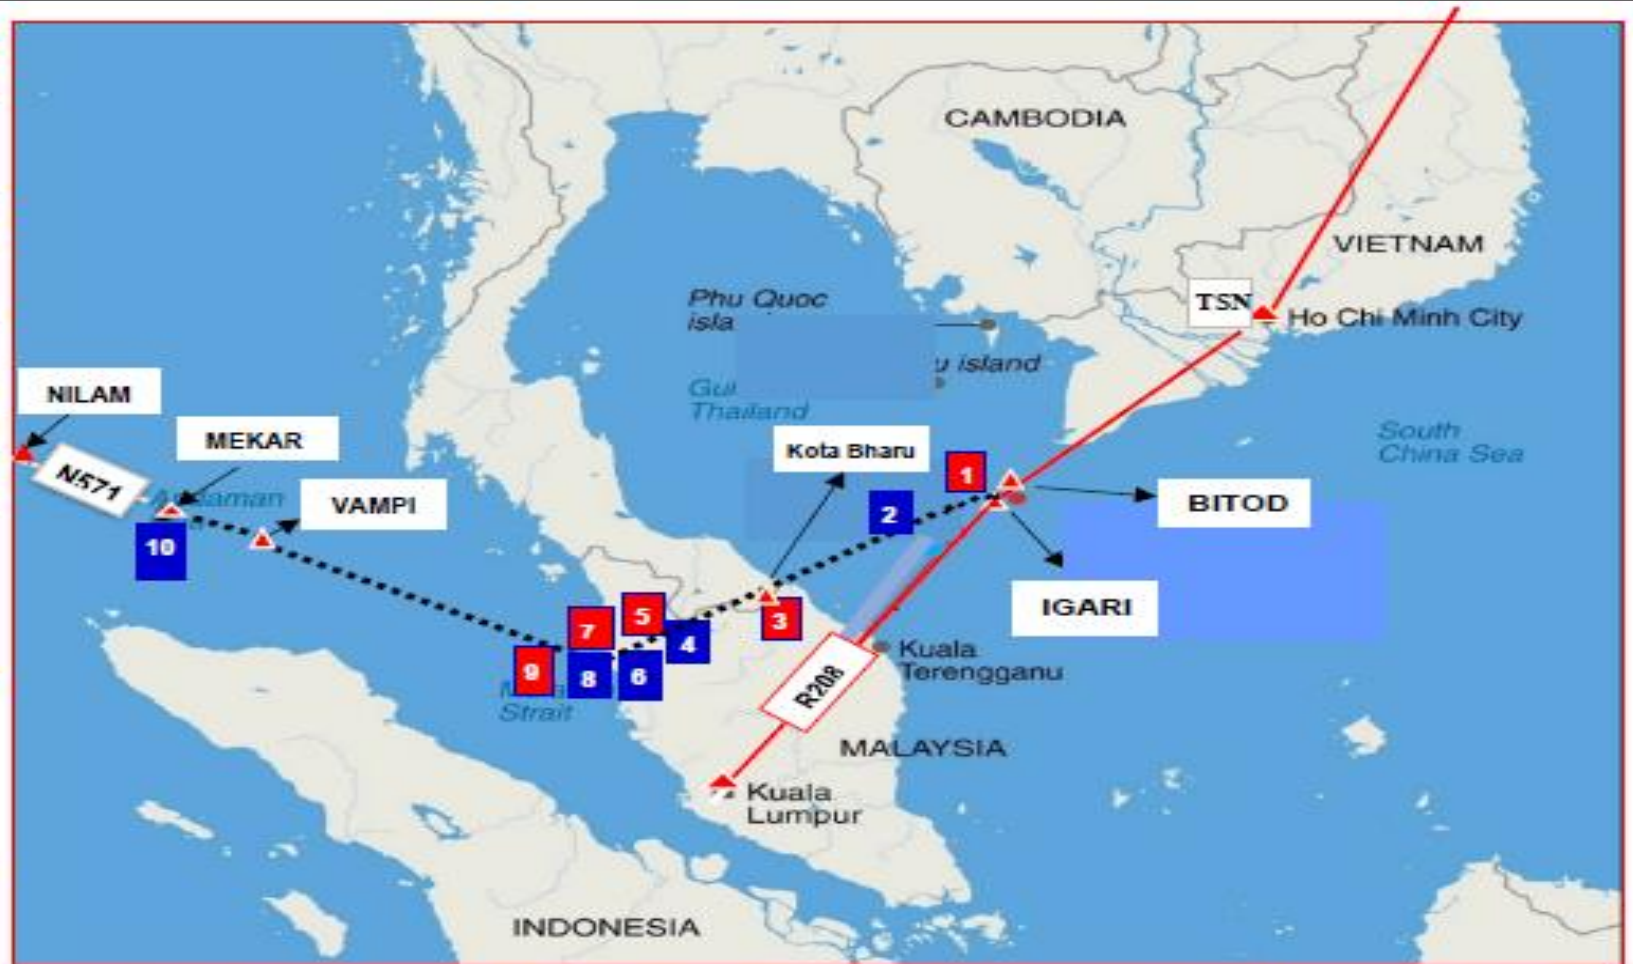
# TURN BACK AND MILITARY RADAR (RMAF)

1	P3362: Appeared at 1730:37 UTC [0130:37 MYT]
2	P3362: Coasted at 1737:12 UTC [0137:12 MYT] Dropped at 1737:22 UTC [0137:22 MYT]
3	P3401: Appeared at 1738:56 UTC [0138:56 MYT]
4	P3401: Coasted at 1744:42 UTC [0144:42 MYT] Dropped at 1744:52 UTC [0144:52 MYT]
5	P3415: Appeared at 1747:02 UTC [0147:02 MYT]
6	P3415: Coasted at 1748:29 UTC [0148:29 MYT] Dropped at 1748:39 UTC [0148:39 MYT]
7	P3426: Appeared at 1751:45 UTC [0151:45 MYT]
8	P3426: Coasted at 1752:25 UTC [0152:25 MYT] Dropped at 1752:35 UTC [0152:35 MYT] P3426 last seen on radar display Approximately 6 nm south of Penang
9	The primary target (military radar) appeared to track west-northwest direction joining RNAV Route N571 at waypoint VAMPI thence to 10 nm north MEKAR <i>Source: RMAF</i>
10	The primary target ended at 10 nm after MEKAR at 1822:12 UTC [0222:12 MYT] <i>Source: RMAF</i>

- 1) Evidence shows that Flight MH370 diverted from the Filed Flight Plan Route.
- 2) The changes in the aircraft flight path after waypoint IGARI are difficult to attribute to anomalous system issues alone
- 3) Flight simulator trials established that the turn back was made while the aircraft was under manual control and not using autopilot
- 4) Civilian and Military radars consistent with each other
