COMMAND OF AERONAUTICS
AERONAUTICAL ACCIDENT
INVESTIGATION AND PREVENTION CENTER

FINAL REPORT
A – Nº 67/CENIPA/2009

AIRCRAFT **PR - MBK**

MODEL **AIRBUS A-320**

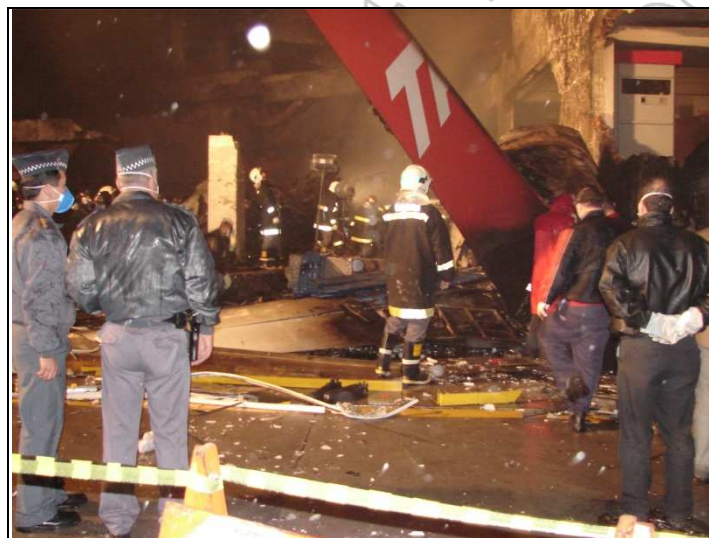
The collision of the aircraft occurred at a ground speed of 96 kt, at an angle of 7° roll to the left and a 7° positive pitch. With the impact, the aircraft was completely destroyed and the wreckage was concentrated in an area of about 100 m².

Figure 3 - Wreckage of the aircraft at the site of impact.

The retractable type landing gear was locked in the extended position, and the flaps were also completely extended (landing configuration).

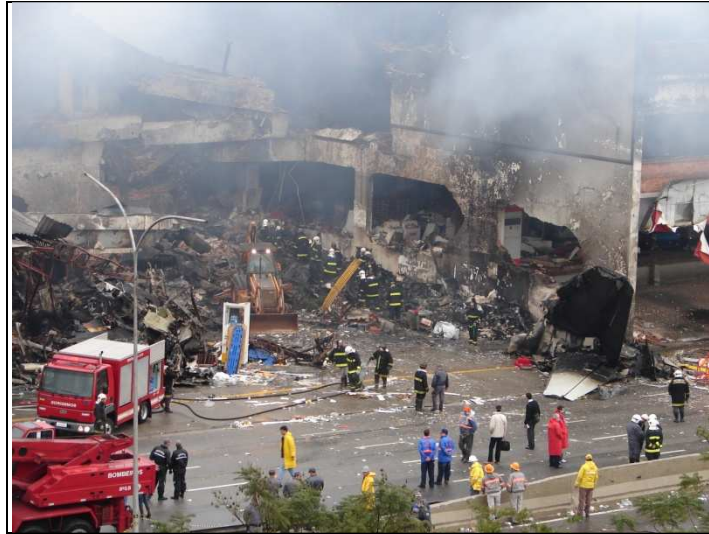
Figure 4 - Aerial view of the site of impact.

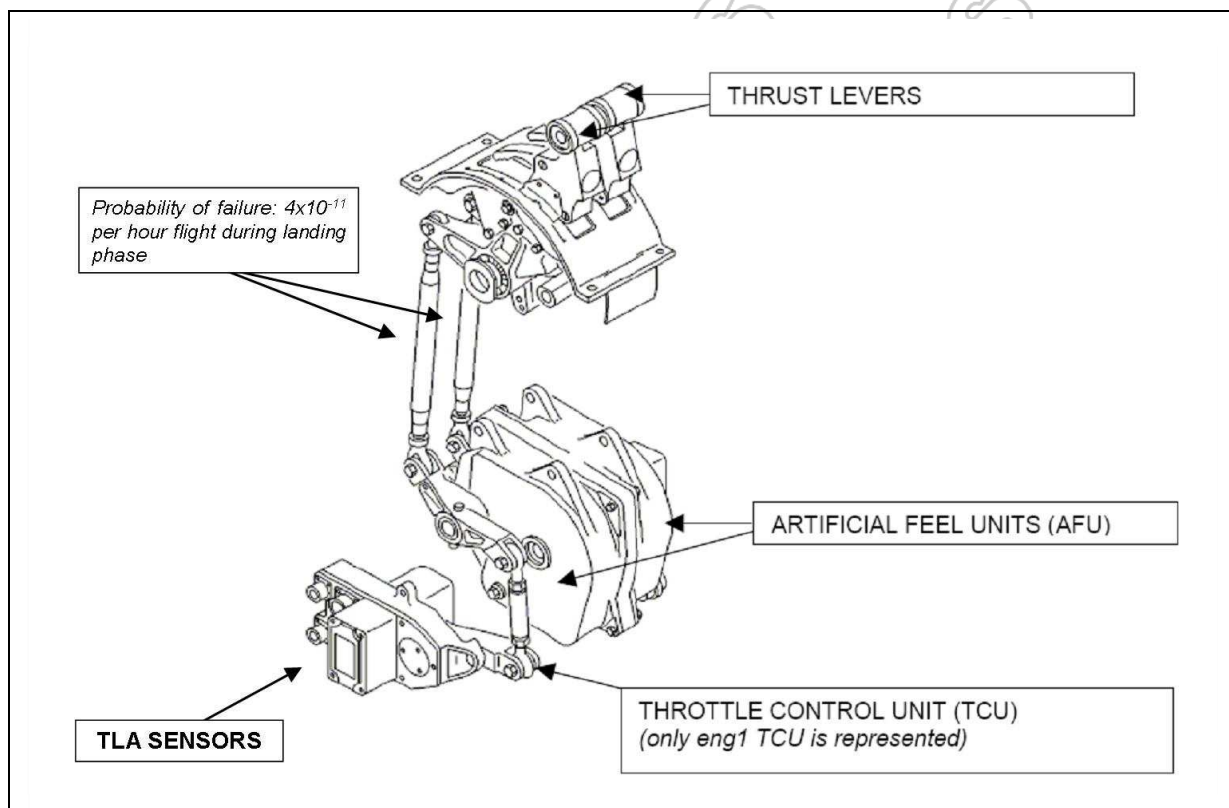
Exams were made in the wreckage of the Artificial Feel Units (AFU) with the purpose of verifying the existence of failures in their quadrants and gears, as well as marks that could confirm the relative position of the thrust levers at the moment of the impact, considering the possibility of a failure of the mechanism that connects the thrust levers to those units.

Figure 5 - Scheme of the power control system.

According to information provided by the aircraft manufacturer, the probability of a failure of the mechanism that connects the thrust levers to the AFUs is 4×10^{-8} per flight hour, and the probability of the failure to occur at the moment of the landing is 4×10^{-11} per flight hour. The sensors that record the position of the thrust levers in the flight data recorder (FDR) are located in the AFUs and not directly in the thrust levers.

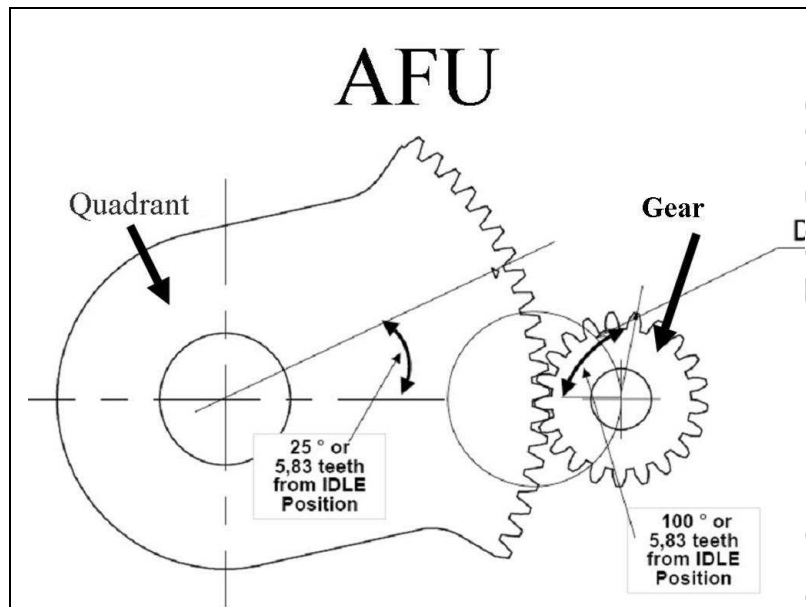
The aluminum structure of the units was found melted due to the heat of the post-accident fire. In the midst of the melted aluminum mass were the gears and the quadrants made of steel.

Figure 6 - Quadrant and gear of the AFU.
