NATIONAL TRANSPORTATION SAFETY BOARD

AIRCRAFT ACCIDENT REPORT

**DELTA AIR LINES, INC.,
LOCKHEED L-101 1-385-1, N726DA
DALLAS/FORT WORTH -
INTERNATIONAL AIRPORT, TEXAS
AUGUST 2, 1985**

NTSB/AAR-86/05

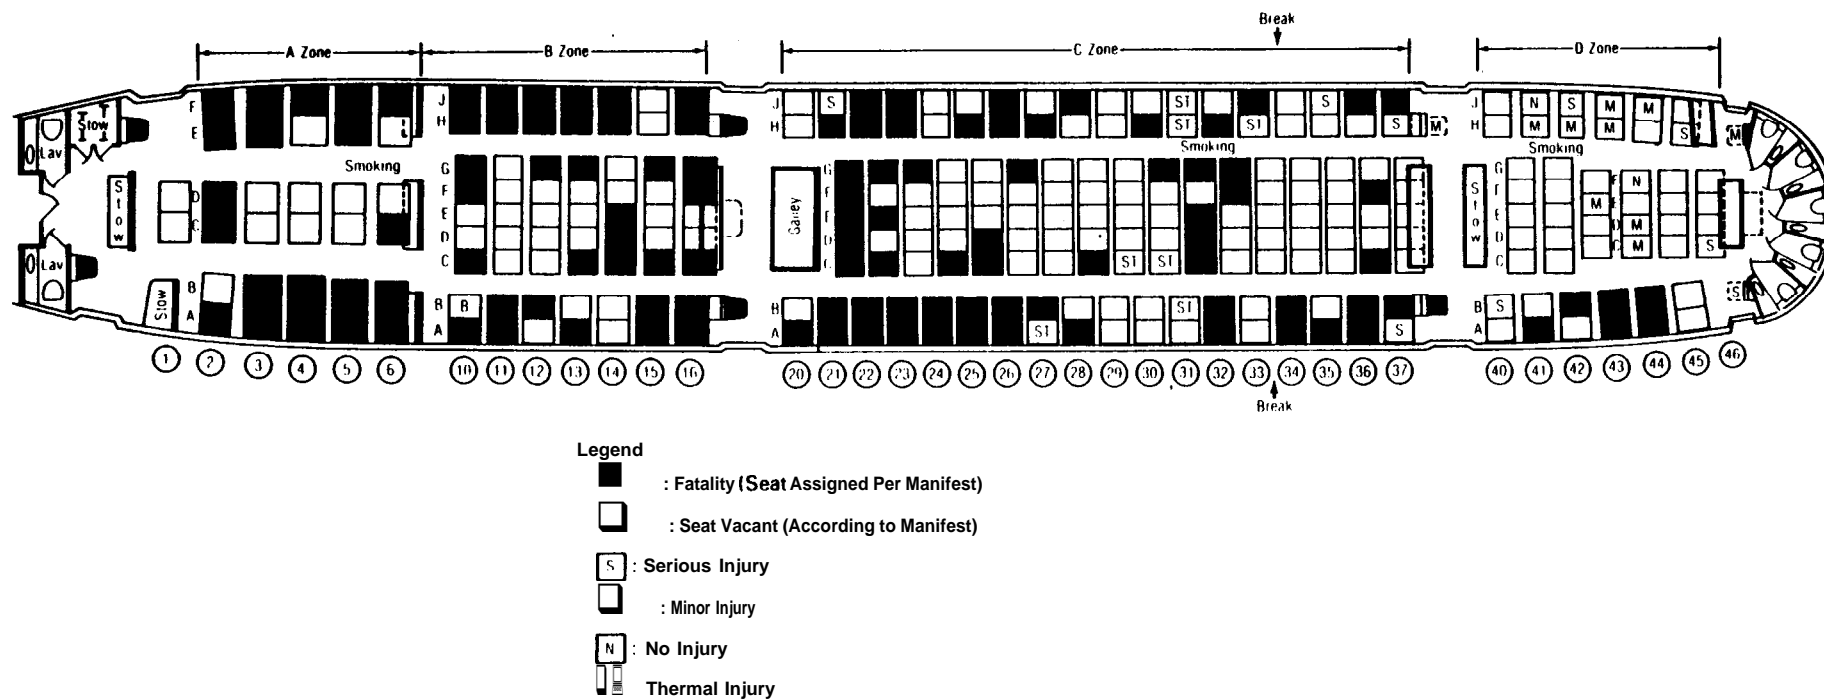
Except for the left cabin wall, which was missing, the remainder of the separated rear cabin section from row 40 aft to row 46 was relatively undamaged. Six passengers seated along the missing left cabin wall were killed. The remaining 16 occupants of this cabin section, including 2 flight attendants, sustained serious and minor injuries, and 2 passengers were not injured.

The rear cabin section came to rest on its left side. The survivors were either flung from the airplane in their seats or released themselves from their seats and exited at the forward end of the separated fuselage section or through the missing left wall. One flight attendant and three passengers could not escape from the cabin because of injuries and were removed by fellow passengers and rescue personnel. Two other flight attendants had only minor injuries and were able to escape unaided after shouting commands to the passengers to get out of the cabin. The flight attendant seated at the right rear (R-4) exit had difficulty releasing her **seatbelt** because the buckle was located on her left hip and her weight was on the buckle. The passengers and flight attendants were covered with fuel and some had fuel on their hands and in their eyes, which caused difficulties in climbing down the cabin to the hole created by the missing left cabin wall. Some persons were able to climb downward to the hole over seats while others fell the width of the cabin to the ground.

Figure 3.--L-1011 cabin seat diagram.

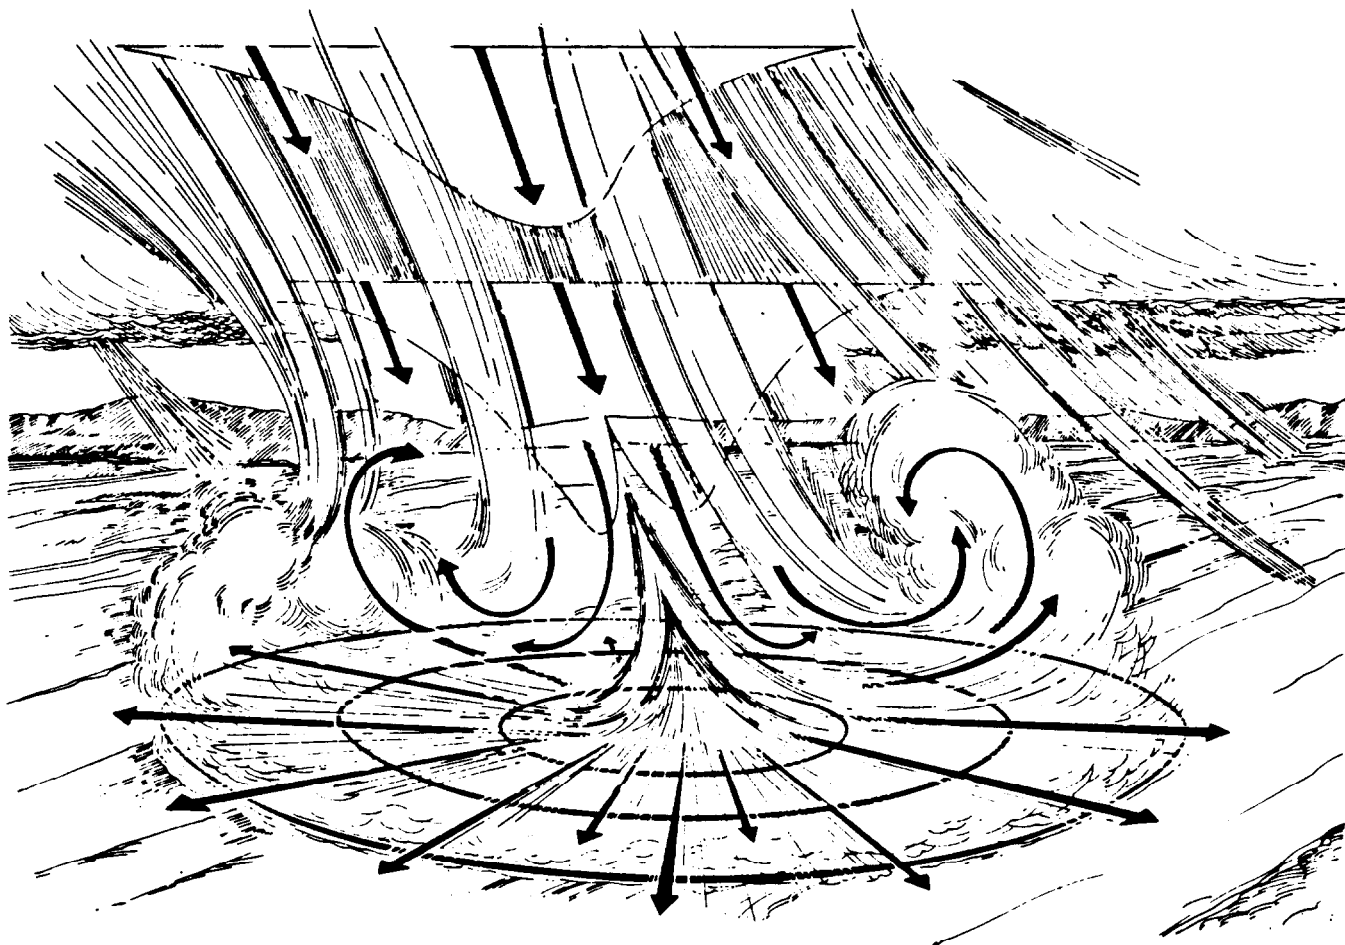
Figure 4.--Typical microburst wind field.

When a microburst is encountered during a landing approach, the airplane will typically experience an increasing headwind, a downdraft, and a decreasing headwind in rapid succession as it passes beneath the outflow and descending air column. The increasing headwind will be recognized as the indicated airspeed increases suddenly and the airplane tends to rise above the glidepath. However, this apparent increase in airplane performance is shortlived as the airplane enters the downdraft and encounters the decreasing headwind caused by the reversal in the direction of the outflow. The rapid reversal of wind direction and speed produces sudden changes in the airplane's angle of attack and airspeed, which may reduce the airspeed far below the initial stabilized airspeed. The reduced airspeed will result in reduced vertical lift, causing the airplane to accelerate downward. Further more, the airplane's longitudinal stability will cause the airplane to pitch nose downward as it attempts to reacquire its trim speed equilibrium. The extent to which the airplane's flight path changes depends upon the severity of the windshear and the pilot's reaction with flight controls and engine thrust. The microburst might also create horizontal vortices which produces sudden changes of vertical wind speeds to further upset the longitudinal stability and perhaps the lateral and vertical stability of the airplane, exacerbating the pilot's control task.
