INVESTIGATION REPORT OF ACCIDENT INVOLVING GEORGIAN AIRWAY'S AIRCRAFT CRJ-100ER (4L-GAE) AT KINSHASA'S N'DJILI AIRPORT DEMOCRATIC REPUBLIC OF CONGO (DRC) ON 04 APRIL 2011

Investigation report of accident involving Georgian Airways CRJ-100ER (4L-GAE), which occurred at Kinshasa's N'DJILI Airport, Democratic Republic of Congo (DRC) on 04 April 2011.

FINAL REPORT OF TECHNICAL INVESTIGATION ON THE ACCIDENT OF THE CRJ-100 PLANE, REGISTER 4L-GAE

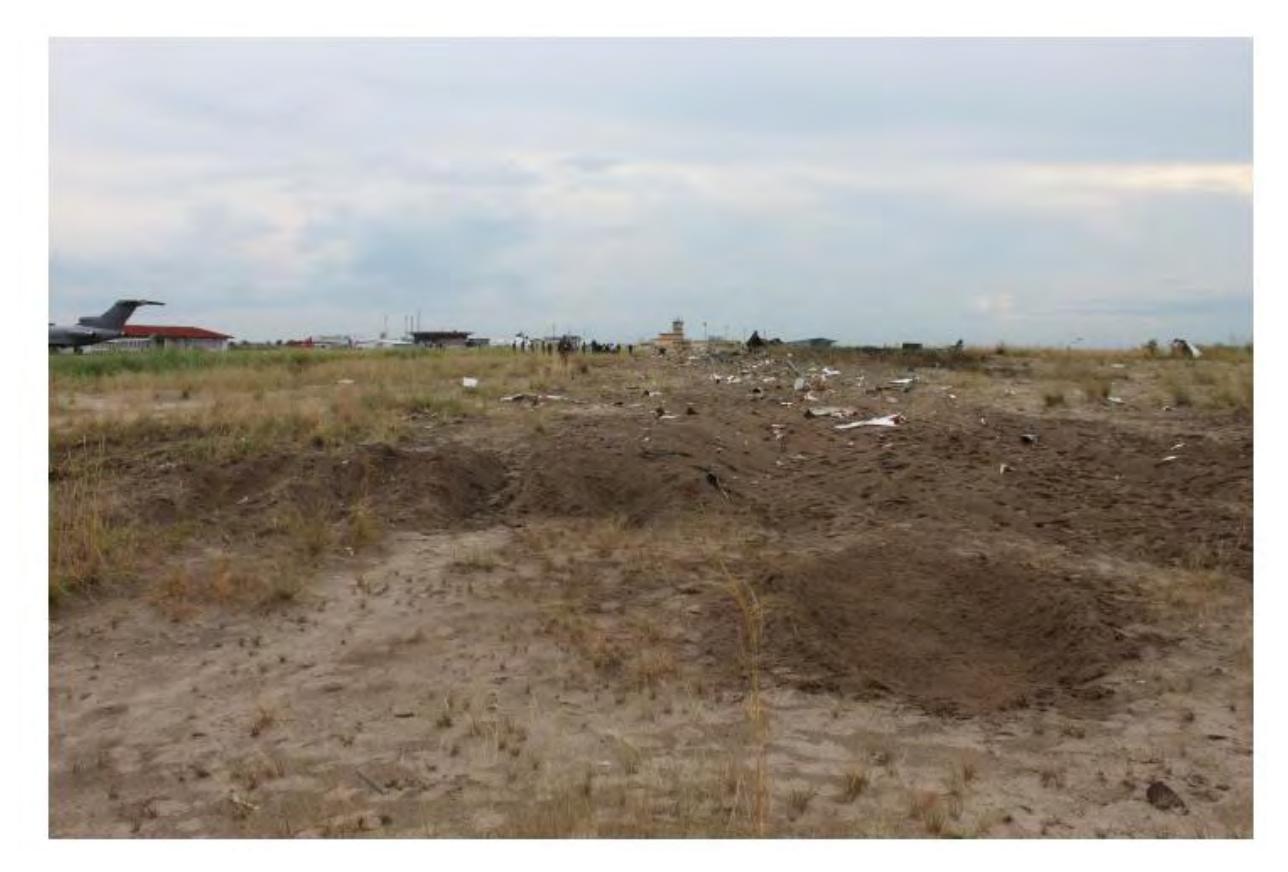
Image shows the initial impact marks of the aircraft. At the moment of impact, the indicated air speed was 180 knots, aircraft attitude was 10 degrees nose down and magnetic heading was 220 degrees. Notice that aircraft components started breaking off immediately following initial impact. The fuselage came to a rest in inverted position about 400 meters beyond the initial impact point.

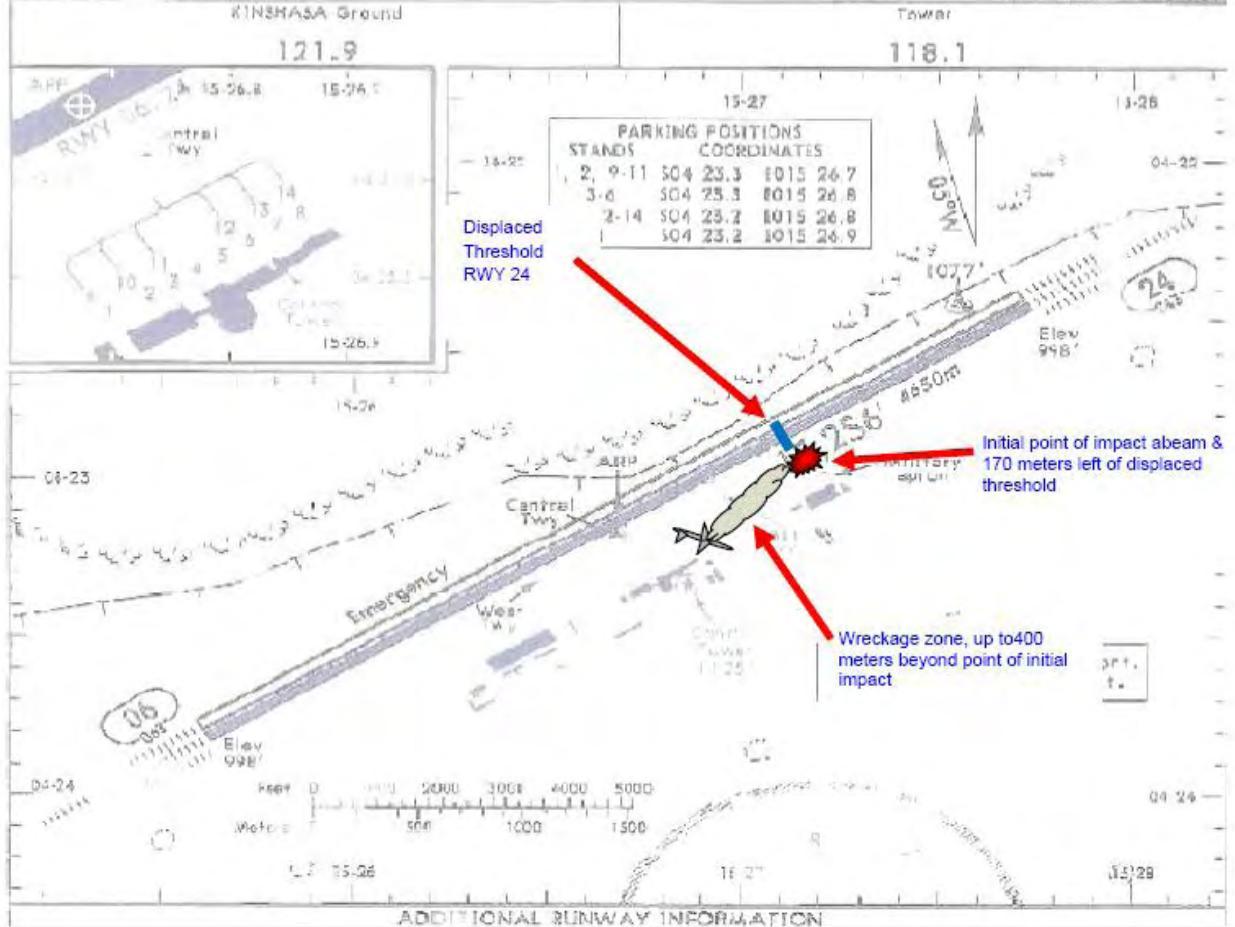
Threshold of Runway 24 was displaced by 1400 meters. Initial point of impact of the aircraft was abeam and 170 meters left of displaced threshold. Wreckage was spread over 400 meters in impact direction (about 220 degrees).

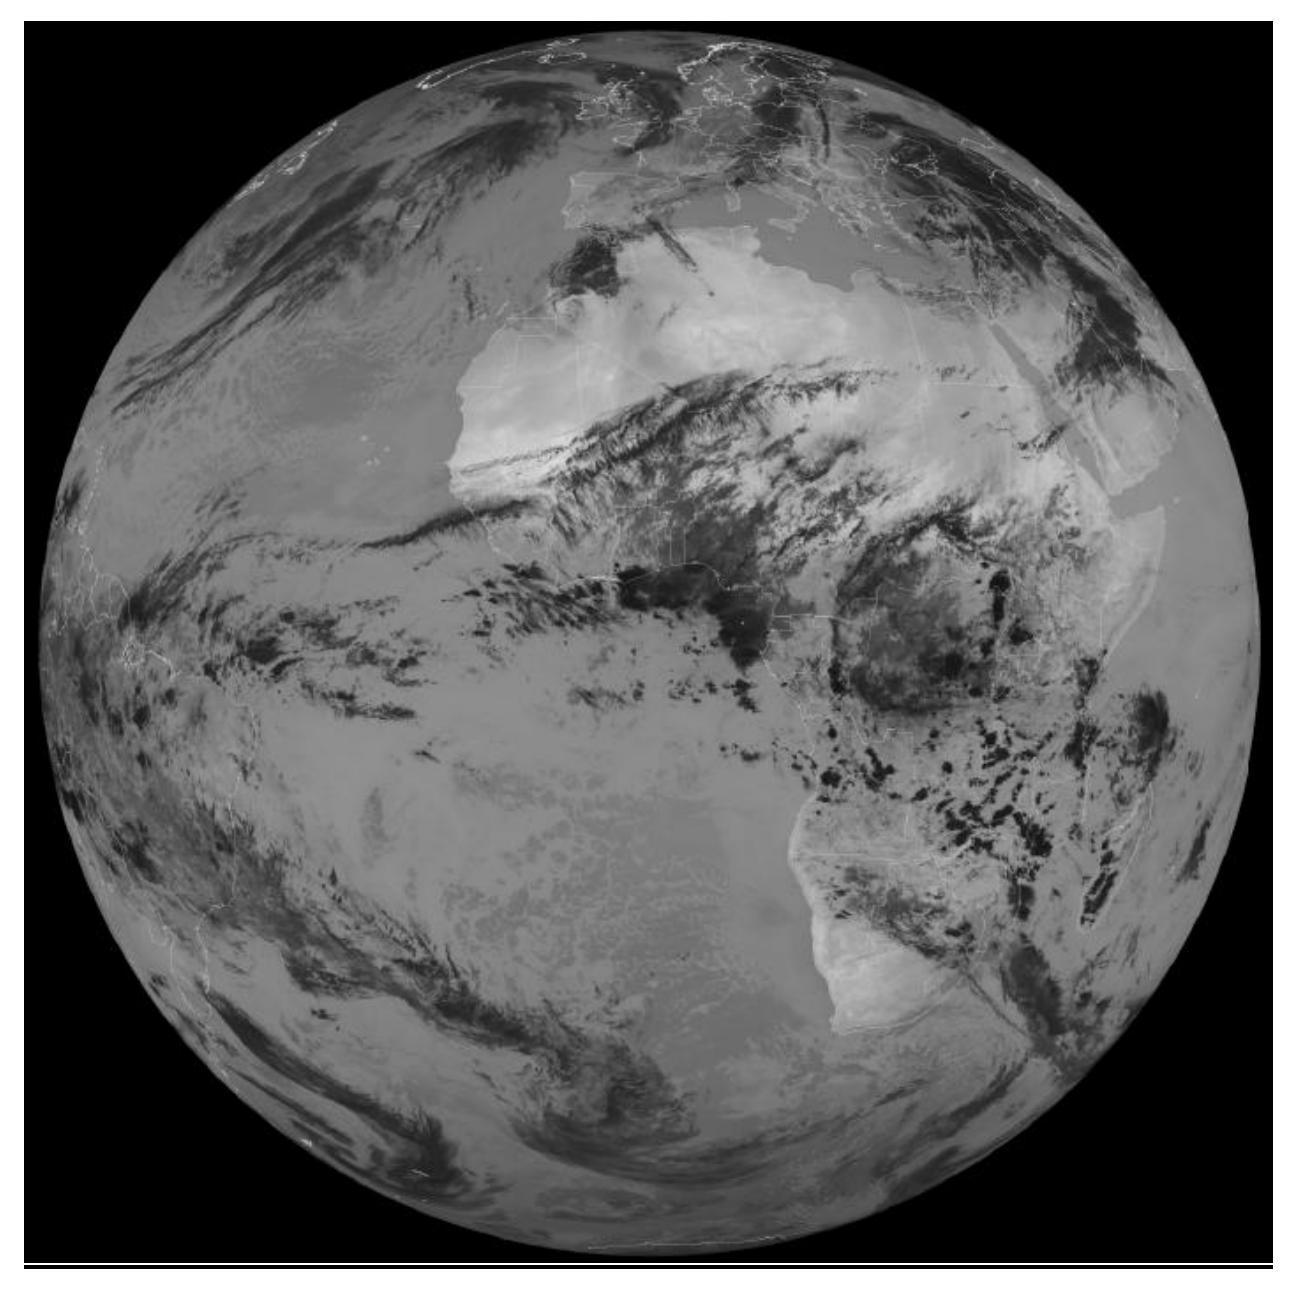
Above: EUMETSAT IR image of weather over Africa on 04/04/2011, taken at 1257 42

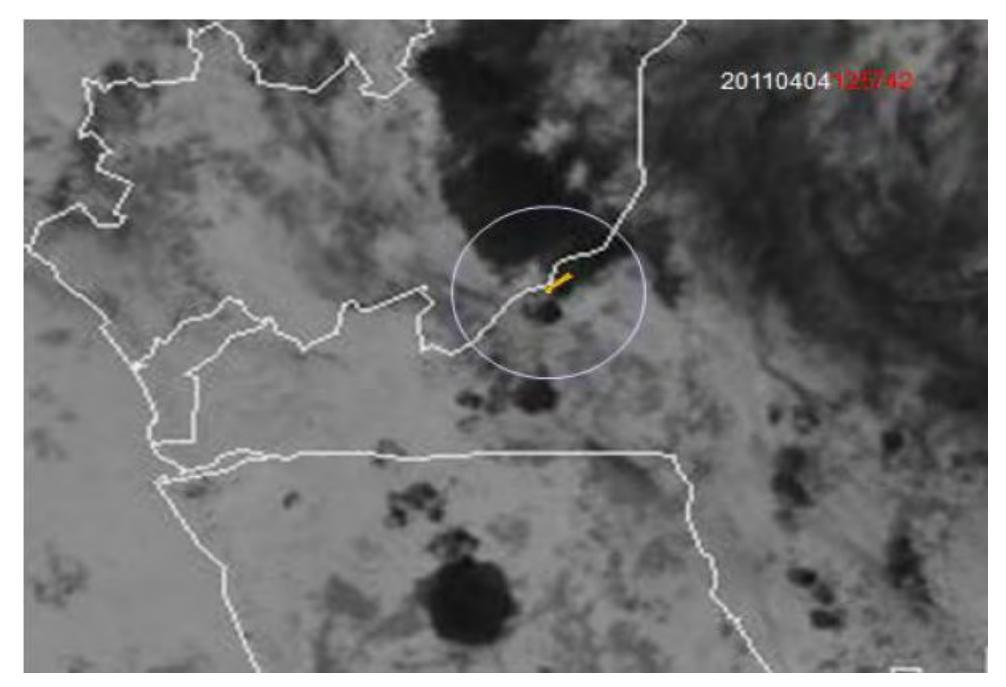
Above: EUMETSAT Infra Red photo of 1257 42 (about 50 seconds after the accident) showing Kinshasa airfield and Runway 24 Localizer Approach path (not to scale).

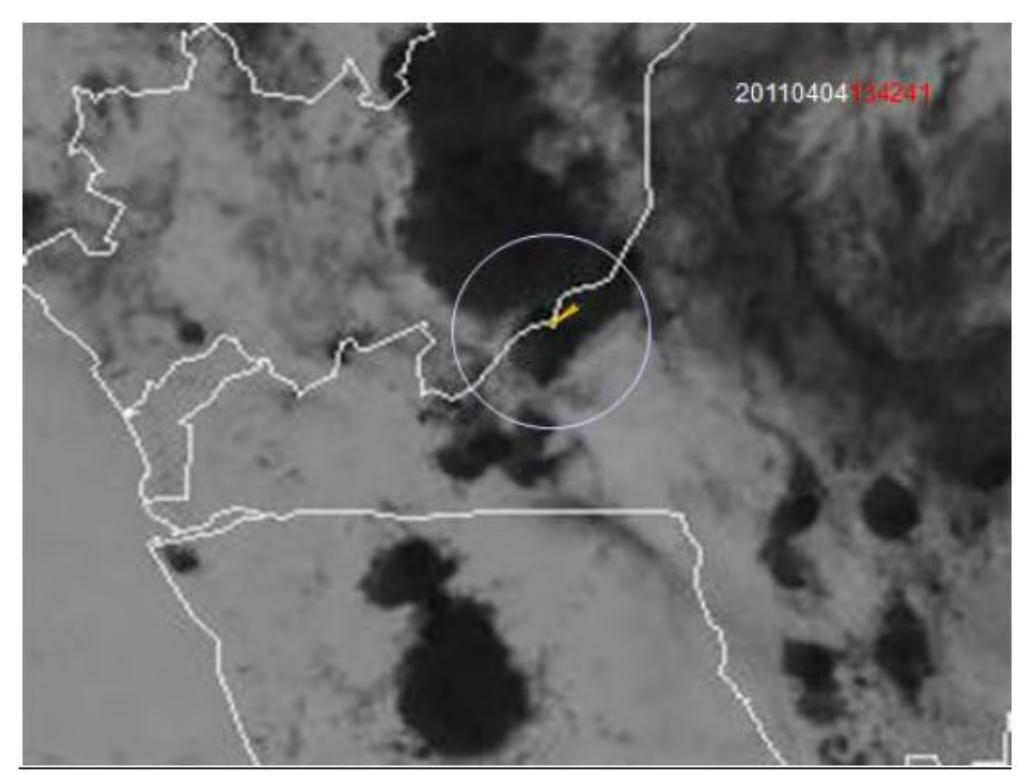
<u>Above: EUMETSAT Infra Red photo of 1342 41 (about 46 minutes after the accident) showing</u> <u>Kinshasa airfield and Runway 24 Localizer Approach path (not to scale).</u>

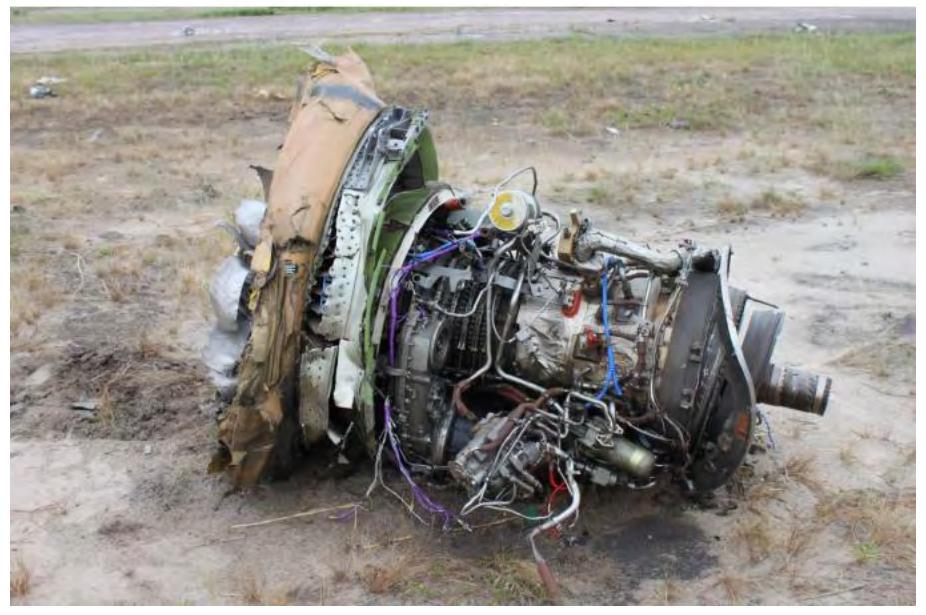
One of the engines separated from the fuselage

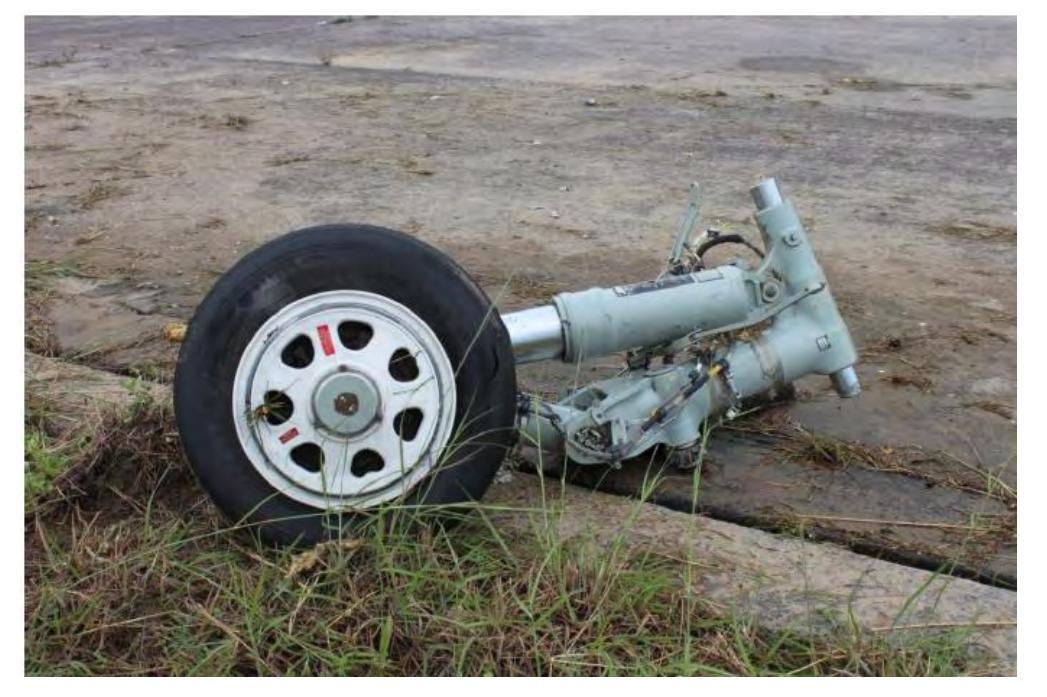
The main landing gear broke off.

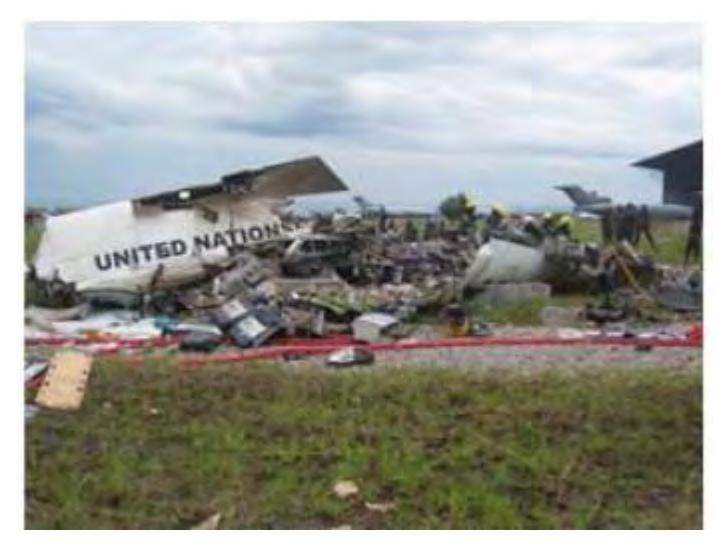
Above: Major part of the fuselage came to a rest about 400 meters away from initial impact point.
