Aircraft Accident Investigation Report KNKT/07.06/07.02.35

NATIONAL TRANSPORTATION SAFETY COMMITTEE

BOEING 737–497 PK–GZC ADI SUCIPTO AIRPORT, YOGYAKARTA INDONESIA 7 MARCH 2007

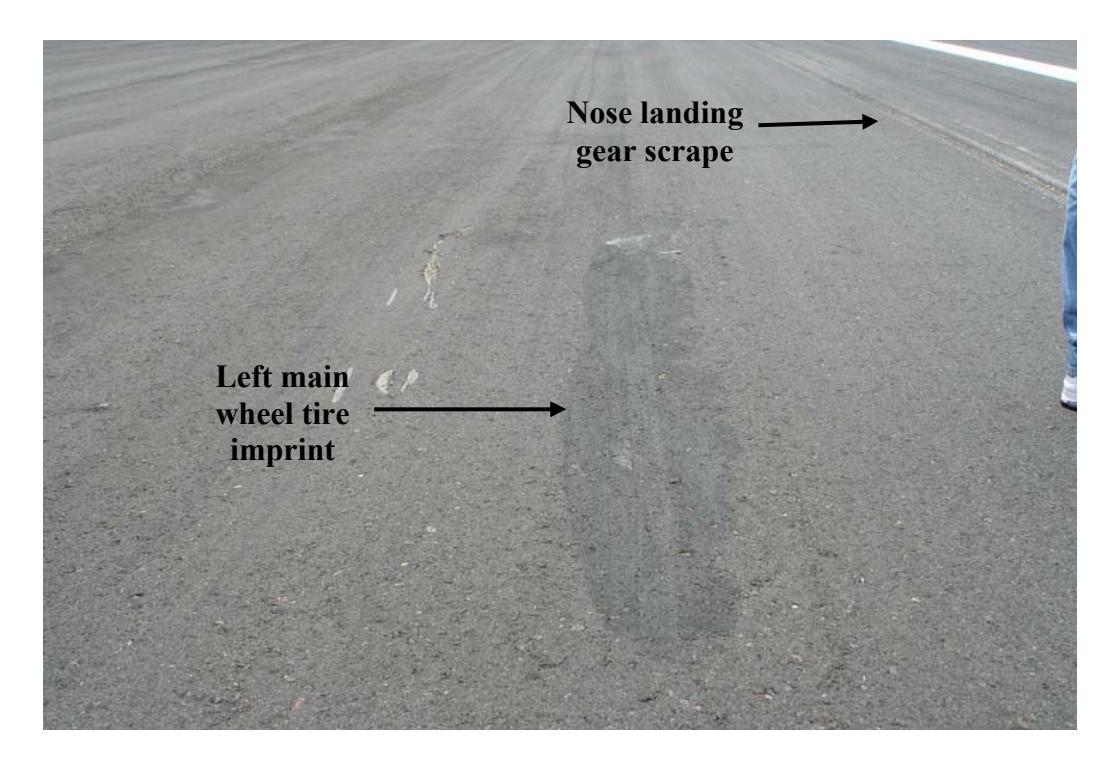
Main-wheel tire marks and nose-wheel axle and oleo impact and scraping marks were found along the runway (Figure 3 and Figure 4). The aircraft initially tracked along the runway centerline, but it left the sealed runway about 10 meters to the right of the runway centerline leaving nose landing gear wreckage (Figure 5) along the runway.

Figure 3: Nose and left main landing gear impact marks on the runway

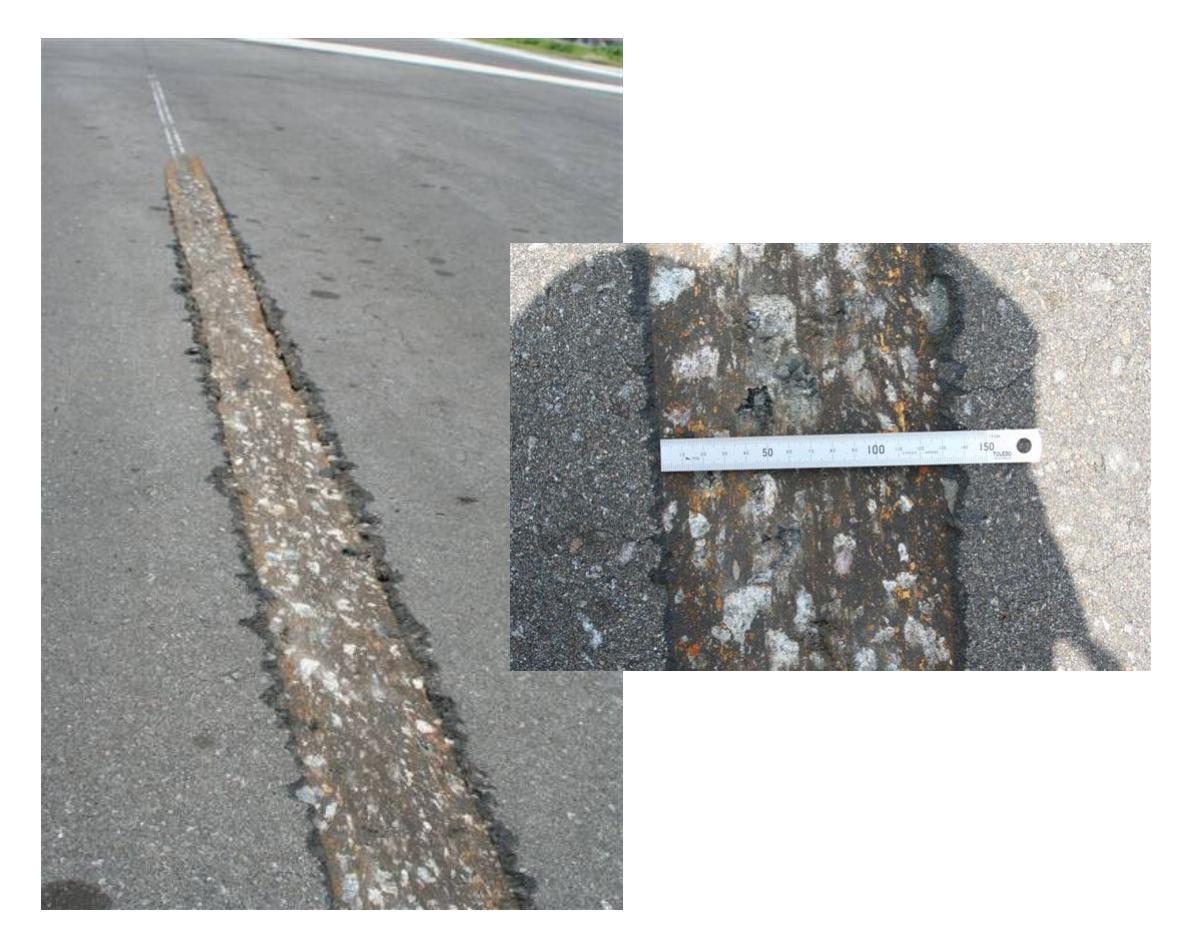
Figure 4: Nose landing gear scrape on runway approximately15 cm wide

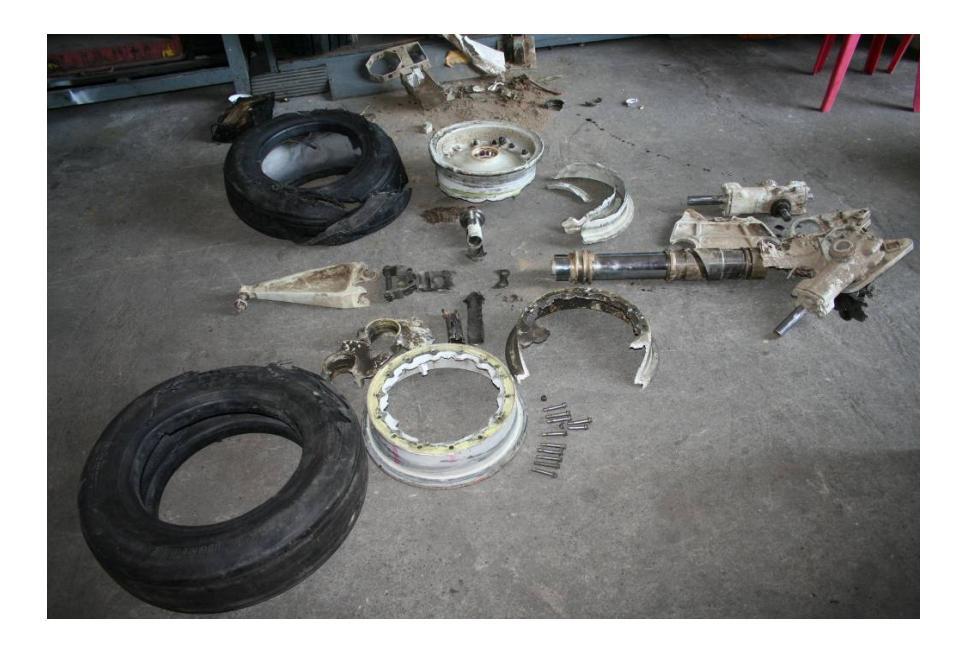
Figure 5: Nose landing gear wreckage layout

The left nose-wheel hub contacted the runway and fractured. Metal from the failed left wheel slashed the right nose wheel tire causing deep cuts to the tire crown. The outer hub of the right nose wheel separated leaving pieces on the runway. Figure 5 failed nose landing gear. The inboard hub of the right nose wheel remained attached to the right axle and was scoring the runway during the high speed landing roll; Figure 3 and Figure 4. The nose landing gear torque link failed. There was no evidence of foreign object damage (FOD) on the left nose wheel tire.

The right nose wheel tire had evidence of FOD, which caused the cut to the crown of the tire, probably due to the failed left nosewheel assembly. The inner walls of both tires showed that there was no evidence of overload or under pressure.

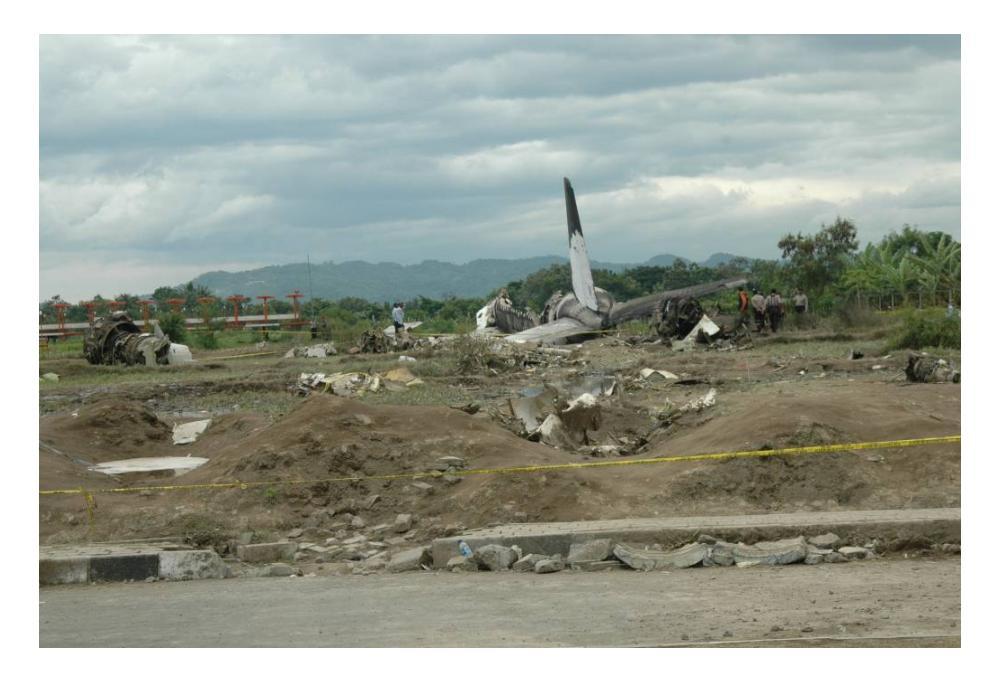
About 160 meters from the end of runway 09, the aircraft crossed a road and the nose of the aircraft impacted an embankment as the engines impacted a concrete gutter (Figure 6).

Figure 6: Left engine impact on road and gutter

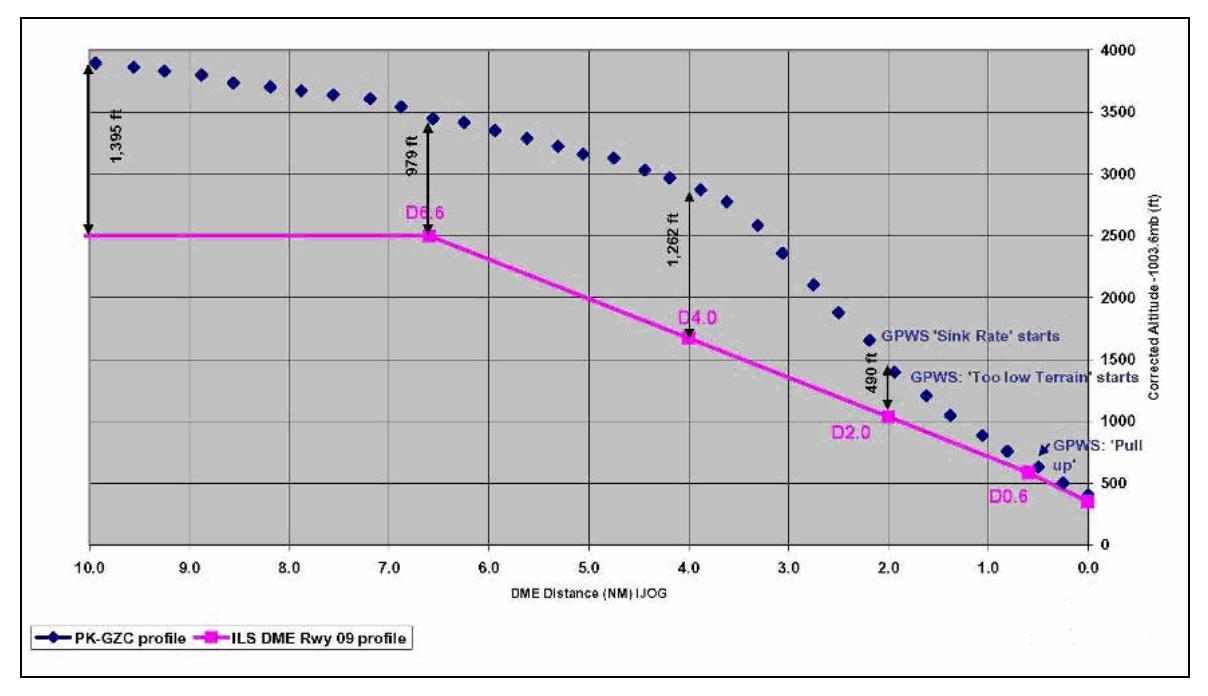
The SSFDR data shows that the aircraft crossed the threshold, 89 feet above the runway, at an airspeed of 232 knots, 98 knots faster than the required landing speed for flaps 40 degrees. The wind was north easterly at 9 knots. The groundspeed was 235 knots. The aircraft touched down at an airspeed of 221 knots, 87 knots faster than landing speed for 40 degrees flap (134 knots) at the aircraft's landing weight of 53,366 kilograms. Shortly after touching down, the copilot called, with high intonation, for the PIC to go around.

Figure 8: Comparison of PK-GZC and ILS DME approach profiles for Yogyakarta runway 09 approach

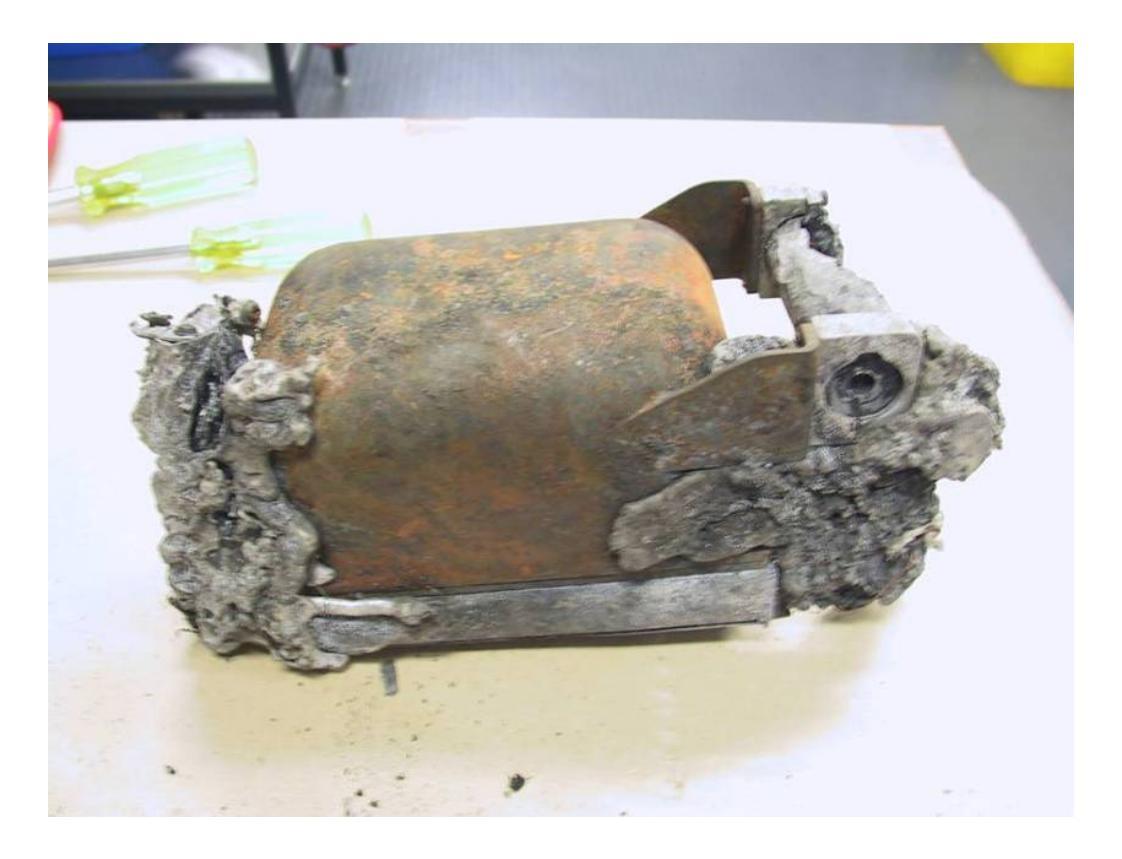
The SSFDR was severely burnt during the post-impact fire (Figure 13). However, the crash protection module survived the impact and fire. It contained 53 hours and 28 minutes of data¹¹, including data relating to the entire accident flight and 31 previous flights.

Figure 13: SSFDR from PK-GZC

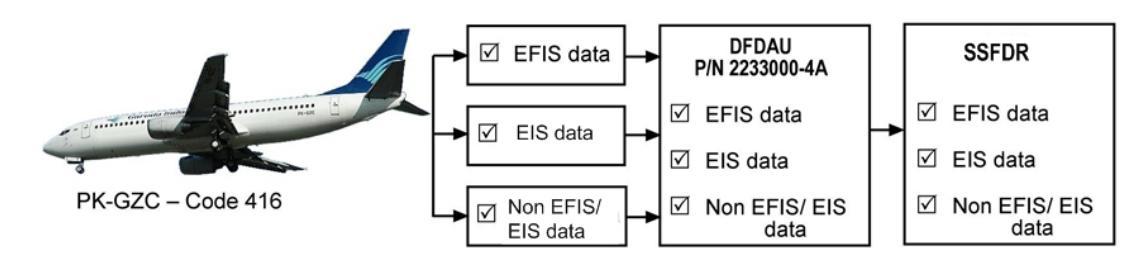
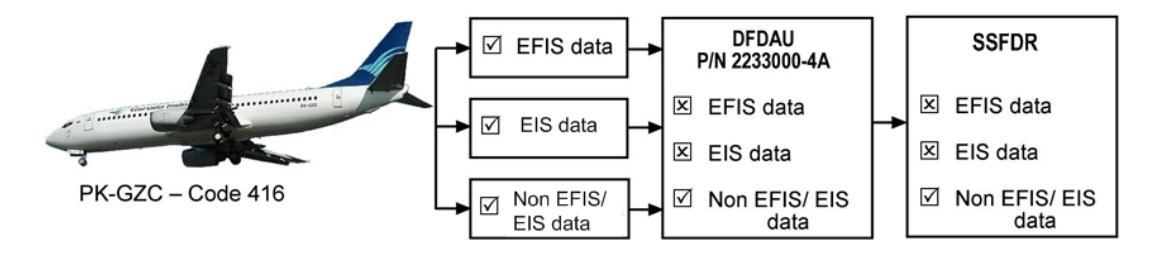
PK-GZC original fitment – DFDAU 2233000-4A effective on PK-GZC (Boeing 31-24-22-01B)

PK-GZC fitment at time of accident – DFDAU 2227000-45 NOT effective on PK-GZC (Boeing 31-24-22-01B)

Figure 14: PK-GZC flight recorder system mismatch resulting in SSFDR not recording EFIS and EIS parameters

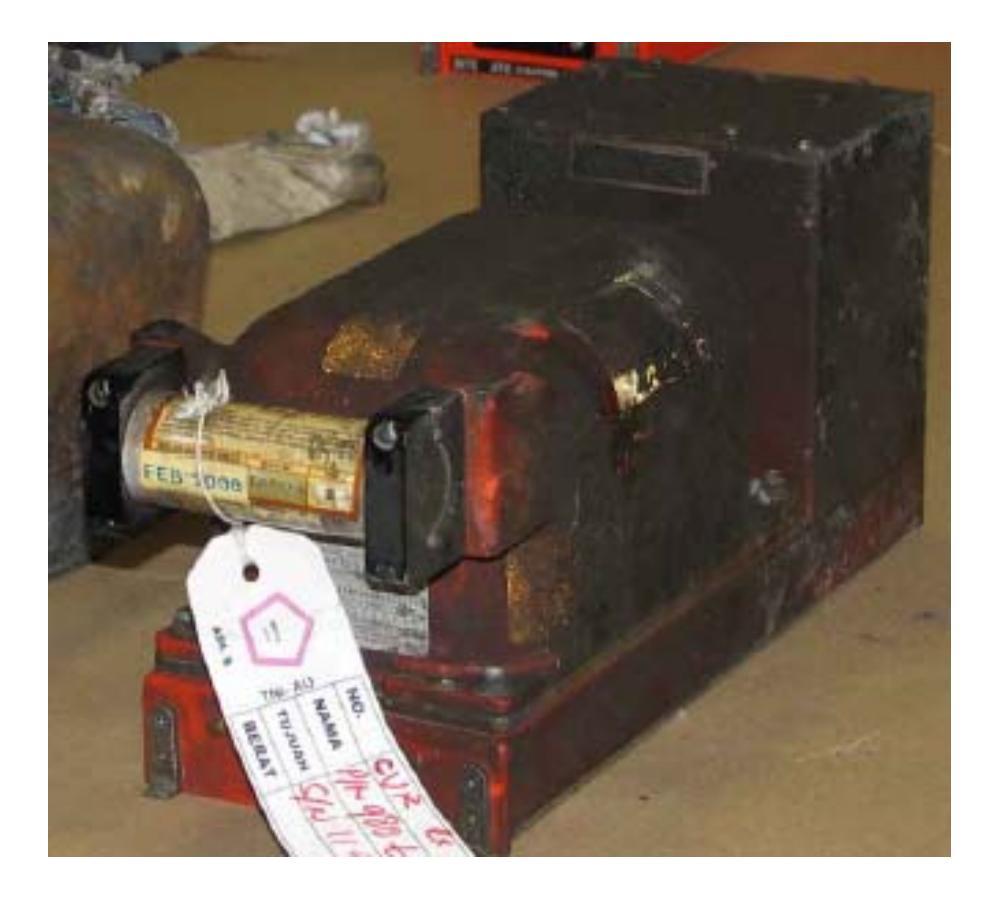
The SSCVR sustained heat damage during the post-impact fire, but it appeared to have survived the impact and fire (Figure 15). However, normal recovery methods were unable to facilitate the download of the SSCVR data.

Figure 15: SSCVR from PK-GZC

The SSCVR manufacturer found that the pointers contained in the electrically erasable programmable read-only memory (EEPROM) on the SSCVR memory module card were corrupted. It is likely that this occurred during the severe impact sequence. Resetting the pointers was only able to be accomplished at the manufacturer's facility. Following resetting, the SSCVR data was successfully downloaded.

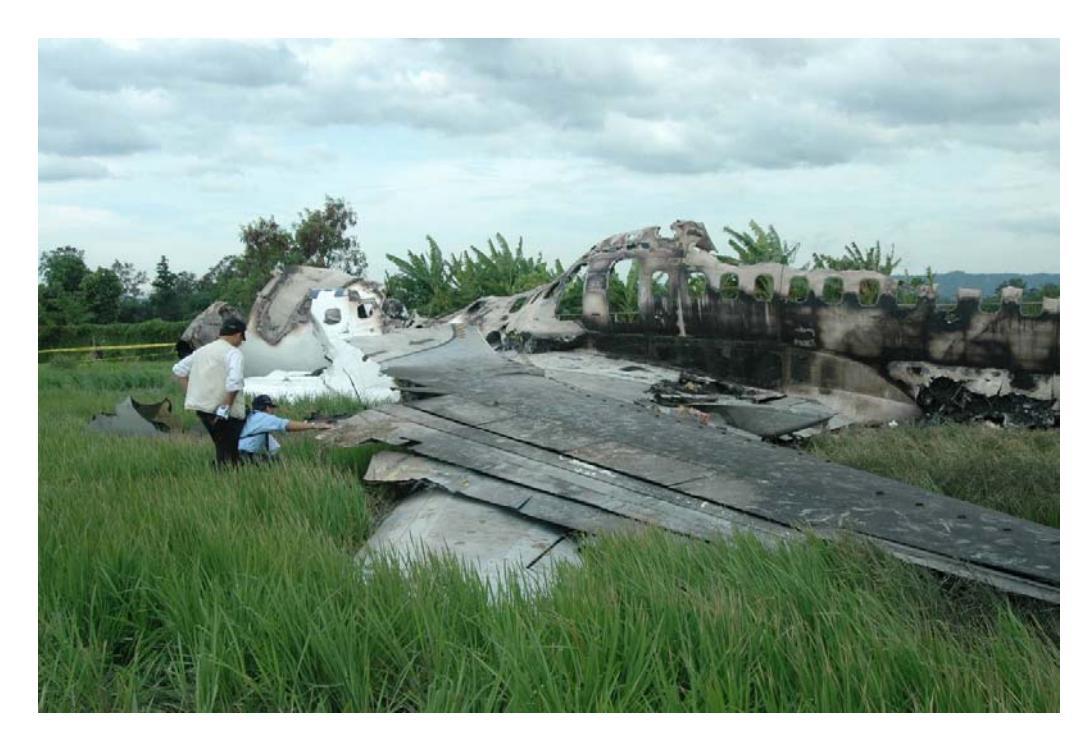
The nose wheel assembly separated from the aircraft on the runway. The engines and landing gear separated from the aircraft and were destroyed. The right wing was severed from the fuselage and swung around the fuselage and came to rest on top of the left wing (Figure 17).

Figure 17: Severed right wing on the left wing

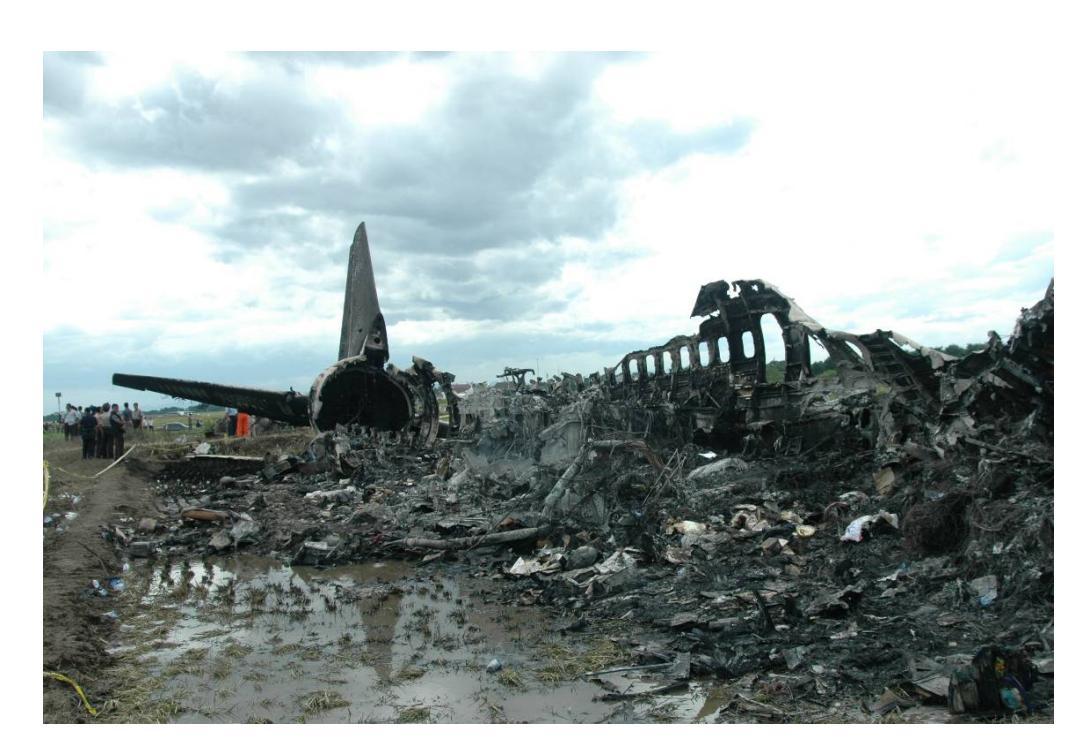
The cockpit area folded back and came to the rest inverted on top of the forward passenger cabin. The aircraft was destroyed by impact forces and the intense fuel-fed, post-impact fire (Figure 18).

Figure 18: General view of the accident site looking back along the direction of the landing

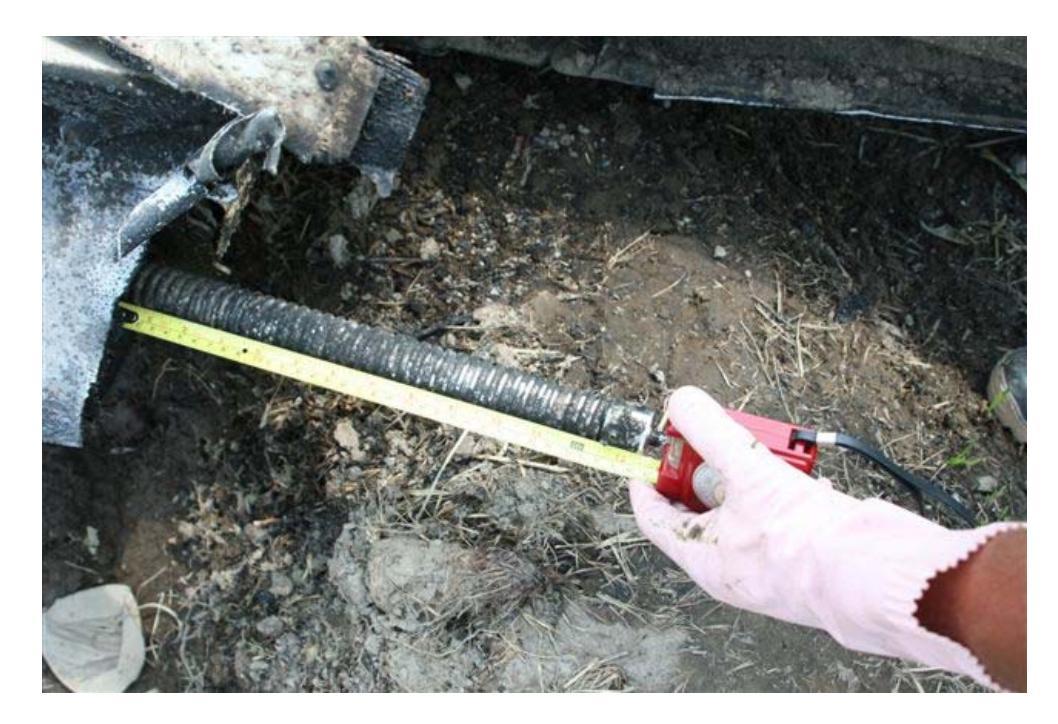
- Both thrust reversers were in the closed position; the stowed position.
- All ground spoilers were in the closed position.
- The auxiliary power unit (APU) was off, and the APU door was closed.
- The left rear door slide was out of its container and the slide bar was attached to door frame. No other evacuation slides were deployed.
- The right side of the fuselage was destroyed by the post-impact fire.
- The left over-wing emergency exit windows were opened.
- Both main landing gear assemblies separated from the wings during the impact.
- Flap position. The measurement was taken from the right inboard flap (outboard and inboard screw jacks). The outboard screw jack was at position 31.5 cm from the end stop, and the inboard screw jack was 31.5 cm from the end stop (Figure 19). The flap position corresponded to 5 degrees extended, or flap 5 position.

Figure 19: Flap screw jack

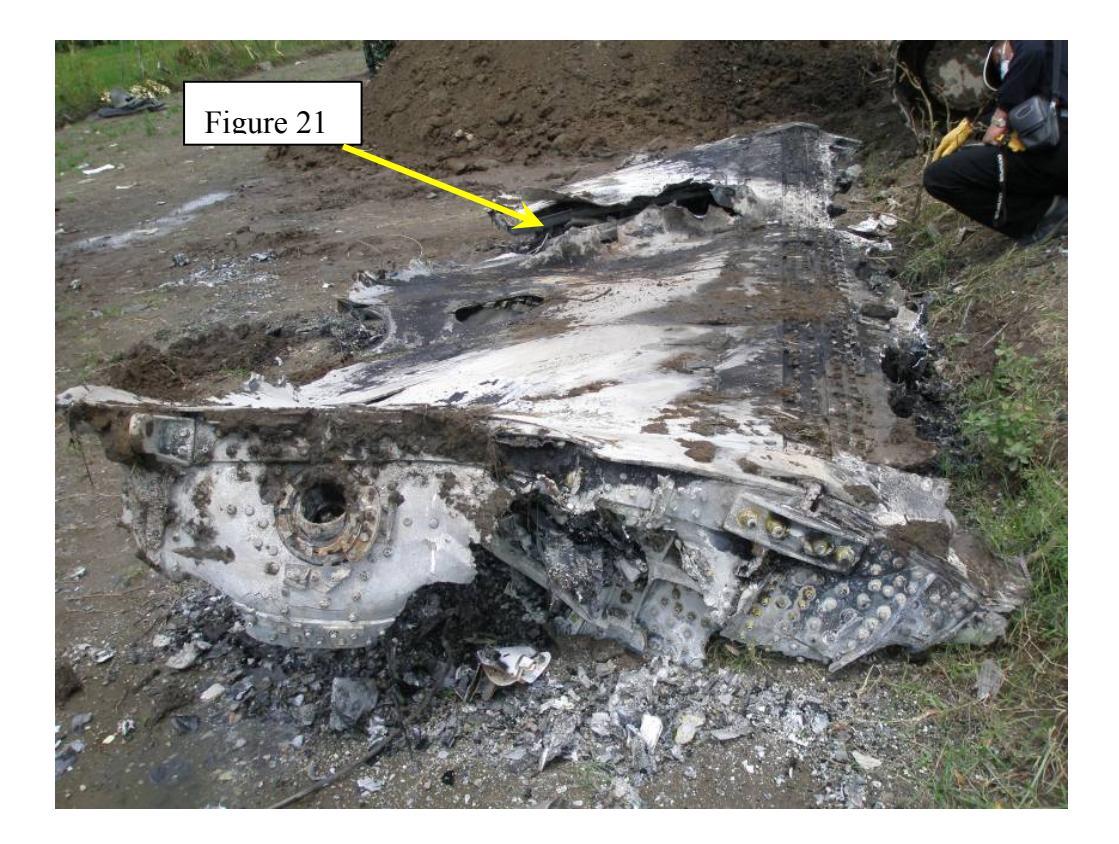
Fuel from the disrupted right wing fed the intense post-impact fire that consumed the aircraft. The right wing fuel tanks exploded during the impact (Figure 20 and Figure 21).

Figure 20: Lower side of right wing at root end

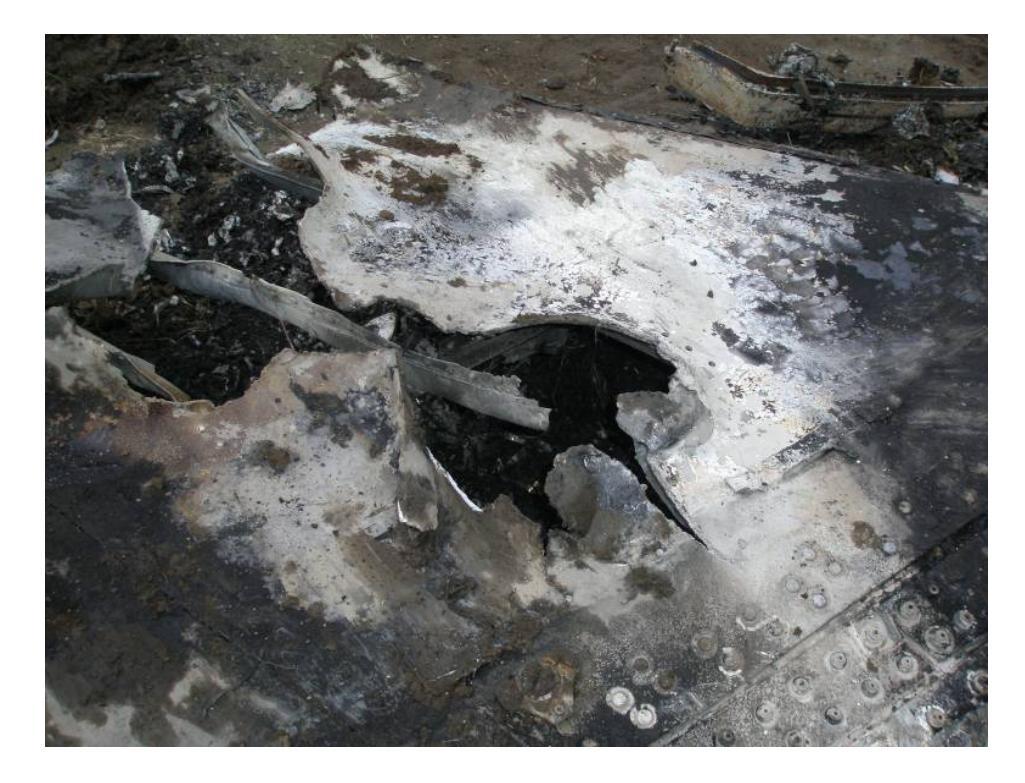
Figure 21: Close-up view of fuel burn explosion damage to right wing

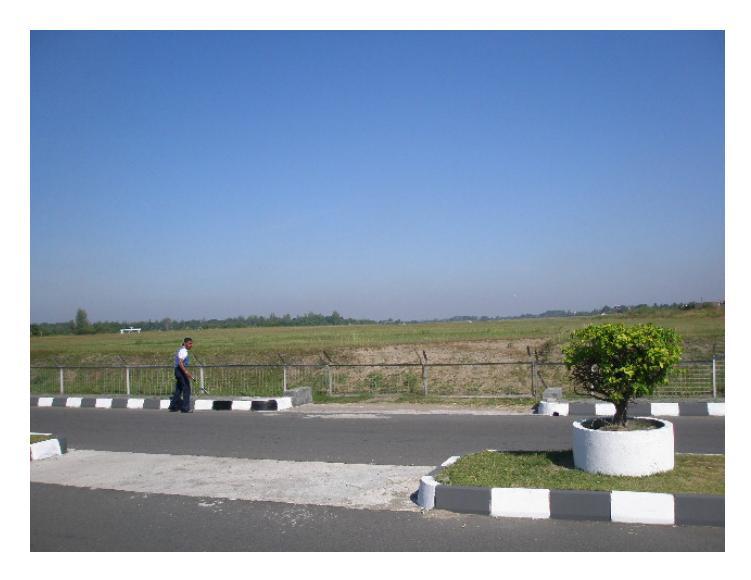
Figure 22: Access road from runway across urban road. View towards the runway

Since the accident on 7 March 2007, the Yogyakarta airport operator constructed an access road between the airport perimeter and the rice field where the accident occurred. The road is along the flight path of arriving and departing aircraft using the Yogyakarta runway and crosses an urban road. It covers two ditches and passes through a median strip on the road (Figure 22 and Figure 23).

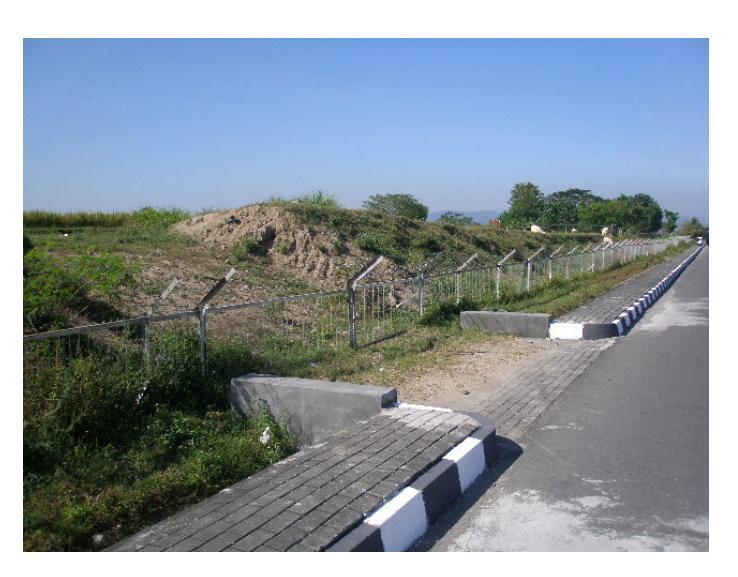
Figure 23: Access road from urban road to rice field. The rice field and accident site are to the left of the picture

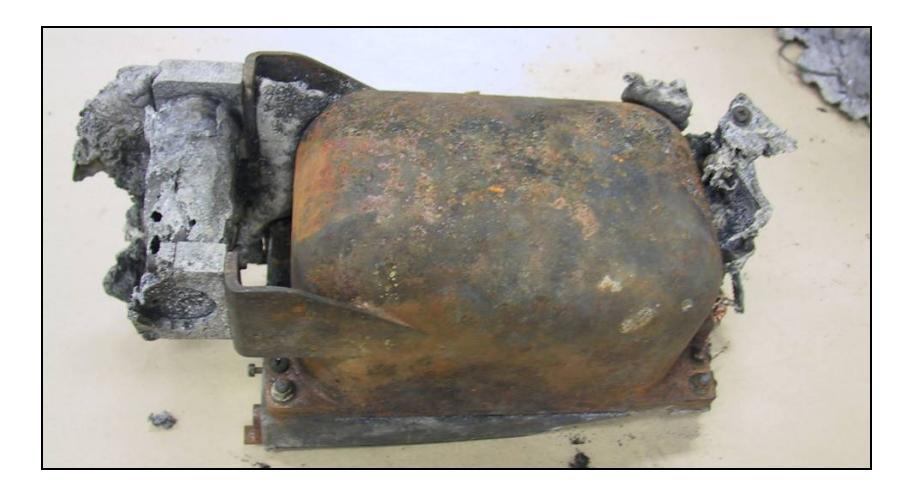
Figure 2: PK-GZC flight data recorder as received at the ATSB on 9 March 2007

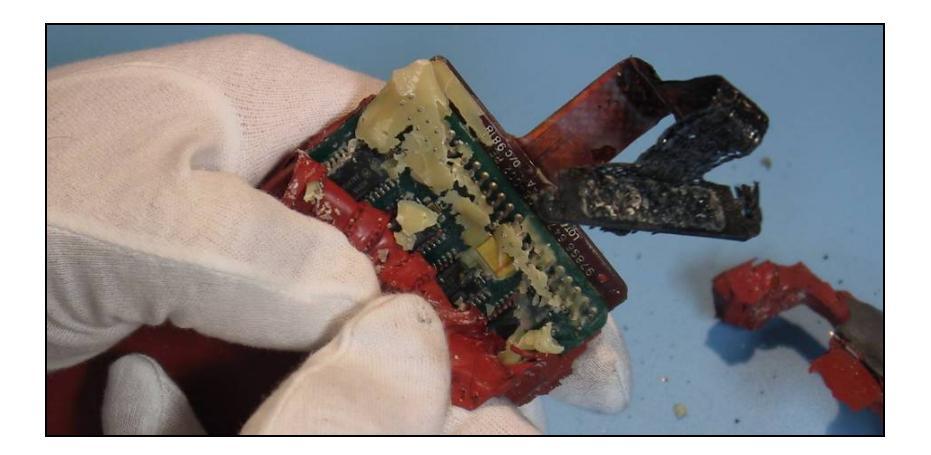
Figure 4: SSFDR memory board connector pins and damaged flex cable

The memory board connector pins were cleaned and the flex cable replaced (Figure 4 and Figure 5)

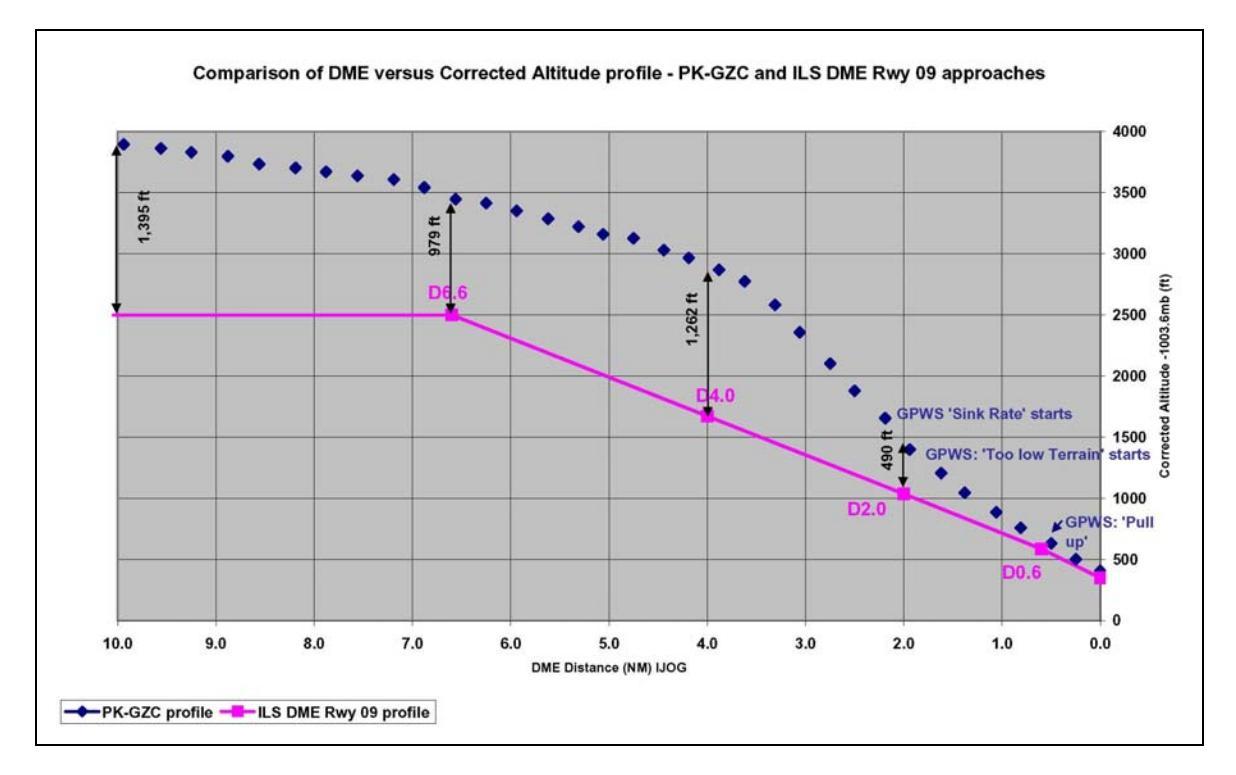
The Garuda Yogyakarta (JOG) Route Manual Charts and Jeppesen ILS DME Rwy 09 chart were used to conduct a distance versus altitude comparison of the PK-GZC approach profile. The altitudes and distances relating to the approach profiles are identical between both chart presentations. The recorded values of DME DISTANCE-LEFT transmitted on ILS DME 109.1 MHz IJOG were plotted against corrected pressure altitude (aerodrome QNH at Yogyakarta was 1003.6 mb). The approach plate elevation profiles from the charts (Figure 7) were compared to the elevation approach profile of PK-GZC during the accident flight.

Figure 7: Yogyakarta runway 09 approach showing DME vs corrected altitude profile of PK-GZC and ILS DME approach plates
