Inquiry AO-2012-002: Airbus A320 ZK-OJQ, Bird strike and subsequent engine failure, Wellington and Auckland International Airports, 20 June 2012

Final Report

Aviation inquiry 12-002 Airbus A320 ZK-OJQ Bird strike and subsequent engine failure Wellington and Auckland International Airports 20 June 2012

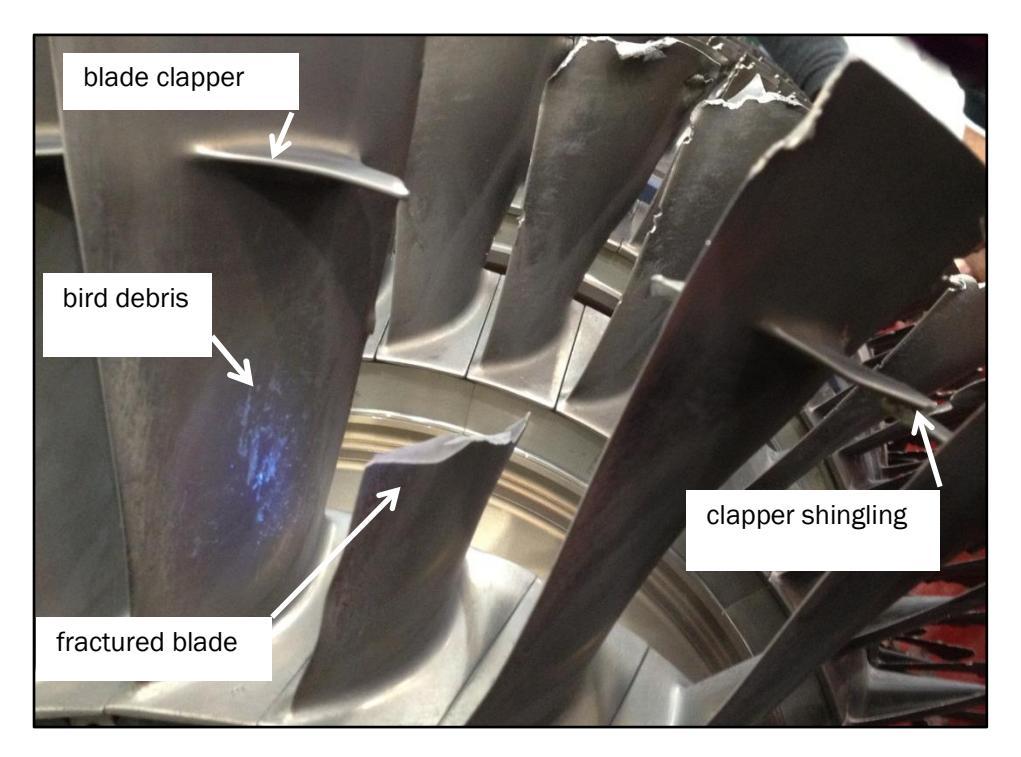
- 3.2.4. One third-stage compressor blade was found fractured and the adjacent blades had soft body impact damage typical of a bird strike. A piece of the fractured blade that was found in the 3-8 rotor drum showed signs of soft impact damage to the leading edge. Extensive hard body impact damage caused by the released blade was evident on all stages downstream of stage 3.

Figure 1 Fractured third-stage blade and an example of clapper shingling

- 4.2.2. The ingestion of the bird into the core of the engine forced the blades out of alignment, causing blade movement during the flight to Auckland. This movement resulted in the clappers¹⁷ shingling¹⁸ and a crack forming and growing under the stresses present. Eventually the crack ruptured and the blade separated, causing the engine surge. It is also possible that because of the disrupted airflow from the then excessive blade movement and shingling, the engine surged, causing the section of blade to rupture and separate. Regardless of the final sequence of events, the initiator was the bird strike and the resulting soft impact damage.

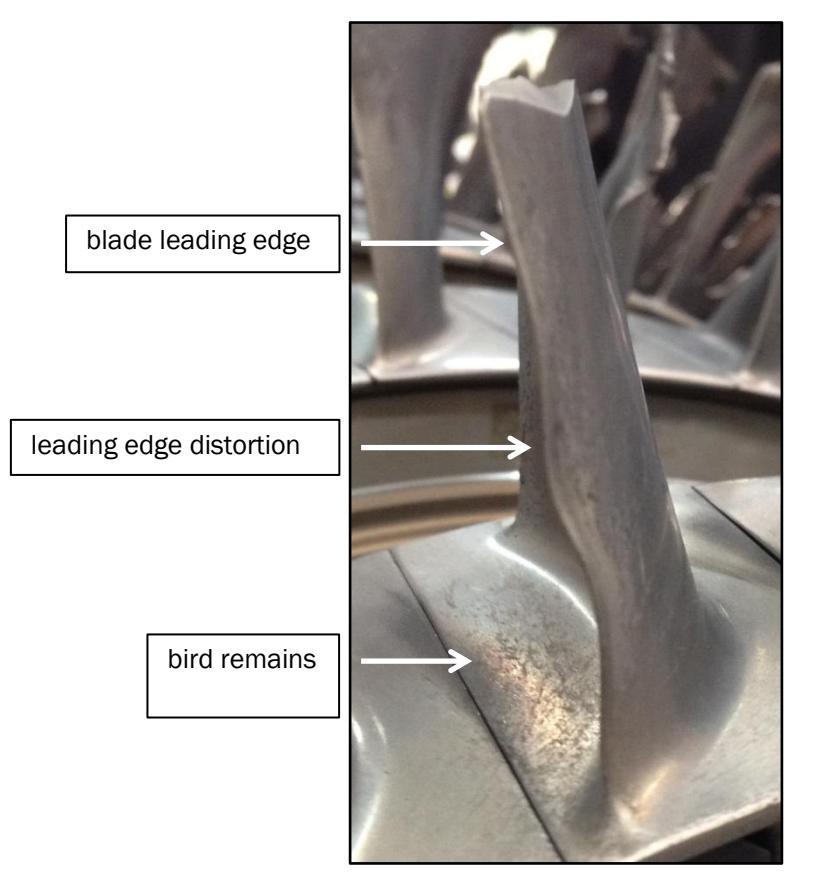
Figure 2 Fractured third-stage blade showing soft body impact damage to the leading edge

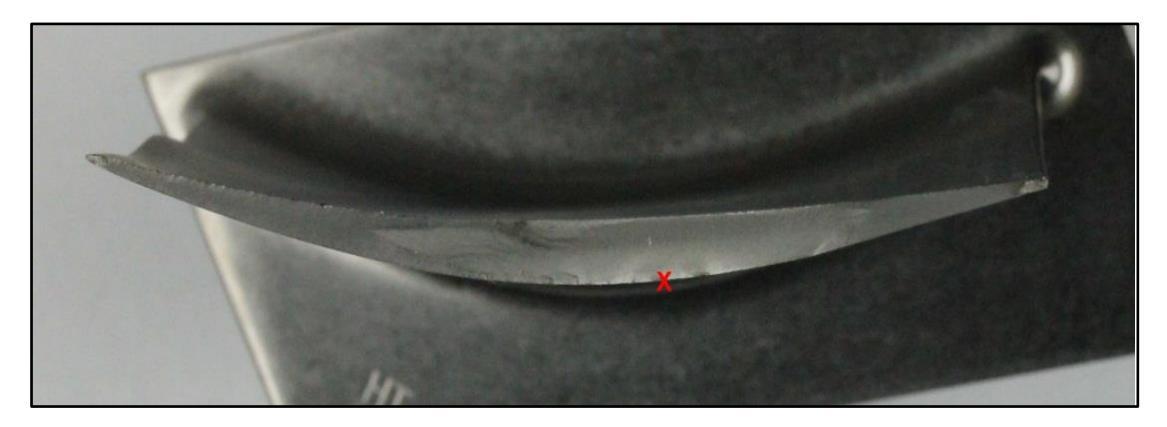
Figure 3 Crack initiation <u>x</u>

- 3.2.5. All 31 of the third-stage high-pressure-compressor blades and the fractured piece of blade were removed and sent to an approved laboratory for further analysis. The fractured blade displayed high-cycle-fatigue crack growth (propagation) followed by aerofoil liberation. High-cycle-fatigue crack growth is caused by stresses placed on the blade during in-service vibrations. The crack originated from the mid chord on the suction side (convex) of the blade about 43 millimetres above the platform and 23 millimetres from the blade leading edge.
