Final Report

of AFRIQIYAH Airways Aircraft Airbus A330-202, 5A-ONG Crash Occurred at Tripoli (LIBYA) on 12/05/2010

Published February 2013

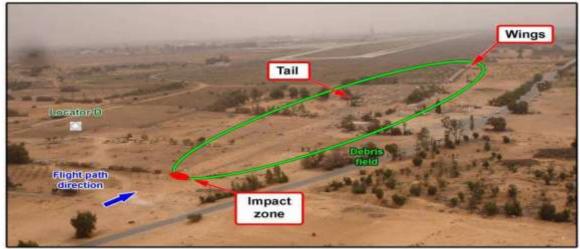
Aerial view of the debris field

Tree-tops were broken over an area located a few meters before the impact zone; elements of the aircraft broke away as a result of these contacts.

The first debris found in the impact zone comes from the soft underbelly of the aircraft, the landing gear doors and the nacelles of the two engines. It should be noted that debris from these parts of the aircraft were scattered over several hundred meters from the point of impact. No trace of the landing gear was observed at this location.

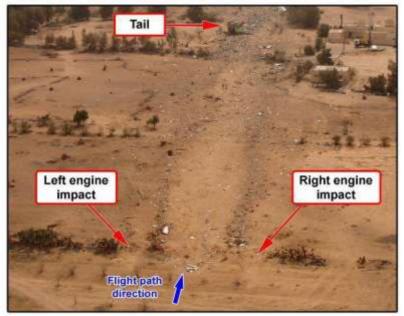
Aircraft ground impact

Many small fragments belonging mainly to the mid and aft sections of the fuselage were distributed eastwards from the impact zone; pieces from the front section of the fuselage were found 180 m from the impact zone.

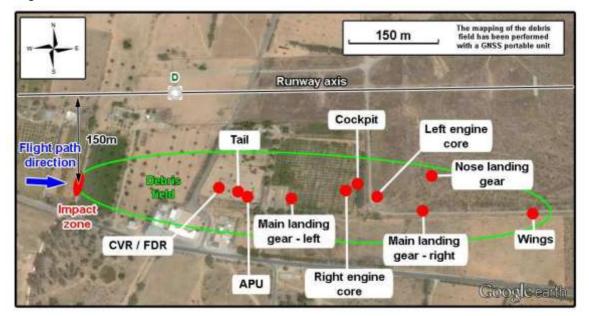
Distribution of the debris field

The first large items from the wreckage were distributed 270 m from the impact zone: the vertical stabilizer, the left Main Landing Gear (MLG), engine #1, the cockpit, engine #2, the right MLG, the nose gear, and finally the wings in the eastern part of the debris field. The latter bore significant fire marks.

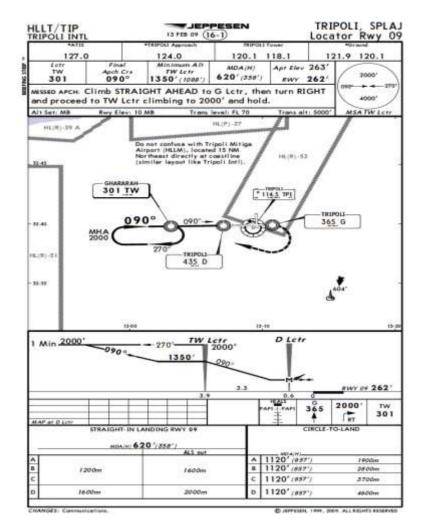
The Jeppesen chart did not provide any glide path after the FAF and did not include the table in the official map identifying crossing altitudes in relation the distance to the runway threshold 09 and rates of descent in relation the speed of the aircraft.

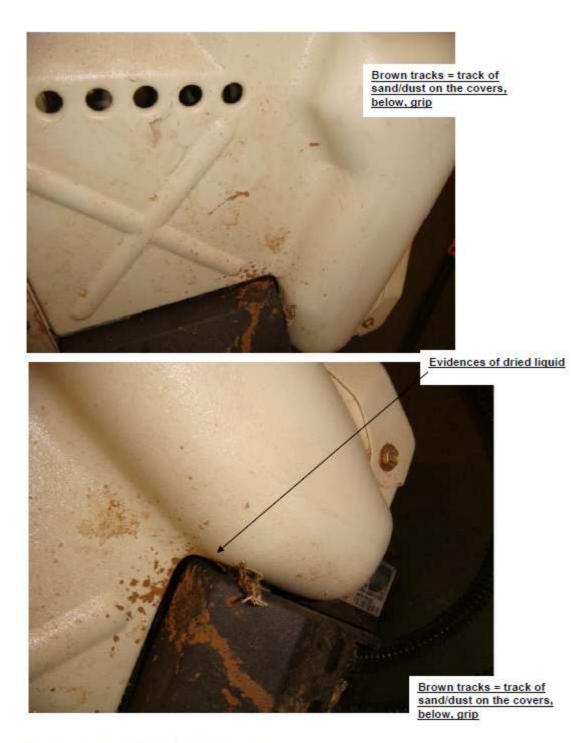
Partial conclusion: tracks of brown sand/dust

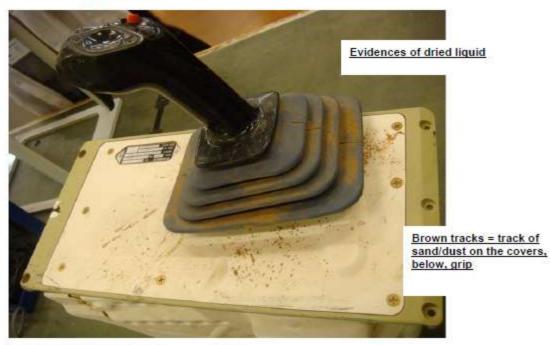
View looking downward

Partial conclusion: tracks of brown sand/dust

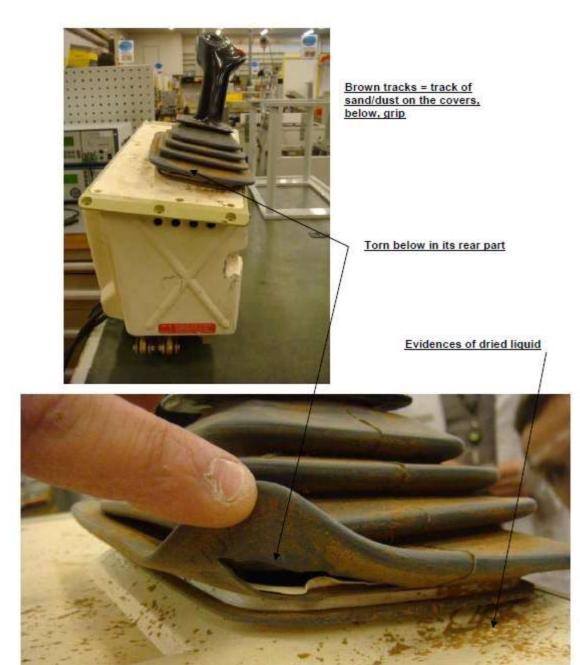
View looking forward

Partial conclusion: tracks of brown sand/dust. Torn below and of friction

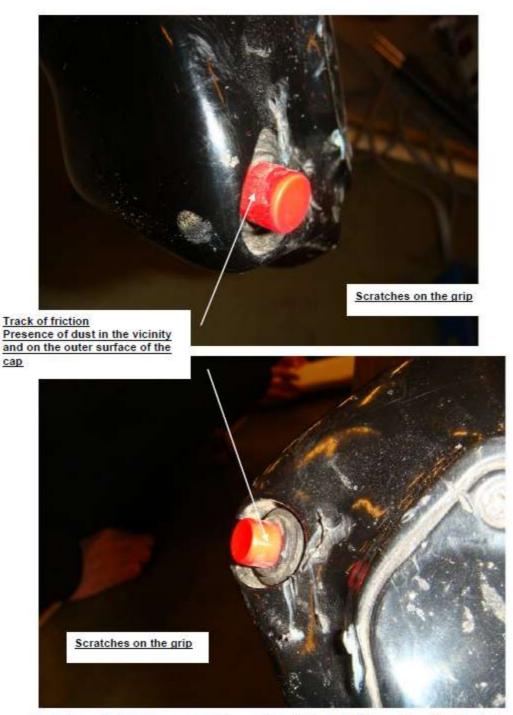
Partial conclusion: numerous scratches on the grip. Track of friction on the side of the button.

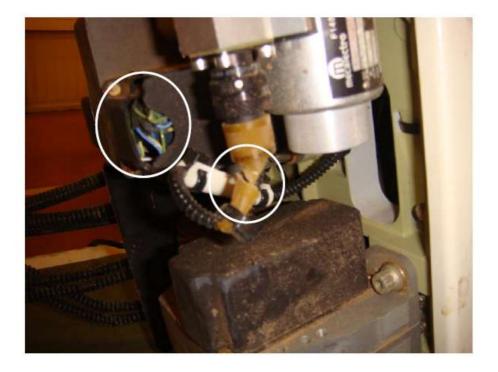
Partial conclusion: track of brown sand / dust inside the SSU. One TTU cover damaged. Connector backshell of the solenoid is broken.

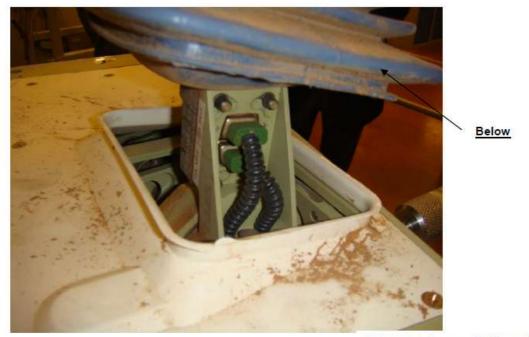
View looking forward

Brown tracks = track of sand/dust

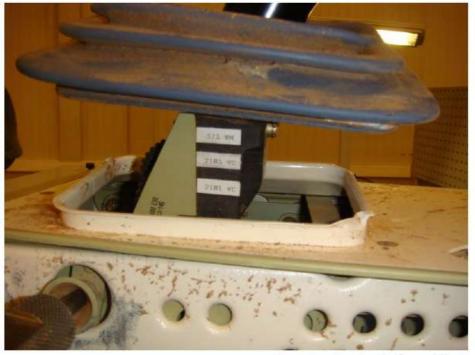
View looking outboard

Brown tracks = track of sand/dust

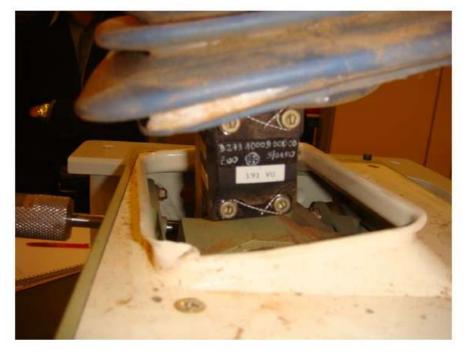
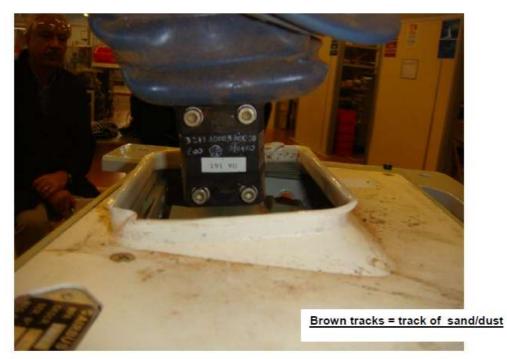
View looking backward

Partial conclusion: numerous tracks of brown sand / dust inside the SSU.

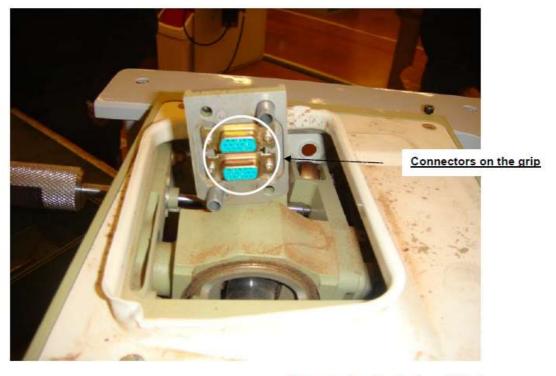
Brown tracks = track of sand/dust

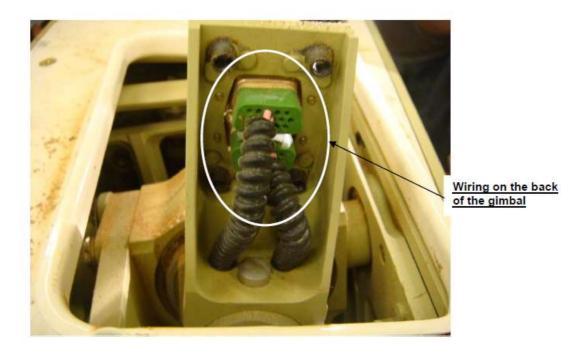
Partial conclusion: numerous tracks of brown sand / dust inside the SSU. Wiring not damaged

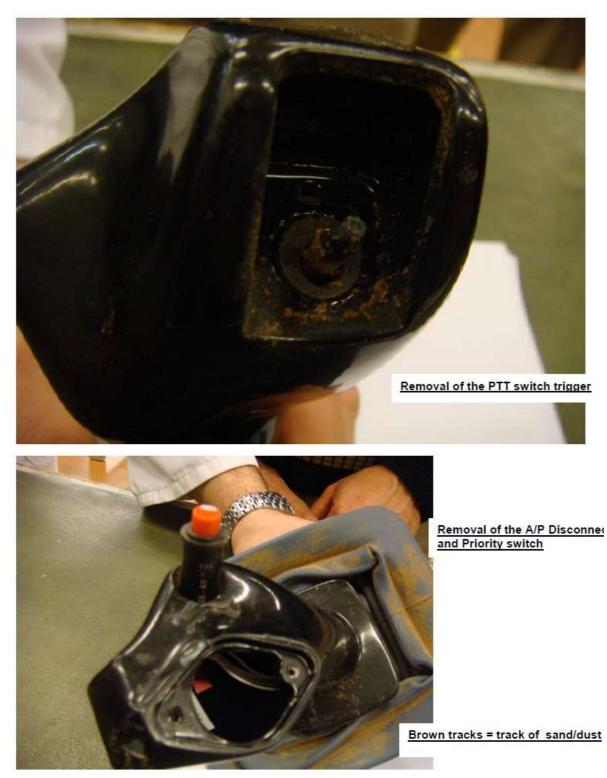
Partial conclusion: numerous tracks of brown sand / dust inside.

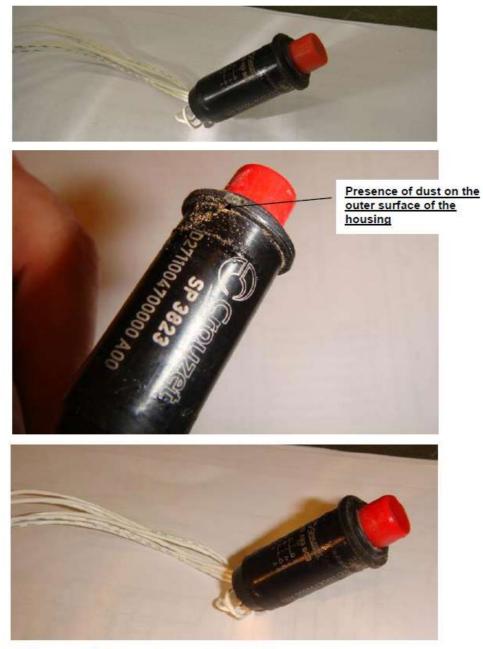
2.13 STEP13: A/P DISCONNECT AND PRIORITY SWITCH INSPECTION

Partial conclusion: no mechanical nor electrical damaged observed.
