*This document is an English translation of the Final Report on the accident involving the Boeing 737-8KN aircraft registered A6-FDN that occurred on March 19, 2016 (00:42 UTC) at Rostov-on-Don aerodrome, the Rostov Region, Russian Federation.*

**INTERSTATE AVIATION COMMITTEE  
AIR ACCIDENT INVESTIGATION COMMISSION  
FINAL REPORT**

Type of occurrence	Fatal accident
Type of aircraft	Boeing 737-8KN, airplane
Nationality and registration marks	A6-FDN
Owner	Celestial Aviation Trading 38 Limited, Shannon, County Clare, Ireland
Operator	Dubai Aviation Corporation, P.O. Box: 353, United Arab Emirates
Aviation authority of the place of occurrence	Southern FATA Interregional Territorial Department
Place of occurrence	Russian Federation, the Rostov region, the Rostov-on-Don aerodrome, reference position: 47°15'54.7" N, 039°49'43.8" E
Date and time	19.03.2016, 03:42 local time (00:42 UTC), nighttime

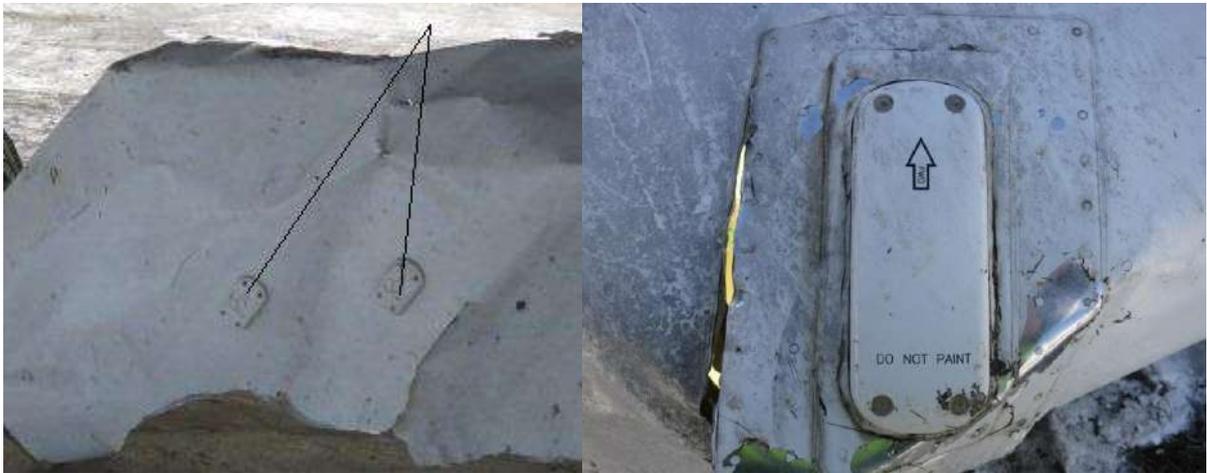
**Fig. 26. The GPS and TCAS antennas**

The fragments of the fuselage skin with the GPS and TCAS antennas had been discovered (Fig. 26).

All the units have the signs of the physical damage on them.

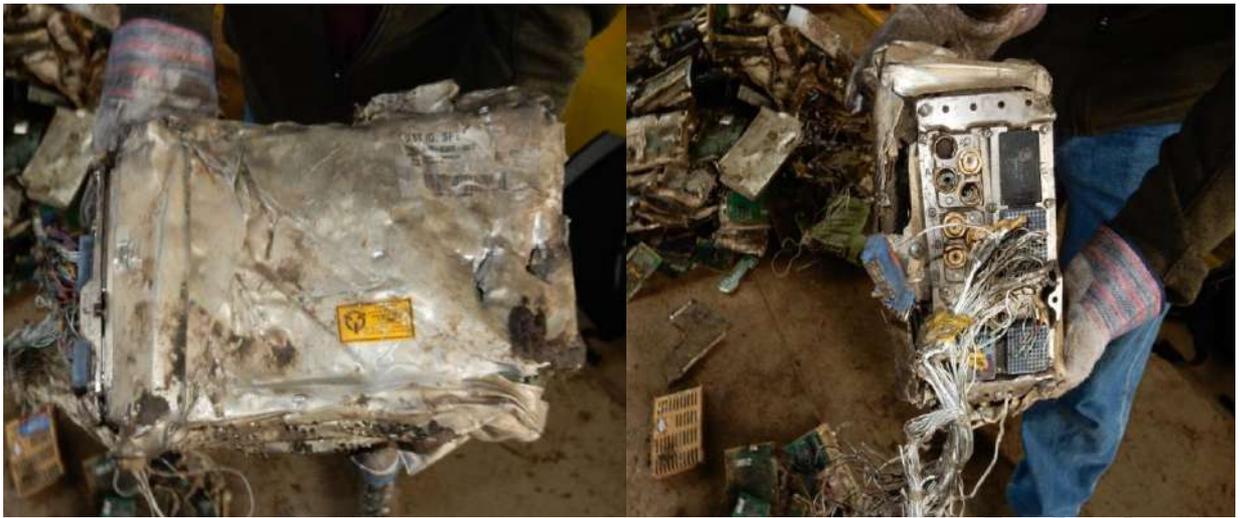
**Fig. 28. The TCAS computer**

- the TCAS computer, p/n 940 0300 001, s/n TPA03476 (Fig. 28);

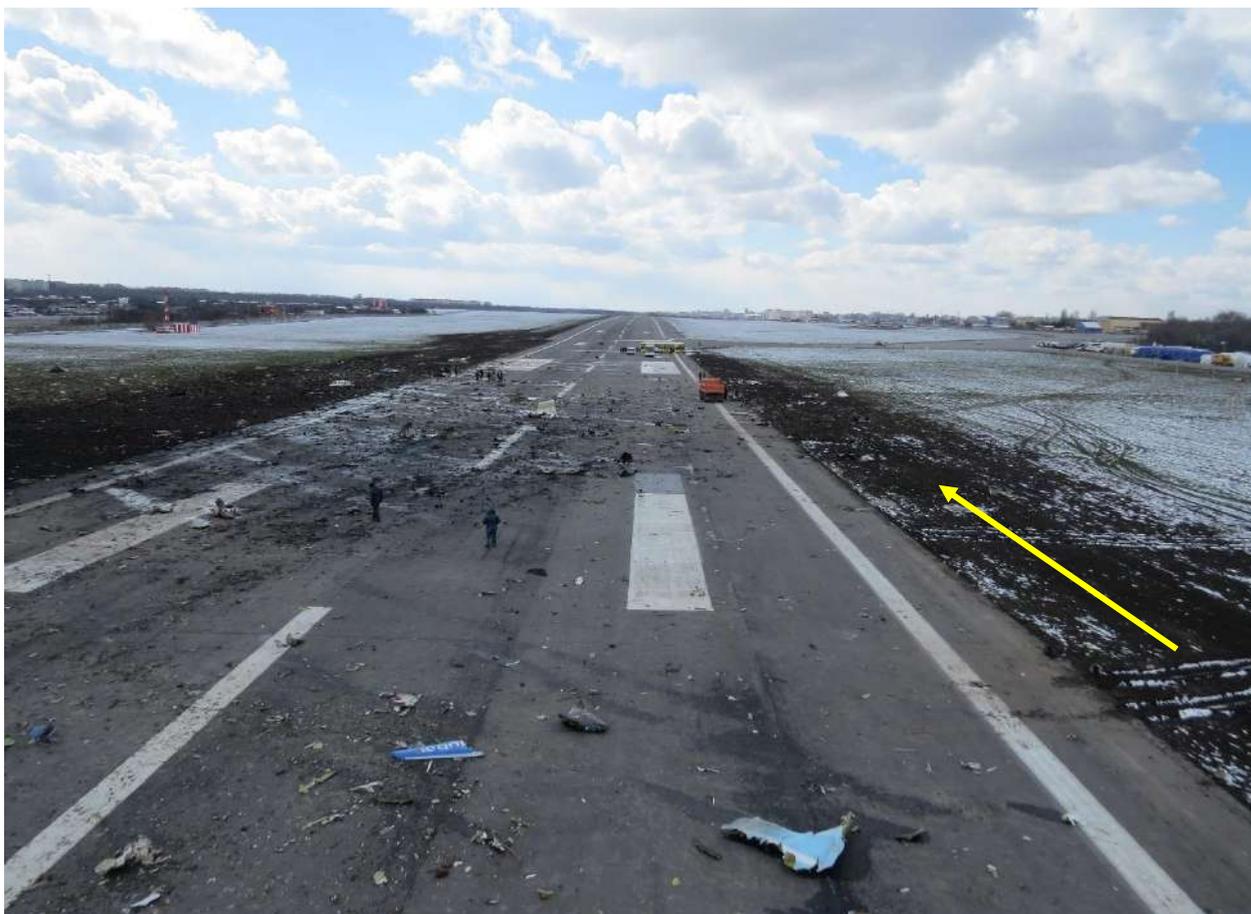
**Fig. 37. First point of impact with ground (the left-to-right direction of flight)**

The accident scene is located at the Rostov-on-Don airport airfield. The first point of impact with ground (the RWY concrete surface) occurred at the  $\approx 120$  m off the RWY22 threshold along the RWY left edge looking forward, reference position: 47°15'54.7" N, 039°49'43.8" E. The main wreckage scatter area is located at the distance of 150-400 m off the RWY22 threshold to the left (the major portion of the wreckage) and to the right of the RWY centerline (Fig. 37).

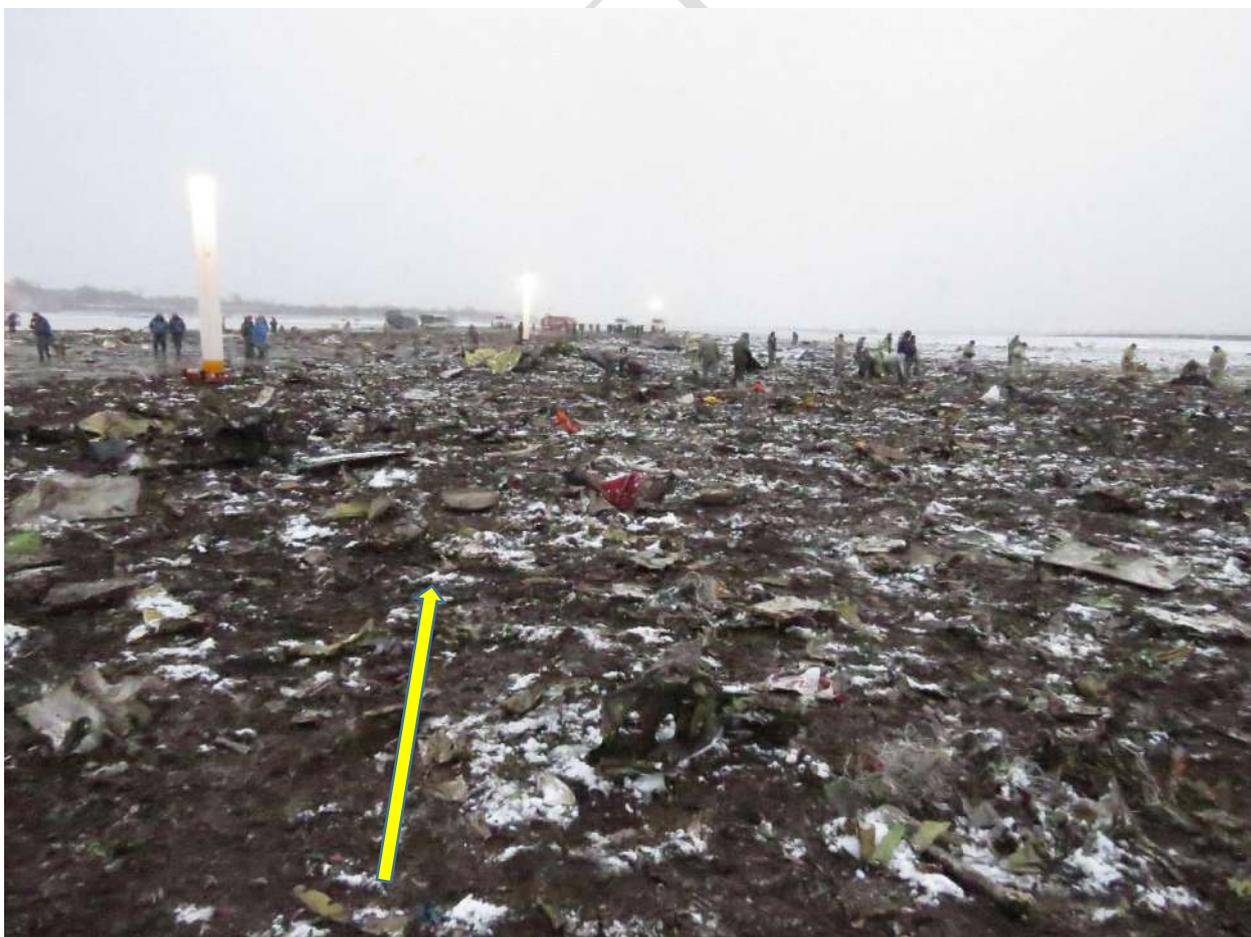
**Fig. 38. The general view of the accident scene (the arrow indicates the flight heading)**

The main wreckage scatter zone is located at the distance of 150-400 m off the RWY threshold on the left side (the larger portion of wreckage) and on the right side off the RWY centerline (Fig. 38).

The impact resulted in the crater formation of about 10-12 m length, 2.5 m width and up to 1.5 m depth. After the impact, the flash of the fuel-air mixture occurred with the subsequent fire.

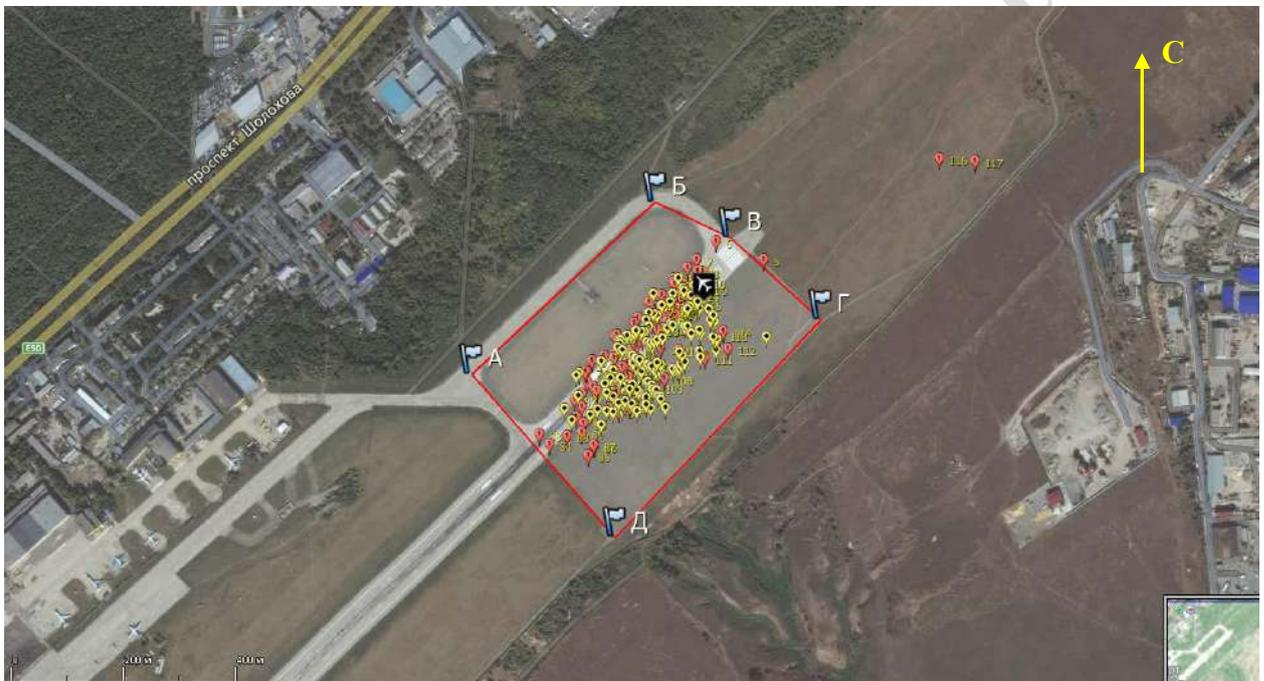
**Fig. 39. The pattern of the wreckage scatter on the accident site**

The main wreckage scatter zone was located inside the A-B-B-Г-Д polygon.

Only two smaller fragments of the fuselage skin were discovered out of the main wreckage scatter zone (the points 116 and 117 on Fig. 39), situated at the azimuth  $\approx 57^\circ$  at the distance of  $\approx 474$  m and, most probably taken away by the wind due to their sailing capacity/windage. The actual weather observed at the Rostov-on-Don aerodrome after the alarm signal declaration as of 00:55: «...*surface wind magnetic 230<sup>0</sup> 16 m/s, gusts 22 m/s...*».

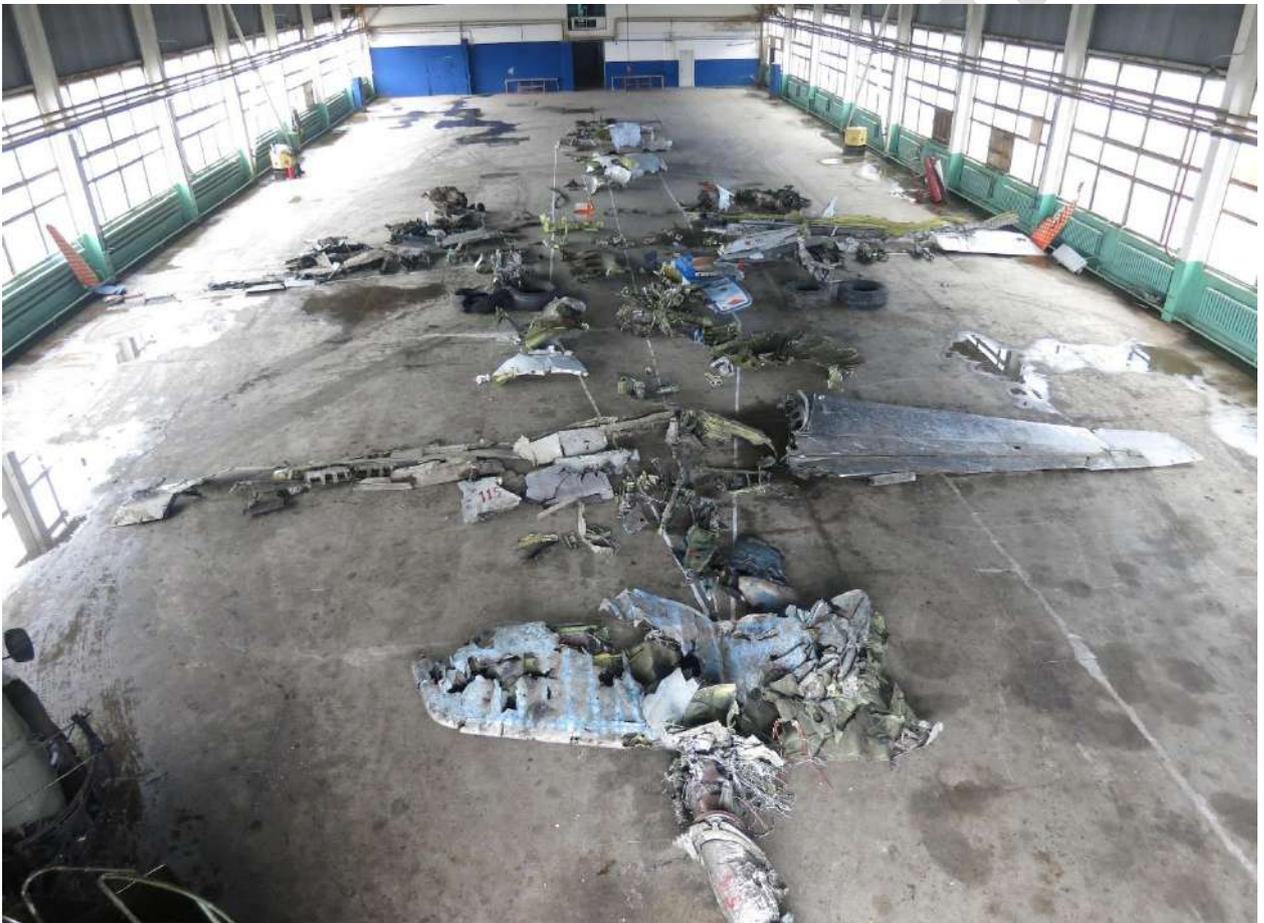
**Fig. 41. The surface layout of the wreckage in the hangar**

At the analysis of the wreckage map (Section 1.12) and the layout the signs of the inflight aircraft destruction prior to the impact with ground were not detected. All the damage of the airframe structure, engines and systems, as well as the disintegration of the avionics occurred due to the application of the huge loads in the accident sequence far beyond the tensile strength.

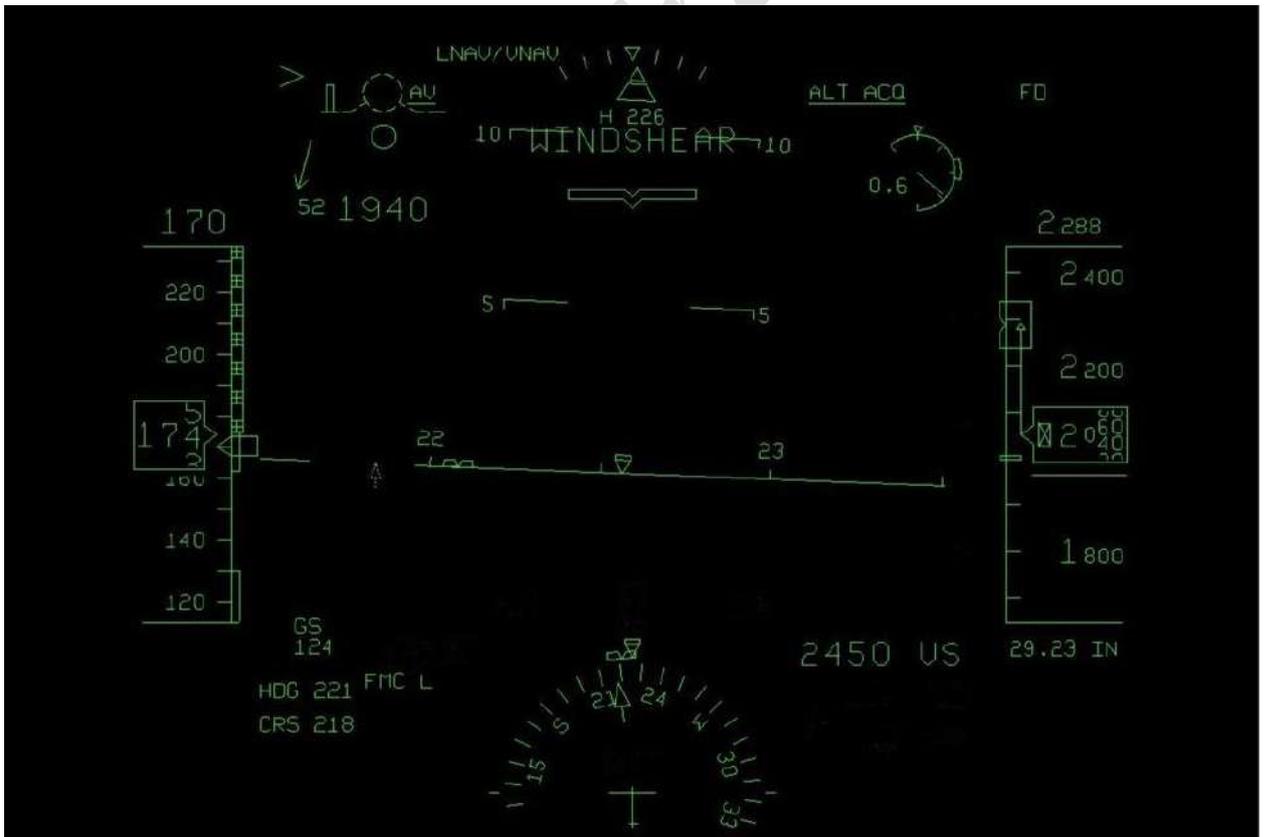
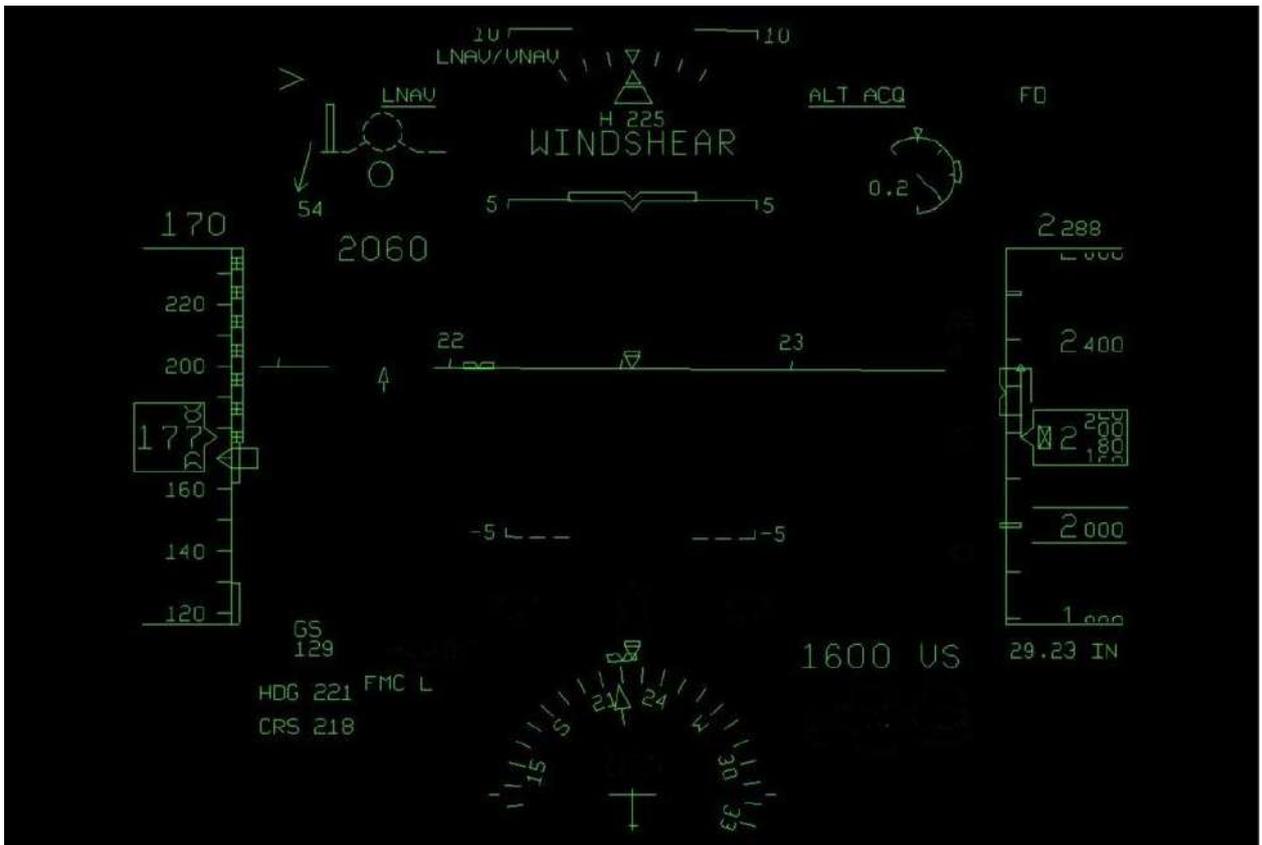
At the moment the Flight Path Symbol on HUD was higher than Guidance Cue (Fig. 59 and Fig. 60), that is to maintain the target flight path the additional control inputs to “nose-down” were required. With the control column position unchanged the PIC, in addition, pressed the trim switches on the control wheel for about 4 s to nose-down (the angle of deflection of the stabilizer was changed for  $1.8^\circ$ ) that resulted in the pitch reduction up to  $3-4^\circ$  and additional acceleration.

Fig. 59. The HUD reconstructed image at the point of time of 22:42:27.5 (the first press on the stabilizer trim switches)

**Fig. 60.** The HUD reconstructed image at the point of time of 22:42:31.5 (the last press on the stabilizer trim switches)

As the result the IAS exceeded the limit value (with flaps, extended on 30°, Vfe is 175 kt) and TE Flap Load Relief was activated. The flaps automatically retracted to 25° (the flap handle remained at the 30° detent). It should be noted that at the initiation of go-around IAS was equal to 160 kt that is the margin to the limit (with no “flap load relief”) at the performance of Windshear Escape Maneuver amounted to 15 kt.

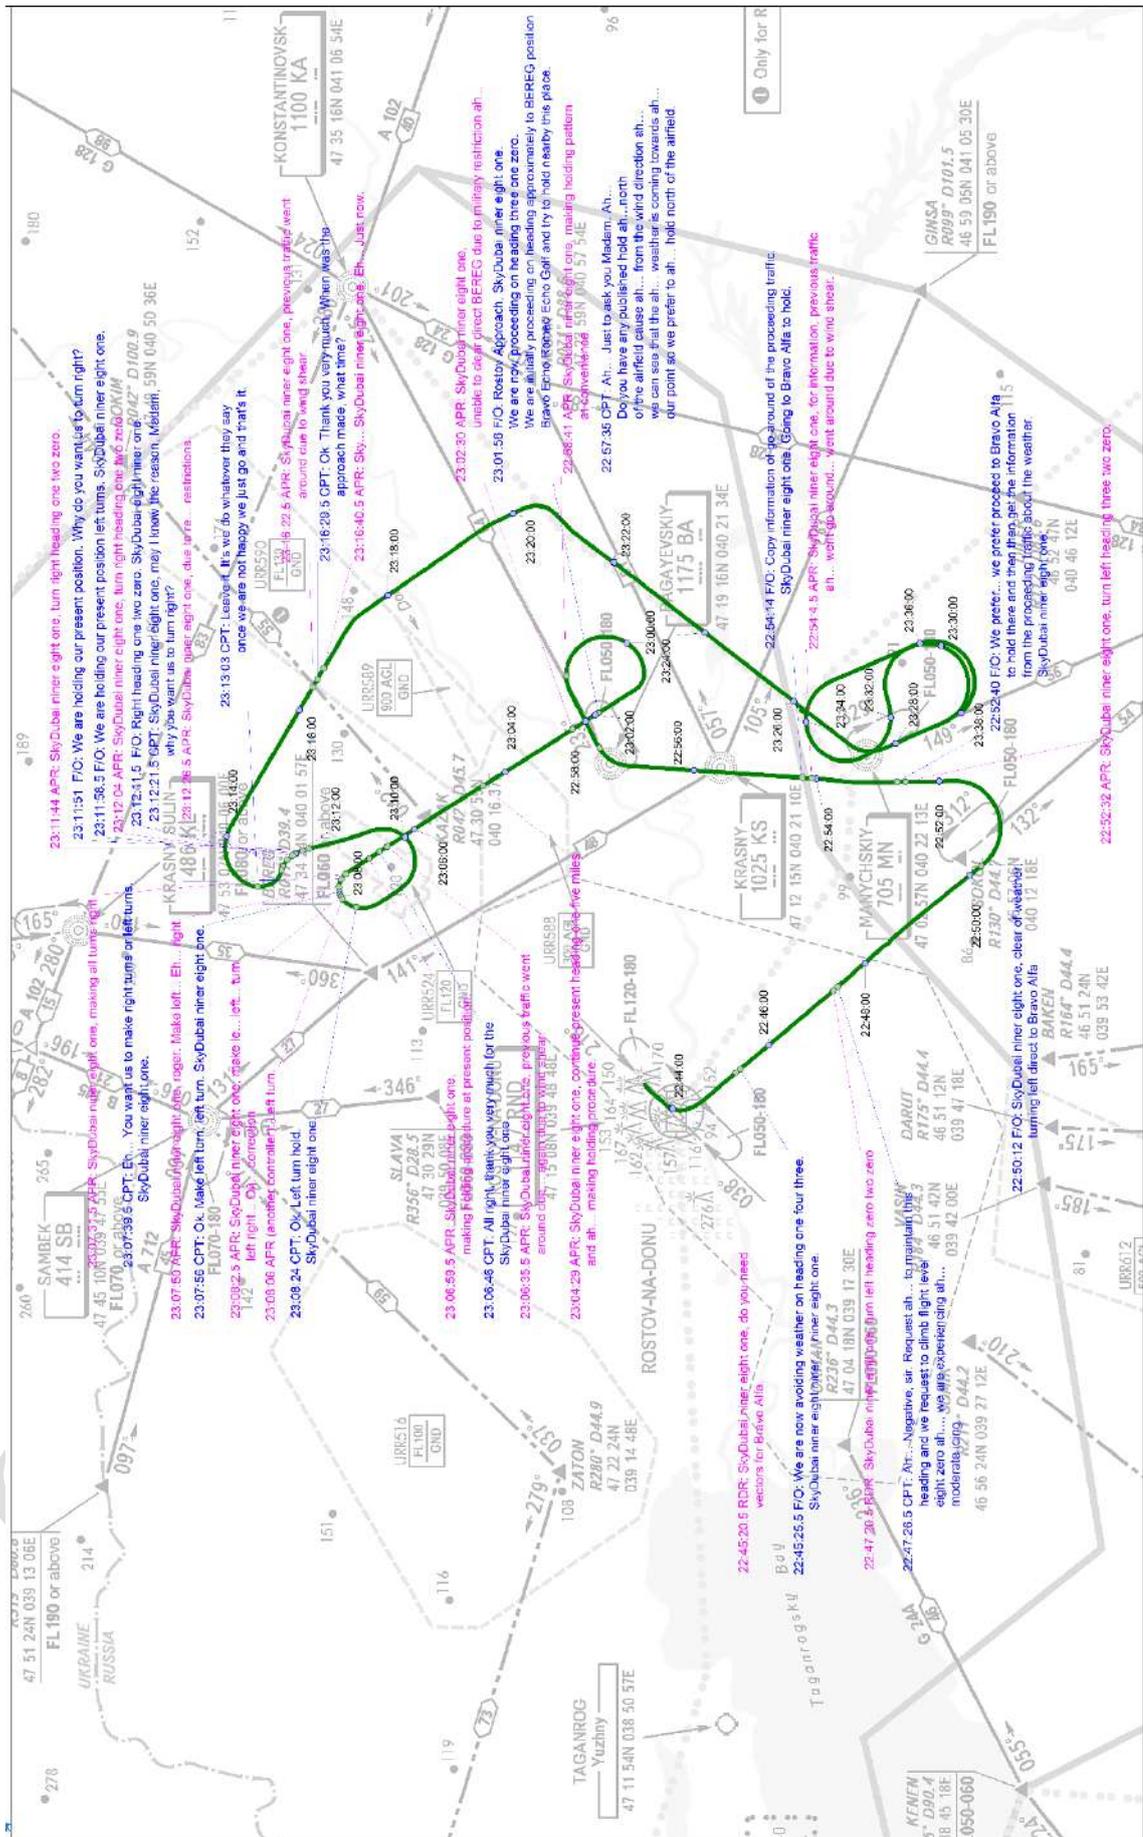
At 22:45:15, the crew set the standard pressure of 1013 hPa. The aircraft flight path after the go-around is given on Fig. 61. On the figure the only crew-ATC communication is stated, which is referred to in the further text.

Fig. 61. The flight path after the first go-around and in the holding area

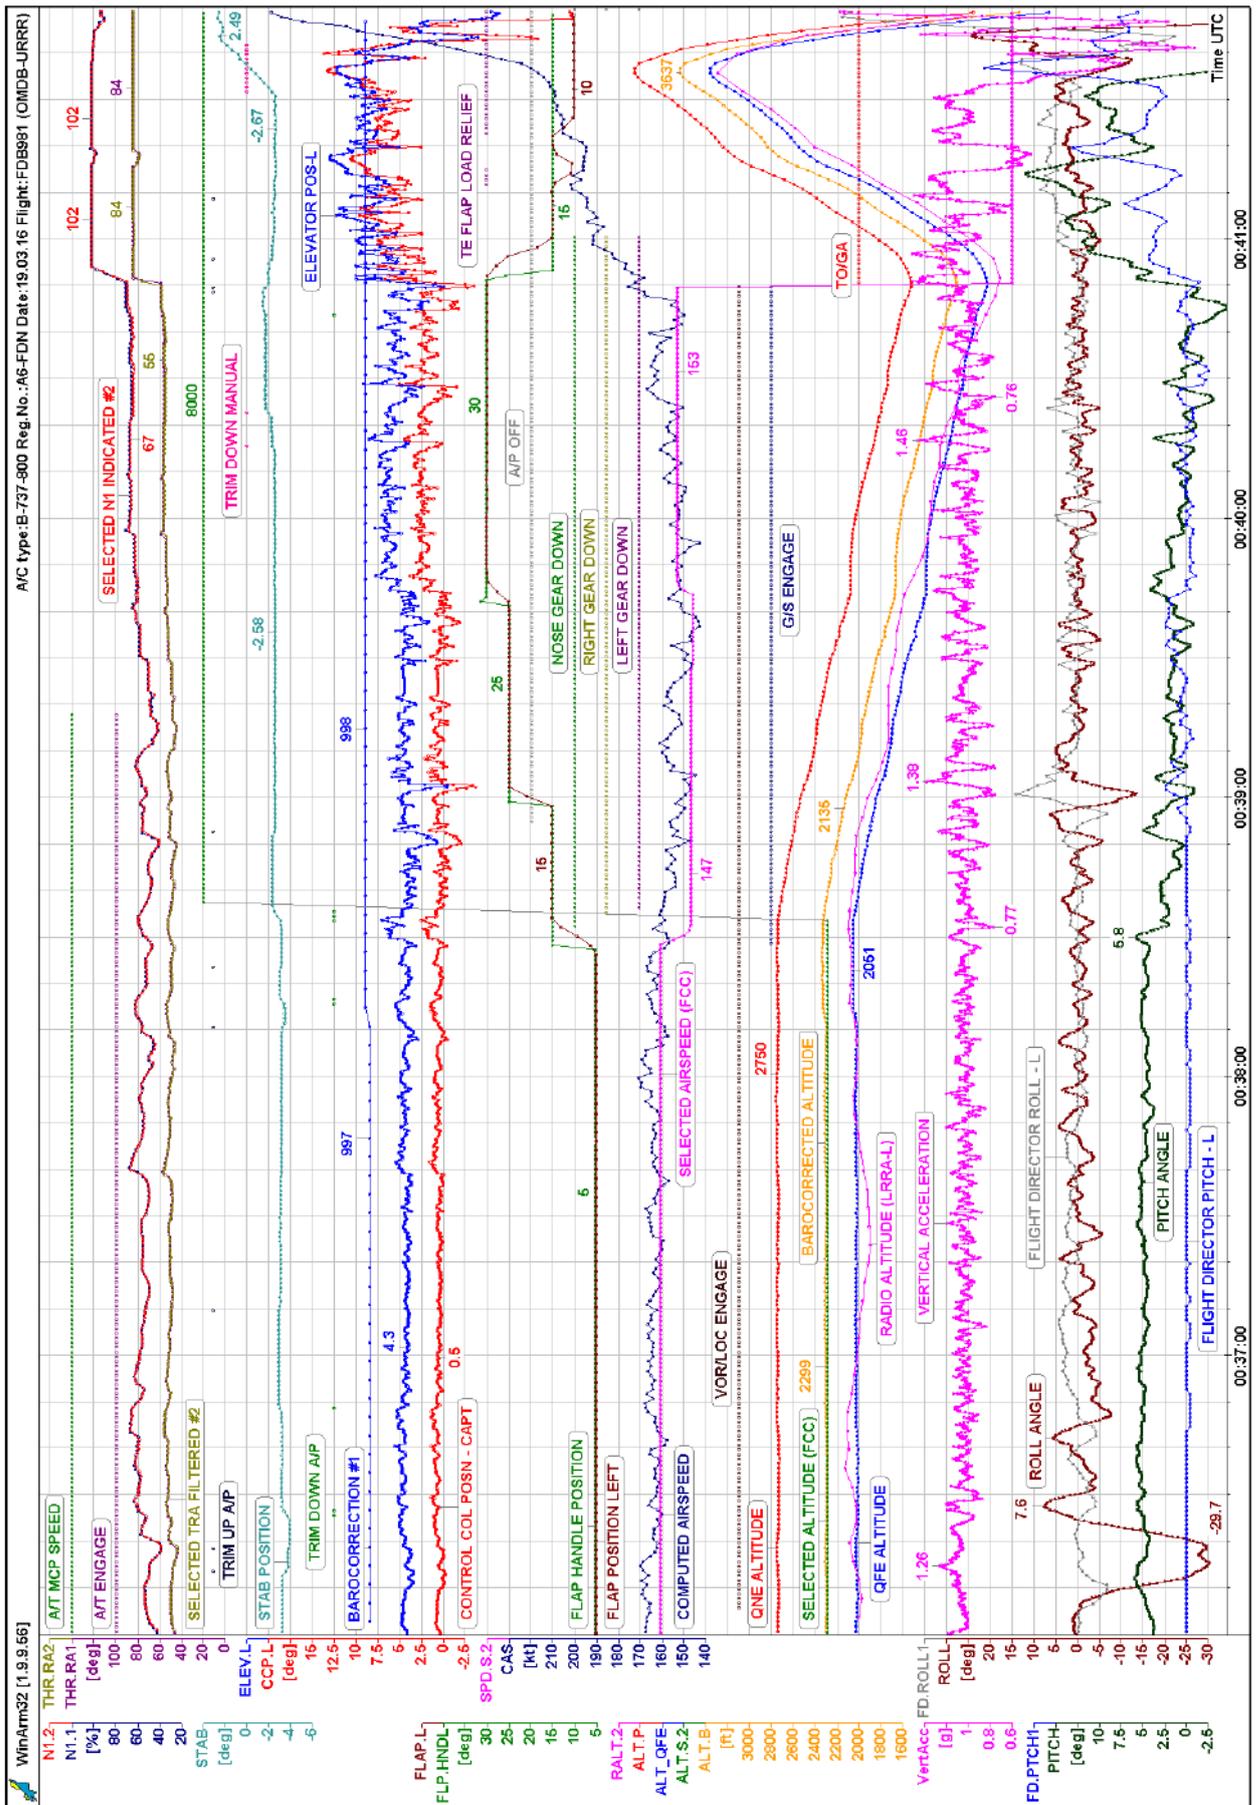
Fig. 62 presents the flight parameters at the second approach. On the plot the parameter “relative altitude (adjusted for baro correction)” stands for QNH altitude.

Fig. 62. The flight parameters at the second approach

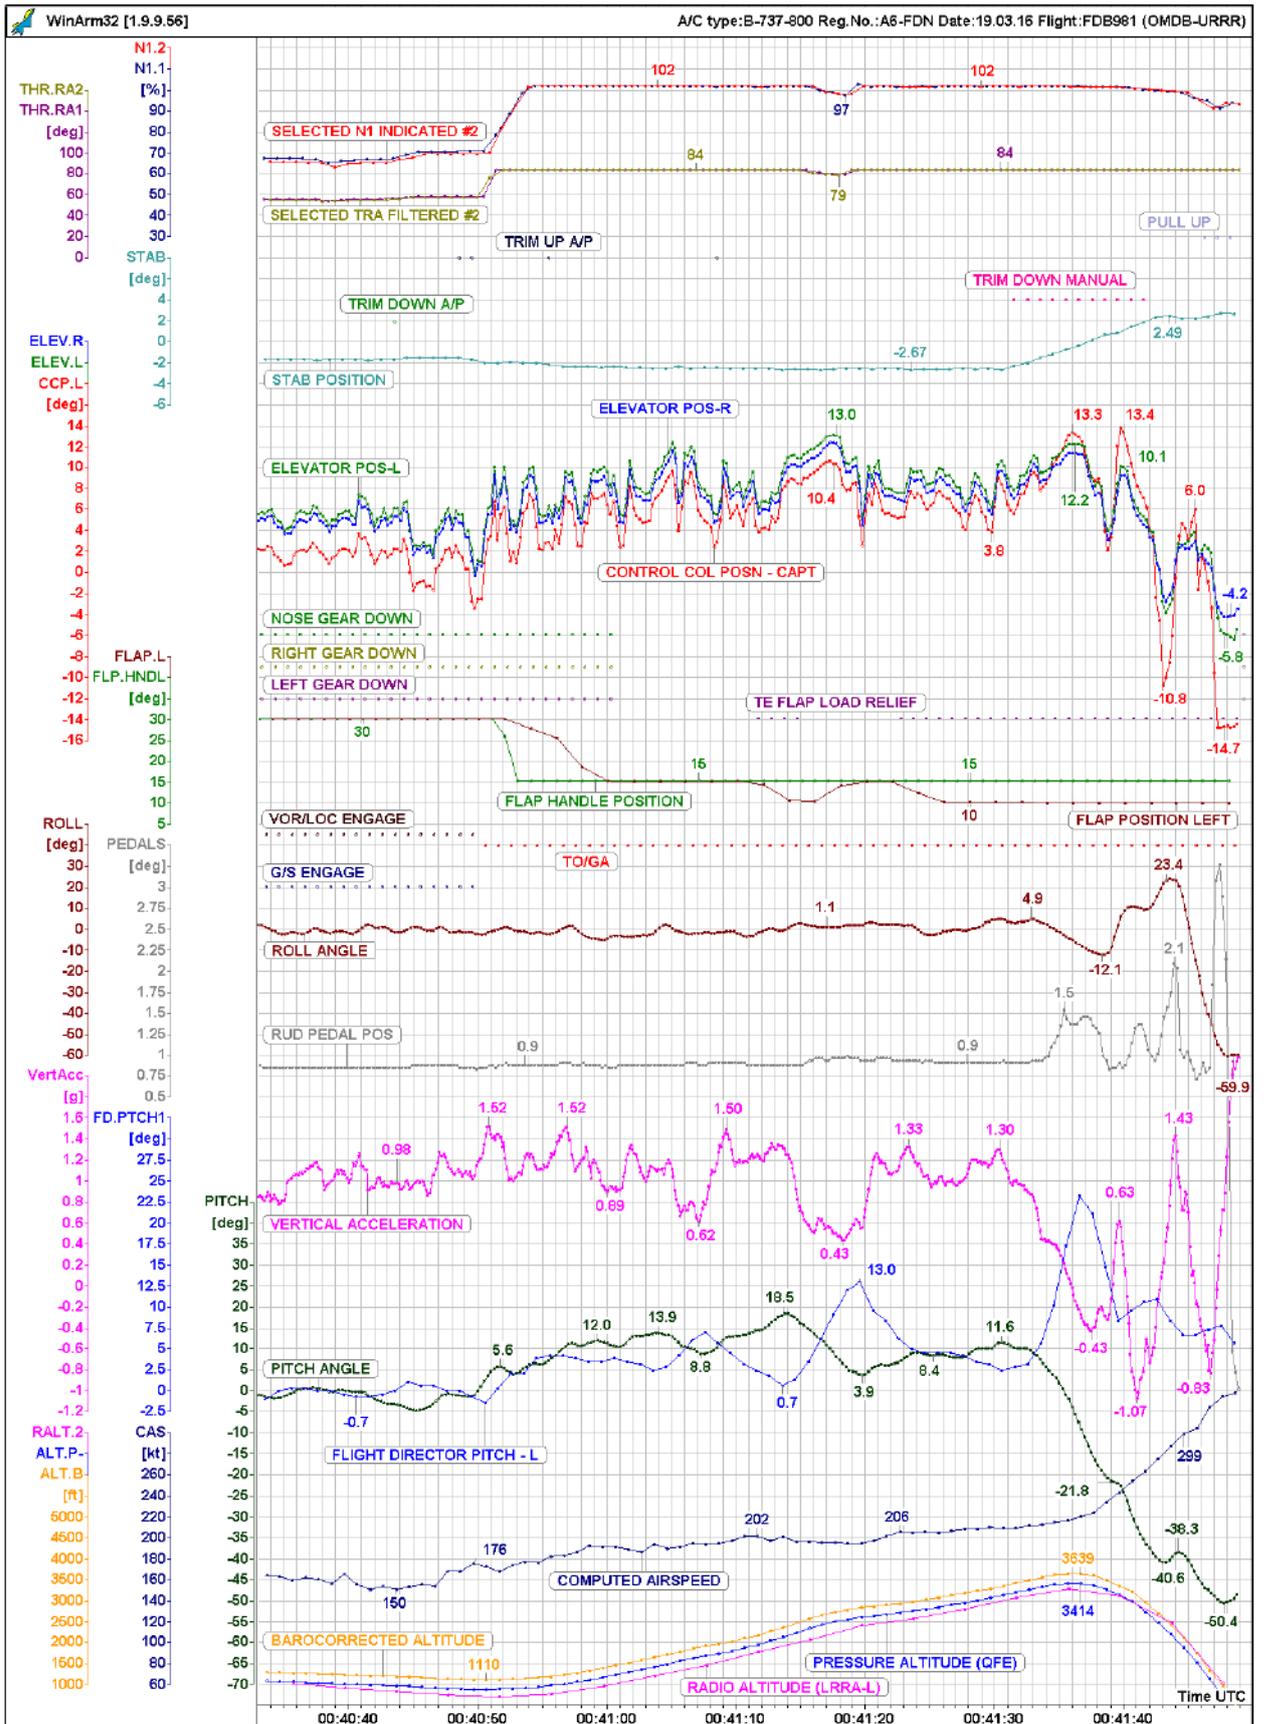
At 00:40:50 the TO/GA mode was activated with the power levers advanced to full thrust. The flight parameters at the go-around are given on Fig. 63.

Fig. 63. The flight parameters at the second go-around

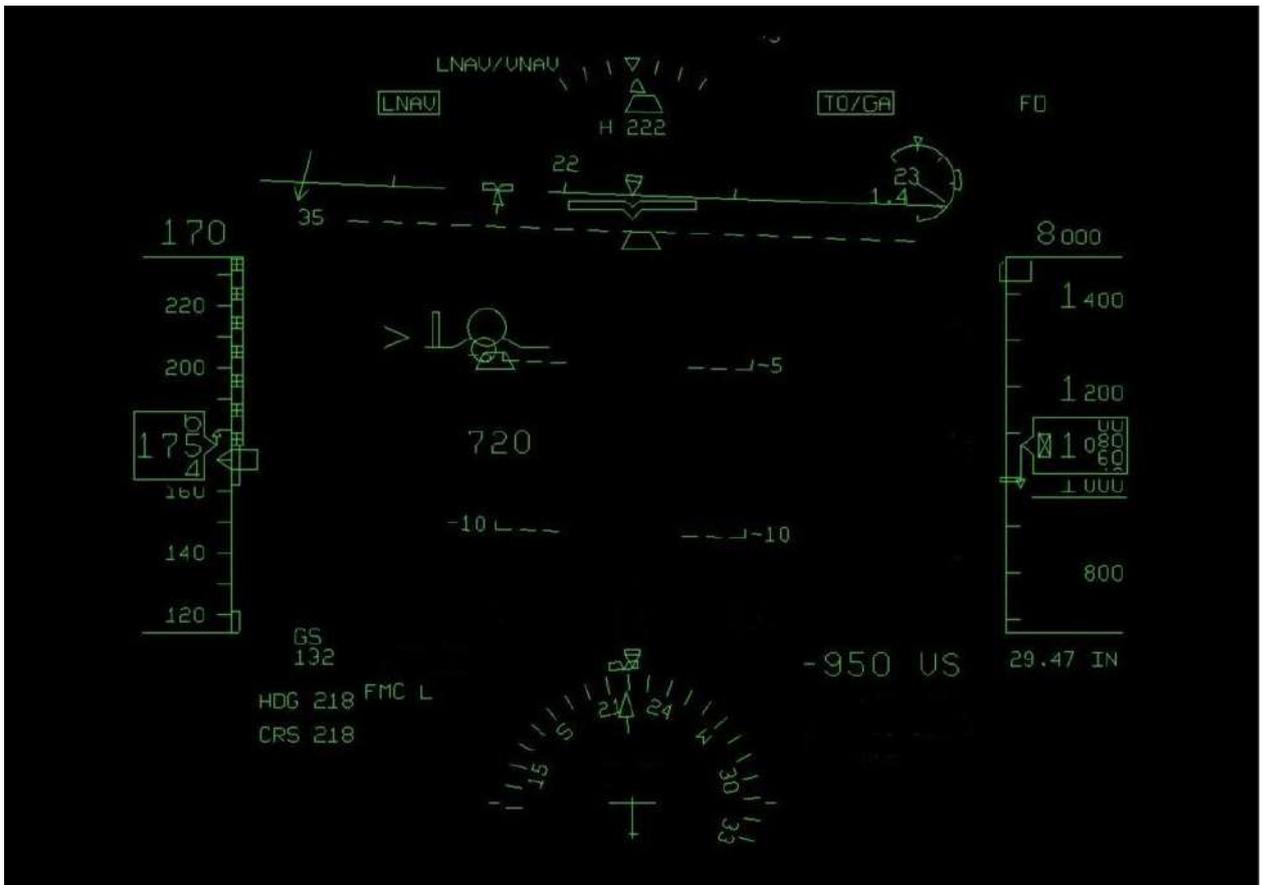
**Fig. 64. The HUD reconstructed image at the point of time of 00:40:50 (the TO/GA mode activation)**

At the point of go-around initiation the altitude was equal to 1100 ft QNH (250 m QFE) with the speed of 173...175 kt, that is it was consistent with  $V_{fe}$  for flaps  $30^\circ$ . As per the information available, it cannot be clearly established if the PIC perceived the abrupt increase of speed readings as one of the signs of the windshear encounter (according to QRH D6-27370-8KN-JXB page MAN.1.9, the IAS alteration for 15 kt at the altitude of less than 1000 ft is applicable to “unacceptable flight path deviations”, which in their turn are one of the signs of the windshear encounter), or as the ordinary sign of an unstabilized approach. It may be assumed that in advancing thrust levers to full thrust the PIC (“in his mind”) initiated, similar to the first go-around, the Windshear Escape Maneuver. Particularly given that, if the PIC perceived the speed leap in question as associated with the windshear encounter, this very maneuver is directly (without an alternative) prescribed by QRH.

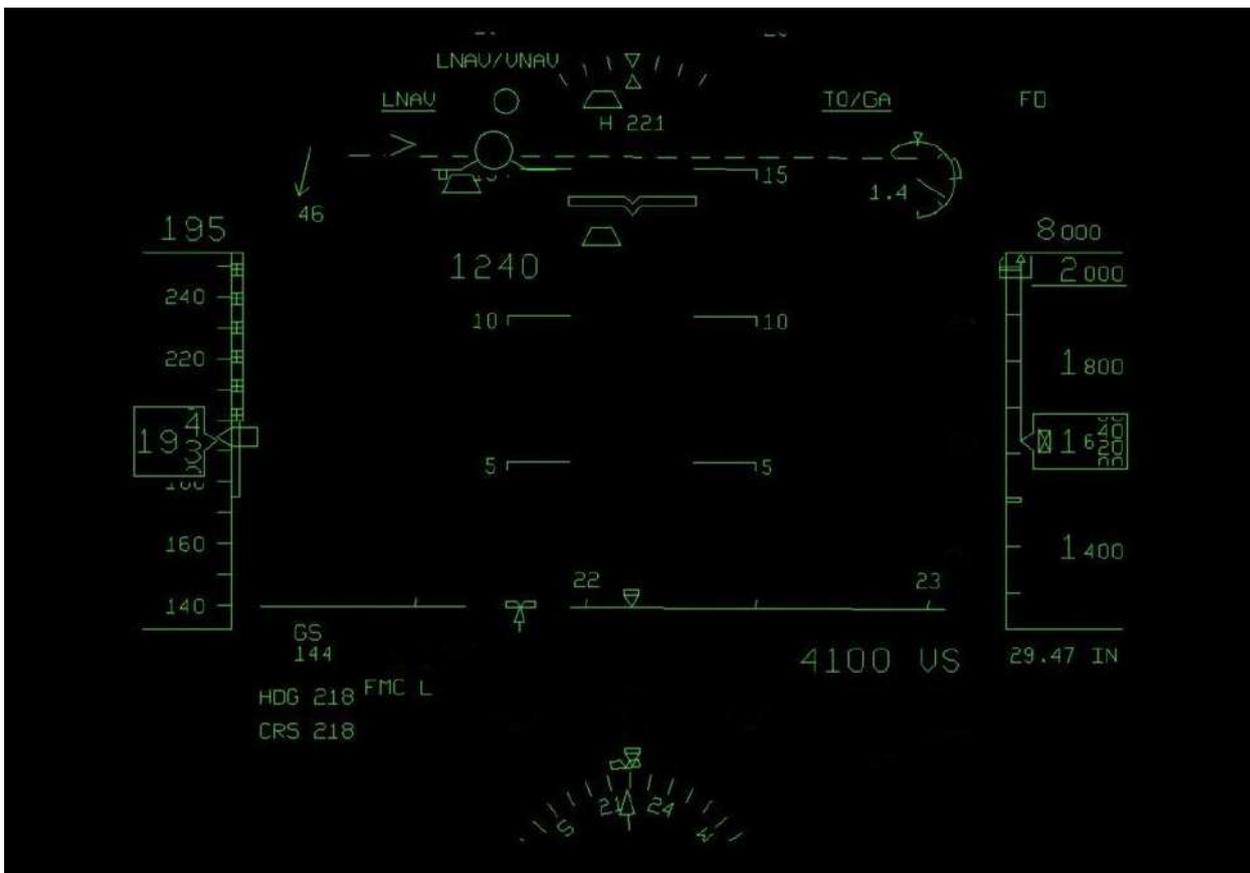
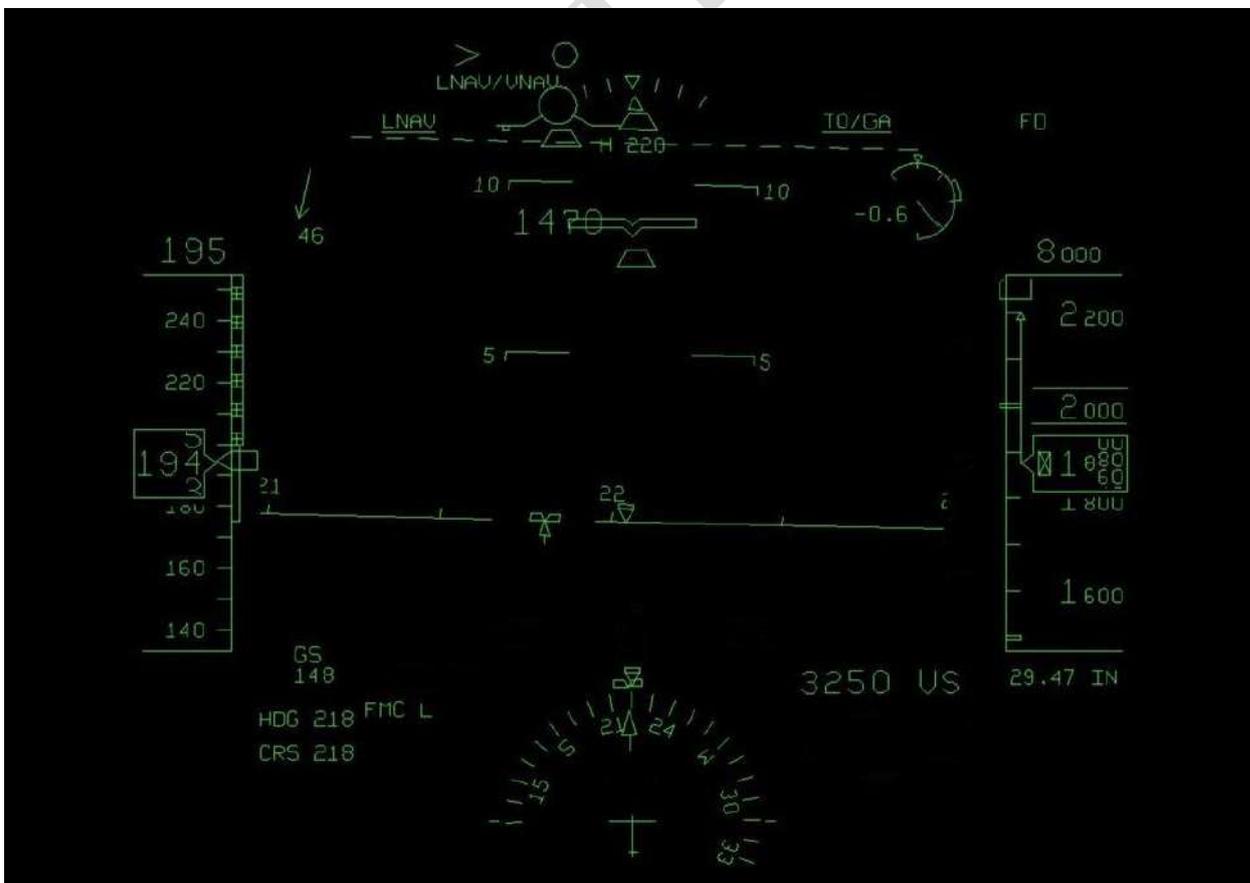
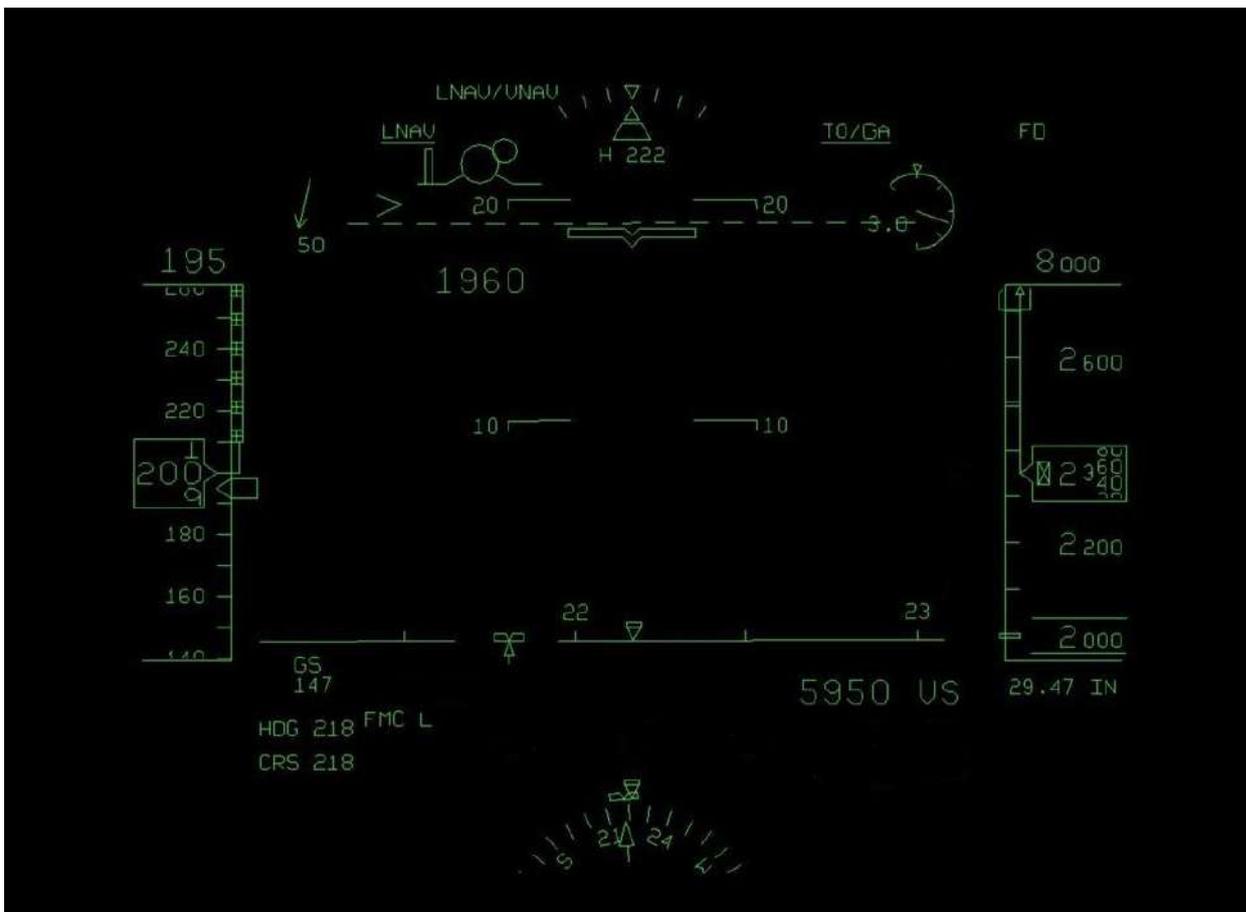
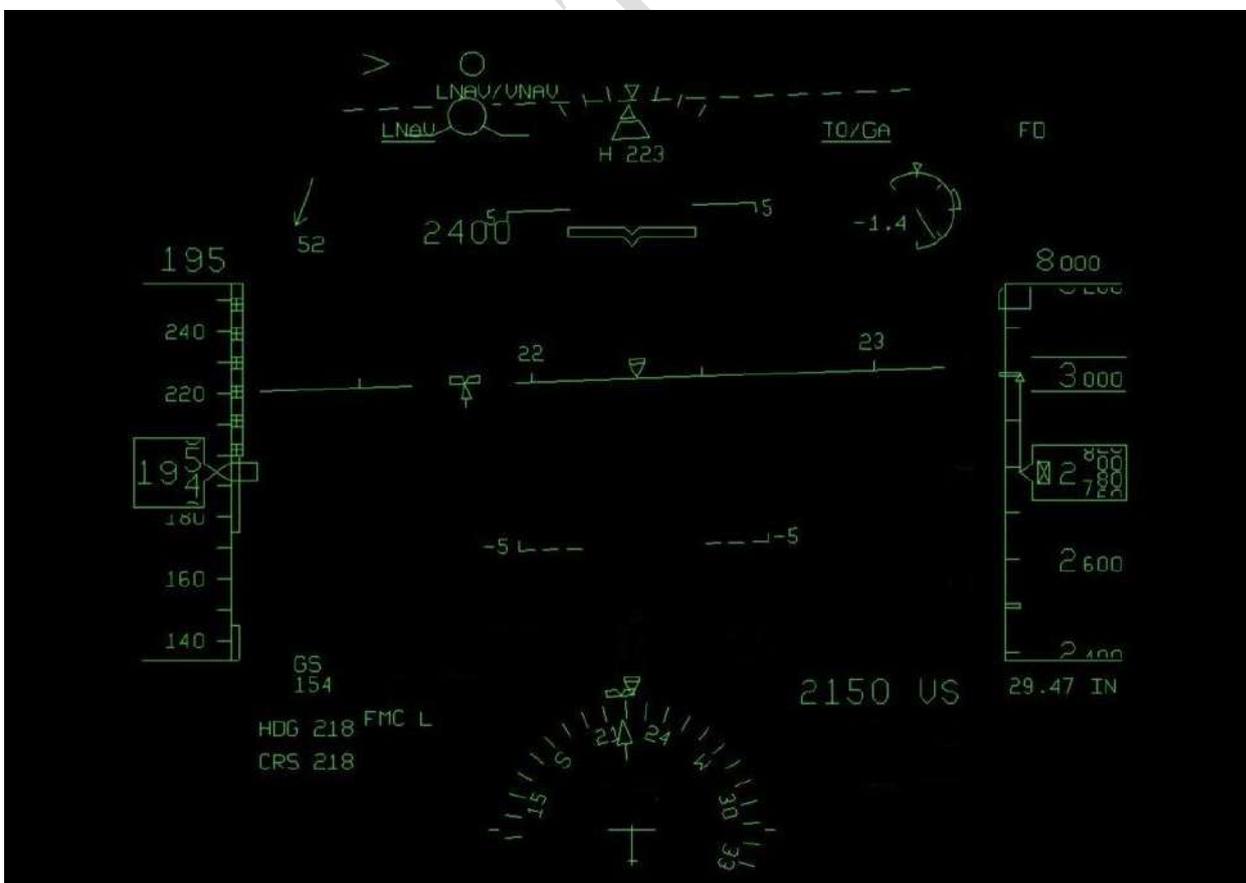
As the result all the further actions in the rapidly changing environment, that was evolving into non-standard (non-trained) situation, were of a belated character. The analysis of the angle of climb (pitch) value shows evidently that the PF (the PIC) had been never able to create the initial pitch of 15°, recommended by FCOM. The actual pitch was changing in steps (6°, 12°, 14°, 9°, 14°, 18.5°, 4°). As oppose to the first go-around, the PIC failed to maintain the climb path, set on by the pitch command bar, the position of which on PFD at the same points of time was equal to<sup>30</sup> (4°, 3.5°, 2.5°, 7°, 3°, 1°, 13°). The HUD reconstructed image as per the points of time 00:41:03 (the pitch local maximum 14°), 00:41:07 (the pitch command bar local maximum 7°), 00:41:13 (the maximum reached pitch 18.5°), 00:41:19 (the pitch command bar local maximum 13°) is given on the below figures (Fig. 65., Fig. 66, Fig. 67, Fig. 68).

Fig. 65. The HUD reconstructed image at the point of time of 00:41:03 (the pitch local maximum  $\approx 14^\circ$ )

Fig. 66. The HUD reconstructed image at the point of time of 00:41:07 (the pitch command bar local maximum  $\approx 7^\circ$ )

Fig. 67. The HUD reconstructed image at the point of time of 00:41:13 (the pitch local maximum  $\approx 18.5^\circ$ )

Fig. 68. The HUD reconstructed image at the point of time of 00:41:19 (the pitch command bar local maximum  $\approx 13^\circ$ )

The average pitch in climb was equal to about 10°, which was obviously insufficient for the given conditions, taking into account that:
