*This document is an English translation of the Final Report on the accident involving the Boeing 737-8KN aircraft registered A6-FDN that occurred on March 19, 2016 (00:42 UTC) at Rostov-on-Don aerodrome, the Rostov Region, Russian Federation.*

**INTERSTATE AVIATION COMMITTEE  
AIR ACCIDENT INVESTIGATION COMMISSION  
FINAL REPORT**

Type of occurrence	Fatal accident
Type of aircraft	Boeing 737-8KN, airplane
Nationality and registration marks	A6-FDN
Owner	Celestial Aviation Trading 38 Limited, Shannon, County Clare, Ireland
Operator	Dubai Aviation Corporation, P.O. Box: 353, United Arab Emirates
Aviation authority of the place of occurrence	Southern FATA Interregional Territorial Department
Place of occurrence	Russian Federation, the Rostov region, the Rostov-on-Don aerodrome, reference position: 47°15'54.7" N, 039°49'43.8" E
Date and time	19.03.2016, 03:42 local time (00:42 UTC), nighttime

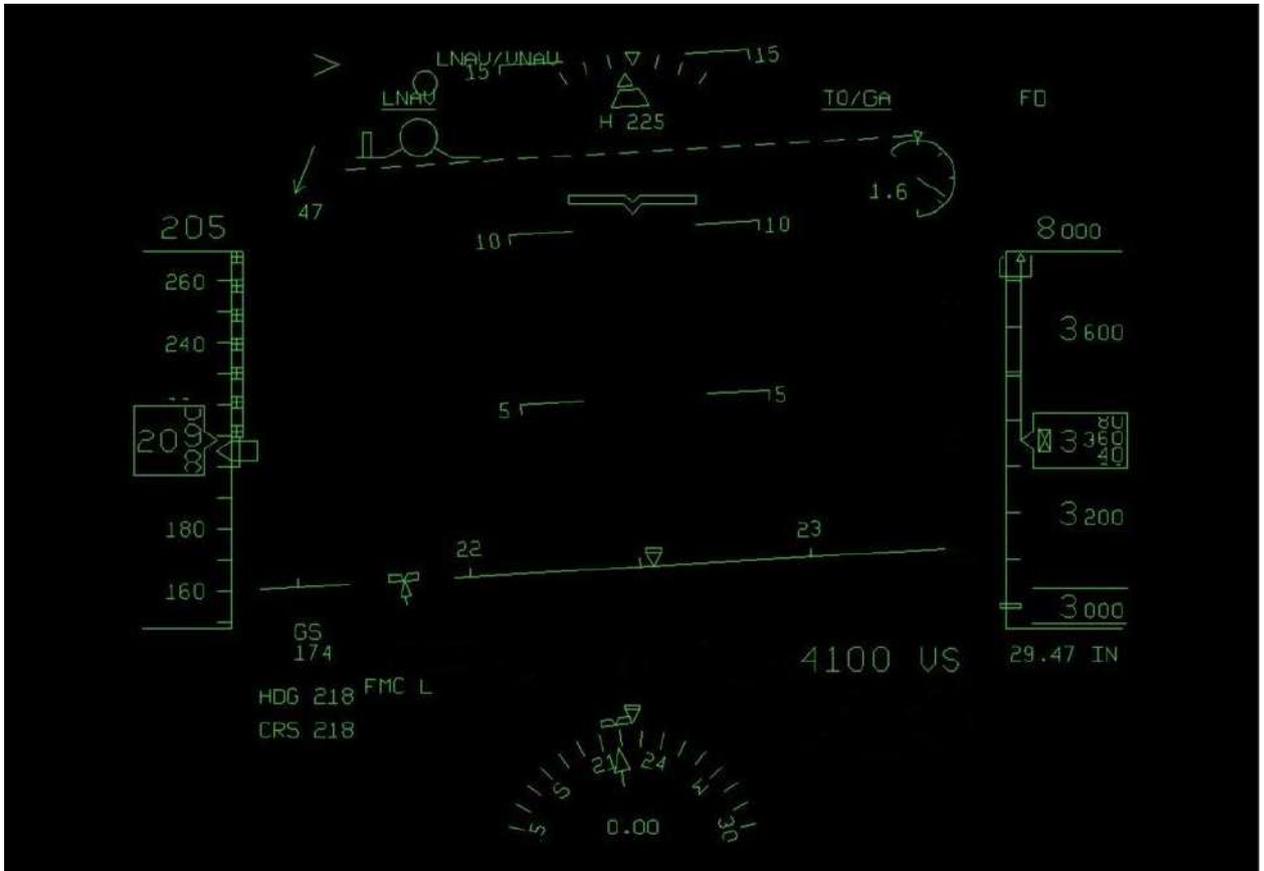
The onset of the critical situation started at 00:41:30.5. In proceeding the piloting of the out of trim aircraft (unbalanced on forces), and obviously enduring inconvenience; at the present parameters of flight: H  $\approx$  3350 ft QNH (935 m QFE), IAS – 210 kt, pitch –  $10^\circ$  to nose-up, the stabilizer setting –  $2.7^\circ$  to nose-up, flaps  $10^\circ$ , the power mode of the engines – the maximum thrust, the PIC pressed the stabilizer trim switches to nose-down. Fig. 69 presents the HUD reconstructed image at that point of time.

Fig. 69. The HUD reconstructed image at the point of time of 00:41:30.5 (the initiation of the stabilizer trim to nose-down)

The figure is the evidence that the system “commanded” the pitch increase (the dashed line – TO/GA pitch target line – is higher than the aircraft reference symbol). In other words, most probably the PIC, having acted in such a manner, tried “to relieve” the pushing forces on the control column, rather than to transition the aircraft to nose down. However, along the stabilizer trim, the pilot did not return the control column to neutral position, with that the stabilizer trim switch remained pressed for an abnormally long time (12 s!!!).

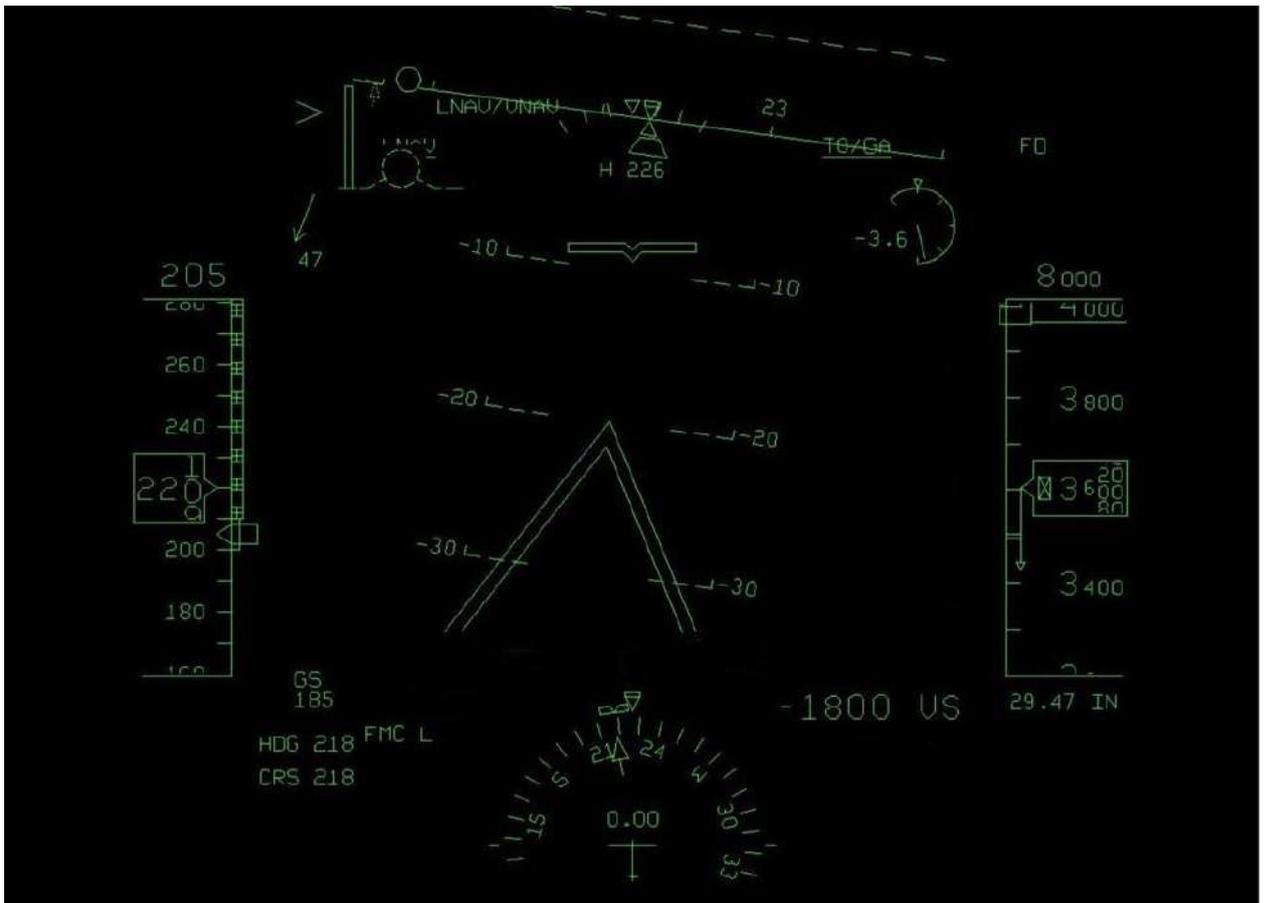
Fig. 70. The HUD reconstructed image at the point of time of 00:41:36

At Fig. 70, at the actual nose-down pitch of about  $10^\circ$ , the upward pointing Pitch Chevron is displayed on HUD (the direction of the aircraft recovery to the “regular” flight) with the top point at the pitch value of  $20^\circ$  nose-down, at the same time the HUD is still operated at the PRI mode. The Pitch Chevron appears when the HUD is switched to the compressed mode. The Pitch Scale is compressed, when the aircraft attitude is such that the Horizon Line or the Flight Path Symbol cannot be displayed conformably. In the compressed mode, the increment of the pitch scale is doubled, from  $5^\circ$  to  $10^\circ$ . The figure is the evidence that in this mode the proportion between the position of Guidance Cue and Flight Path Symbol, the target and actual pitch symbols is no longer respected. At that the Flight Path Symbol is displayed in dashed line – becomes “ghosted” (the term, used in the HUD Pilot Guide) – this means it is no longer conformal with the real world, though being in a qualitatively correct position against the Guidance Cue.

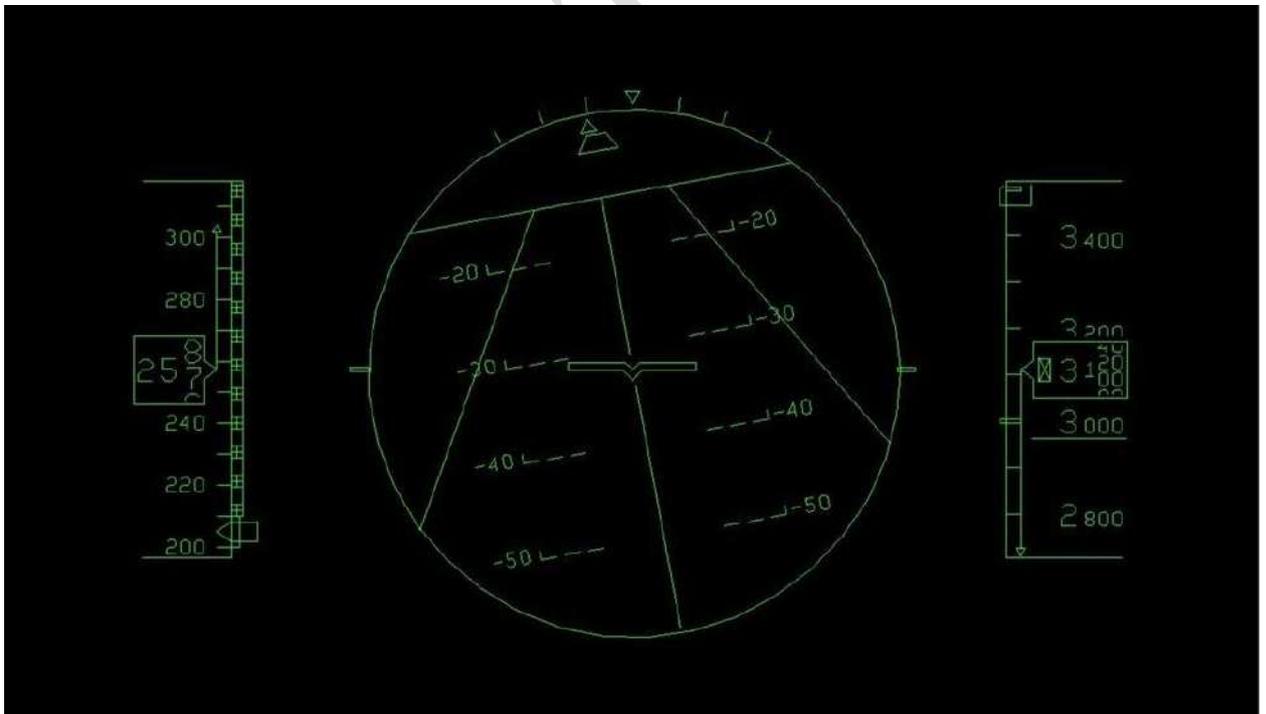
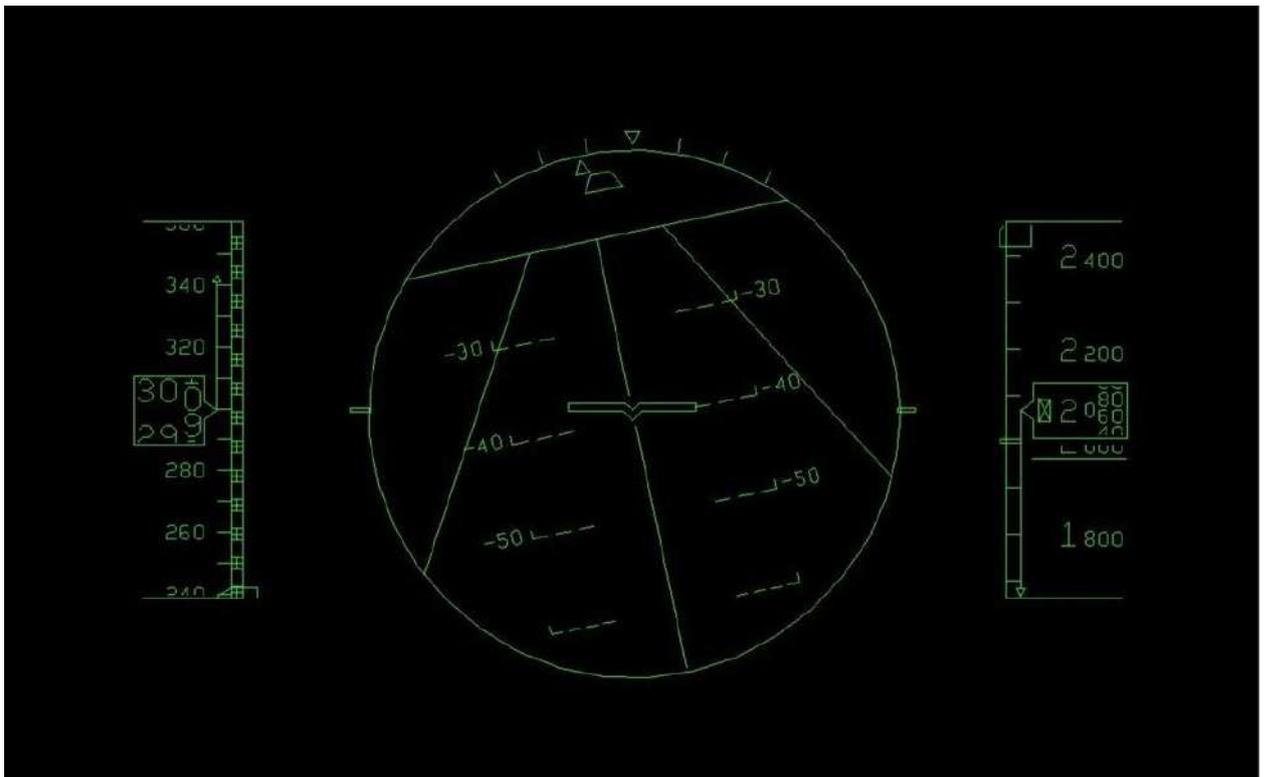
Fig. 71. The HUD reconstructed image at the point of time of 00:41:40

**Fig. 72. The HUD reconstructed image at the point of time of 00:41:43**

Fig. 71 and Fig. 72 represent the HUD reconstructed images at the points of time, coherent with the maximum reached negative G (-1.07) and the moment of the F/O's interference into the control. It is apparent that HUD switched to the display mode, corresponding to upset. The HUD is switched to this mode, when the nose-down pitch exceeds 20°. According to the HGS Pilot Guide, this mode enhances interpretation of an unusual attitude by the pilot. All the “redundant” information is retracted out from the HUD screen. These are only altitude and IAS scales, pitch and roll together with the slip indicator that are displayed.

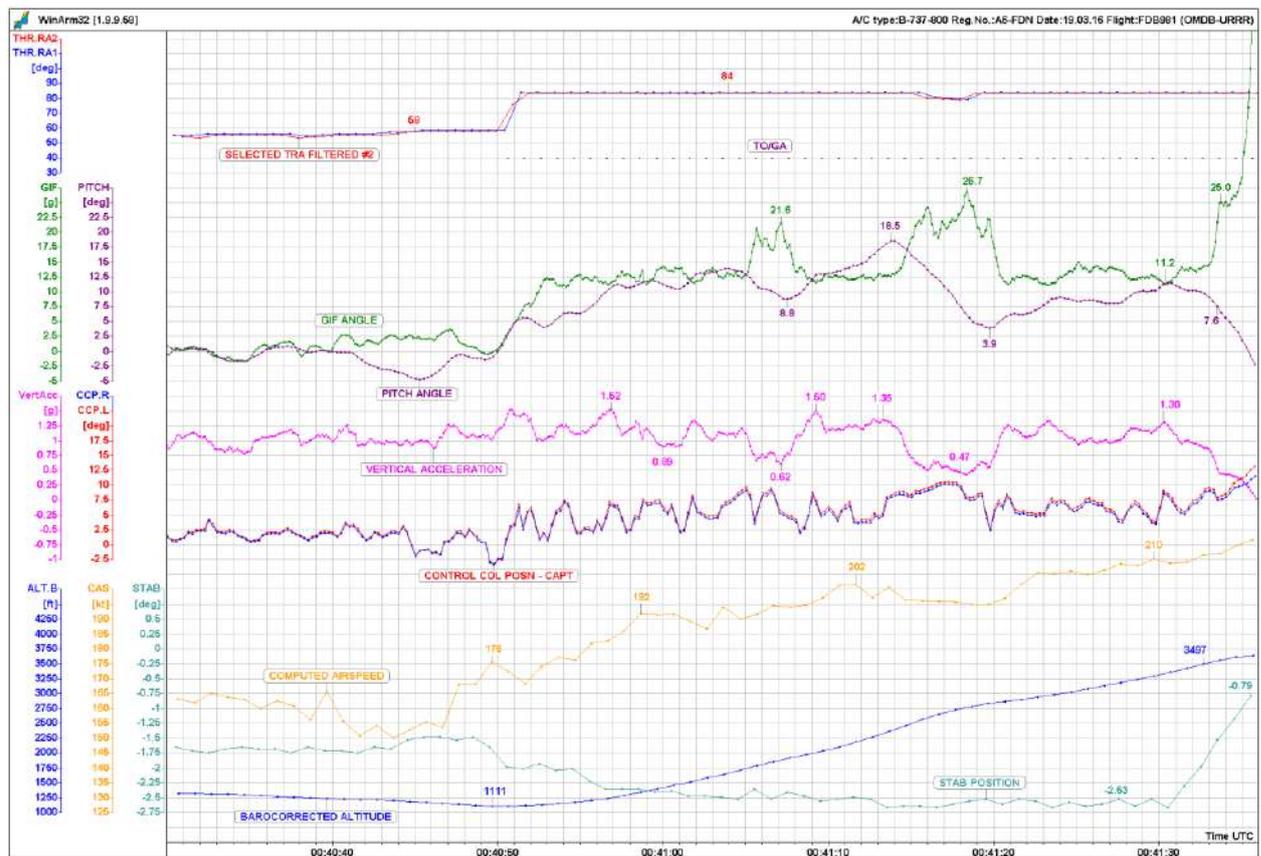
The results of the calculations by formula are given on Fig. 73. The plot is the evidence that within time intervals of 00:40:52–00:40:56, 00:41:05–00:41:09, 00:41:14–00:41:23 and from 00:41:33 up to the end of the flight there are substantial differences in the values of the recorded pitch and GIF angle, with that the GIF angle is greater, that means that there are prerequisites for the occurrence of the “pitch-up” illusion.

Fig. 73. The estimated GIF angle
