## **FINAL ACCIDENT REPORT**

**Airbus A320**  
**SATA INTERNACIONAL**

**CS-TKO**

**REPORT Nr 33/ACCID/2009**

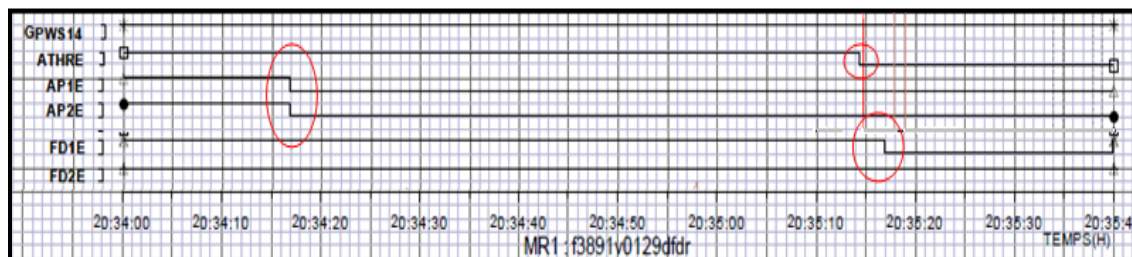
Pic. 13 – A/THR, AP 1 & 2, FD 1 & 2. Red circles show each one disengage moment.

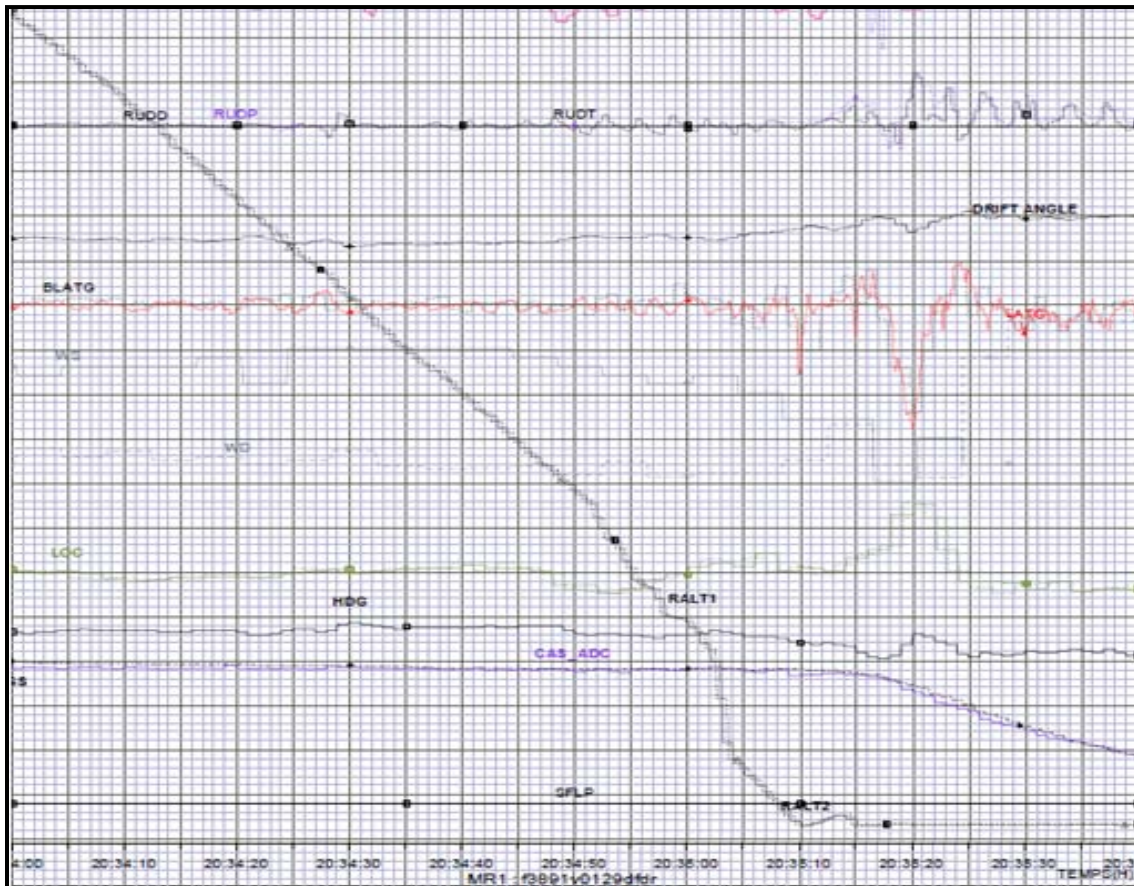
Pic 14 – No Glide Slope or Localizer deviation; speed maintained 141kt until touchdown.

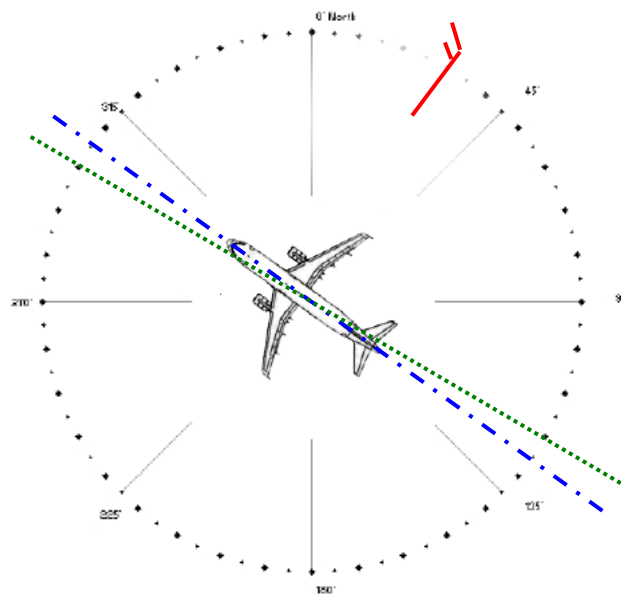
On final, the aircraft experienced right wind of 13kt speed, from 030 degrees (in **red** in the picture). Aircraft heading was 306 degrees (in **blue** in the same diagram); the rwy 30 QFU (301 degrees) is represented in **green**:

Pic. 29– Diagram: CS-TKO heading (in **blue**), wind vector (in **red**) and RWY 30 QFU (in **green**).

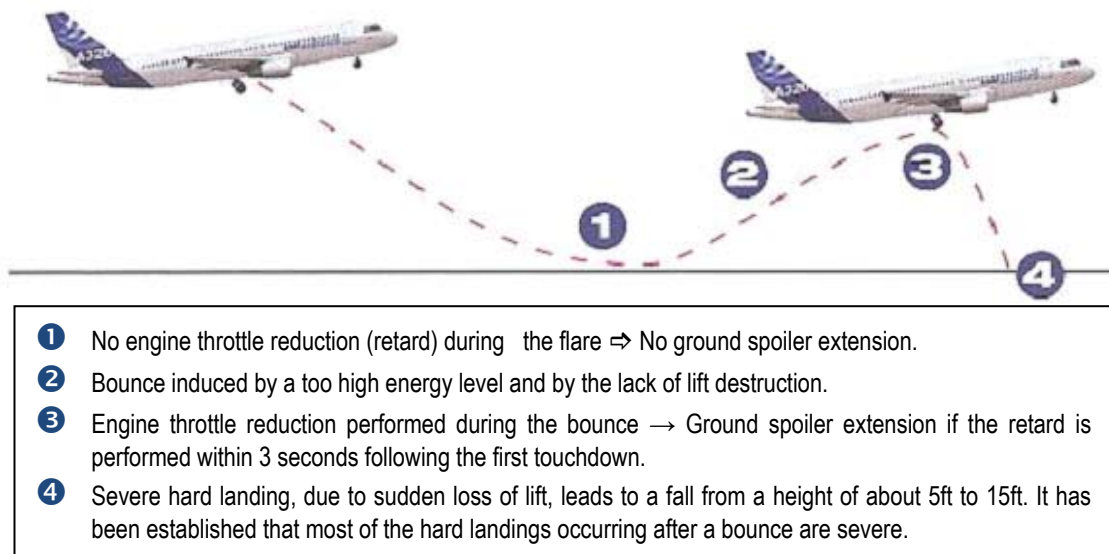
Pic. 33

In this case an untimely extension of ground spoilers, due inappropriate thrust levers selection, caused the ground spoilers deployment, with the aircraft in the air, with consequent hard landing (*Pic. 33 – retrieved from Airbus Safety Magazine, issue 9 / Feb 2010*).
