Runway overrun Onur Air

Runway overrun after rejected take-off of
the Onur Air MD-88, registration TC-ONP, at
Groningen Airport Eelde on 17 June 2003

The Hague, 6 April 2006 (investigation number 2003071)

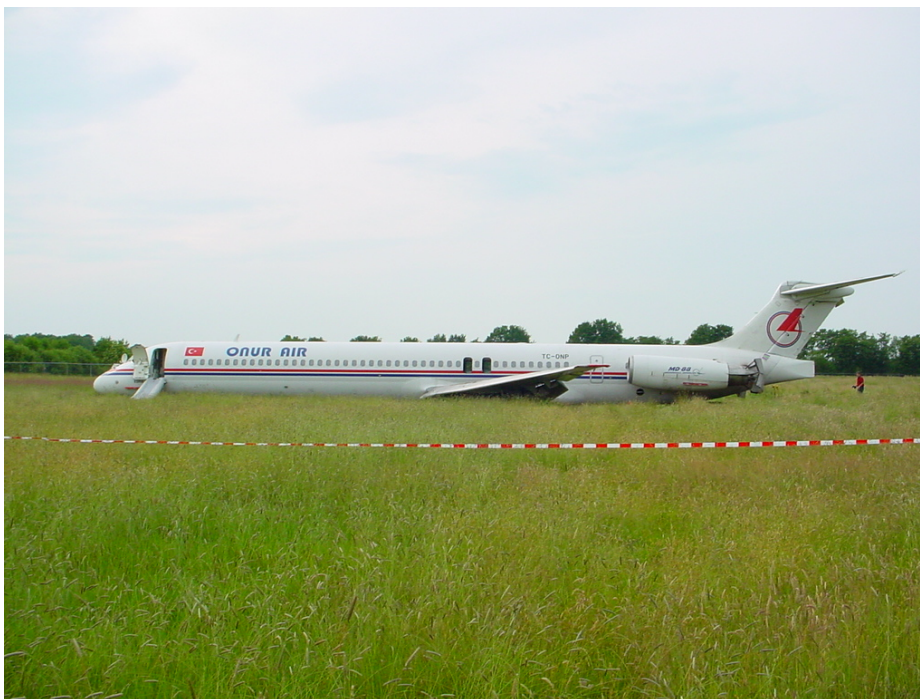
Both pilots stated that during rejection brakes and reversed engine thrust had been applied, which is confirmed by the FDR readout. The aircraft overran the runway end with a speed of approximately 75 knots. During the deceleration in the soft soil, it hit the approach lighting system, including the concrete structures embedded in the ground. It came to a stop approximately 100 meters beyond the runway end. There was no fire. All occupants evacuated the aircraft safely. Some of them returned to the aircraft and re-entered it, to pick up their belongings. In addition, the pilots remained on board and only left the aircraft when instructed to do so by the fire brigade.

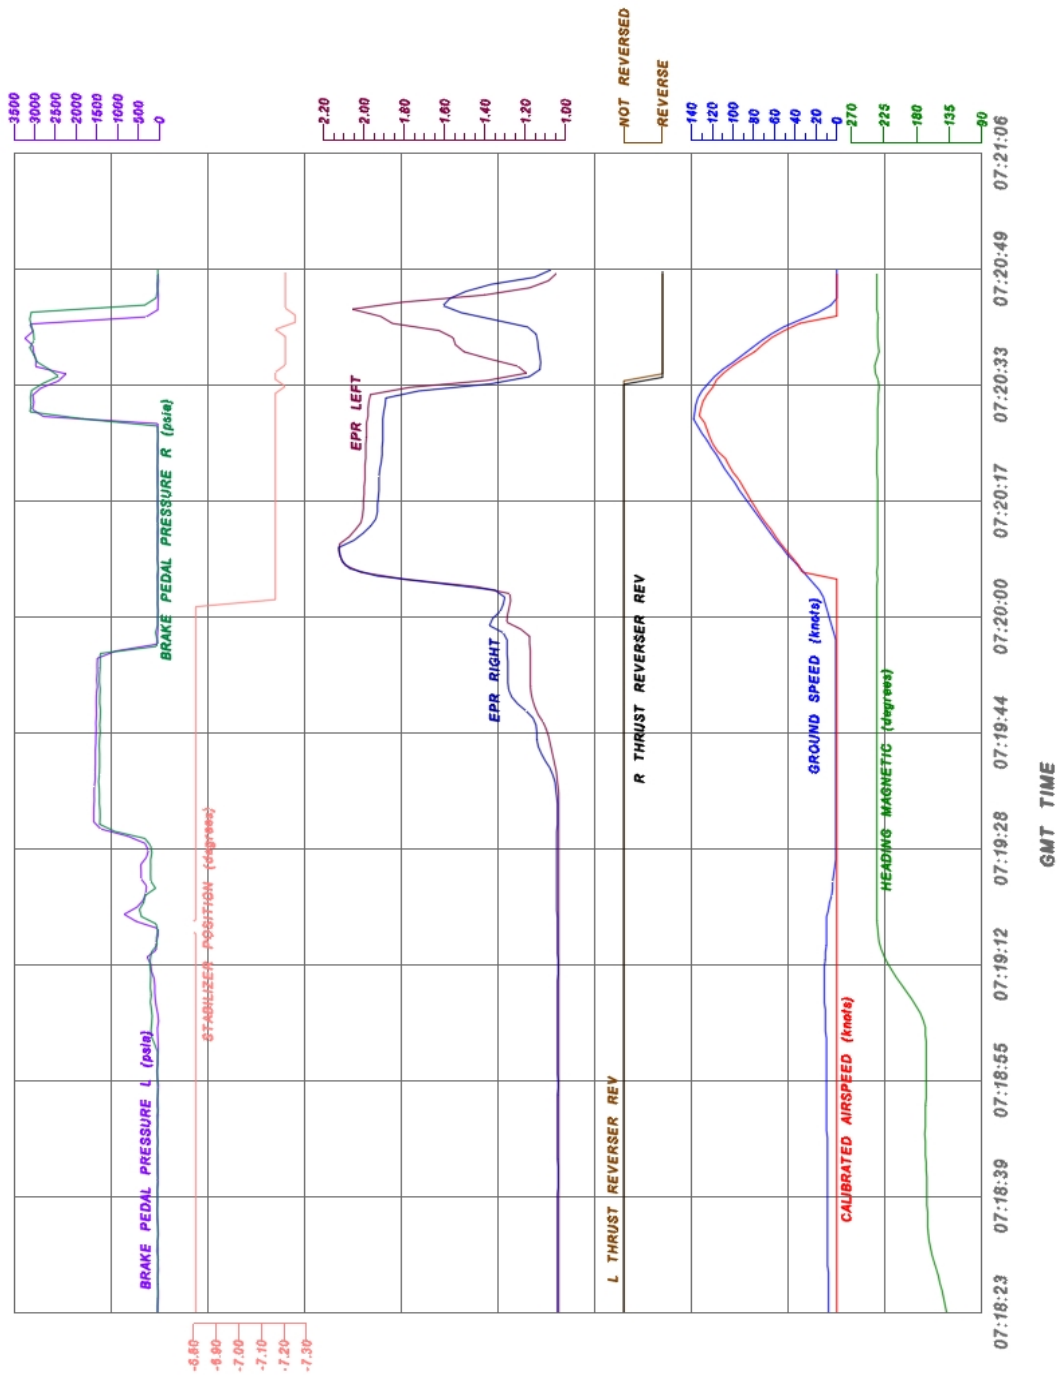
FDR data plot

On the runway checks were performed. FDR data indicated a stabilizer position change from 6.8 to 7.2 degrees aircraft nose up (ANU). Thereafter the crew initiated a static engine spin-up. Again the stabilizer warning sounded. The crew released the brakes and started the take-off roll. From the CVR it is derived that during the entire take-off roll the warning sounded continuously.

When attempting to rotate the captain experienced a heavy elevator control force. The captain stated that he needed much more than normal back pressure on his control column to lift the nose. He felt "it was impossible to make the take-off", and as the nose did not rise he decided to reject the take-off. Post accident analysis revealed that the rejection was initiated at 128 knots.
