Investigation report

L2012-08

Airliner Veering Off the Runway during the Landing Roll at Helsinki-Vantaa Airport on 19 August 2012

OH-ATH

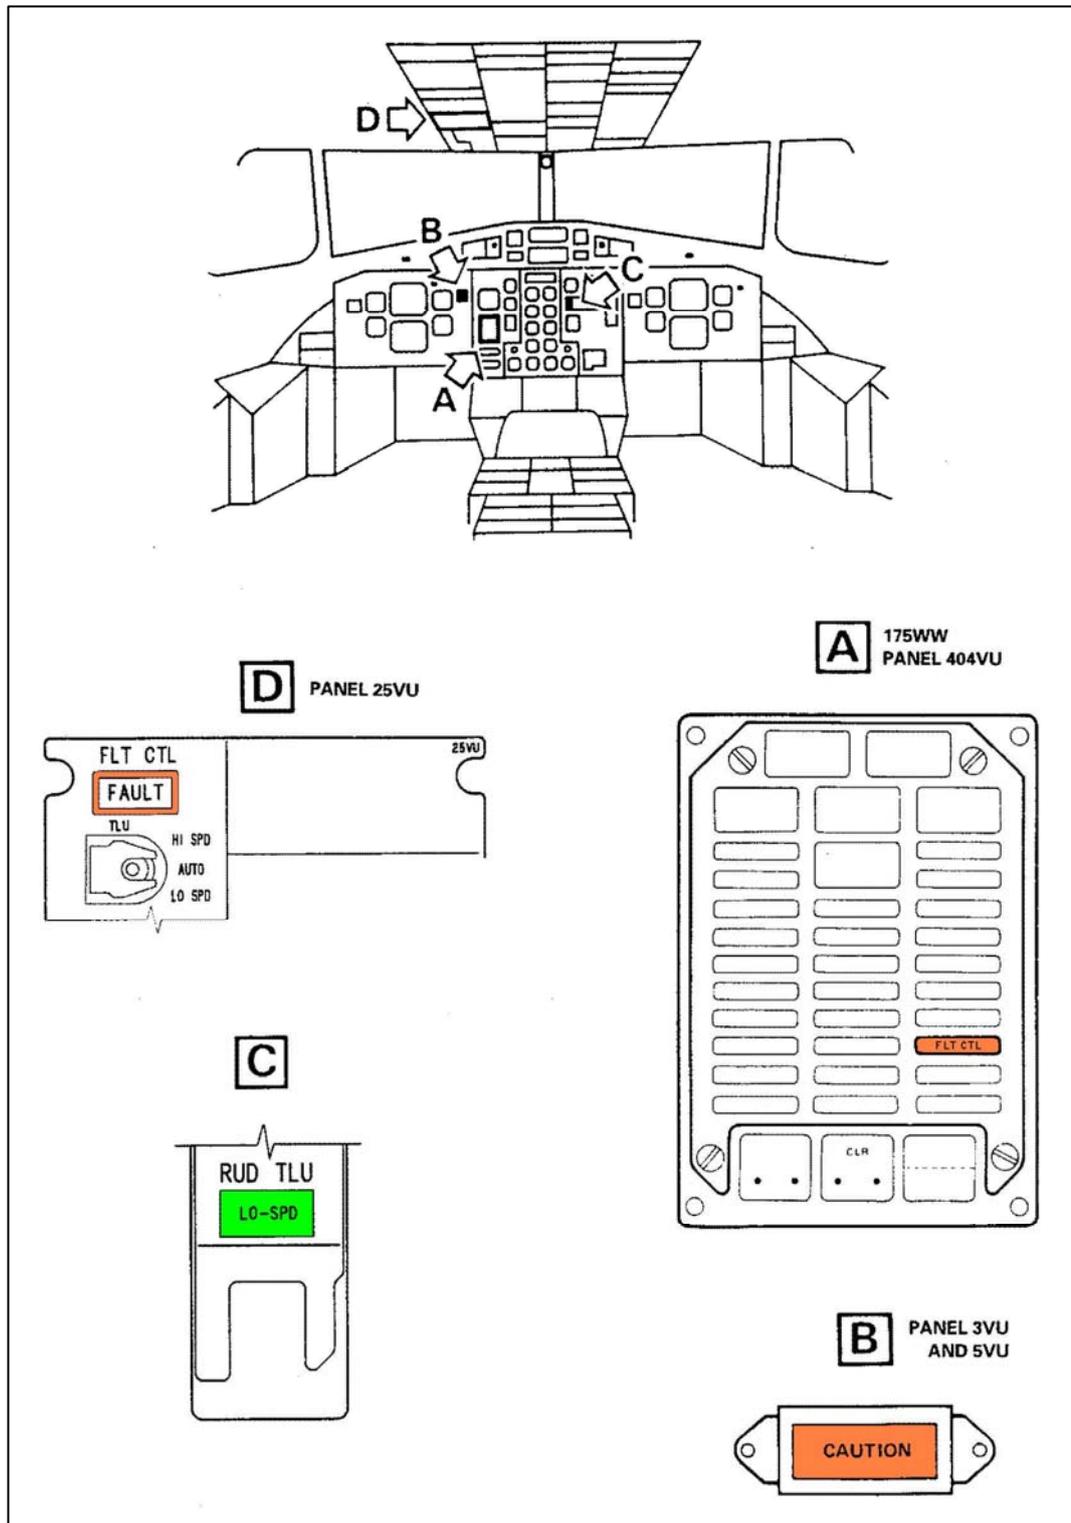
Figure 6. The TLU's caution lights, switch and displays in the cockpit. (Source: ATR)

In case of a TLU fault there are caution lights, displays and a switch in the cockpit for the purpose of establishing the situation and to switch on the TLU's standby system (Figure 6, The TLU's caution lights, switch and displays in the cockpit). When the TLU's automatic functioning fails, two CAUTION lights [B] illuminates and an aural alarm sounds. In addition, in conjunction with the fault, the FLT CTL (Flight Controls) warning light [A] is illuminated on the crew alerting panel and the FAULT light [D] illuminates in the upper panel next to the TLU switch.

When the automatic functioning of the TLU fails it is possible to manually [D] set the rudder's mechanical travel limiter either to the low speed (LO SPD) mode, which permits full travel, or the high (HI SPD) speed mode, which limits rudder travel to ± 4 degrees.
