NATIONAL COMMISSION OF INQUIRY

REPORT

on the accident
on 6 March 2003
at Tamanrasset
to the Boeing 737-200
registered 7T-VEZ
operated by Air Algérie

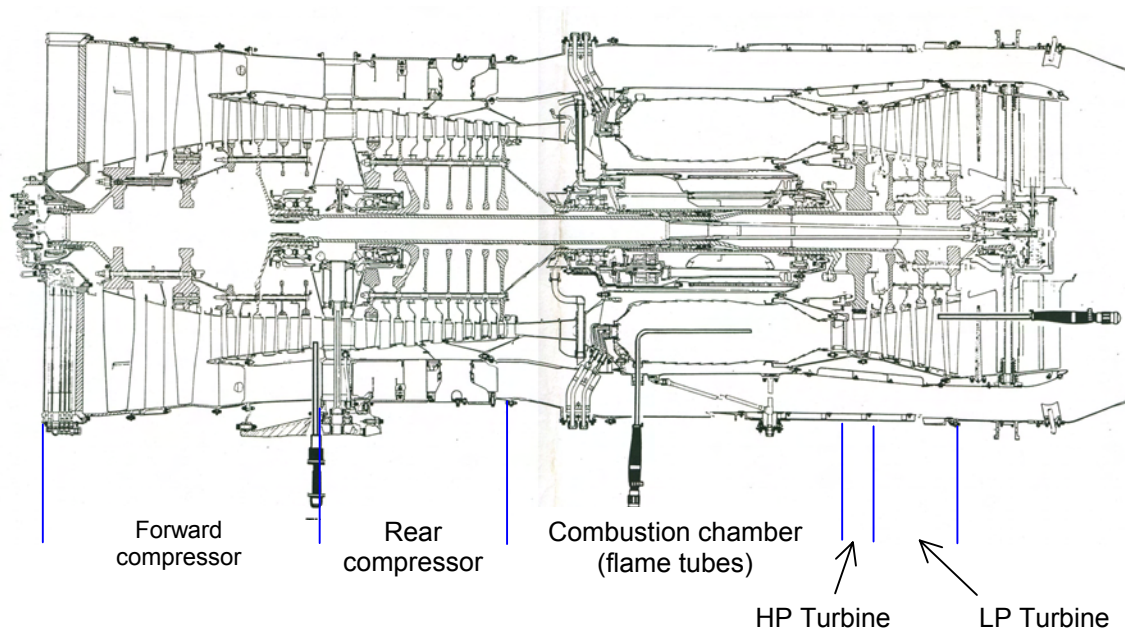
Diagram of the JT8D jet

The damage observed resulted from the impact and there was no indication of engine rotation or traces of foreign body ingestion.

The body of the regulator was destroyed on impact; it was broken and separated into three parts, with separation of the two main units along the joints. The largest part lost its covers. The different internal mechanisms made it impossible to determine selected thrust.

The nine injectors were clean and in good condition. Their output sections are geometrically correct, with no traces of burning or partial obstruction by possible foreign bodies. Their primary and secondary supply conduits showed no blockages.
