# Report

Accident on **9 August 2007**  
off **the coast of Moorea (French Polynesia)**  
to the **DHC6-300**  
registered **F-OIQI**  
operated by **Air Moorea**

Bureau d'Enquêtes et d'Analyses  
pour la sécurité de l'aviation civile

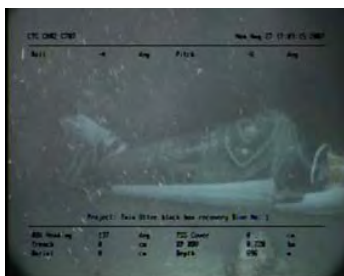
Rear part

The rear part of the aeroplane, from the baggage hold to the tail, was in one piece. It was resting on the complete left half fuselage (fixed and mobile parts). A part of the right half of the fuselage was ripped off.

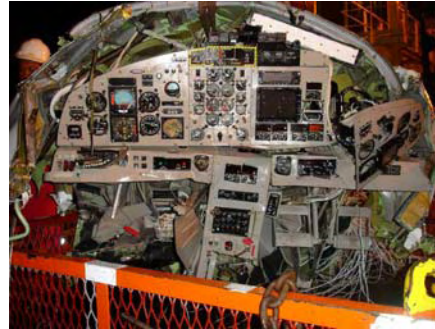
Raised instrument panel

- ☐ HSI and RMI: heading 120°
- ☐ Left and right VSI: - 3,000 ft/min
- ☐ Left gauge: 210 lb
- ☐ Right gauge: 190 lb
- ☐ Boost pump Aft and Fwd: ON
- ☐ Right air speed indicator: 100 kt
- ☐ Tank selectors: Aft and Fwd
- ☐ Autofeather pushbutton: pressed

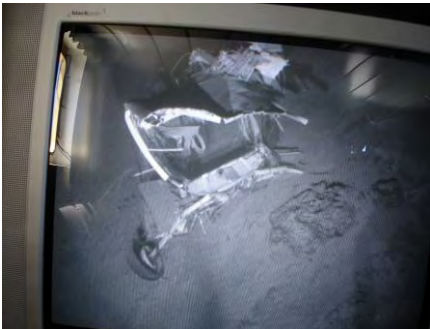
A part of the central fuselage (passenger cabin) with, underneath, the left landing gear, was found forty-five metres north-north-east of the rear part of the aeroplane, 670 metres deep. A detailed examination was made: no bodies were found, and there were no seats in the cabin.

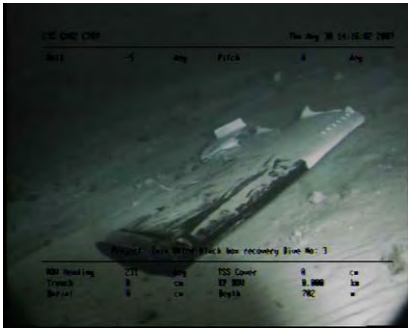
A part of right wing was found eleven metres southwest of the rear part of the aeroplane, 650 metres deep.

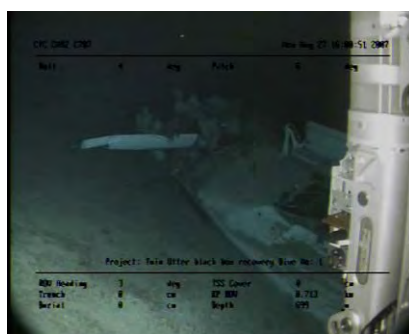
A part of left wing was found eleven metres to the south of the rear part of the aeroplane, 668 metres deep.

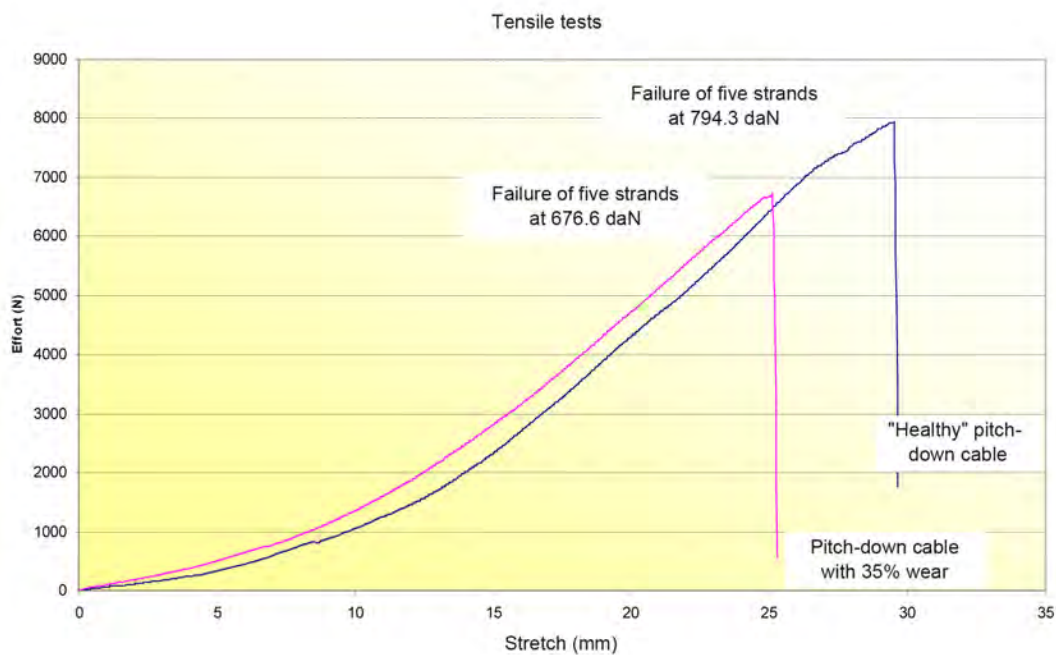
The second test was performed on the aft pitch-down control cable. The loads were centred on the zone located in line with the cable guide whose rate of wear was estimated at 35%.

Note: For safety reasons, the test stopped when the drop in the load detected by the machine was above 80%. In both cases, two outer strands remained unbroken after the test.

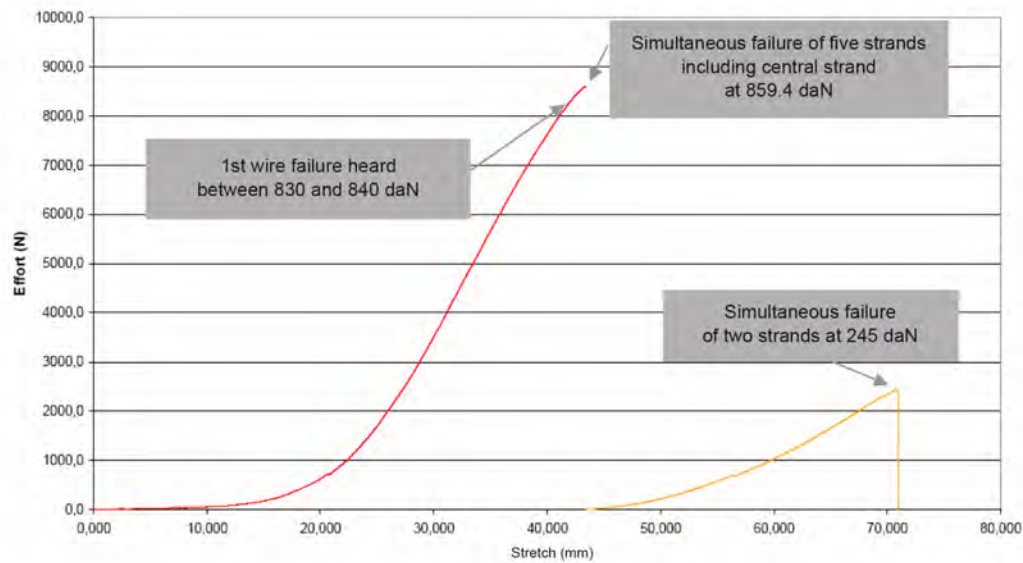
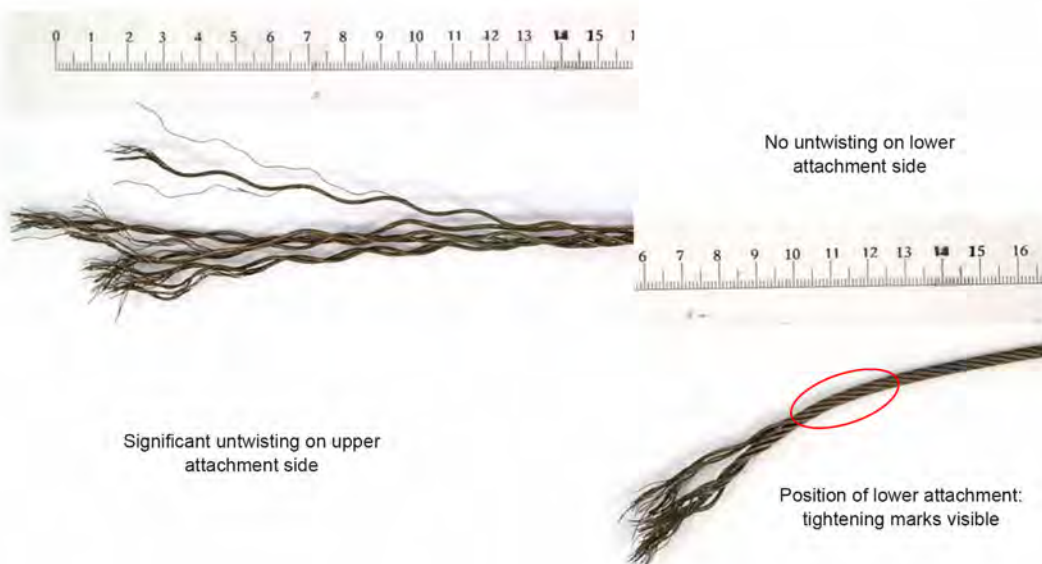
### *Tensile test on a new cable*

On a new cable, the failure occurred close to the lower attachment system.

Note: The proximity of the attachment system prevented the untwisting of the cable on the lower failed end. Signs of pinching were observed on this cable at the attachment point.

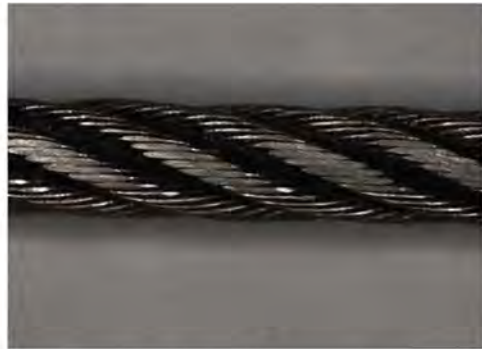
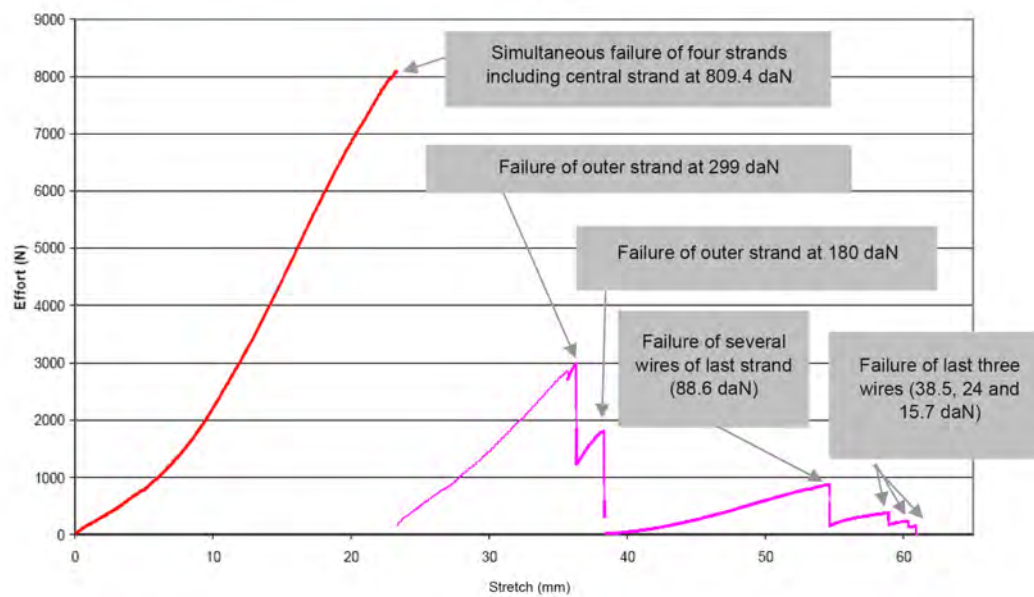
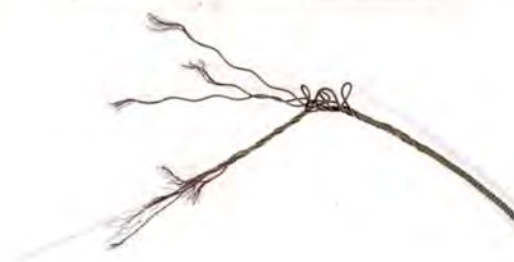
### *Tensile test on a slightly worn cable*

On a slightly worn cable, the failure occurred in the worn area, located in the middle of the section between the attachments.

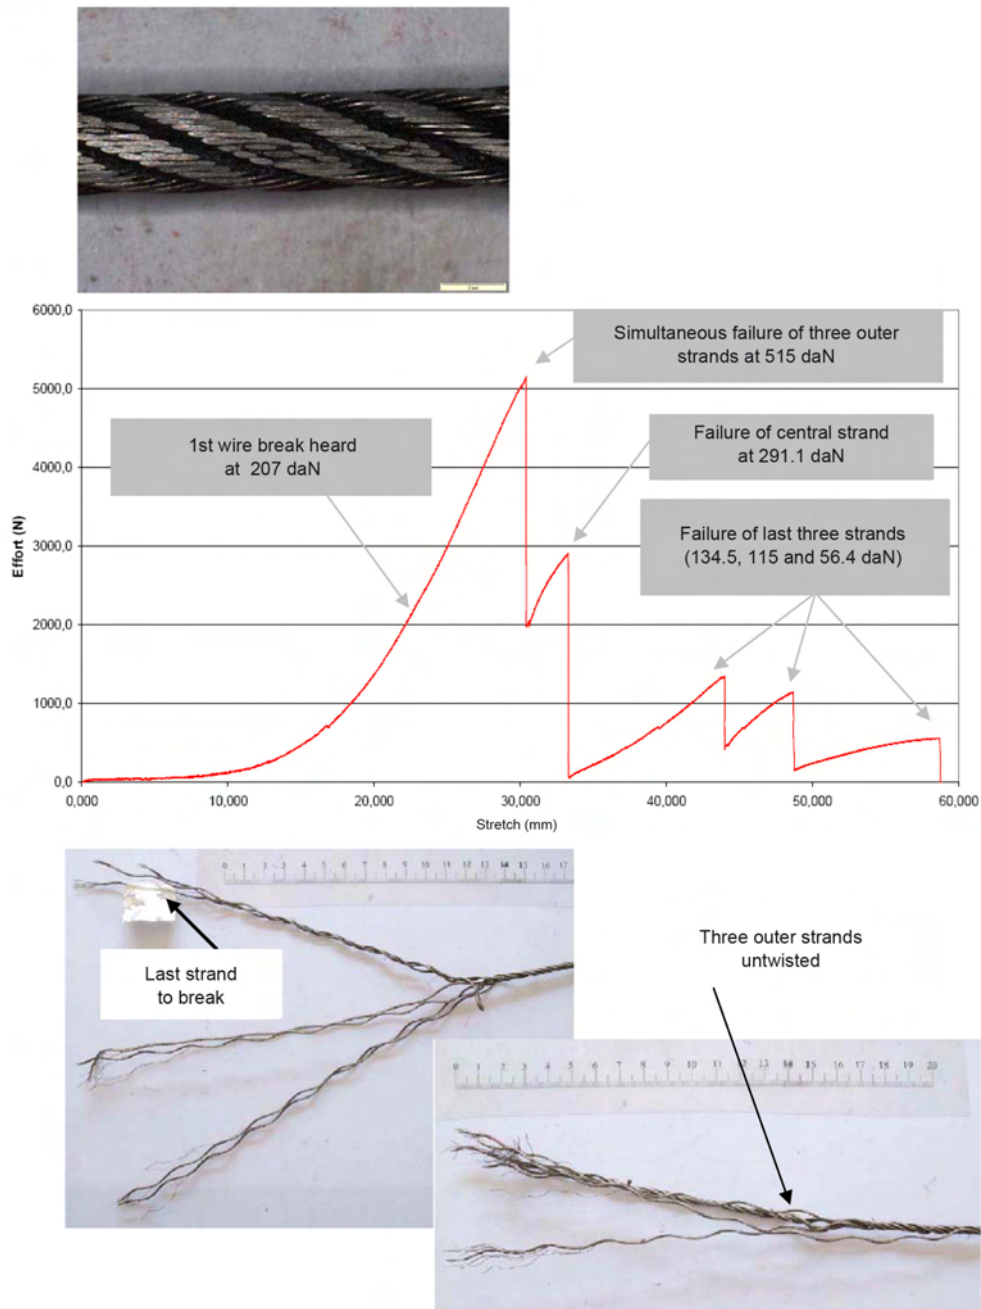
*Tensile test on a cable showing similar wear to that of F-OIQI's pitch-up cable*

On a cable worn like the F-OIQI aft pitch-up cable, the failure also occurred in the worn area between the attachments.

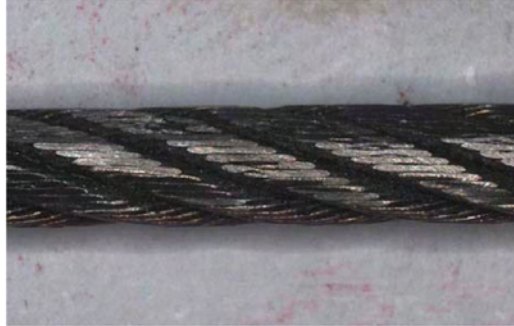
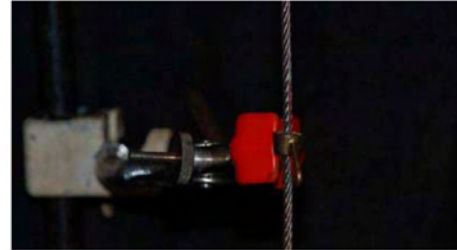
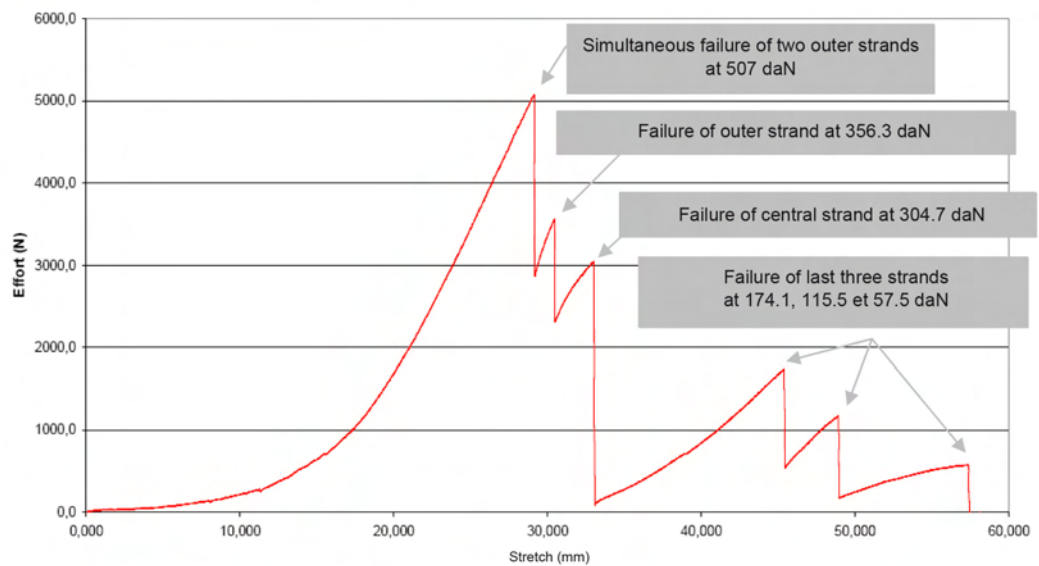
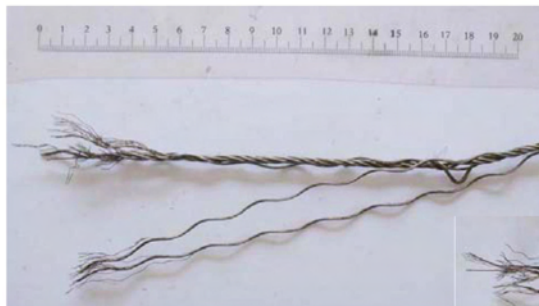
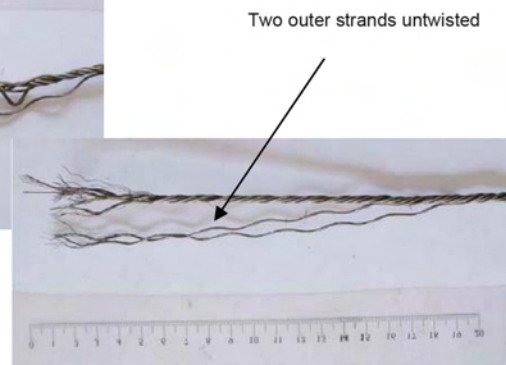
*Tensile test on a cable showing similar wear to that of the F-OIQI's pitch-up cable with a system simulating the presence of the cable guide*

In addition to the set-up for the previous test, a system with a diameter, thickness and rigidity all similar to those of the cable guide was placed in contact with the cable in its worn section. The failure occurred at this point.

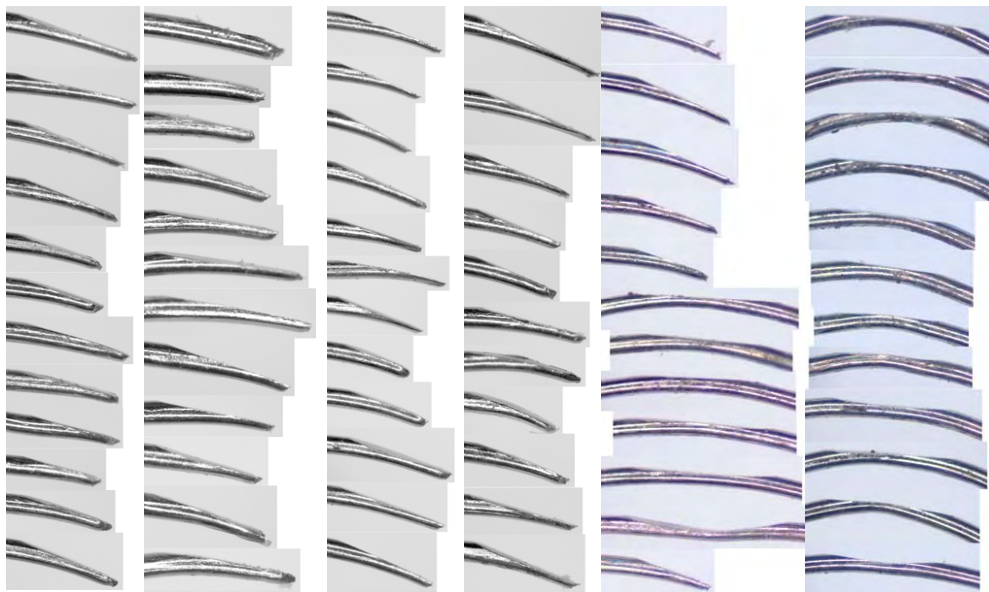
**Annexe 2 : Usure observée sur le câble de  
commande de profondeur à piquer du F-OIQI  
( taux d'usure évalué à 35% )**

Profils d'usure des fils appartenant aux couronnes extérieures des torons externes

Torons rompus au cours de l'essai

Torons non rompus après essais  
: Les fils rompus l'ont été au  
cours des manipulations post  
essai.

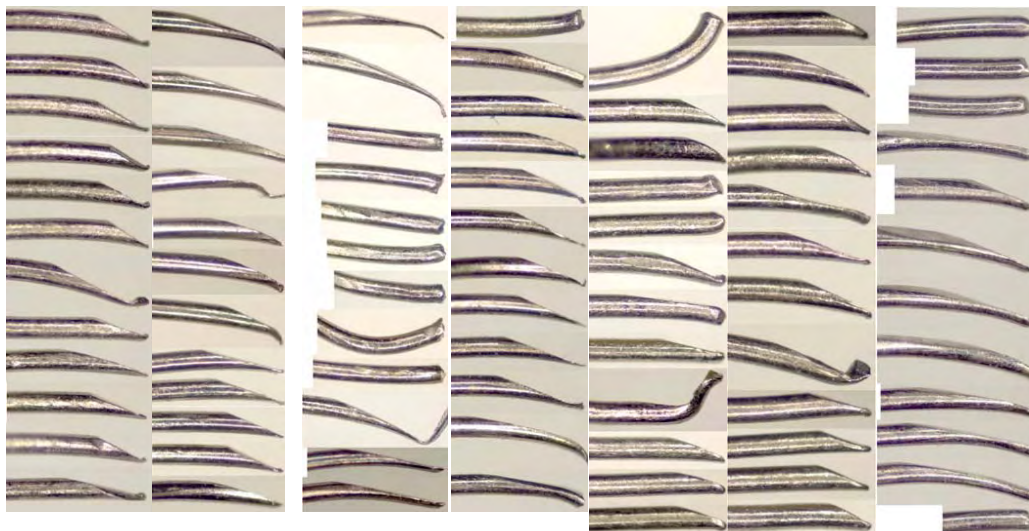
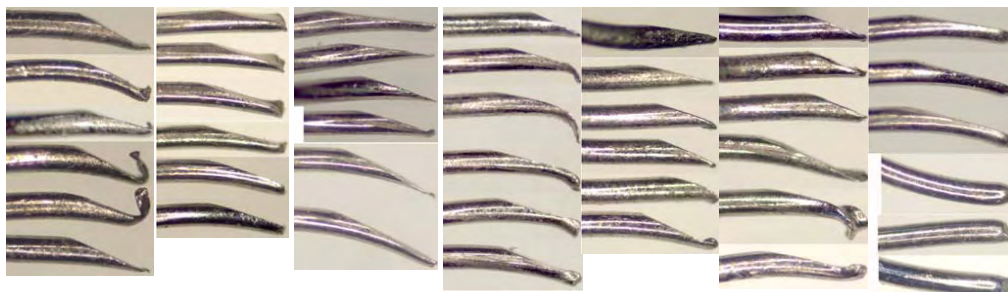
**Annexe 3 : Usure observée sur le câble de  
commande de roulis du F-OIJL  
(Taux d'usure évalué à 80%)**

Profils d'usure des fils appartenant aux couronnes extérieures

Profils d'usure des fils appartenant aux couronnes intérieures

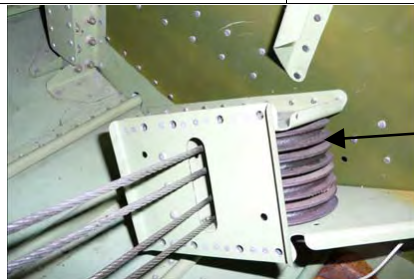
Pulley cluster located at STA 378.13

3. Any aircraft that is operated in a hot humid climate has accelerated wear (carbon steel) at the pulley at STA 378.13. This is due to condensation running down the cables and then collecting at the pulleys. The condensation causes oxidation on the control cables. The control cables transit back and forth through the pulleys during normal flight operations. The pulleys wear off the oxide, leaving a bare surface. This allows another layer of oxide to form, creating a cycle that accelerates cable wear.

4. Experience has indicated that it is beneficial to tension cables to the low end of the range in the rigging specifications (less wear).
5. Replacement interval on cables is sufficiently short to detect cable damage before failure.

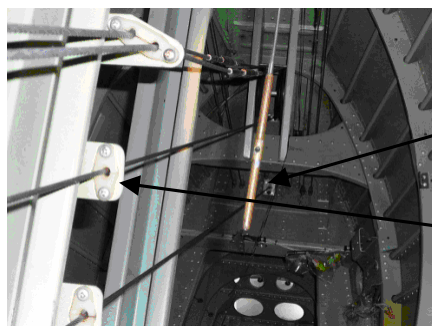
Fairlead at STA 486.34

6. The fairlead at STA 486.34 if not relocated as per TAB 646/9 has been found to show signs of wear or found worn out and the elevator cable rubbing on P/N C6FS1714-3 (MOD 6/1458).

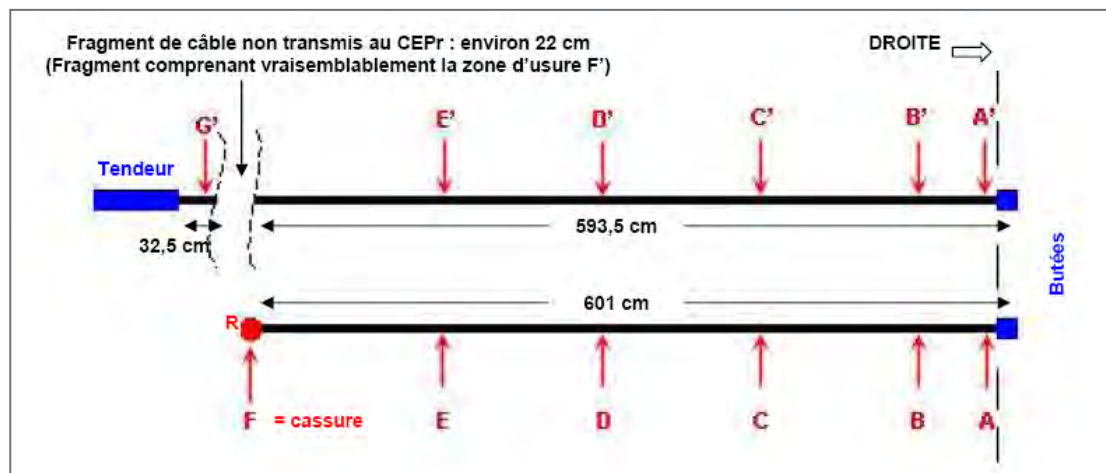
The wear noted on the lower and upper cables was located exactly the same distance from the stops and had the same appearance.

- ☐ The wear zones A and A' extended about 3 to 4 cm and on a lower sector at 180°. They were characterised by the formation of flat spots on the outer wires.
- ☐ The wear zones B and B' extended about 3 to 10 cm and on a lower sector at 90°. They were not characterised by flat spots but rather by small tears on the outer wires.
- ☐ The wear zones C, C', D, D', E and E' had the same appearance. They extended between 3 and 6 cm and were identified on the whole outside of the cable. This wear was very significant and was characterised by the formation of flat spots on the outer wires.

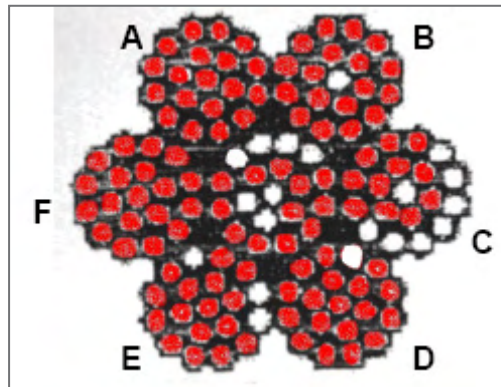
On the cross-section below (strands identified arbitrarily from A to F), the broken wires in line with wear are identified in red, that is to say 113 wires from a total of 133. This wear was characterised by the formation of flat spots, with traces of chafing parallel to the cable axis.

The twenty other wires failed under twisting traction with a striction of the wires in line with the failure surface. Several of them, part of strand C, showed wear behind their wear. This wear was of the same type as those noted in line with the breaks.
