FINAL
KNKT.13.04.09.04

Aircraft Accident Investigation Report

PT. Lion Mentari Airlines (Lion Air)
Boeing 737 - 800; PK-LKS
Ngurah Rai International Airport, Bali
Republic of Indonesia
13 April 2013

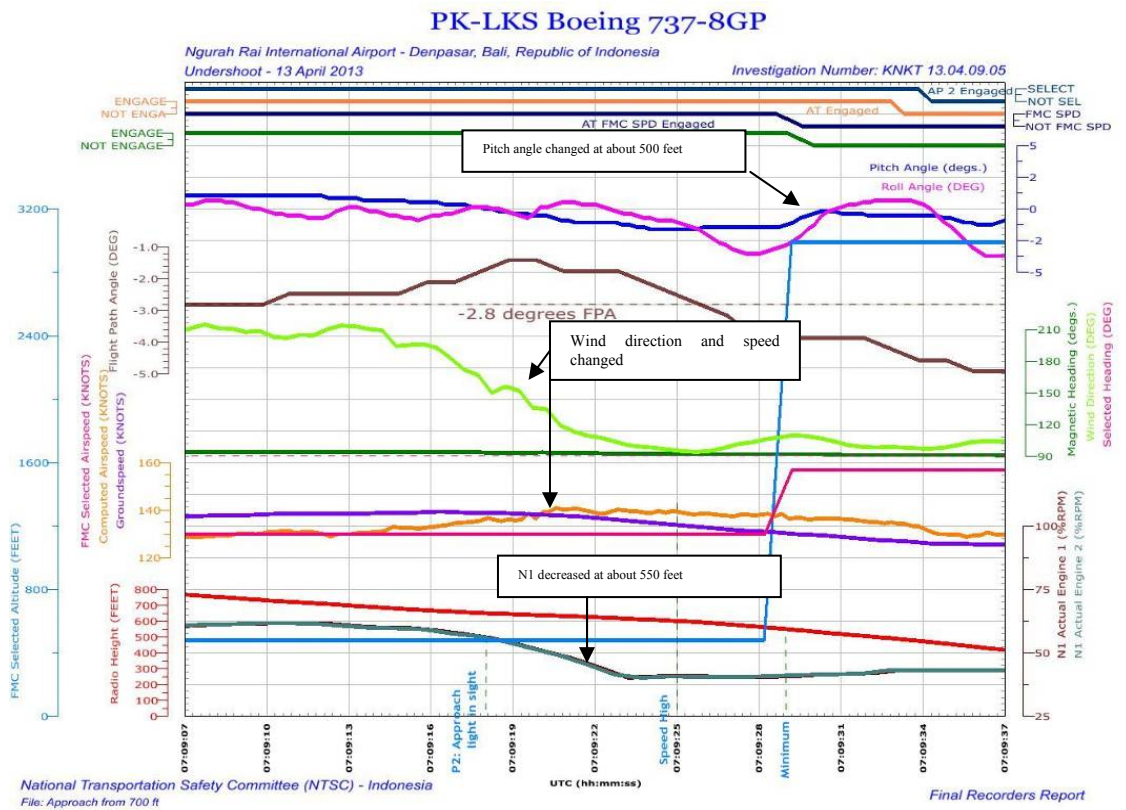
Figure 12: FDR data pitch, wind and N1

No aircraft systems malfunction were recorded on FDR after the aircraft departed from Bandung on the last flight.

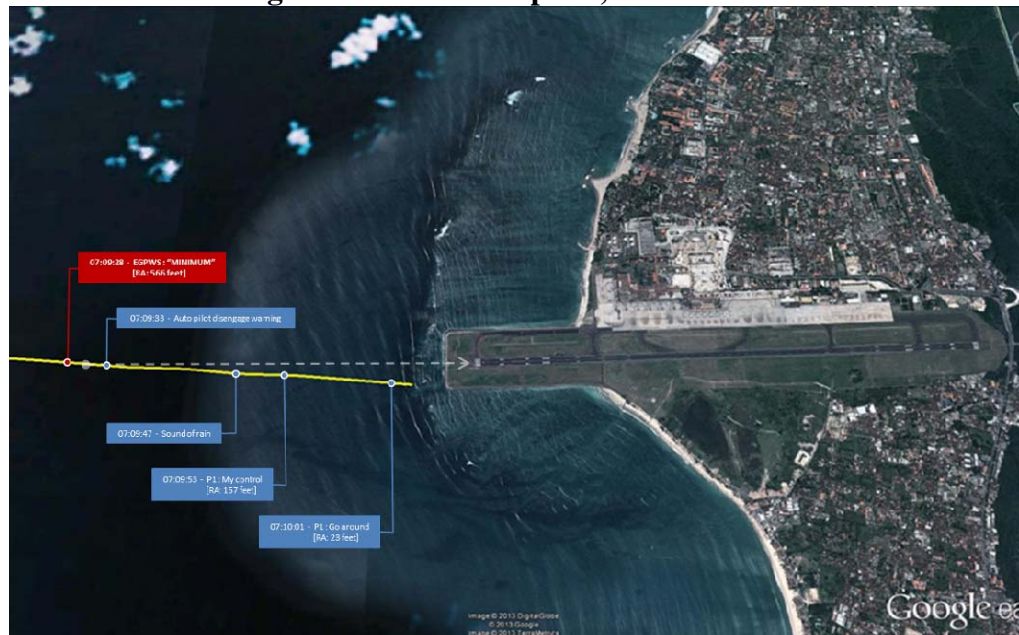
Figure 13: Aircraft flight path superimposed to Google Earth

From figure 13 it was indicated that the flight from minimum descent altitude (MDA) still following the VOR approach lateral configuration (091°), rather than lining up to the runway lateral orientation (087°).

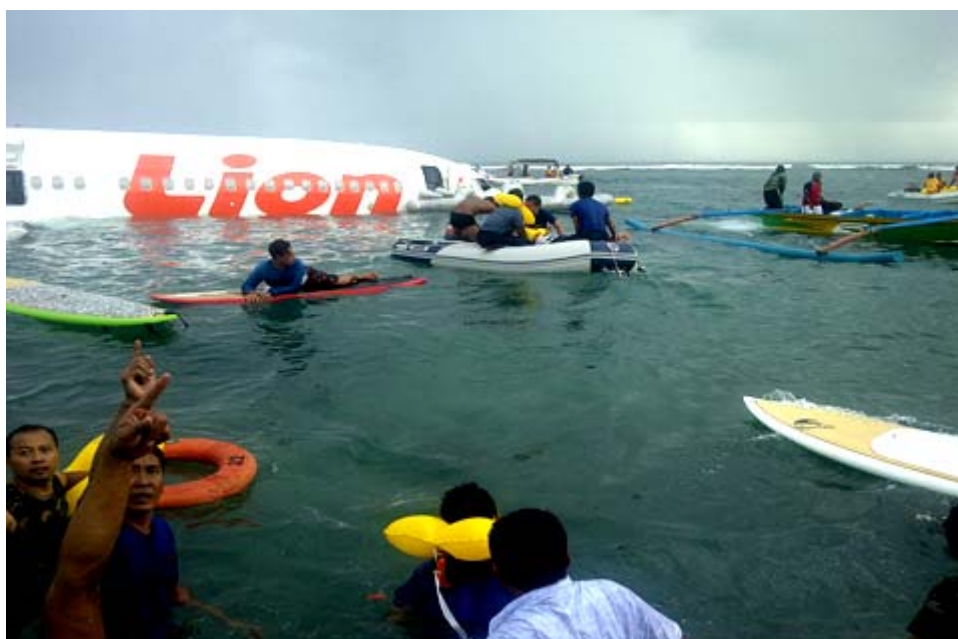
Figure 18: The situation during evacuation process

At 0717 UTC, the local armed forces, police, SAR agency and local people supported the evacuation operation.
