Accident  
on 24 December 2000  
at Tahiti Faaa Airport  
to the DC10-10  
registered N132AA  
operated by Hawaiian Airlines

**REPORT**  
**n-aa001224a**

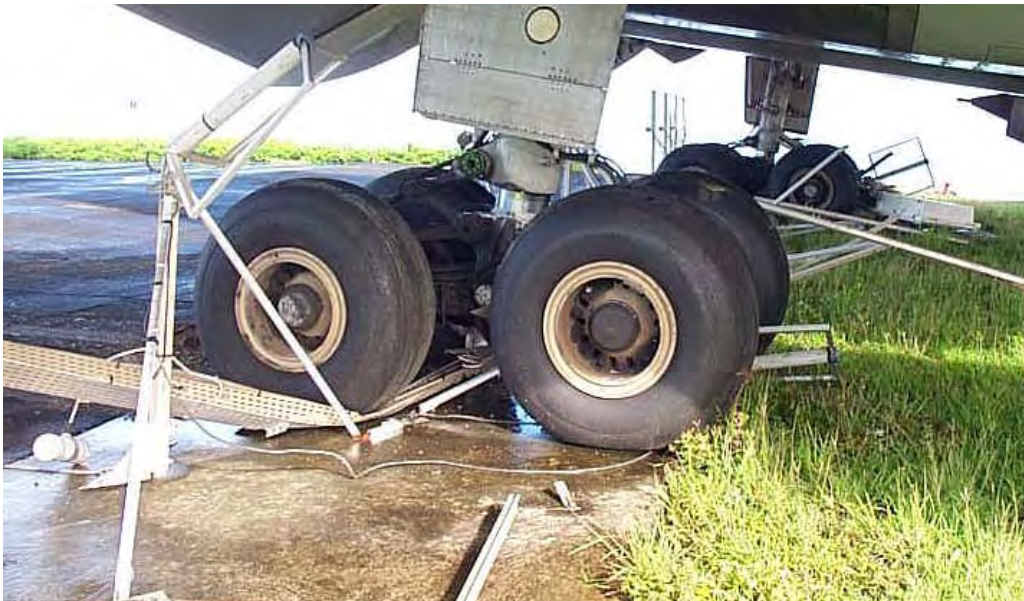
The visible damage on the airplane, from forward to aft, was as follows:

- Impact marks between the nose and nose gear.
- The nose gear was marked by the impact with the localizer aerials, one of which was jammed inside. The anti-shimmy was destroyed. No serious structural damage was visible.
- The air intake on the right engine was punctured by a rock and that of the left engine showed signs of scraping along the ground. Some fan blades on the left engine were slightly damaged. The pylons of both on-wing engines were twisted.
- The left main landing gear had struck the localizer installations. Numerous contact marks with the antennae were visible.
- The left inner flap was damaged on its lower part. The right inner slat was deformed by contact with the pylon of engine three.

Note: the localizer antennae, located seventy-two meters from the end of the runway, were destroyed.
