**Air Accidents Investigation Branch**

**Report on the accident to  
Boeing 747-121, N739PA at  
Lockerbie, Dumfriesshire, Scotland  
on 21 December 1988**

The report concludes that the detonation of an improvised explosive device led directly to the destruction of the aircraft with the loss of all 259 persons on board and 11 of the residents of the town of Lockerbie. Five recommendations are made of which four concern flight

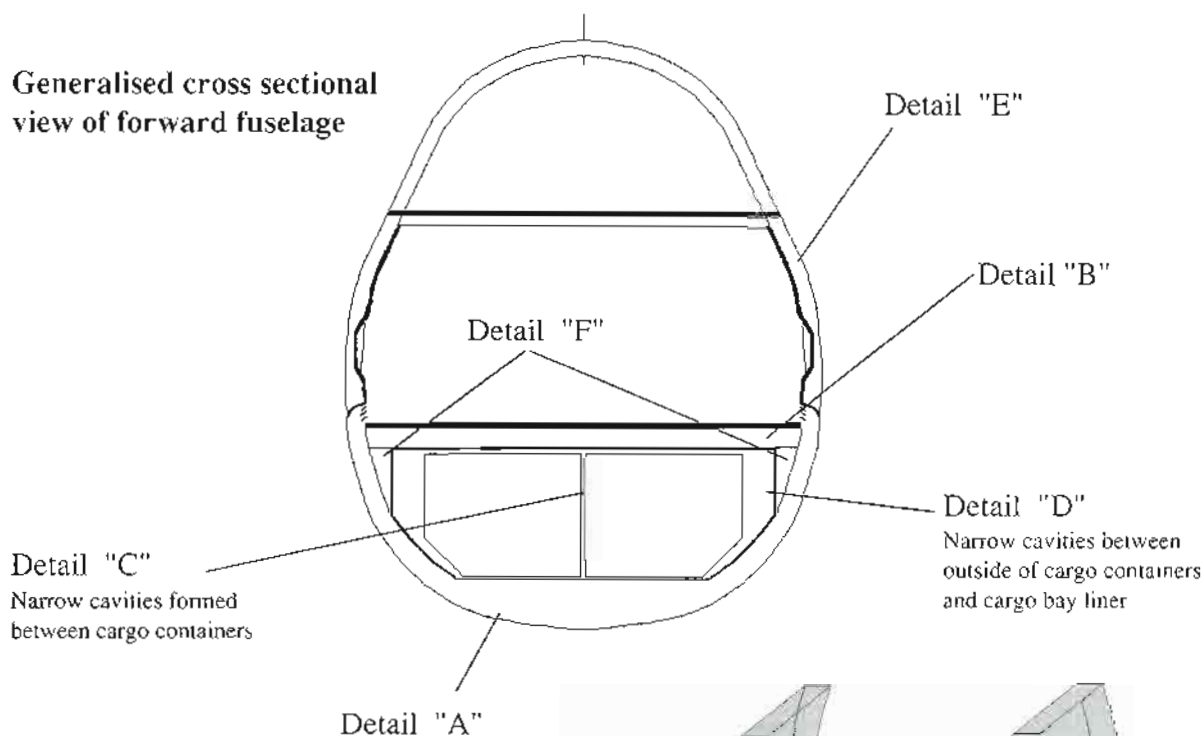
Vertical cavities between frames, bounded by fuselage skin and cabin side liner panel  
Top of cavity largely blanked by upper deck floor panels

Longitudinal 'manifold' cavity, formed in space between container side and curved fuselage side

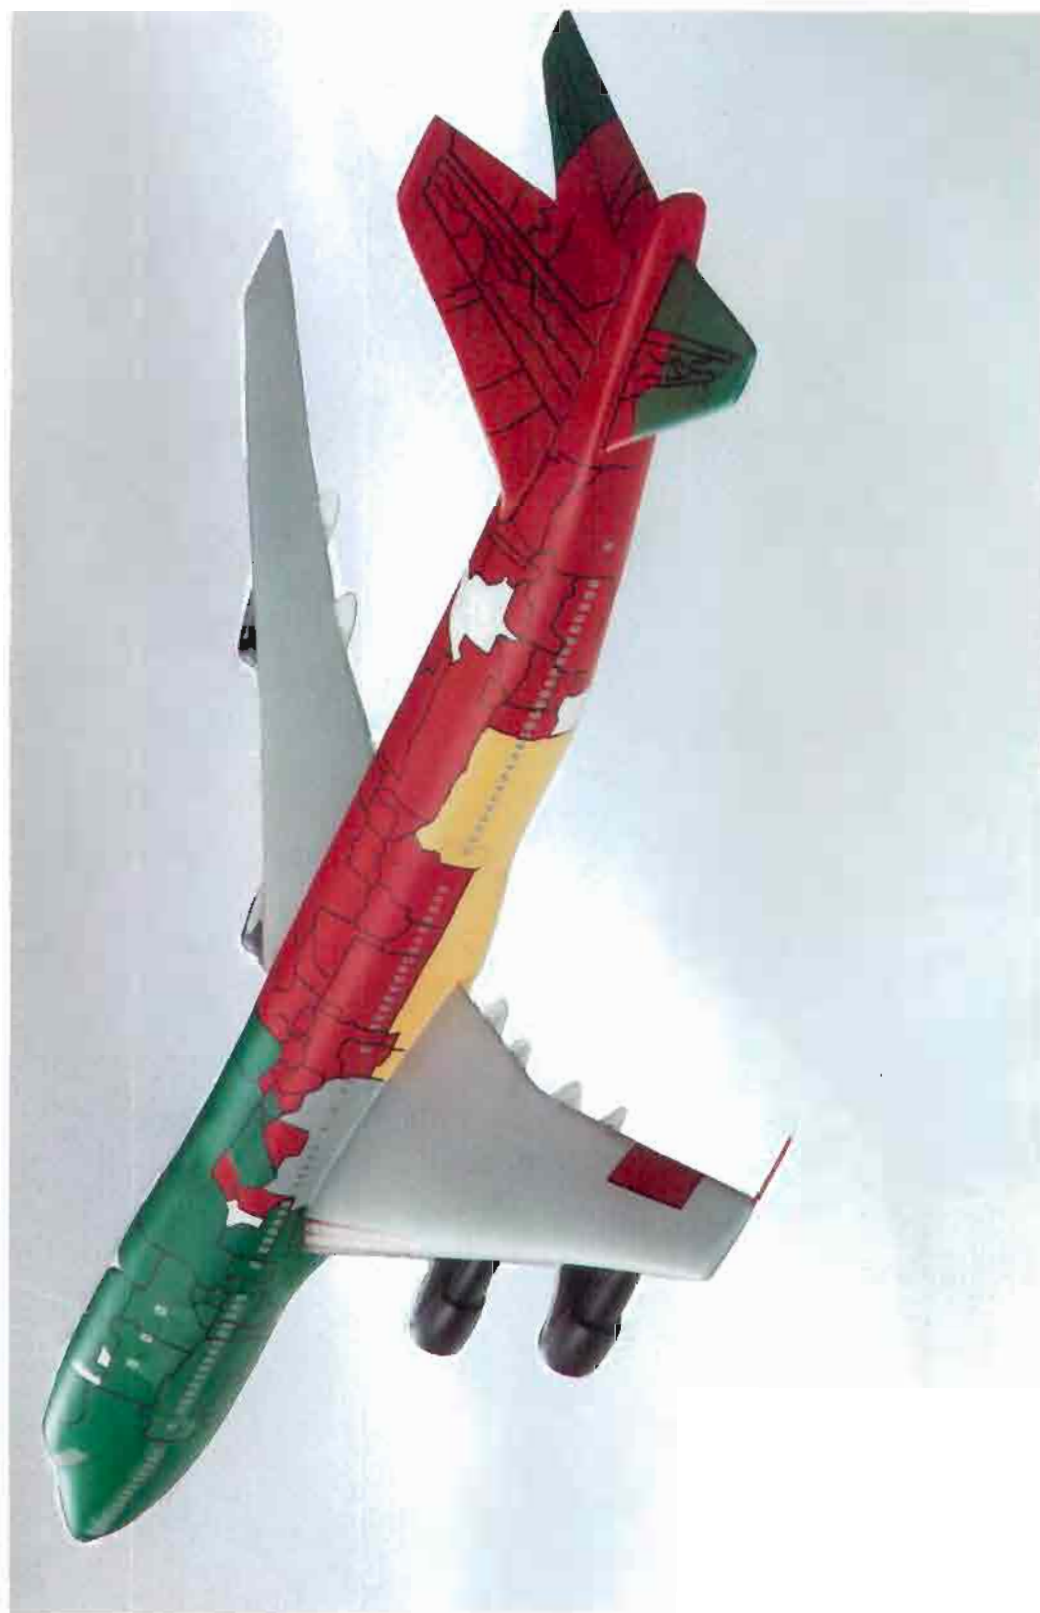
**Figure B-5**

**Model showing fuselage and tail surface fracture lines**  
 (colour coded to show location of items on the ground)

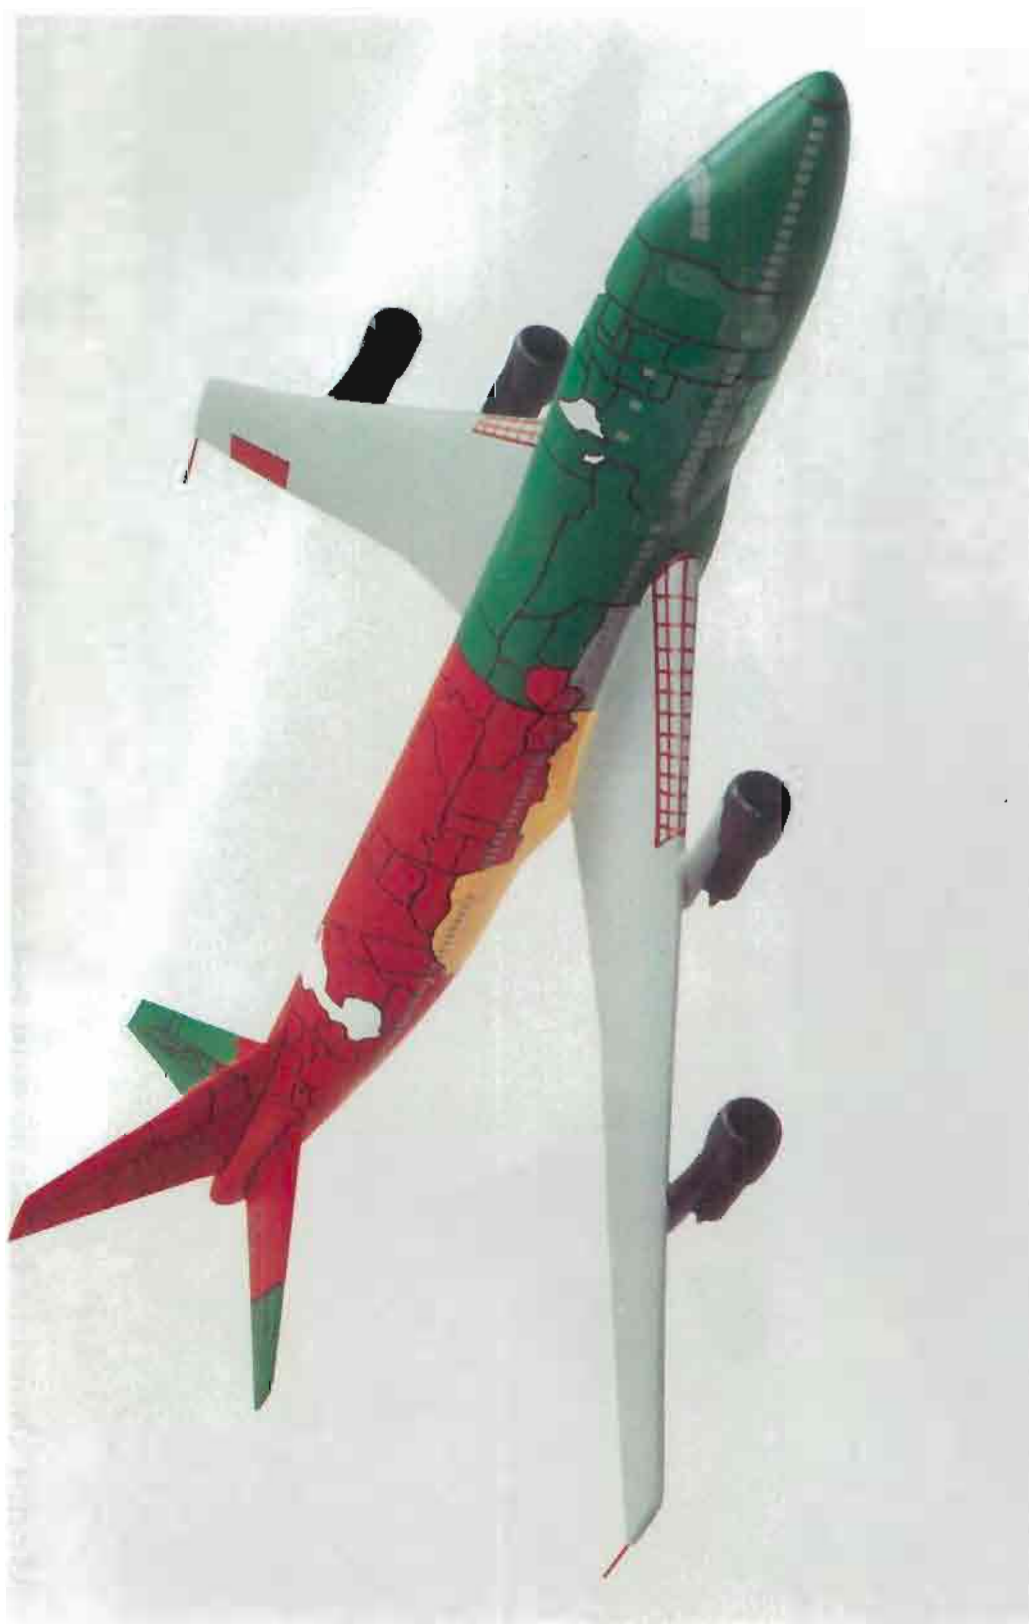
**Figure B-6**

**Model showing fuselage and tail surface fracture lines**  
(colour coded to show location of items on the ground)

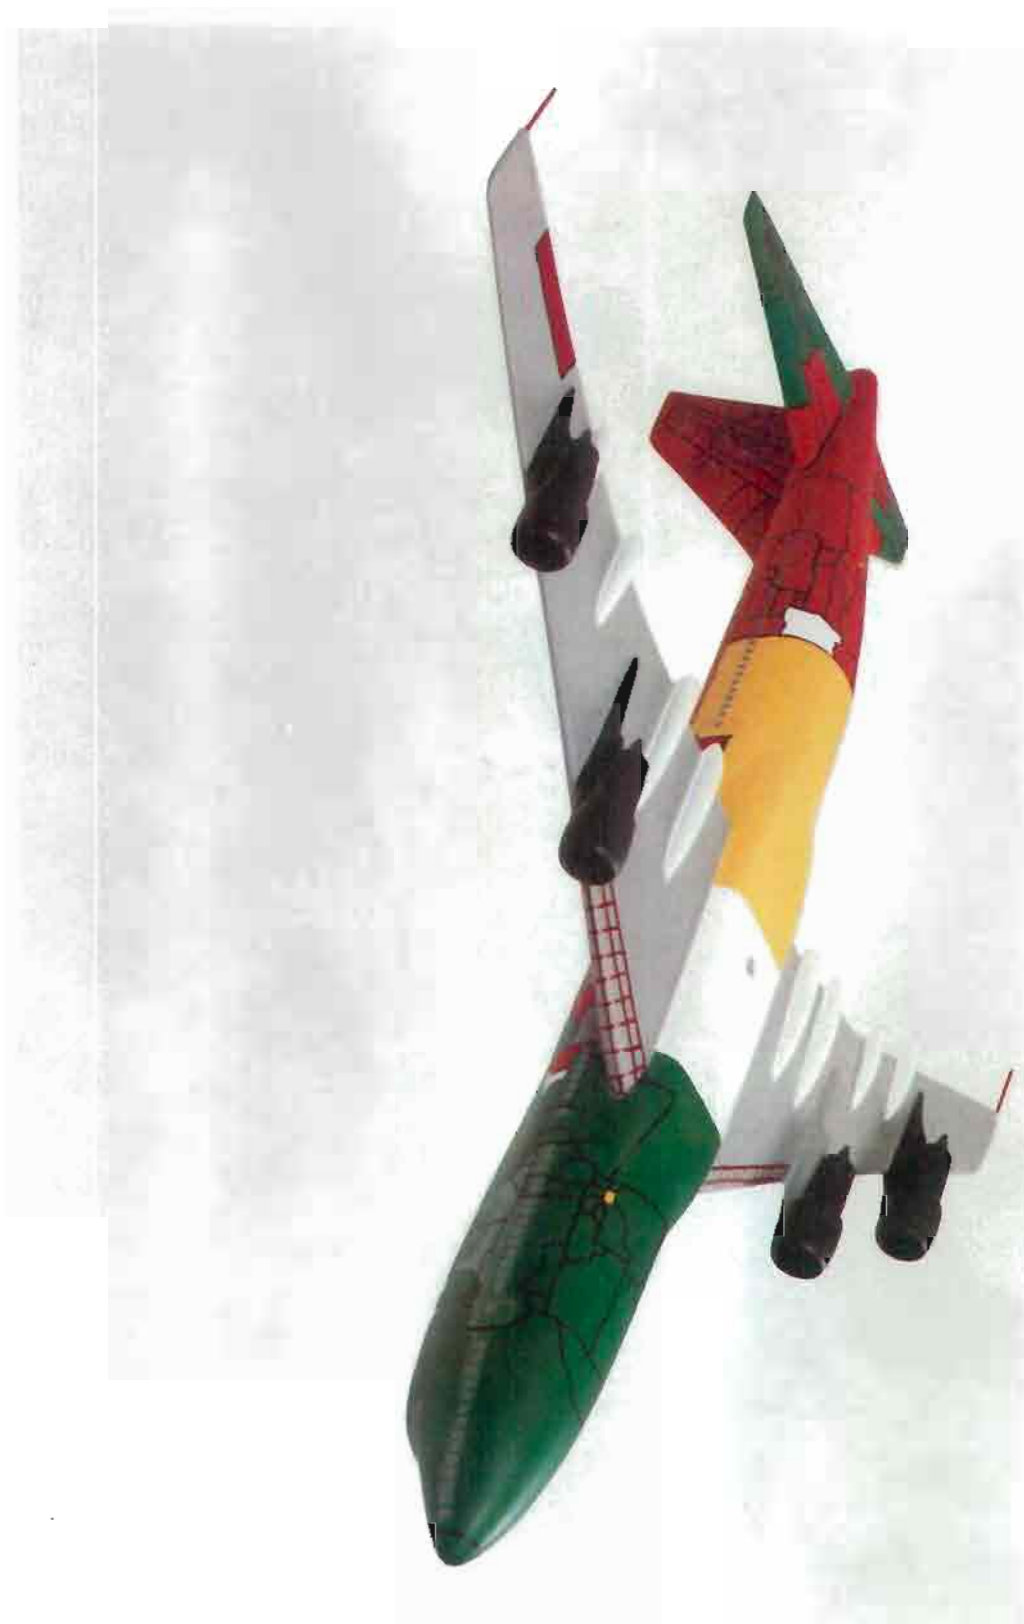
Figure B-7

**Model showing fuselage and tail surface fracture lines**  
 (colour coded to show location of items on the ground)

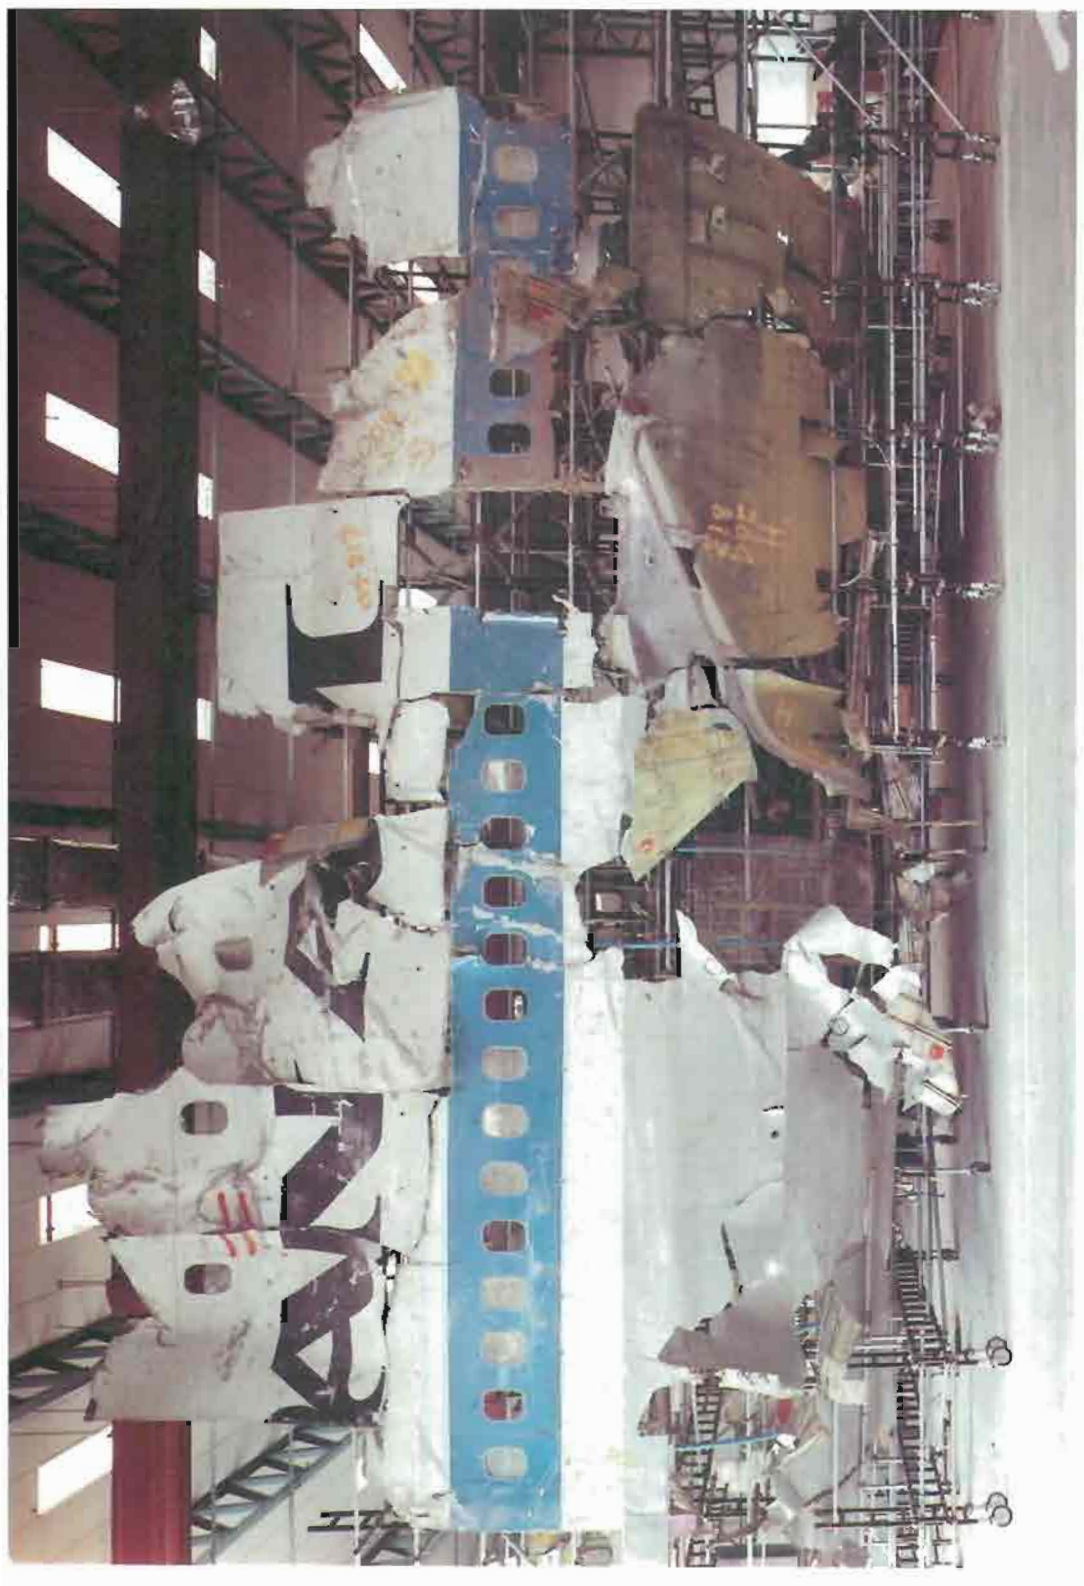
Figure B-16

Fuselage three-dimensional reconstruction

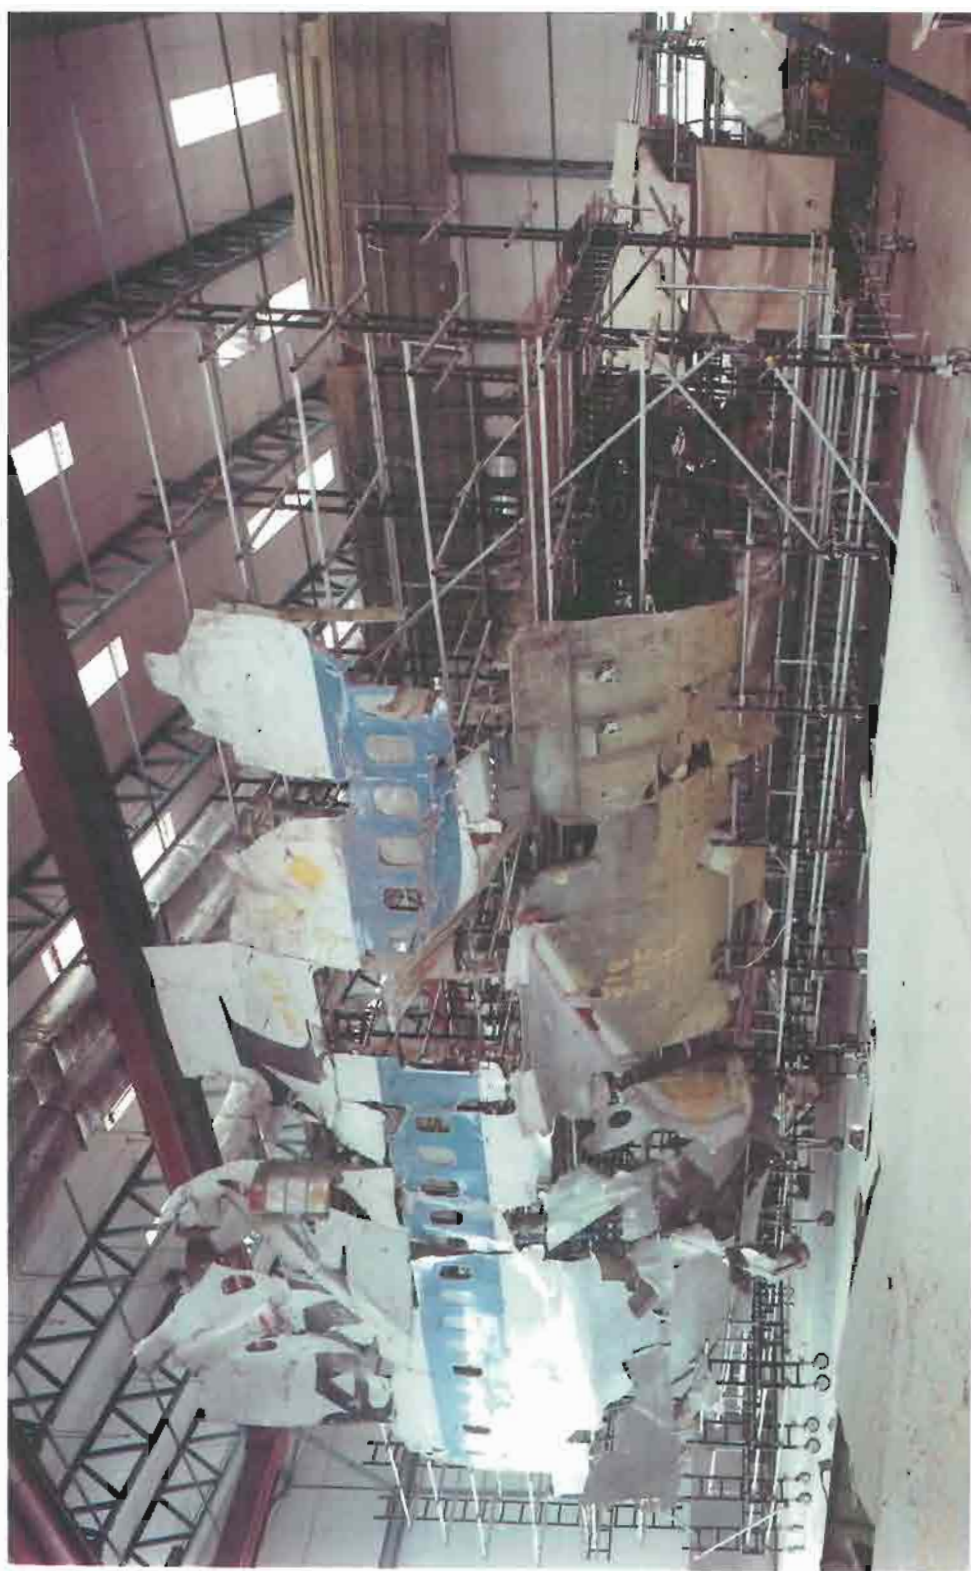
Figure B-17

Fuselage three-dimensional reconstruction

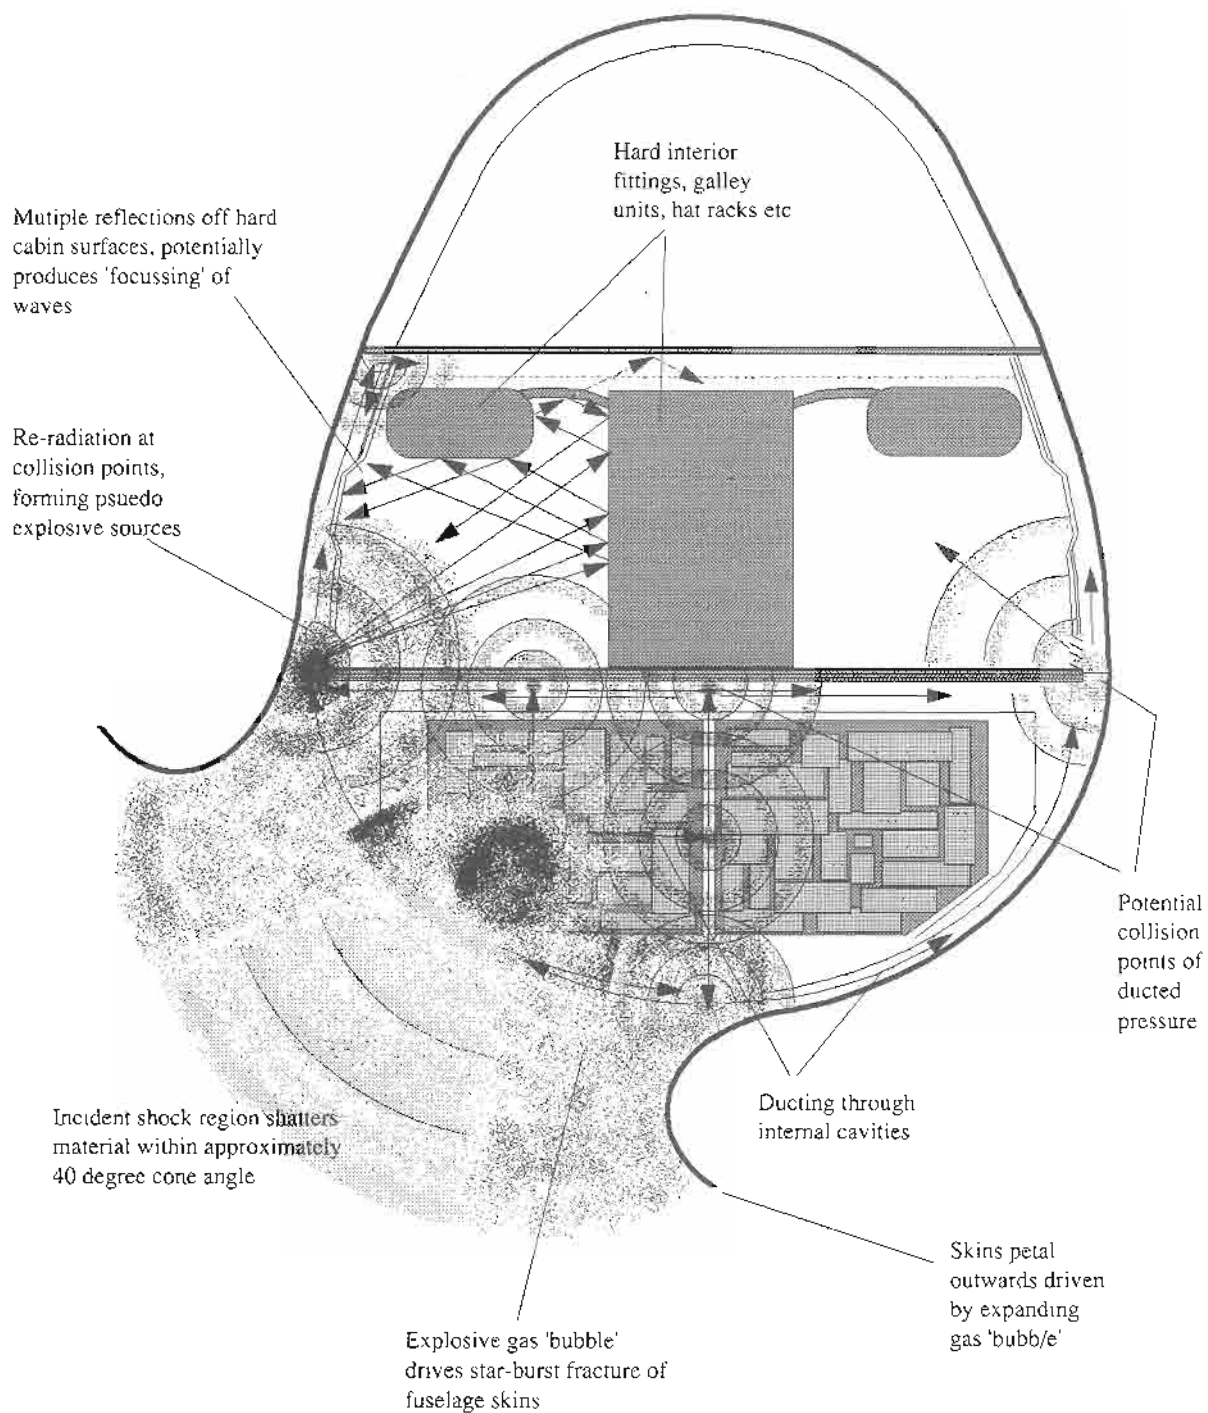
**Figure B-26**

**Potential Shock and Explosive Gas Propagation Paths**  
(schematic representation)

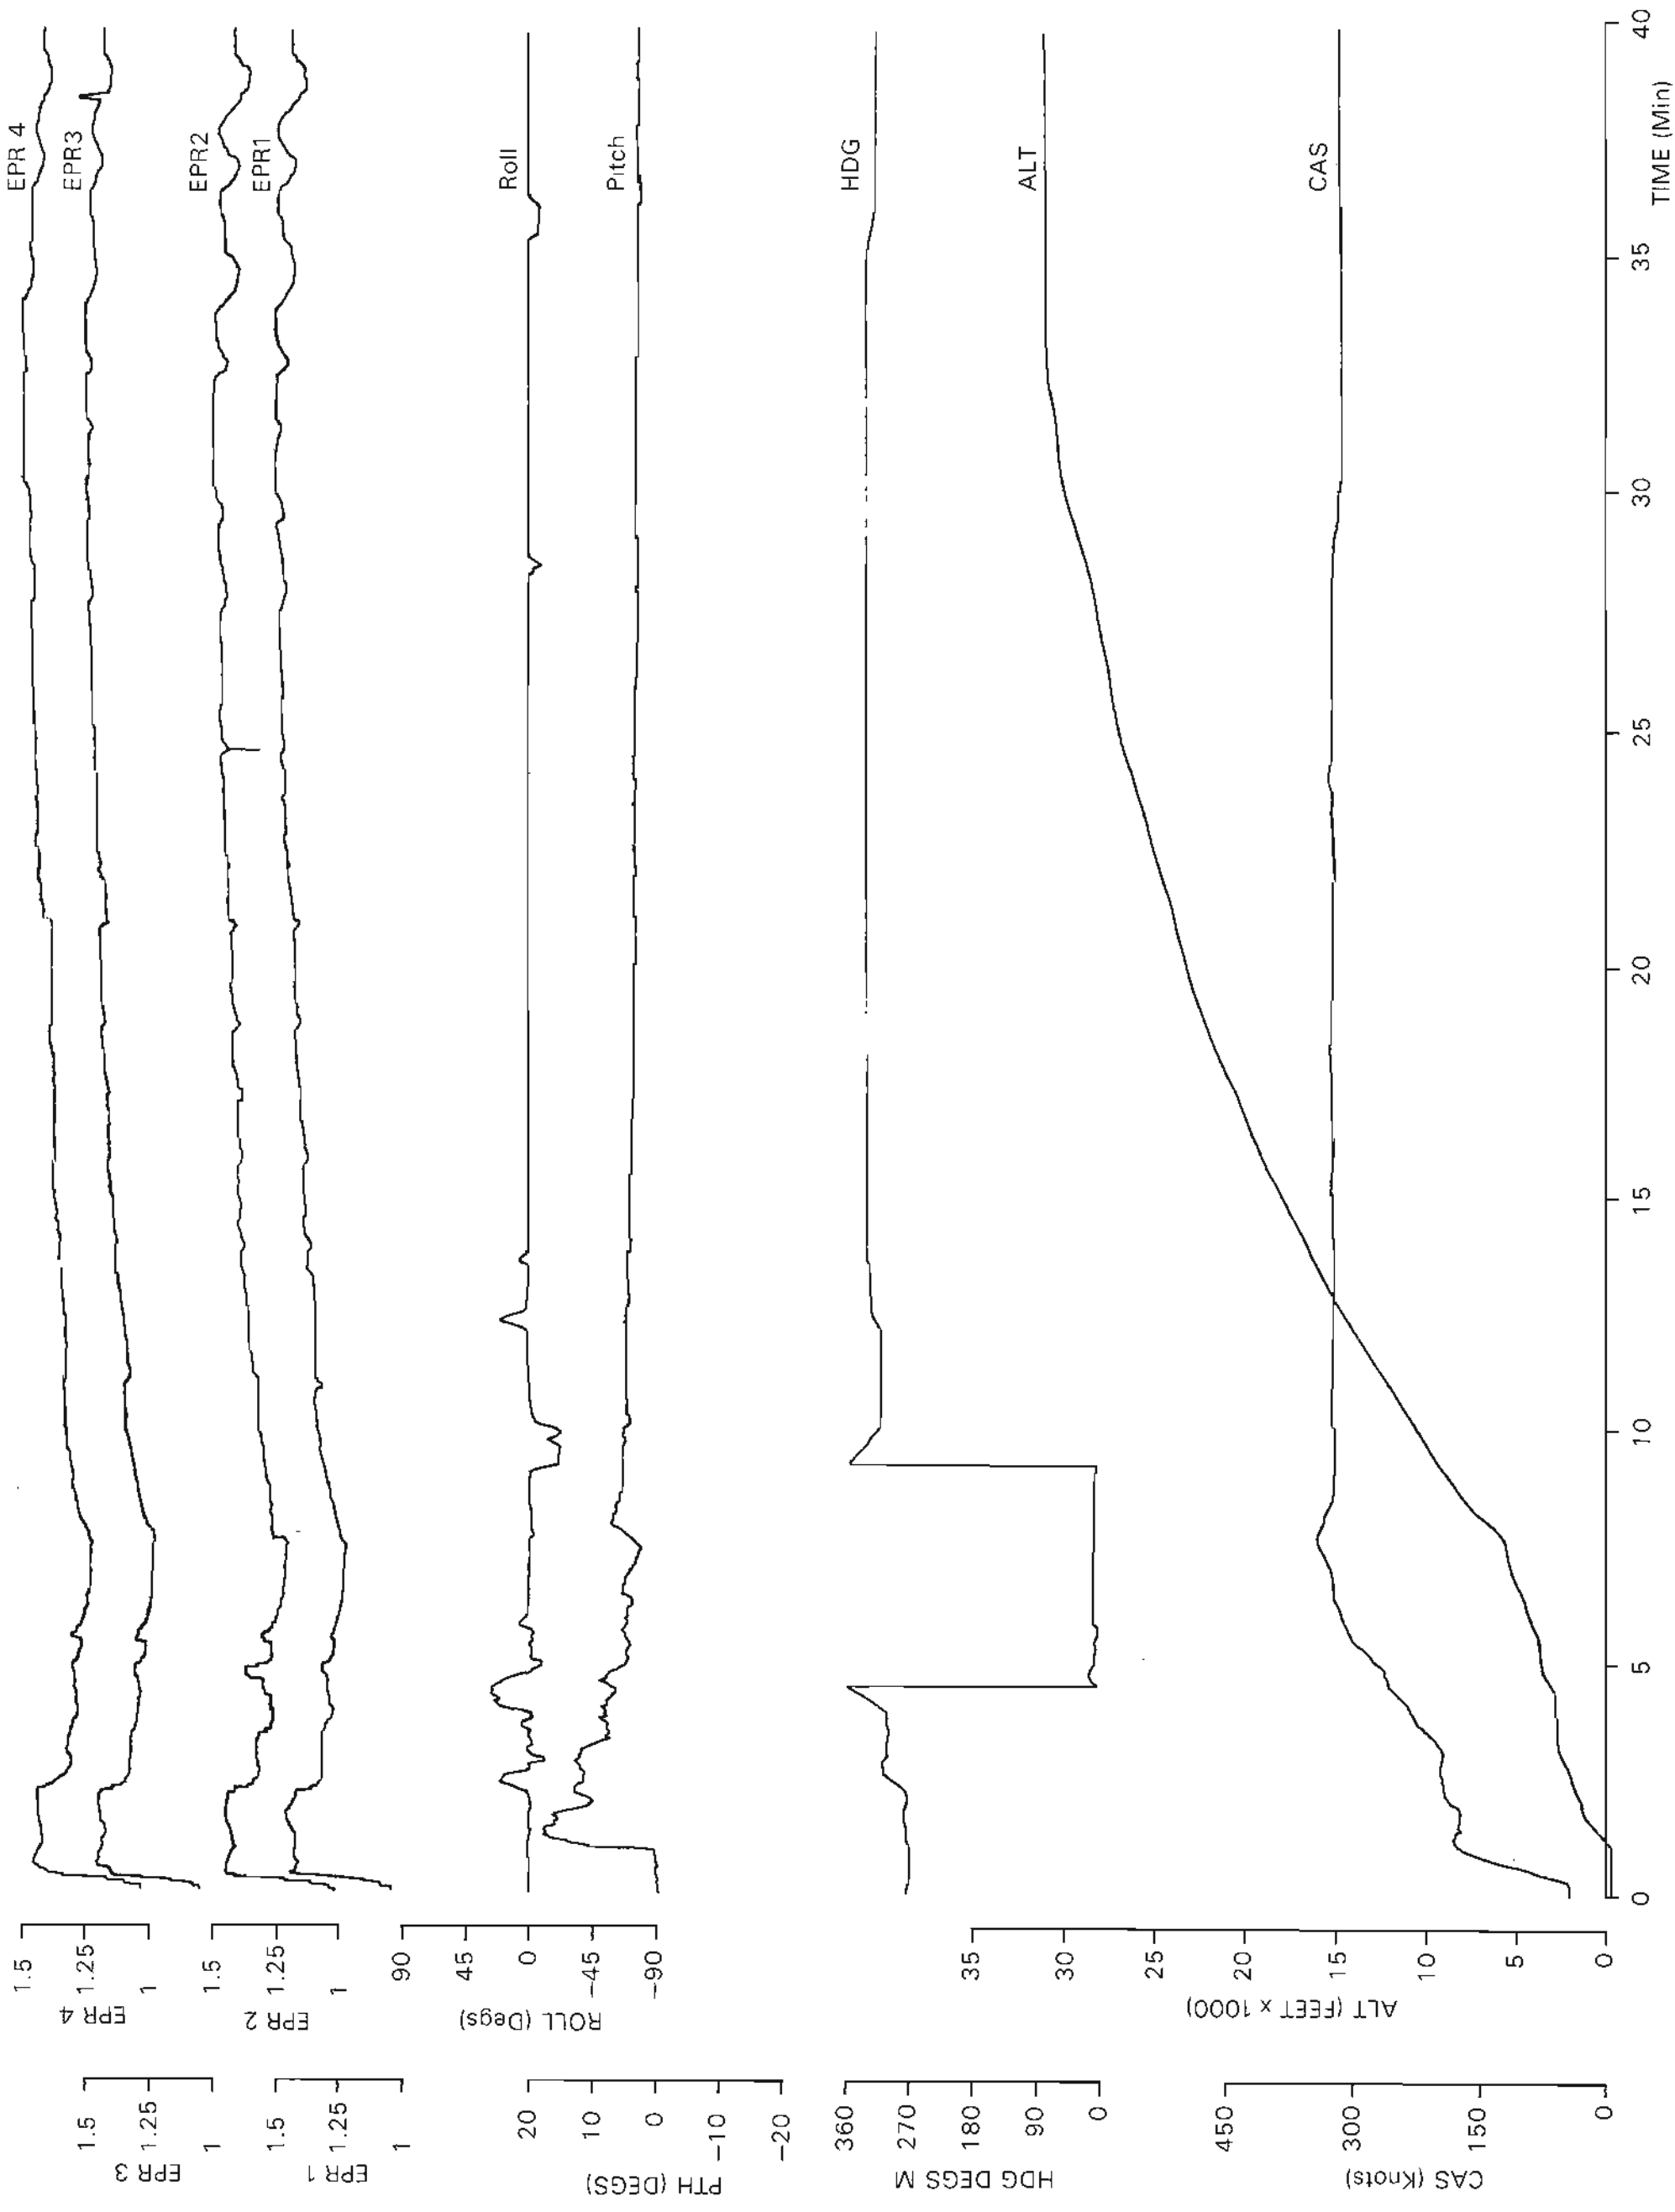
Figure C-1

The 25 hour duration of the DFDR was satisfactorily replayed. Data relating to the accident flight was recorded on track 2. The only significant defect in the recording system was that normal acceleration was inoperative. There was one area on the tape, 2 minutes from the end, where data synchronisation was lost for 1 second.

Selected DFDR parameters of final flight of N739PA

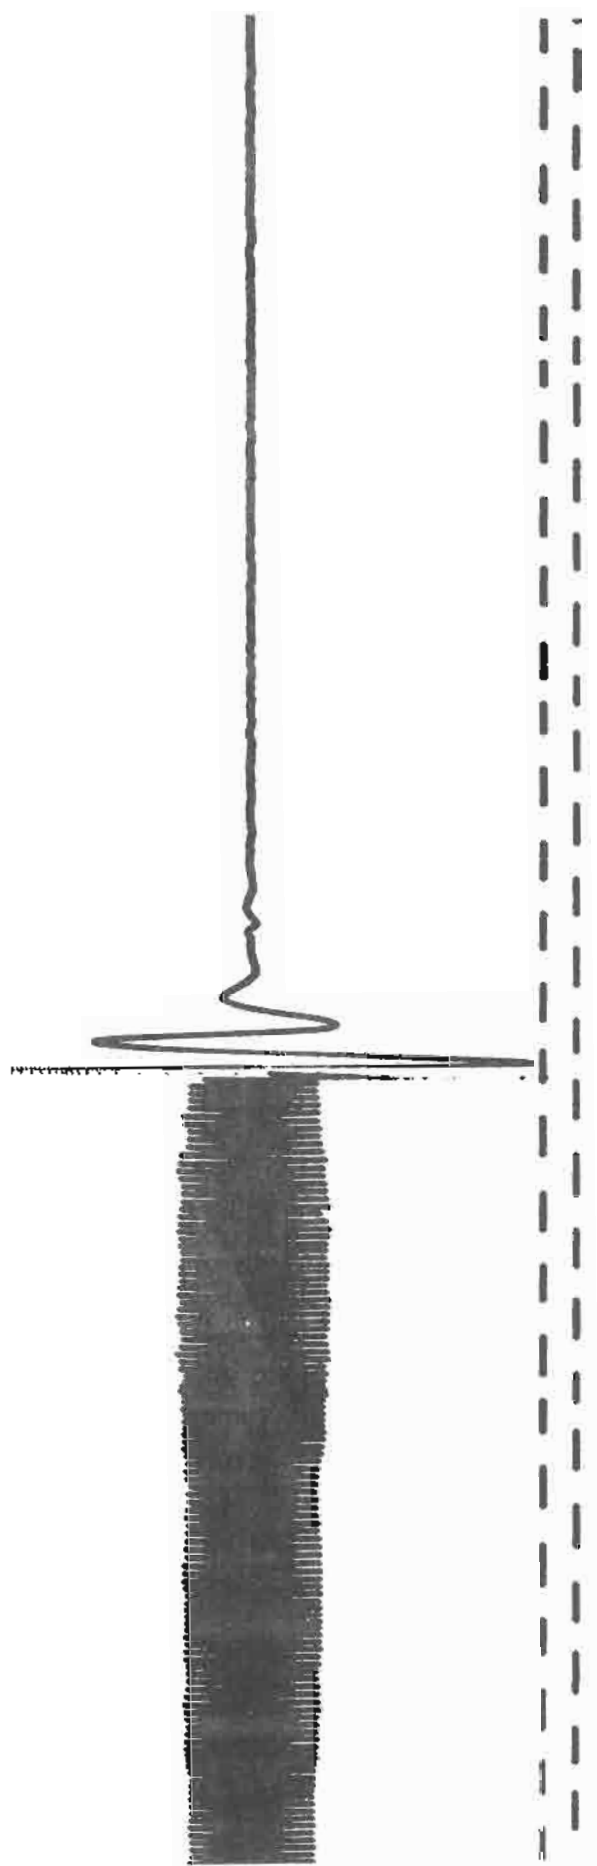
Figure C-2

To determine the mechanism that stopped the recorder a bench test rig was constructed utilizing an A100 CVR and an A152 CAM. Figures C-2 to C-5 show the effect of shorting, earthing or disconnecting the CAM signal wires. Figure C-8 shows the CAM channel signal response to the event which occurred on Flight PA103. From this it can be seen that there are no characteristic transients similar to those caused by shorting or earthing the CAM signal wires. Neither does the signal stop cleanly and quickly as shown in Figure C-5, indicating that the CAM signal wires were not interrupted. The UV trace shows the recorded signal decaying in a manner similar to that shown in Figure C-6, which demonstrates the effect of disconnecting electrical power from the recorder. The tests were

The effect on the recorded signal of shorting  
the signal wires to the CAM

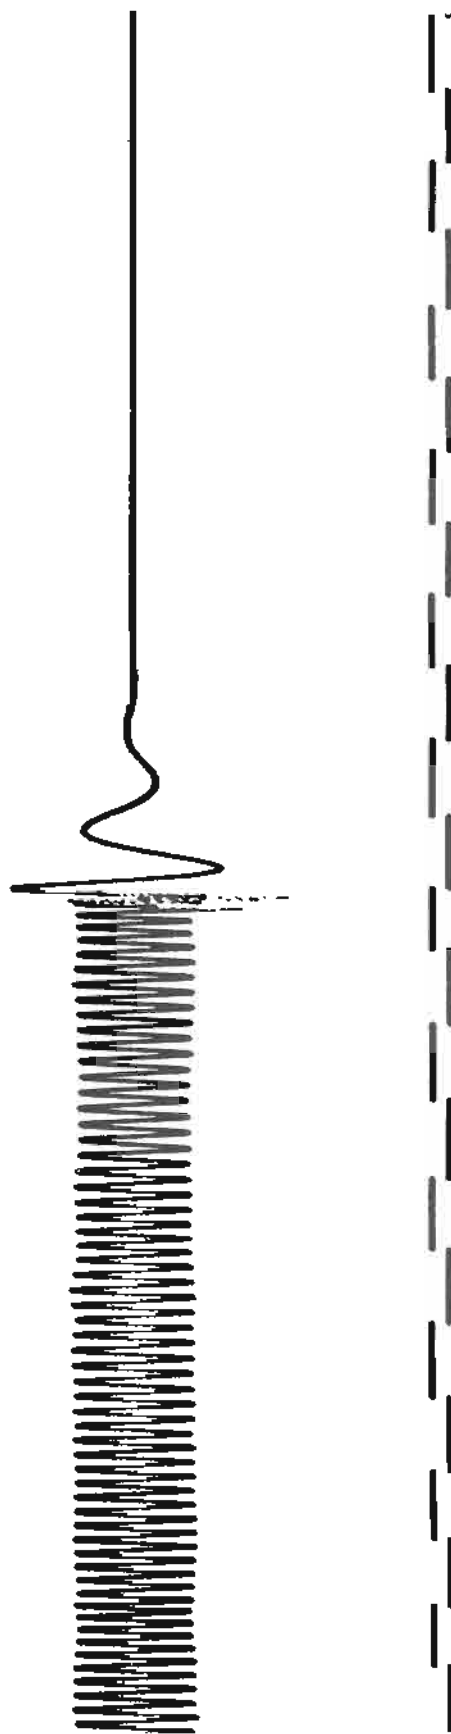
Figure C-3

The effect on the recorded signal of earthing  
the hi wire to the CAM

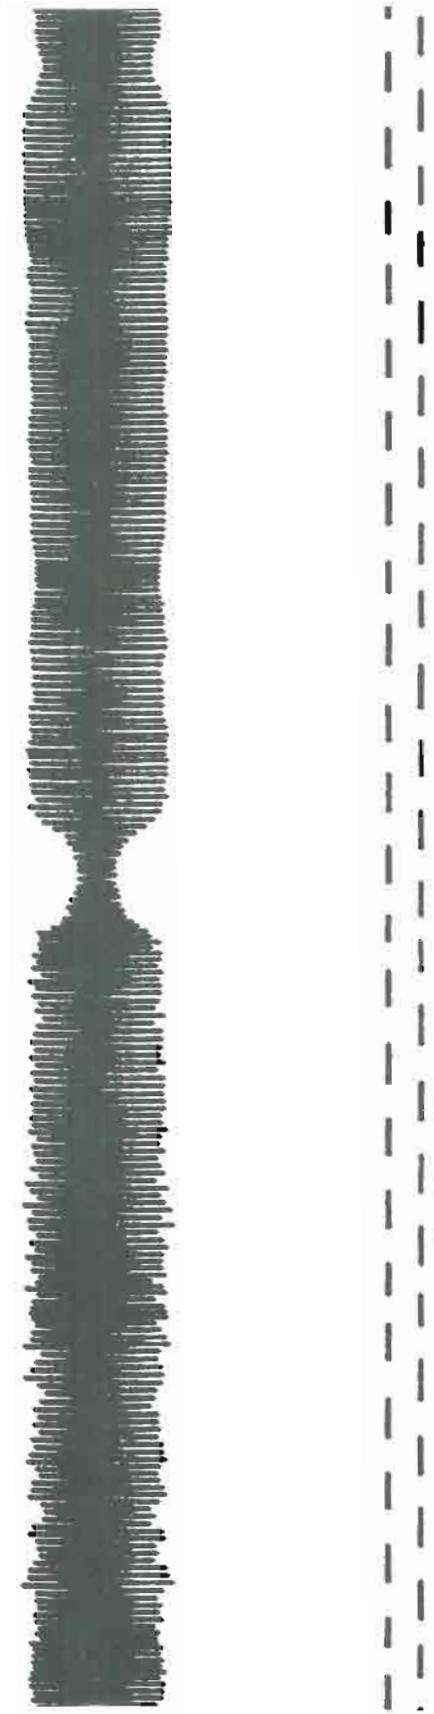
Figure C-4

The effect on the recorded signal of earthing  
the lo wire to the CAM

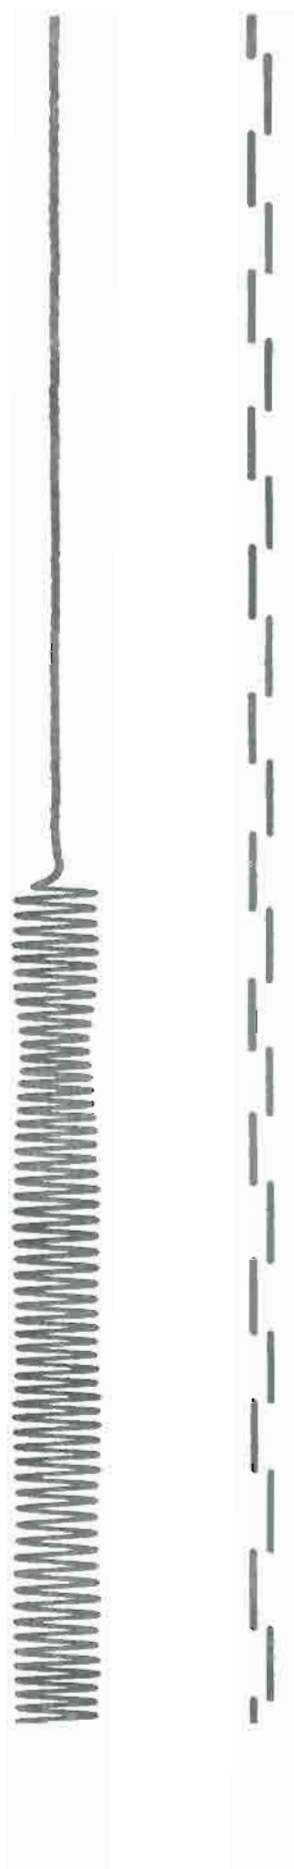
Figure C-5

The effect on the recorded signal of disconnecting  
the CAM signal wires

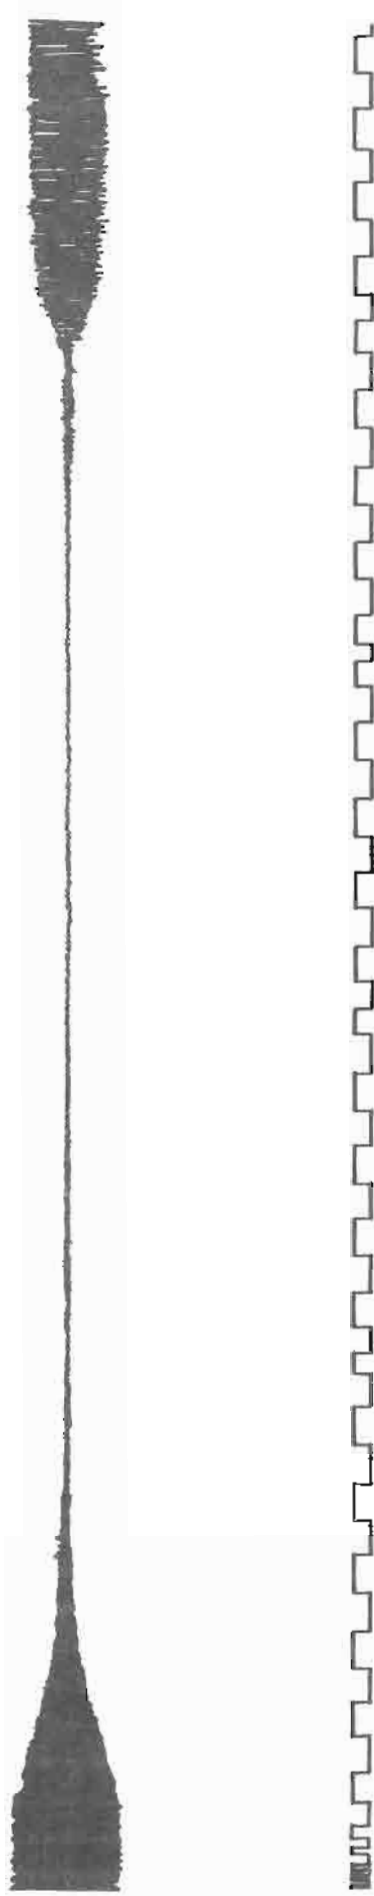
Figure C-6

The effect on the recorded CAM signal of disconnecting  
the CVR power supply

In order to respond to events that result in the almost immediate loss of the aircraft's electrical power supply it was therefore recommended during the investigation that the regulatory authorities consider requiring CVR systems to contain a short duration (i.e. no greater than 1 minute) back-up power supply.

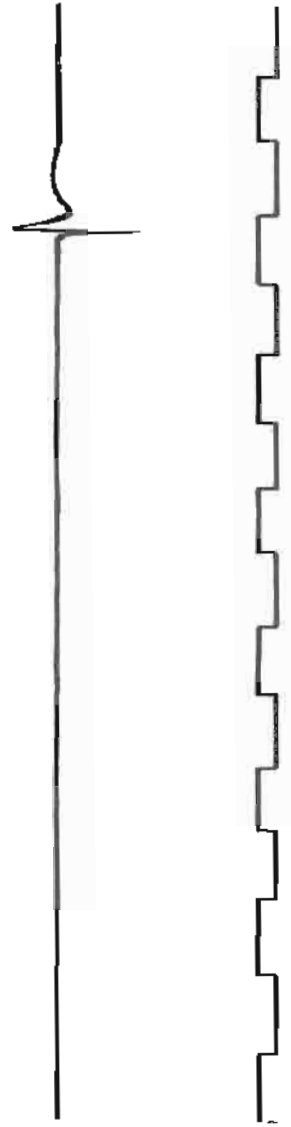
Figure C-7

The effect on the recorded CAM signal of applying  
power to the CVR

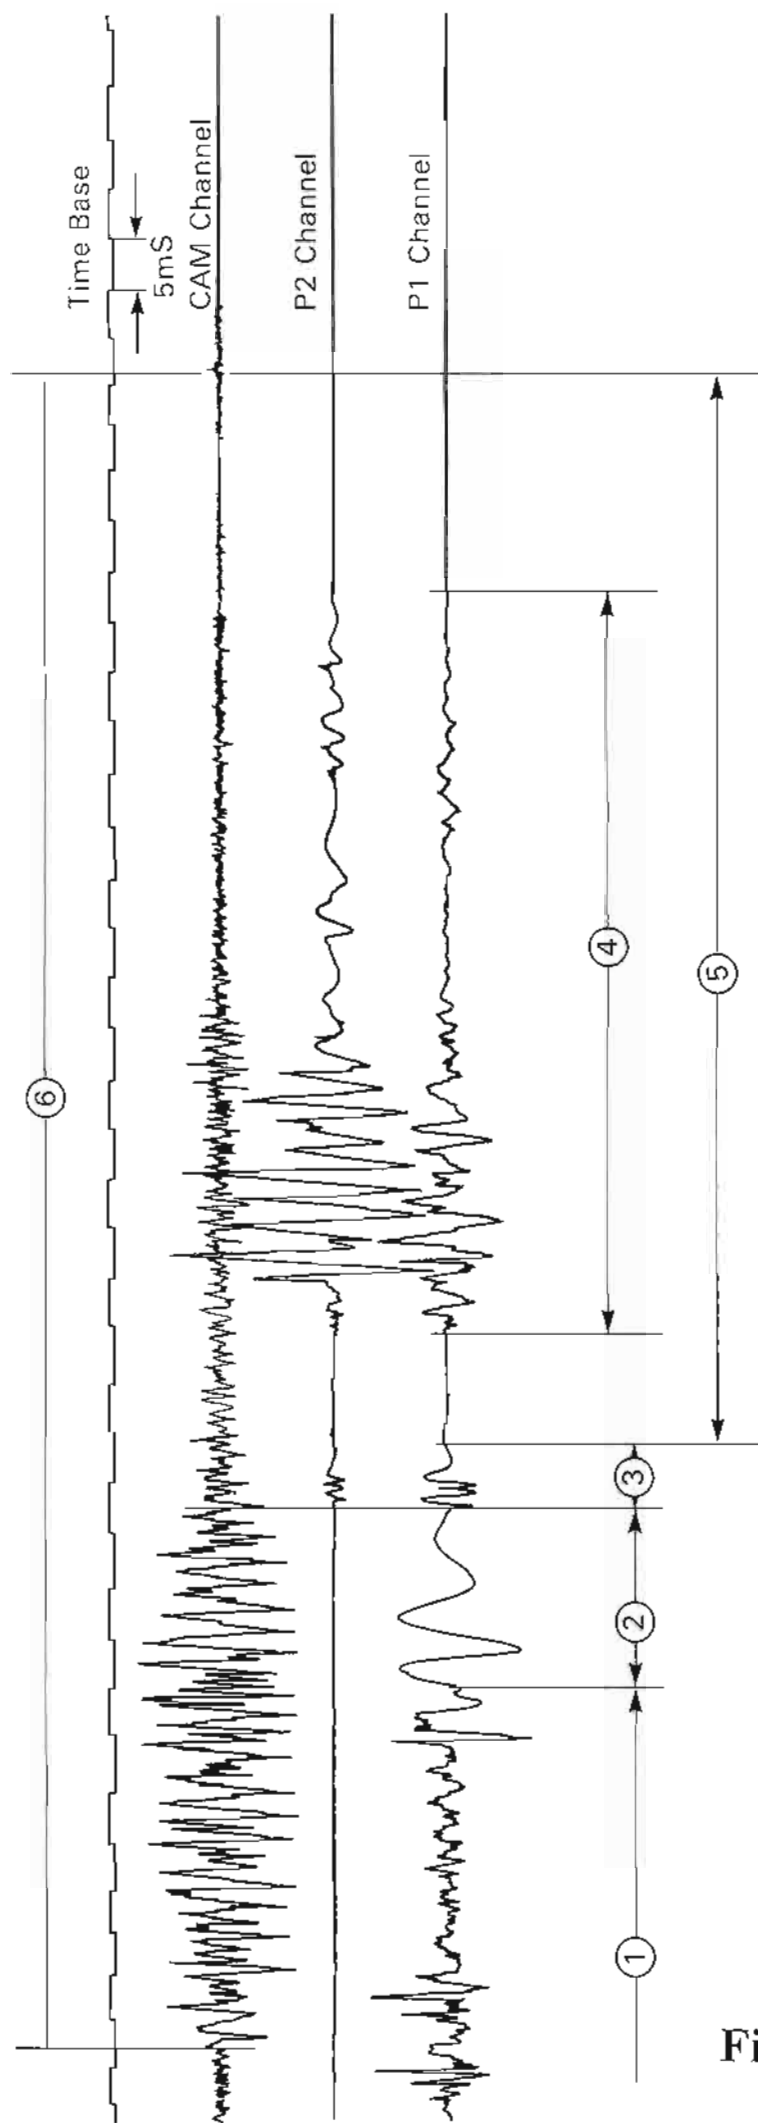
Figure C-8 is an expanded UV trace of the final milliseconds of the CVR record. Three tracks have been used, the flight engineer's RTF channel which contained similar information to the P2's channel has been replaced with a timing signal. Individual sections of interest are identified by number. On the bottom trace, the P1 RTF track, section 1 is part of the Shanwick transatlantic clearance. During this section the loud sound on the CAM channel is evident.

The CAM unit is of the old type which has a frequency response of 350 to 3500 Hz. The useable duration of the signal is probably confined to the first 60 milliseconds of the final 170 milliseconds and even during this period the AGC is limiting the signal. In the remaining time the sound is being distorted because power to the recorder has been disconnected. The ambient cockpit noise may have been high enough to have caused the AGC to have been active prior to the event and in this event the full volume of the sound would not be audible. Distortion from the incomplete erasure of the last recording may form part of the recorded signal.

The end of the recorded signals from the CVR of  
the final flight of N739PA
