**Air Accidents Investigation Branch**

**Report on the accident to  
Boeing 747-121, N739PA at  
Lockerbie, Dumfriesshire, Scotland  
on 21 December 1988**

The report concludes that the detonation of an improvised explosive device led directly to the destruction of the aircraft with the loss of all 259 persons on board and 11 of the residents of the town of Lockerbie. Five recommendations are made of which four concern flight

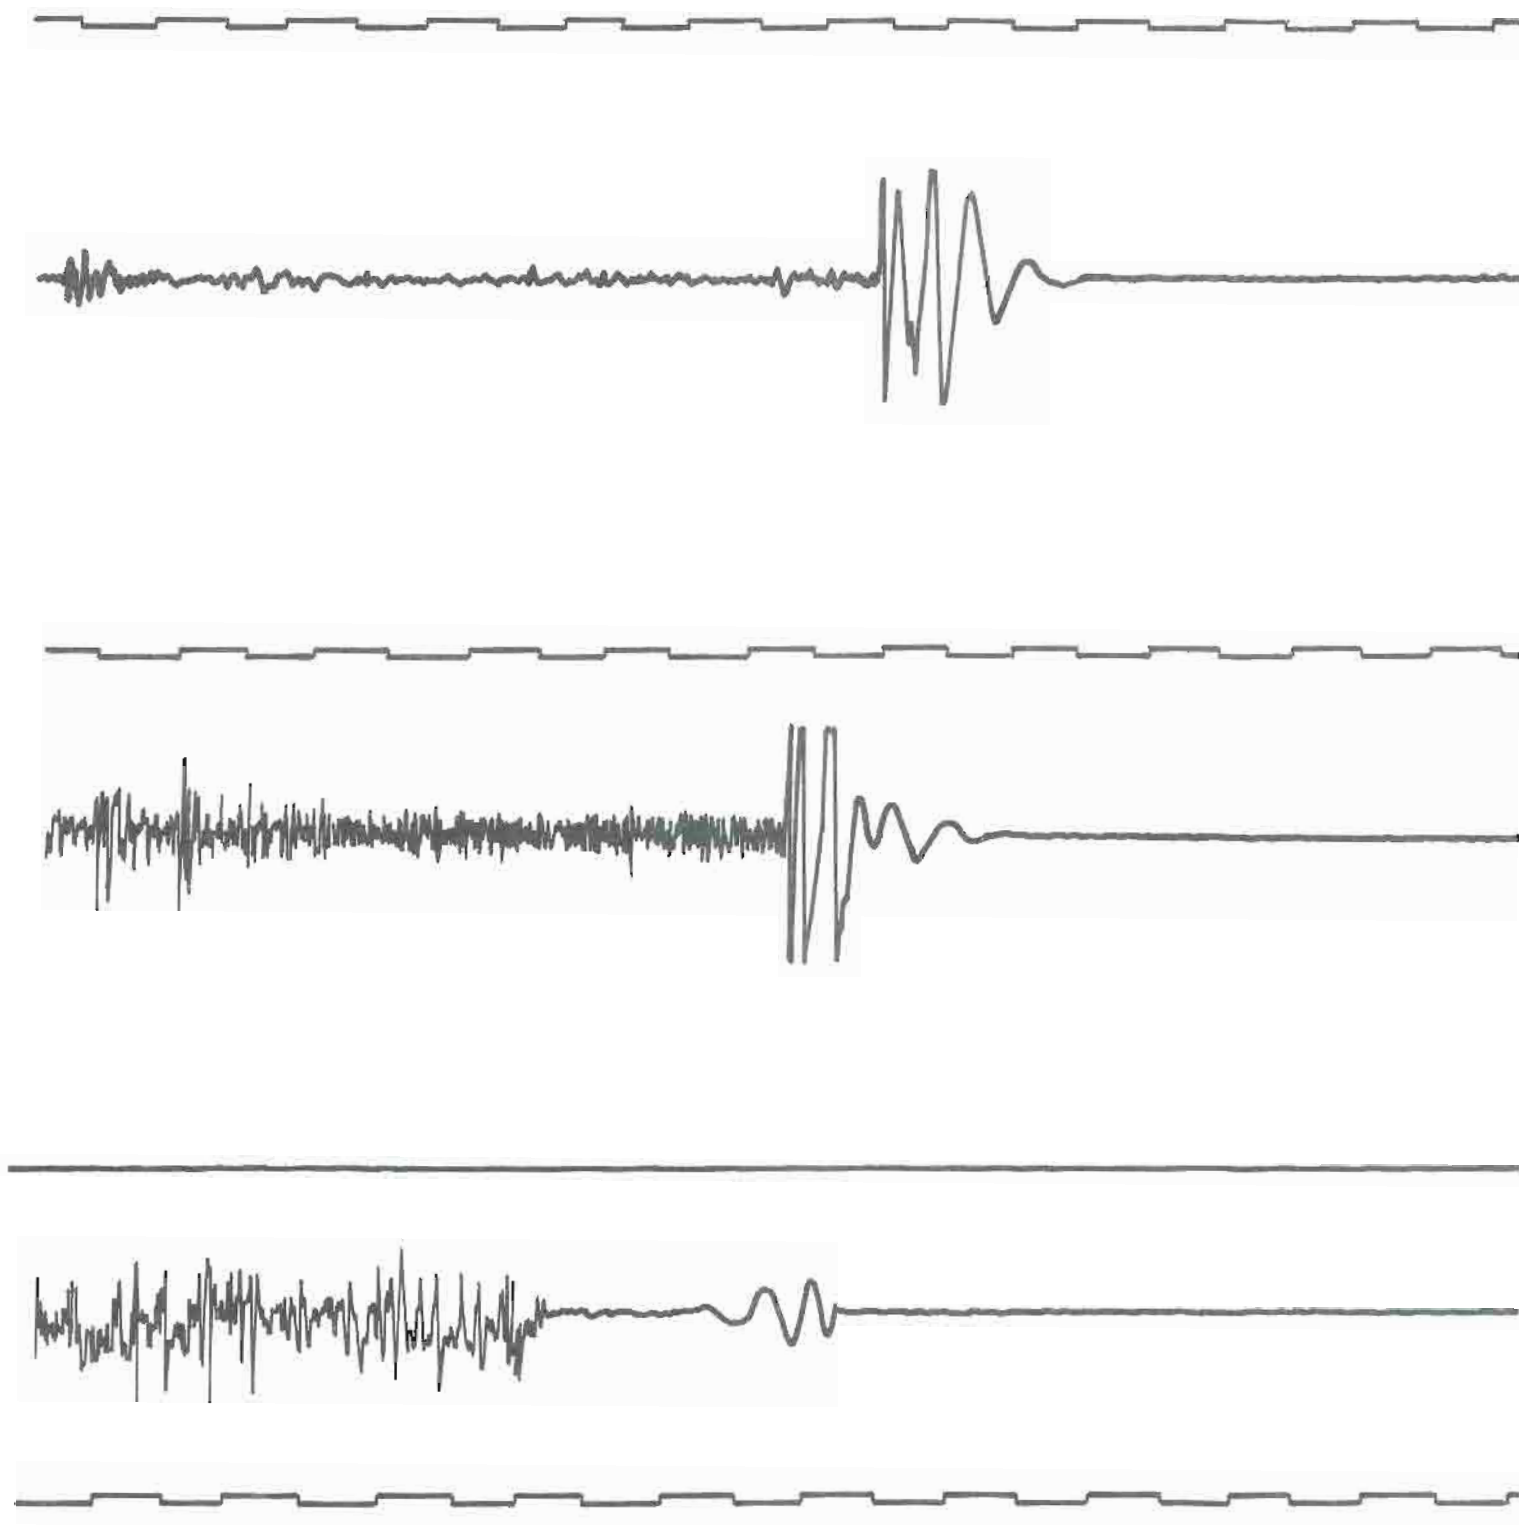
Figure C-10

Three typical end of RTF transmission transients  
from N739PA, recorded on the CVR

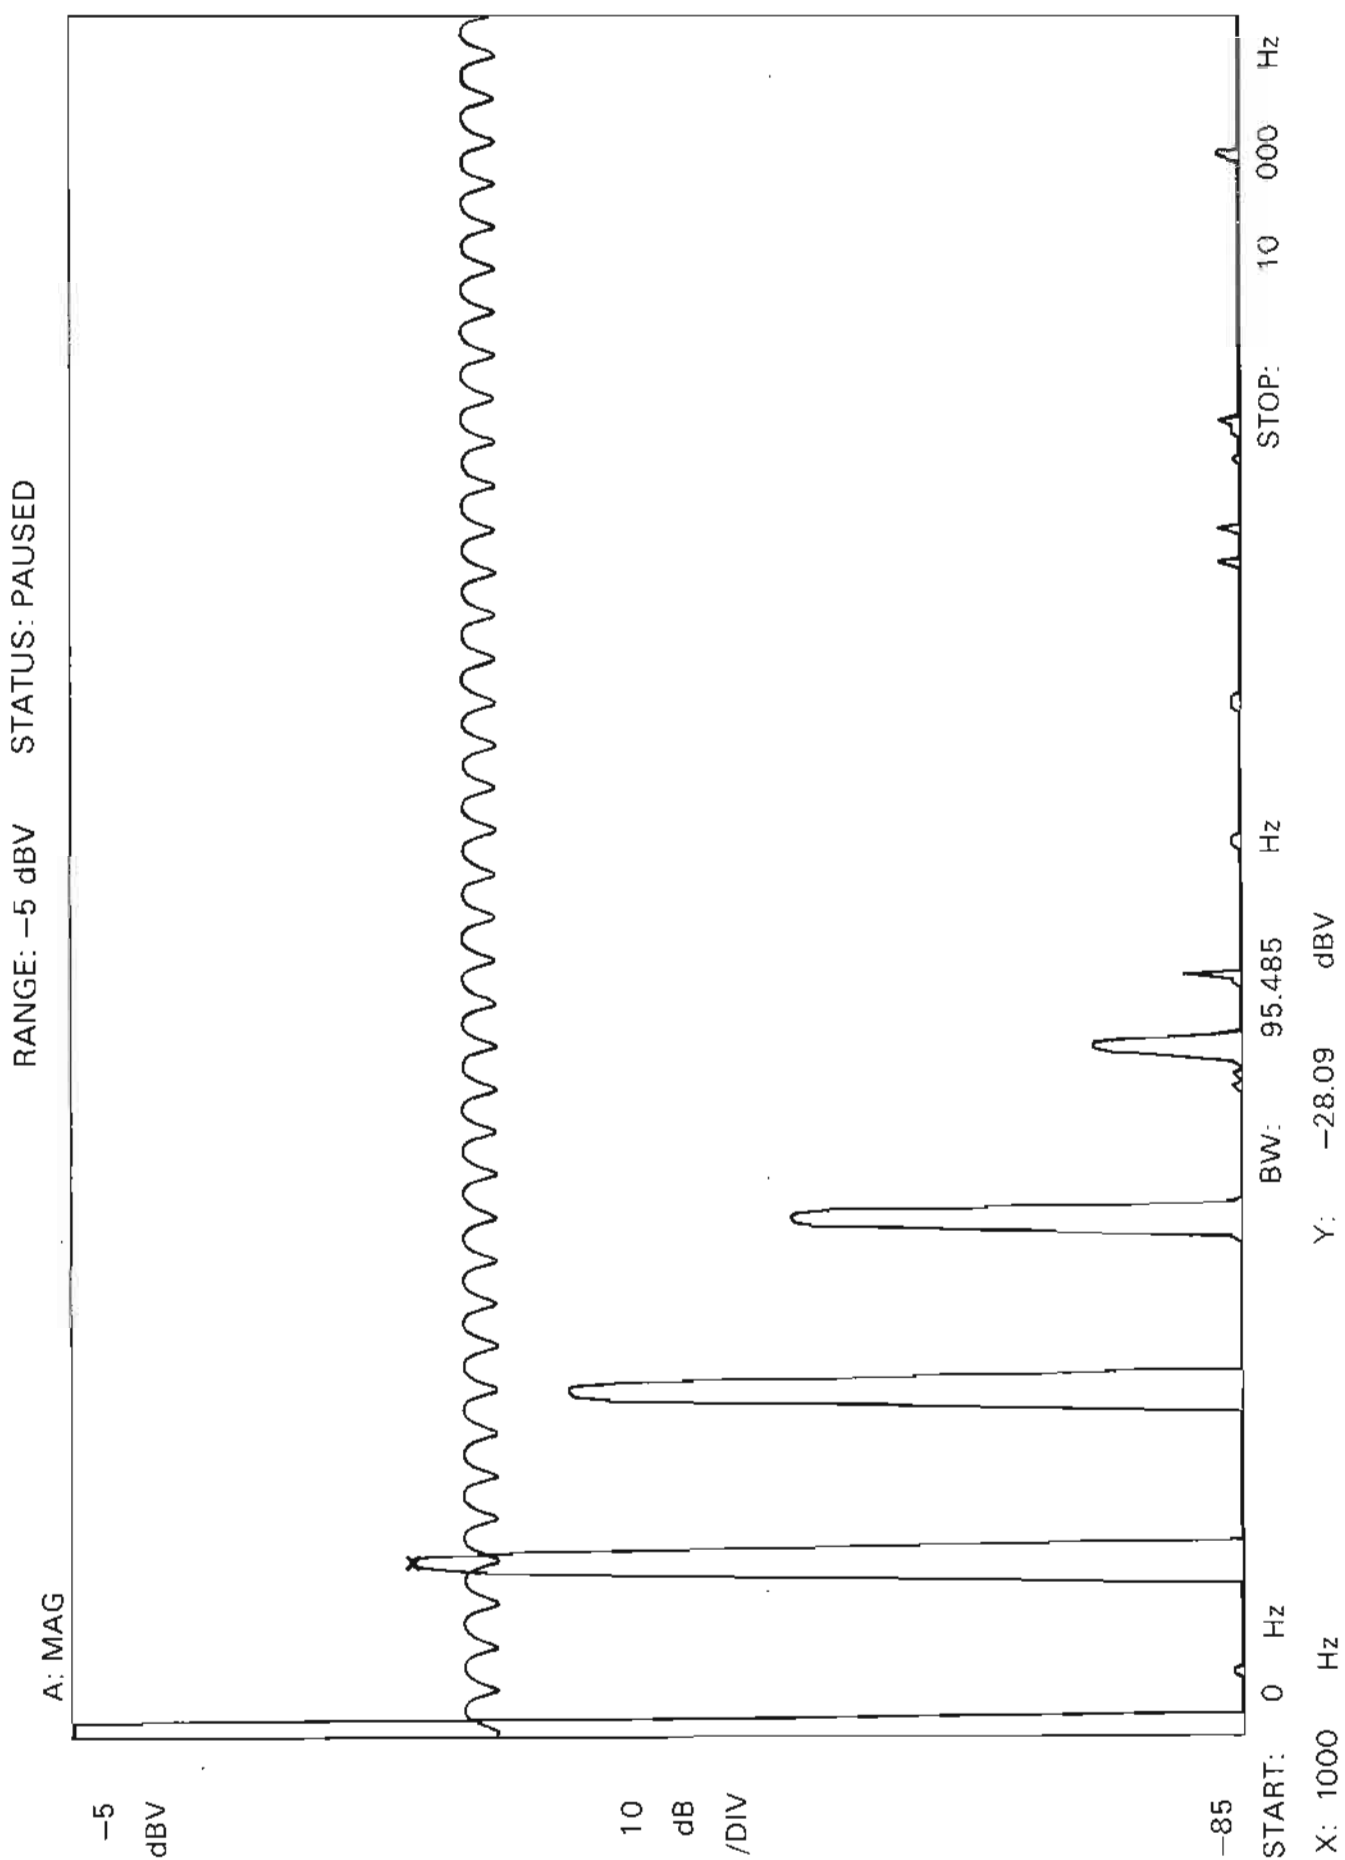
Figure C-12

Additionally some of the frequencies present on the recording were not present in the original sound, but are the result of the rise in total harmonic distortion caused by the increased amplitude of the incoming signal. Outputs from a frequency analysis of the recorded signal for the same frequency of input to the CVR, but at two input amplitudes, are shown in Figures C-11 and C-12. These illustrate the effects on harmonic distortion as the signal level is increased. Finally the recorded signal does not lend itself to analysis by a digital spectrum analyser as it is, in a large measure, aperiodic and most digital signal analysis algorithms are unable to deal with a short duration signal of this type, however, it is hoped that techniques being developed in Canada will enable more information to be deduced from the end of the recording.

Harmonic distortion of a relatively high amplitude

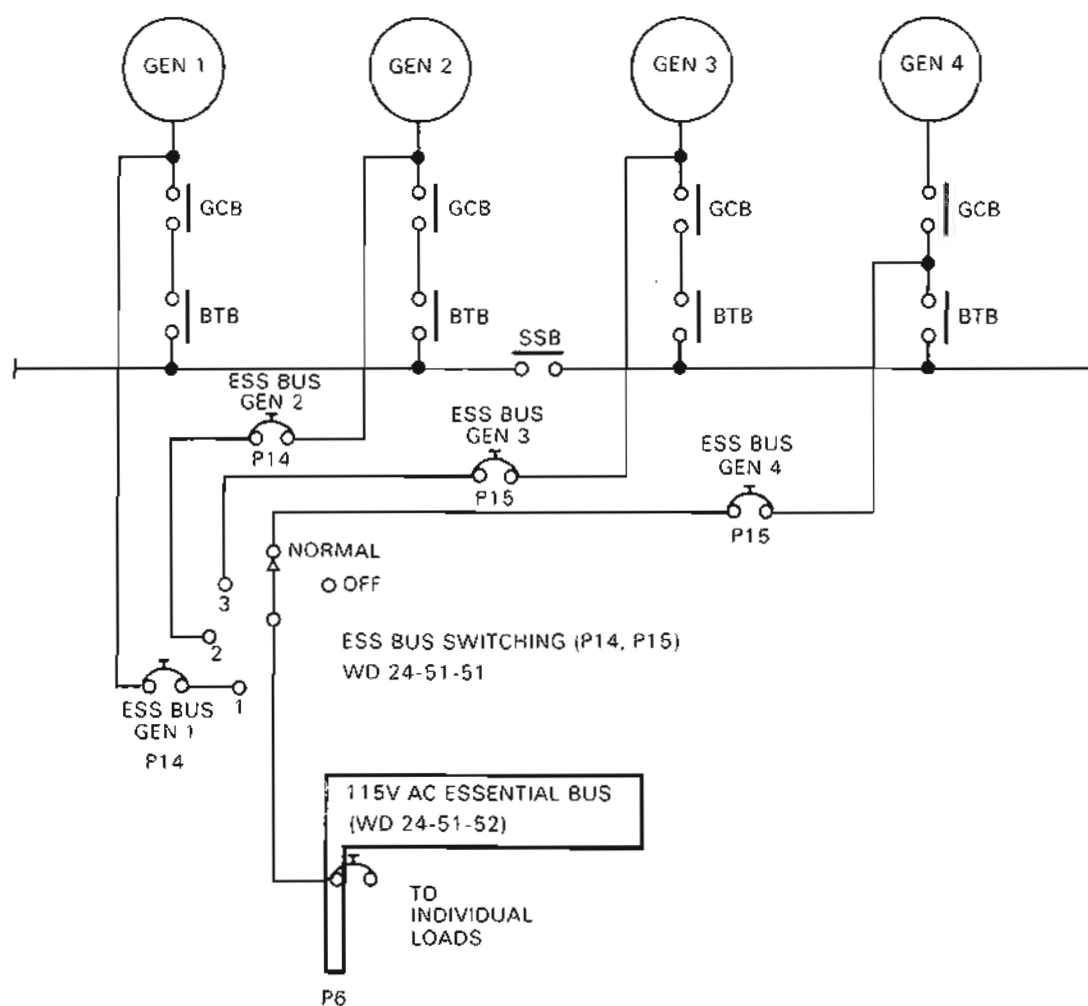
Figure C-13

The short time interval of 55 milliseconds after which the AC supply to the flight recorders was lost limits the basis on which a fault path analysis of the AC electrical system can be undertaken. On the available information only a differential (feeder) fault could have isolated the bus-bar this quickly, with the generator field control relay taking 20 milliseconds to trip. However, in normal operation, the generators would have been operating in parallel and the essential AC bus-bar would have been supplied via the number 4 BTB from the sync bus. If the fault conditions had continued, a further 40 to 100 milliseconds would have elapsed before the BTB opened. If the BTB was open prior to the fault it would have attempted to close and restore the supply to the essential bus. Any automatic switching causes electrical transients to appear on the CVR and data losses on the FDR. Both the CVR and the FDR indicate that a clean break of the AC supply occurred with no electrical transients associated with BTBs open or closing in an attempt to restore power. In the absence of any additional information only two possibilities are apparent:

- i) That all 4 generators were simultaneously affected causing a total loss of AC electrical power. The feeders for the left and right side generators run on opposite sides of the aircraft under the passenger cabin floor. The only situation envisaged that could cause simultaneous loss of all 4 generators is the disruption of the passenger cabin floor across its entire width.
- ii) That disruption of the main equipment centre, housing the control units for the AC electrical system, caused the loss of all AC power. However, again it would have to affect both the left and right sides of the aircraft as the control equipment is located at left and right extremes of the main equipment centre.

Boeing 747 main 115 volt AC power load distribution

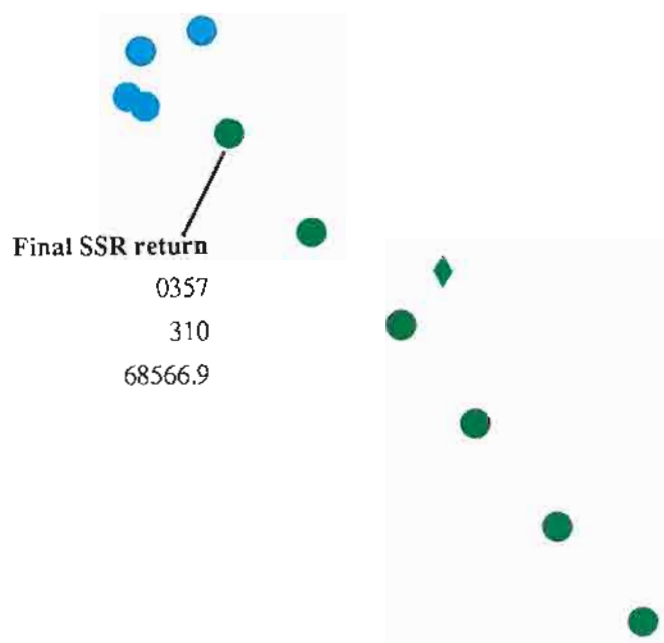
**Figures C-14**

Eight seconds after the sound on the CVR the Great Dun Fell radar showed 4 primary radar returns. The returns indicated a spread of wreckage in the order of 1 nautical mile across track. On successive returns of the radar, two parallel wreckage trails are seen to develop with the second trail, to the north, becoming evident 30 to 40 seconds after the first.

1st Primary Added

**Radar returns from the final flight of N739PA**

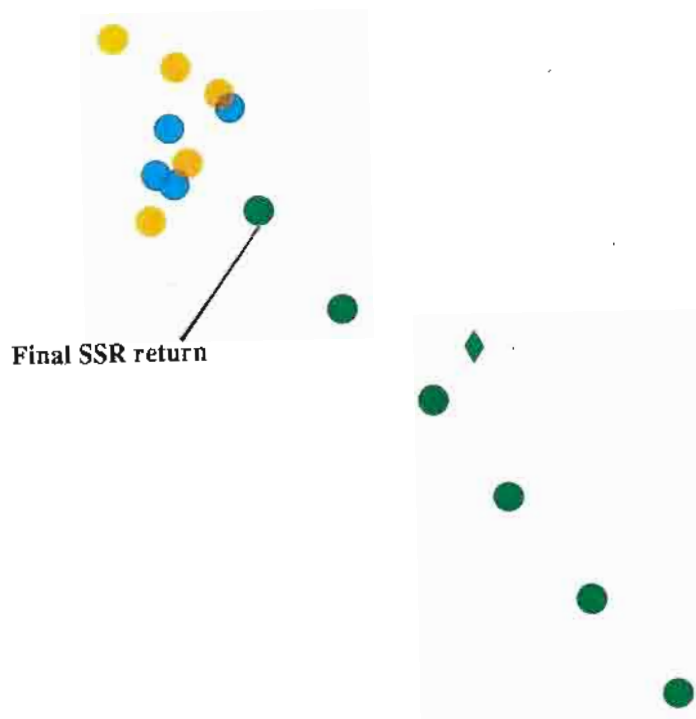
**Figures C-15**

2nd Primary Added

**Radar returns from the final flight of N739PA**

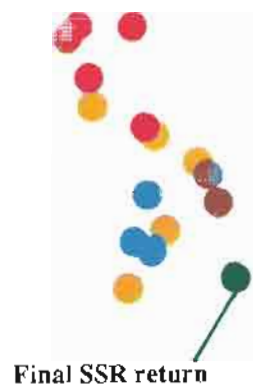
**Figures C-16**

3rd Primary Added

**Radar returns from the final flight of N739PA**

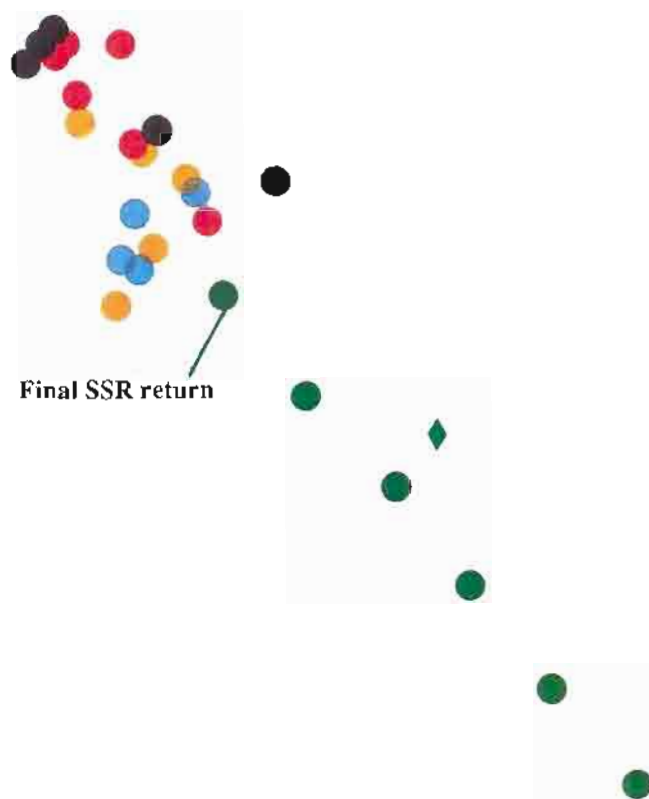
**Figures C-17**

4th Primary Added

**Radar returns from the final flight of N739PA**

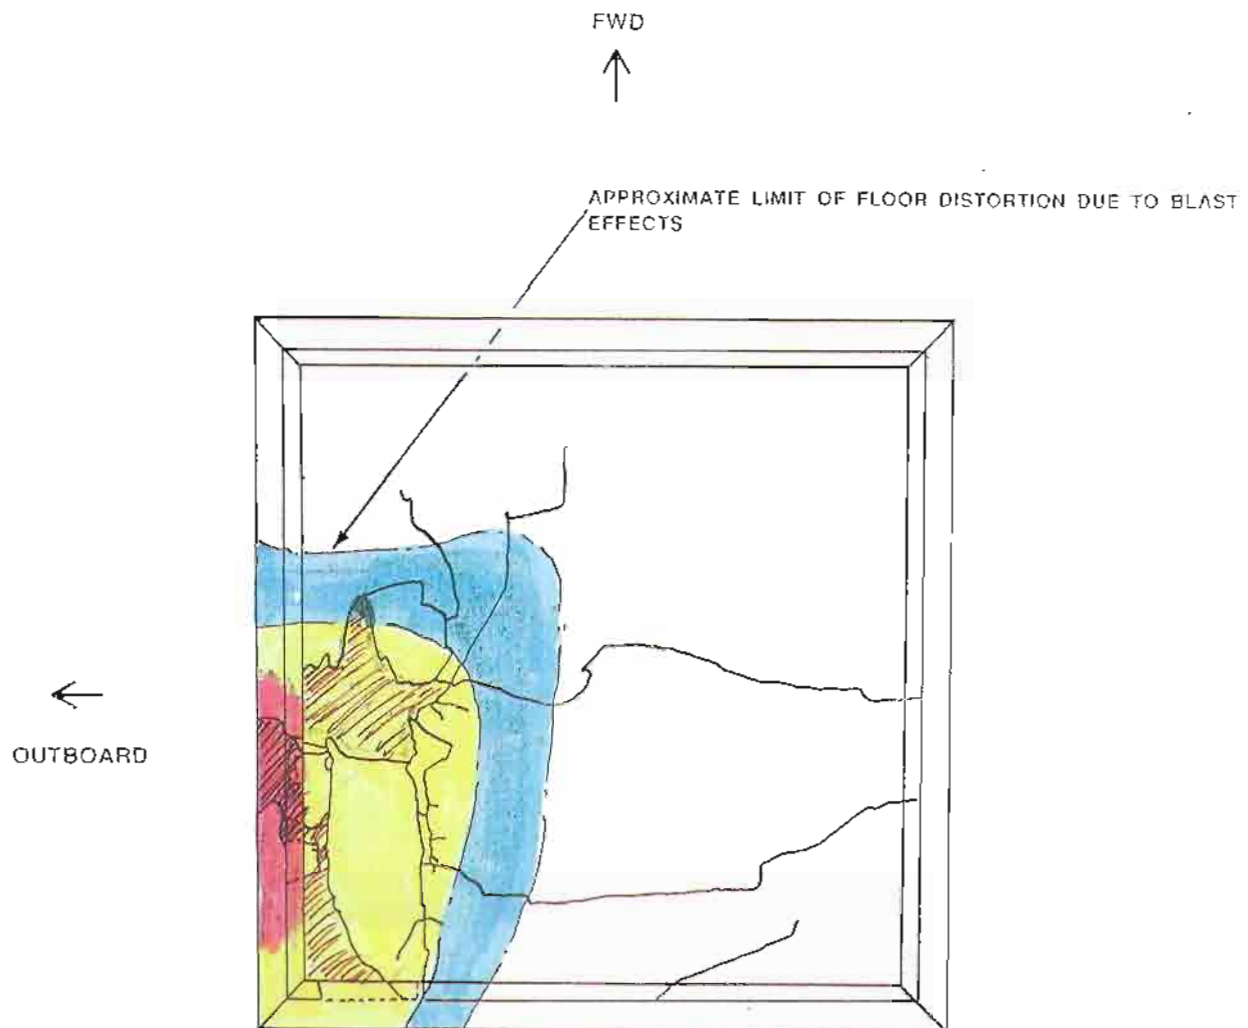
# BAGGAGE CONTAINER FLOOR DAMAGE DIAGRAM

Blast damage to the forward face of container 7511 was as a direct result of hot gases/fragments escaping from the aft face of container 4041. No evidence was seen to suggest that more than one IED had detonated on Flight PA103.

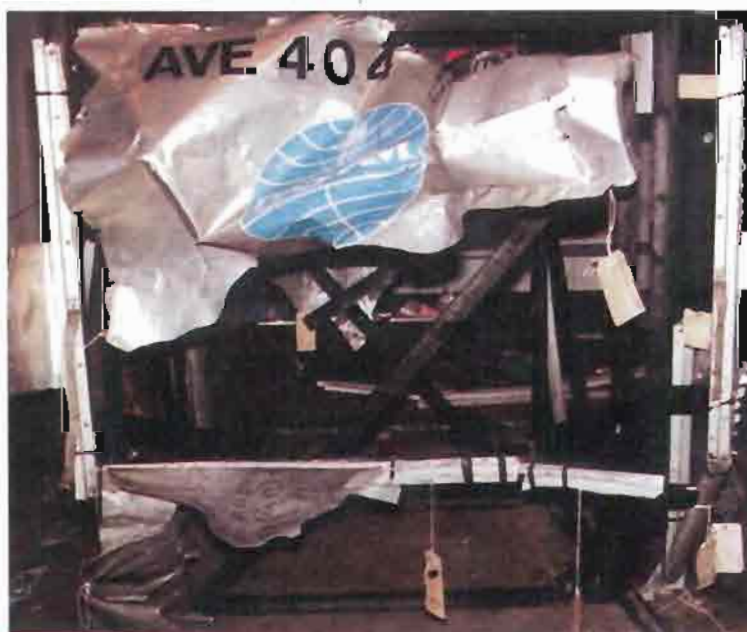
**Figure F-6**

- a Stiffener section from base of vertical face
- b Vertical face forward edge member, lower stiffener section and skin fragment
- c Distorted upper section of vertical face skin
- d Forward section of sloping face skin, severely distorted
- e Fragment of container skin, provisionally thought to be part of sloping face skin.

**Outboard faces of AVE 4041**

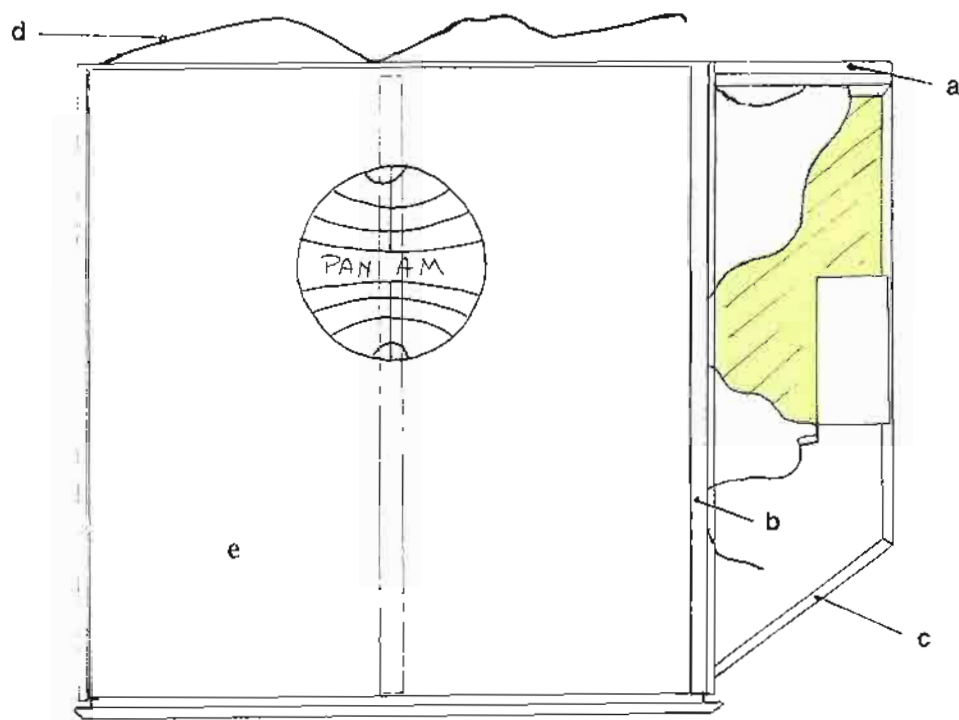
Outboard section of roof edge member

- b Forward face outboard skin, attached to vertical edge member
- c Forward edge member of sloping face
- d Roof skin panel, complete except for aft outboard corner
- e Forward face panel, complete with top, left and lower edge members

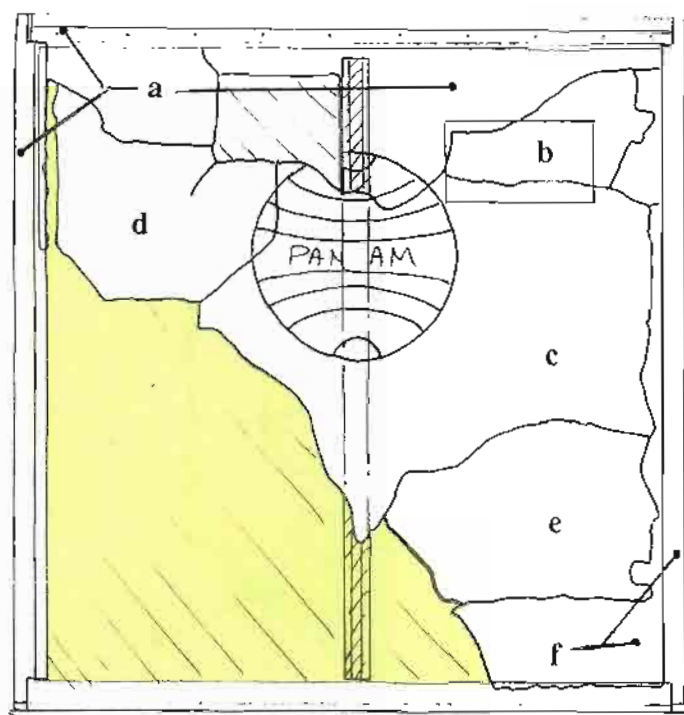
- a Aft, top and roof edge members including upper section of skin
- b Repair patch from upper right side
- c Mid section of skin including stiffener section
- d Upper skin section
- e Lower skin section
- f Right side vertical edge member attached to lower piece of skin

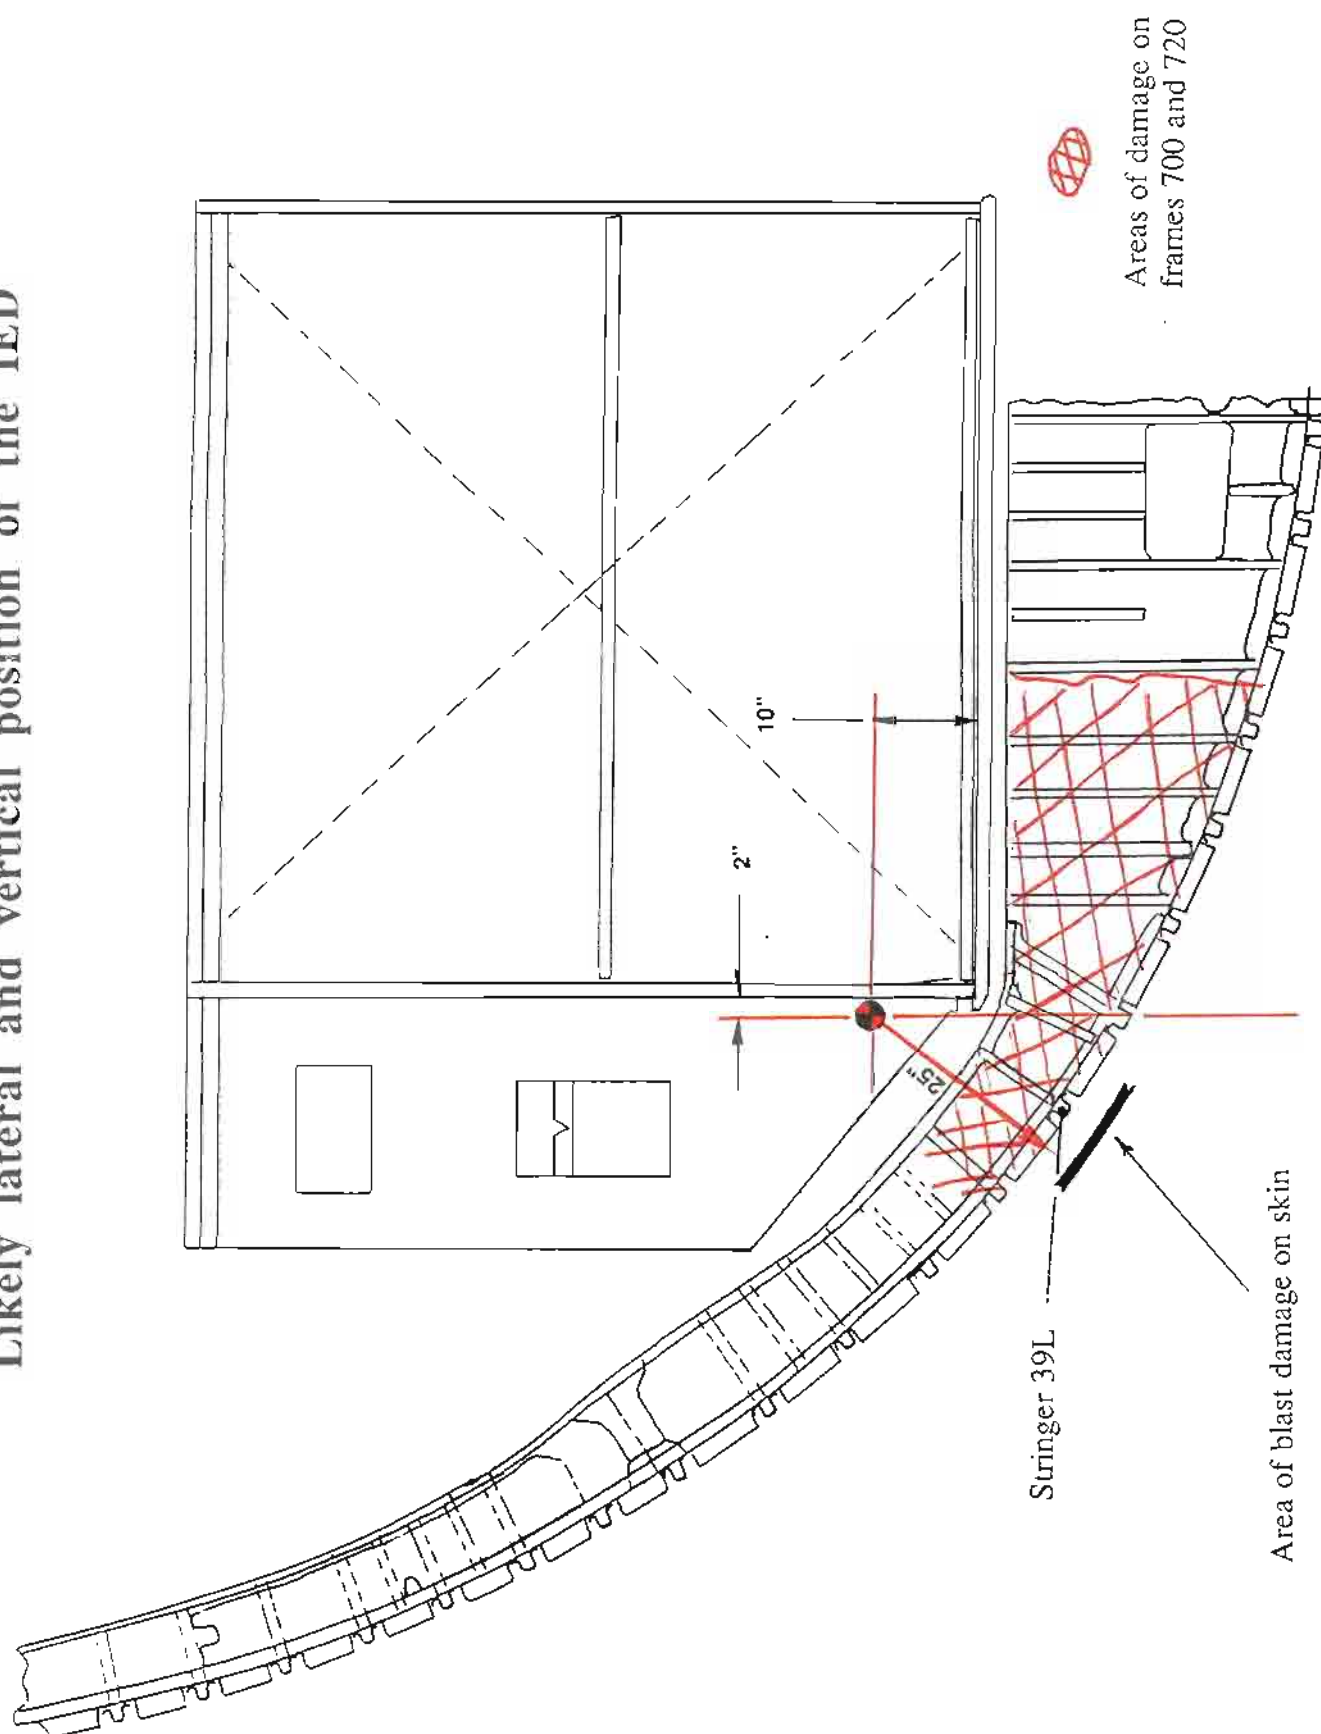
Figure F-13

## Likely lateral and vertical position of the IED

Whilst the analytical method makes no allowance for the effect of the IED casing, or any other baggage or container structure interposed between the charge and the fuselage skin, the presence of such a barrier would have tended to absorb energy rather than redirect the transmitted shock wave; therefore its presence would have been more critical in terms of charge size than of position. Certainly, the standoff distance predicted by this method was strikingly similar to the figure of 25 inches derived independently from the container and fuselage reconstructions.

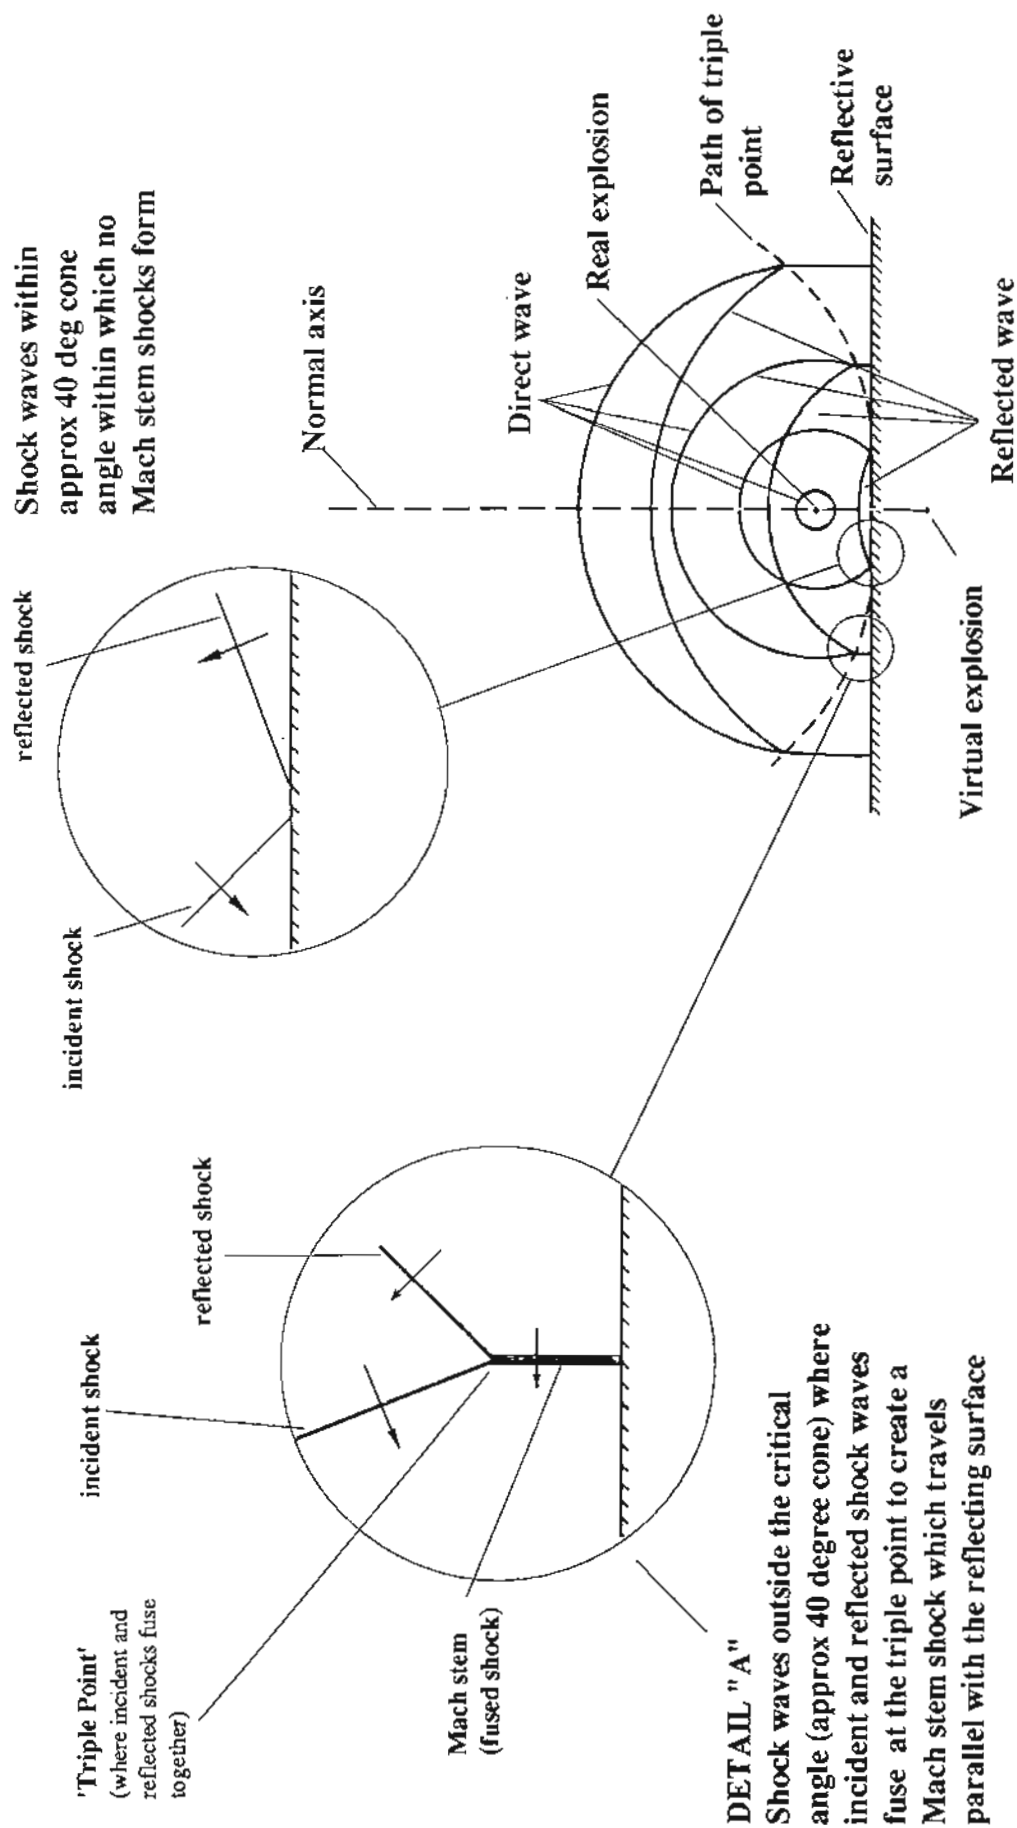
Figure G-1

Within the constraint of the likely charge size used on Flight PA103, calculations suggested that the initial Mach stem shock wave pressure close to the region of Mach stem formation (i.e. the shock wave *face-on* pressure, acting at right angles to the skin), was likely to be more than twice that of the incident shock wave, with a velocity of propagation perhaps 25% greater. However, the Mach stem out-of-plane pressure, i.e. the pressure felt by the reflecting surface where the Mach stem touches it, would have been relatively low and insufficient to shatter the skin material. Therefore, provided that the charge had sufficient energy to produce skin shatter within the conical central region where no Mach stems form, the size of the shattered region would be a function mainly of charge standoff distance, and charge weight would have had little influence. Consequently, it was possible to calculate the charge standoff distance required to produce a given size of shattered skin from geometric considerations alone. On this basis, a charge standoff distance of approximately 25 to 27 inches would have resulted in a shattered region of some 18 to 20 inches in diameter, broadly comparable to the size of the shattered region evident on the three-dimensional wreckage reconstruction.
