AIRCRAFT ACCIDENT INVESTIGATION REPORT

**China Airlines
Airbus A300B4 – 622R, B-1814
Da-Yuang, Tao-Yuang
February 16, 1998**

May 18, 2000

Civil Aeronautics Administration

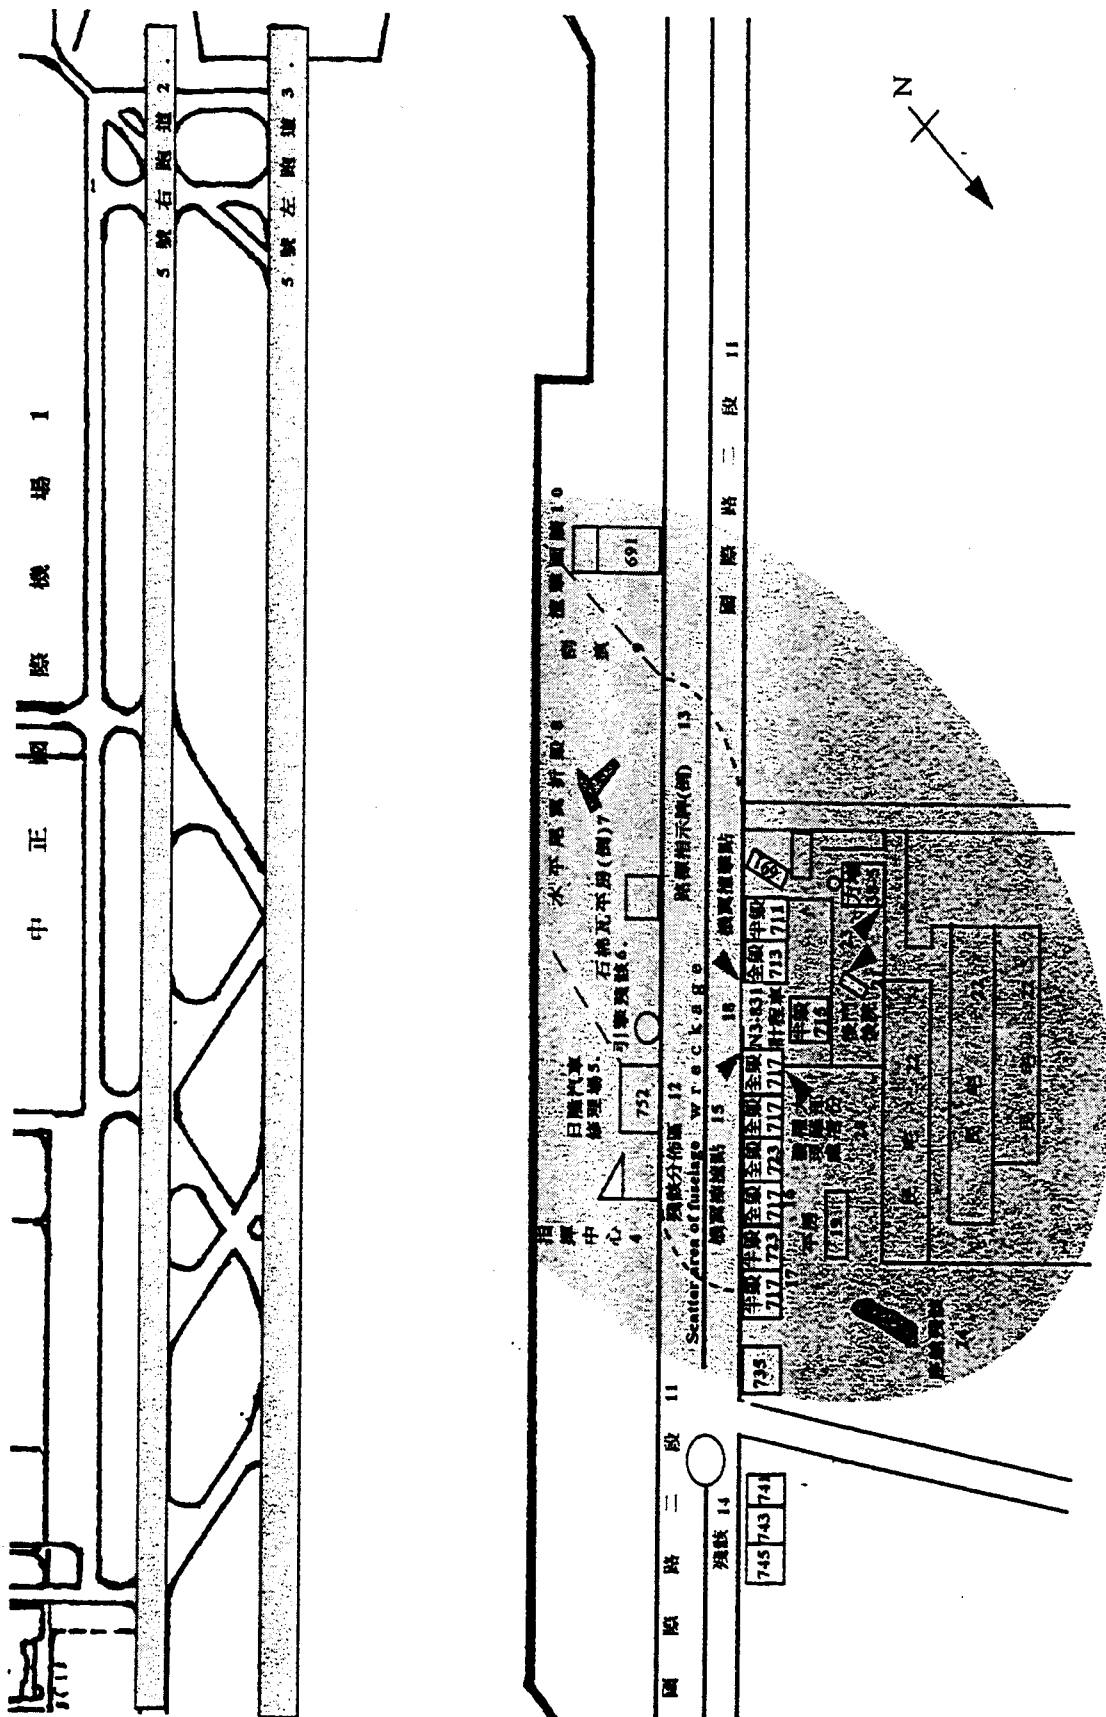
Diagram Map of the Scene

1. CKS International Airport
2. Runway 05 R
3. Runway 05 L
4. Command Center
5. Jih-Lung Auto Tune-Up Shop
6. Engines Wreckage
7. Fallen Asbestos Shingle Bungalow
8. Broken Tailplane
9. Scratch/Gash
10. Collided With Fence
11. Kuo-Chi Rd., Sec. 2
12. Scatter Area of Fuselage Wreckage
13. Fallen Road Sign
14. Wreckage
15. Collision Point of Wing
16. Completely Destroyed
17. Partly Destroyed
18. Taxi
19. Bungalow
20. Exhibited Location of Most Victims
21. Back Door/Back Yard
22. Residence
23. Residence
24. Cabin Frame/Skin Wreckage
