AIRCRAFT ACCIDENT REPORT

Controlled Flight into Terrain

Ilyushin IL-76 TD, RDPL-34141
Baucau, Timor-Leste
31 January, 2003

Australian Transport Safety Bureau

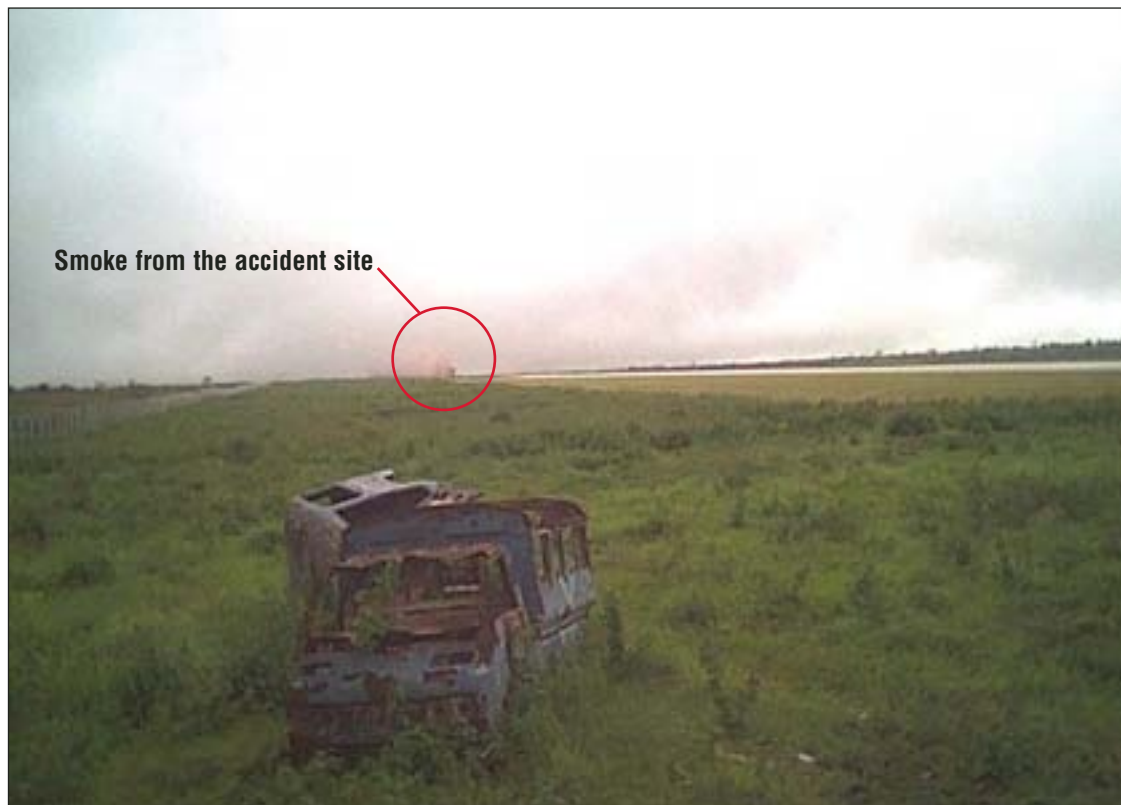
FIGURE 5:
Smoke seen to the northwest of the aerodrome

- the aircraft landing gear was not extended as it overflew the aerodrome on the first occasion (see Figure 3)
- the aircraft landing gear was extended during the first landing approach (see Figure 4), but the aircraft appeared too high to be able to land, and discontinued the landing approach
- the weather at the time was overcast with a low cloud base
- a few minutes after the discontinued first landing approach, they heard an explosion to the northwest of the aerodrome, and saw flames and smoke in that vicinity (see Figure 5).

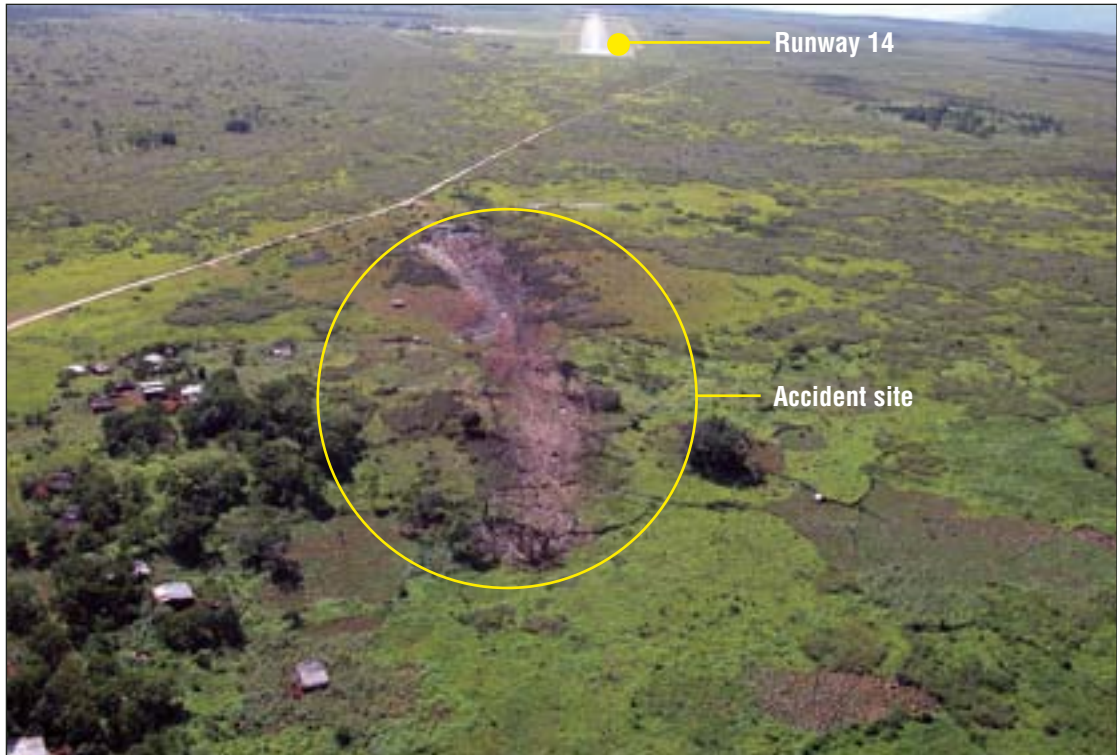
FIGURE 19:
Accident site in relation to Baucau runway 14

The aircraft impacted terrain about 1 NM (2 km) to the north-northwest of Baucau aerodrome. The accident site is depicted at Figures 19 and 20.

The terrain between the impacted trees and the aerodrome contained no other significant groups of trees of similar height to those impacted (see Figures 19 and 20). The investigation concluded that had the correct QNH had been used to establish QFE, impact with the trees may have been avoided. The investigation also concluded, however, that the likelihood of impact with terrain at a point closer to the runway would probably have remained almost certain. Under those circumstances, even though the aircraft would probably have sustained severe damage by impact forces, the consequences of the CFIT event may not have been as catastrophic.

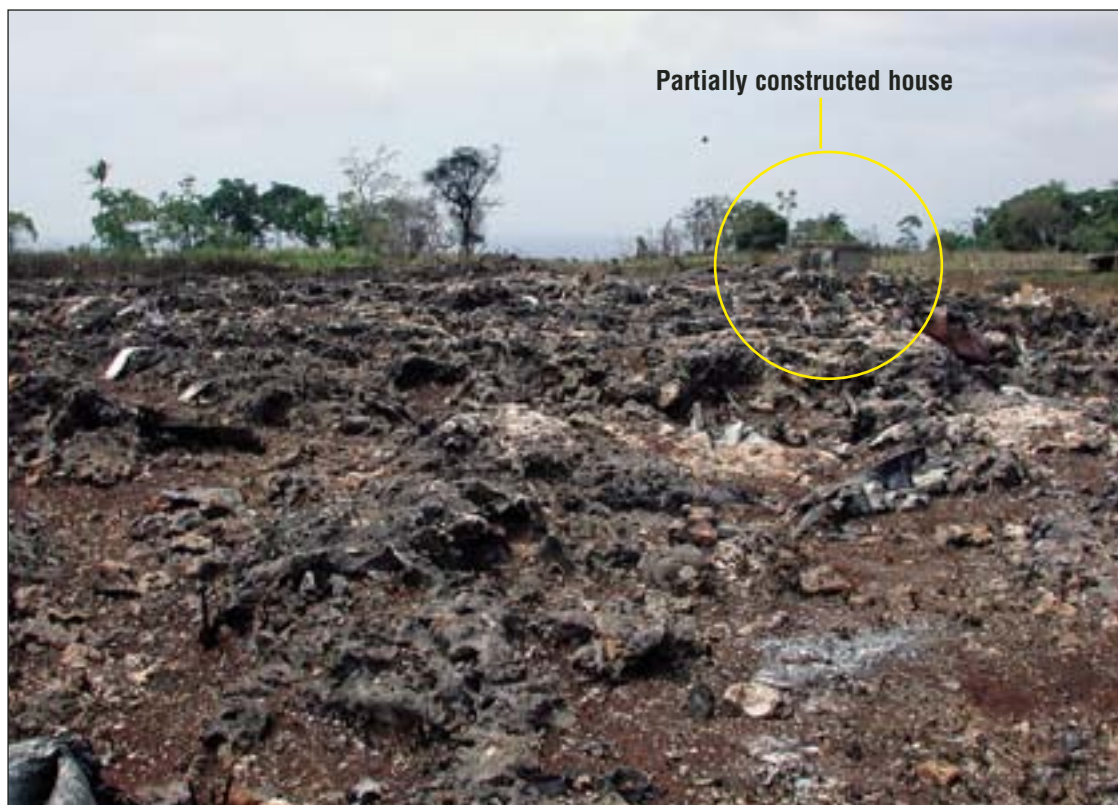
FIGURE 22:
Terrain within the wreckage area

A serrated area of rising ground consisting of coral outcrops up to a metre (3.3 ft) high was located just past the partially constructed house that was struck by the aircraft during the impact sequence. The area was difficult to traverse on foot, and the Australian investigation team likened it to an 'enormous cheese-grater' (see Figure 22).

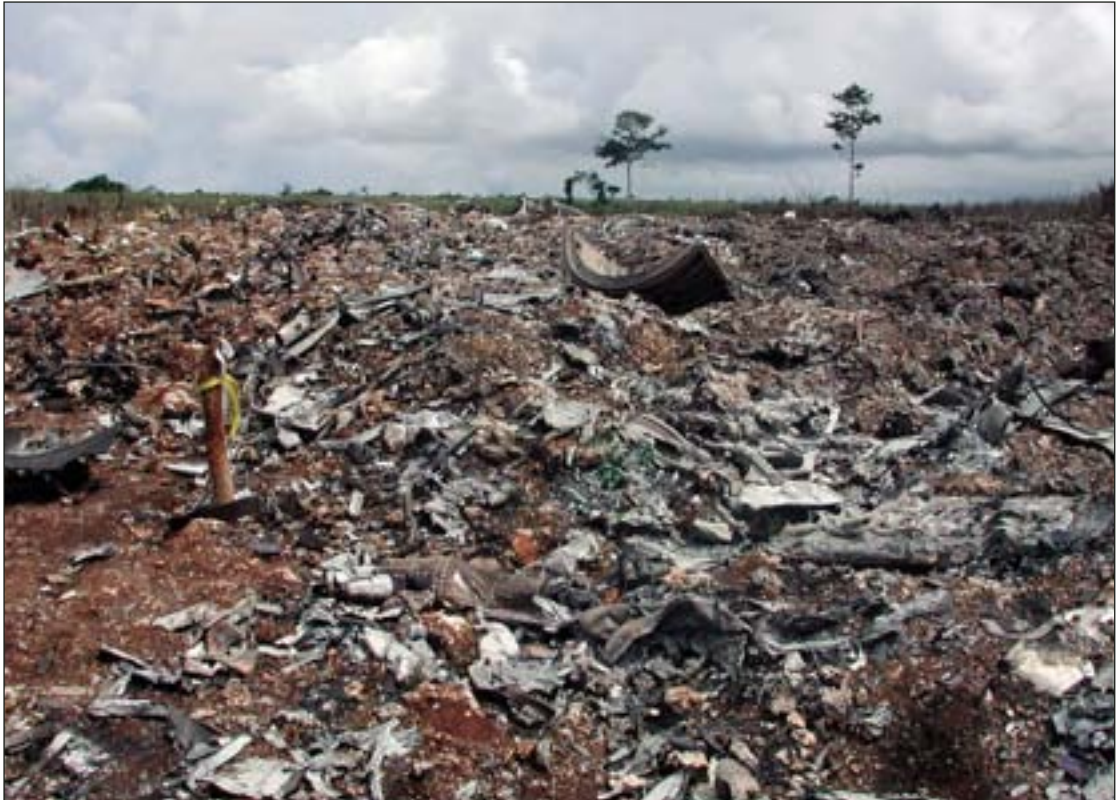
FIGURE 23:
Commencement of the cockpit wreckage area

Many small parts of the forward fuselage section, wing sections, and engine fan blades were found to the left of the wreckage trail, starting from the beginning of that serrated portion of ground. Several of the cockpit instruments, controls, the quick access recorder, the remains of most of the occupants, and large sections of the cockpit windows were also found to the left of and beyond that area (see Figure 23). The area also displayed evidence of an intense short-duration fire.

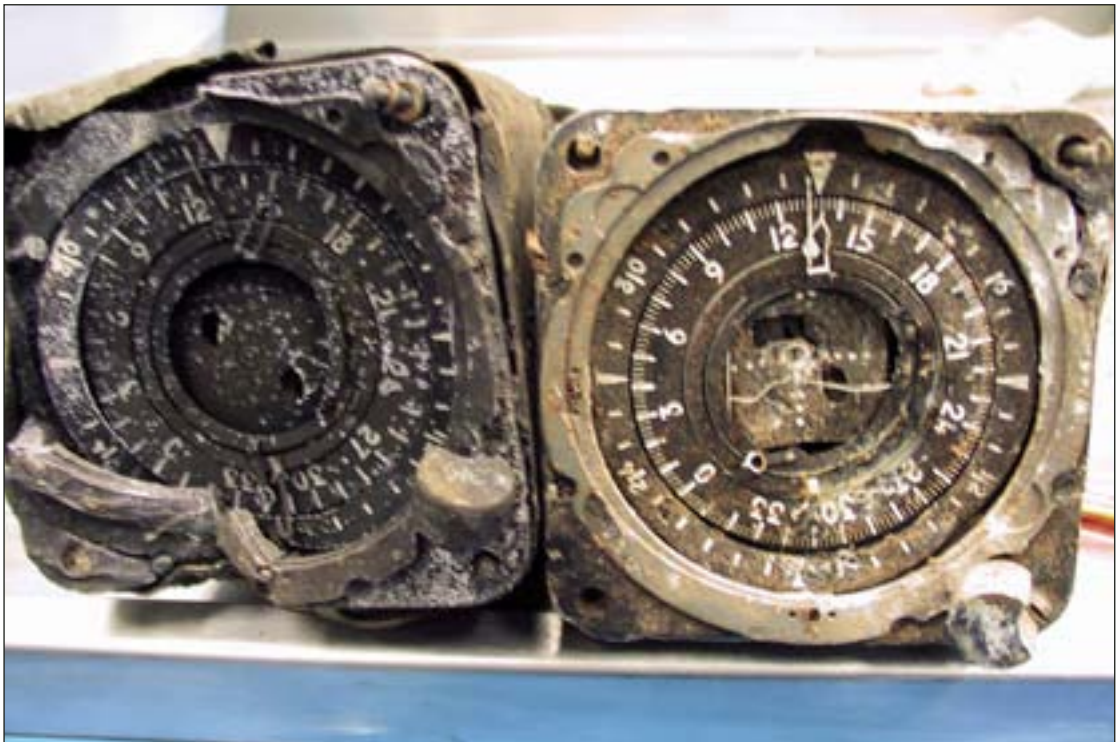
FIGURE 24:
Course Indicators recovered from the wreckage

Two CIs were recovered from the wreckage (see Figure 24).

The impact forces had substantially damaged both the CIs. One was badly sooted from exposure to the post-impact fire around where it lay after being dislodged from the instrument panel. The 3K desired heading pointer on the less-damaged CI was aligned to a magnetic heading of about 134 degrees. The 3K desired heading pointer of the more-damaged CI had been bent during the impact sequence.

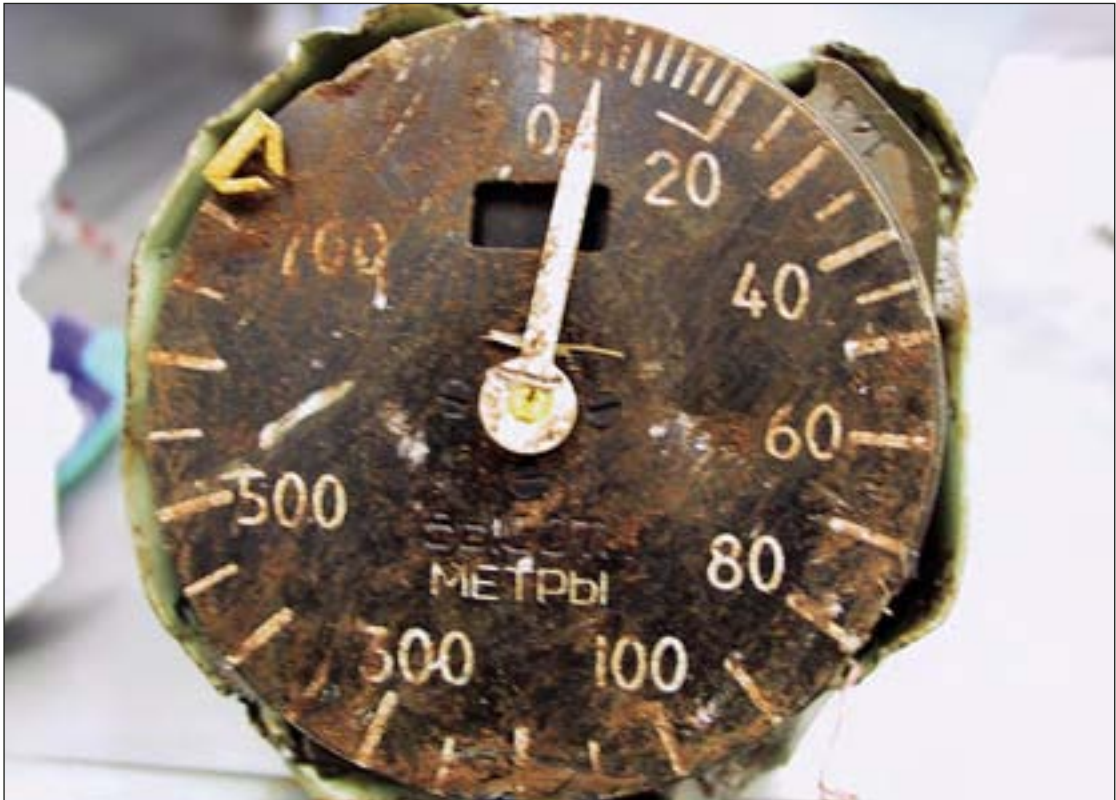
FIGURE 26:
The PB-750 radio altimeter indicator located in the aircraft wreckage

The more-damaged indicator was a PB-750 m scale unit (see Figure 26). The reference bug on that indicator was set to 750 m.

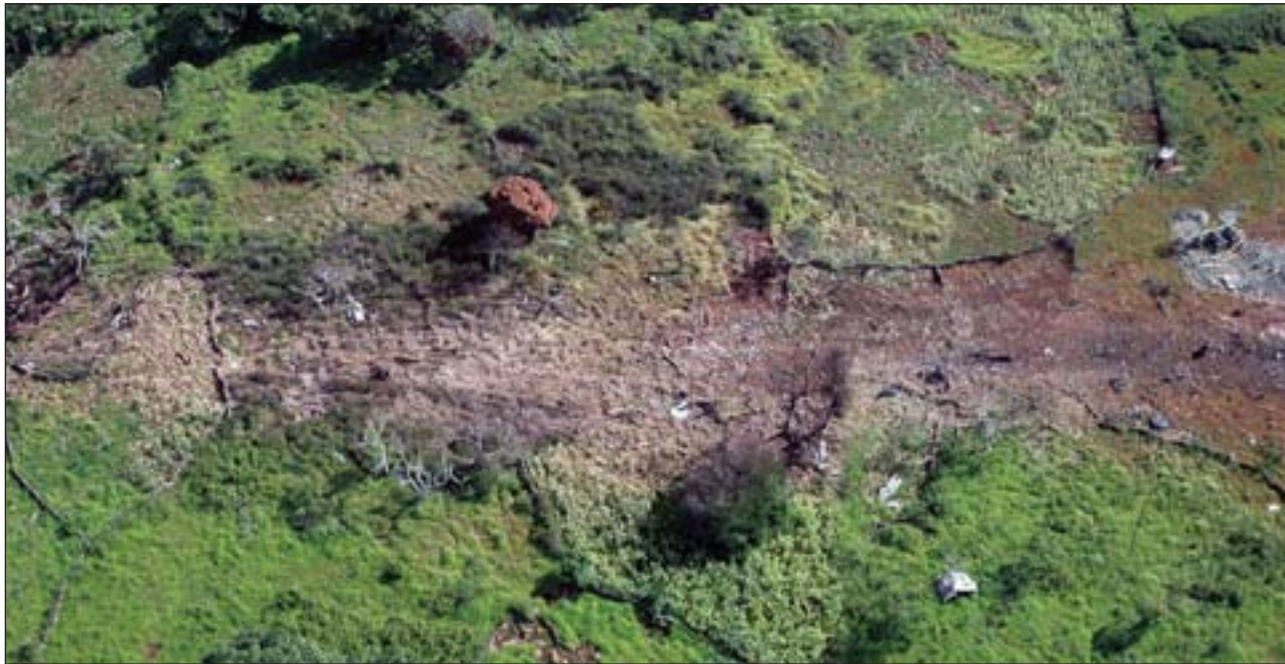
FIGURE 29:
Chemical damage from fuel spillage

Fuel spillage and misting occurred from the damaged and ruptured left wing following the impact with the trees at the beginning of the wreckage trail. The chemical damage from fuel spillage and misting resulted in the browning of much of the vegetation in and around the north-western and central areas of the wreckage trail (see Figure 29).

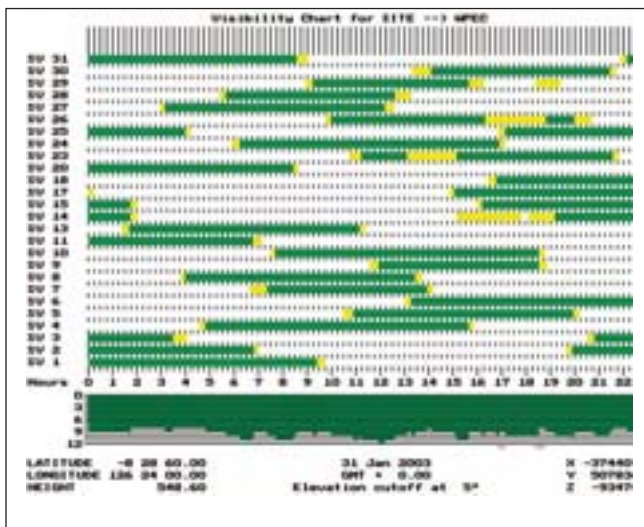
FIGURE 35:
GPS satellite coverage at Baucau

In certain locations, there are insufficient satellites in view to provide RAIM integrity monitoring. Those gaps in coverage are referred to as RAIM holes. There were 11 satellites in view at Baucau at the time of the occurrence (see Figure 35). Green signifies a satellite's elevation of greater than 5 degrees above the horizon and yellow signifies a satellite's elevation of between 0 degrees and 5 degrees above the horizon.

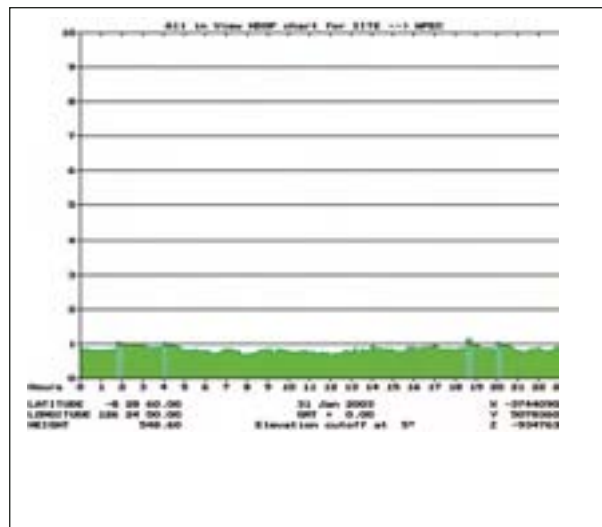
FIGURE 36:
Satellite HDOP at Baucau

Dilution of precision may also affect the integrity of navigation data provided by a GPS, and its extent is dependent on the number of satellites in view to a GPS, and also the geometry of those satellites relative to the user. Under ideal conditions, the calculated position of a GPS will be at the point where two satellite range rings intersect. However, in reality the calculated position will be in an area of uncertainty, because of errors in the satellite ranges, and the area of uncertainty will become greater as the two satellites get closer to each other. Dilution of precision occurs in both vertical (VDOP) and horizontal senses (HDOP), with HDOP being more critical in terms of the integrity of lateral navigation solutions. The calculated HDOP at Baucau at the time of the occurrence was less than 1, and would have resulted in little effect on the integrity of lateral navigation data that was being provided by the aircraft's GPS (see Figure 36).

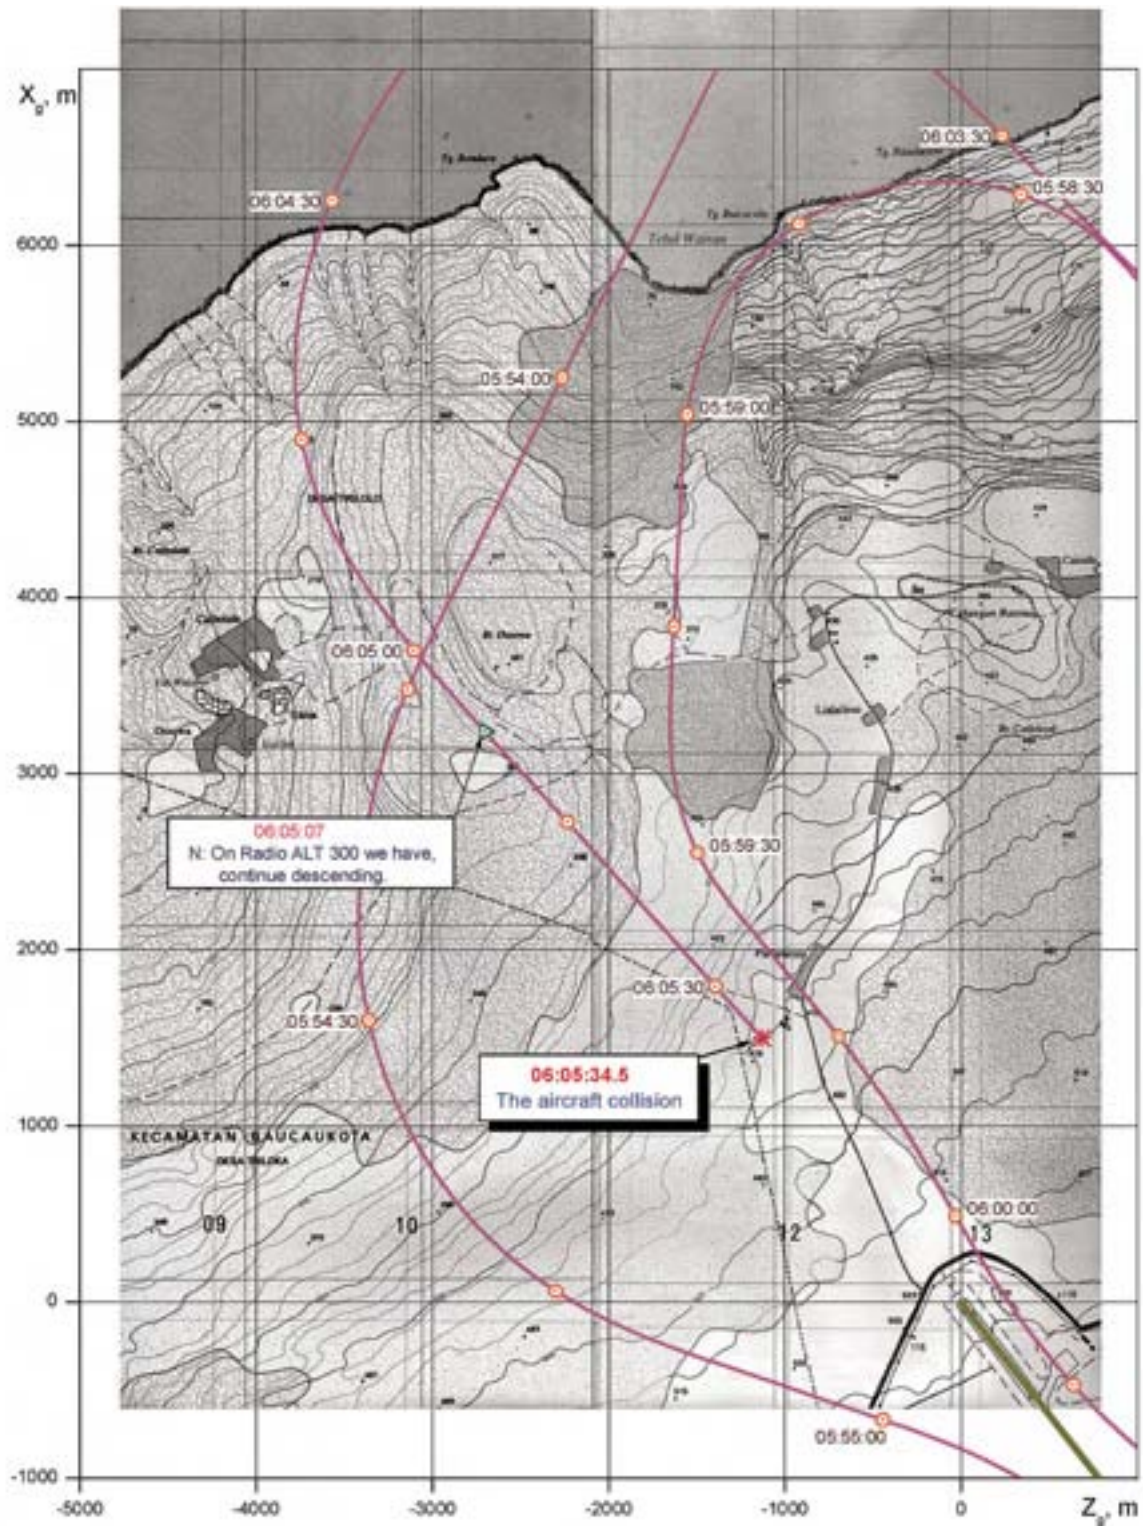
FIGURE 37:
Aircraft position over the terrain at 06:05:07

The IAC plotted the aircraft's flight path onto the Baucau, East Timor 2507-42 T754 Edition 2 topographic map. The map displayed contour elevations in metres AMSL. The IAC reported that it concurred with the Australian investigation team that the aircraft had been overhead the 320 m (1,050 ft) contour at time 06:05:07 (see Figure 37).

The IAC reported that at time 06:05:07 the aircraft was therefore at about 300 m (984 ft) barometric altitude with the altimeter subscales set at 714 mm Hg, and not at 300 m absolute altitude. The IAC concluded that under those circumstances, the flight navigator had mistakenly referred to barometric altitude as radio altitude. The Australian investigation team concurred with the IAC's conclusion.

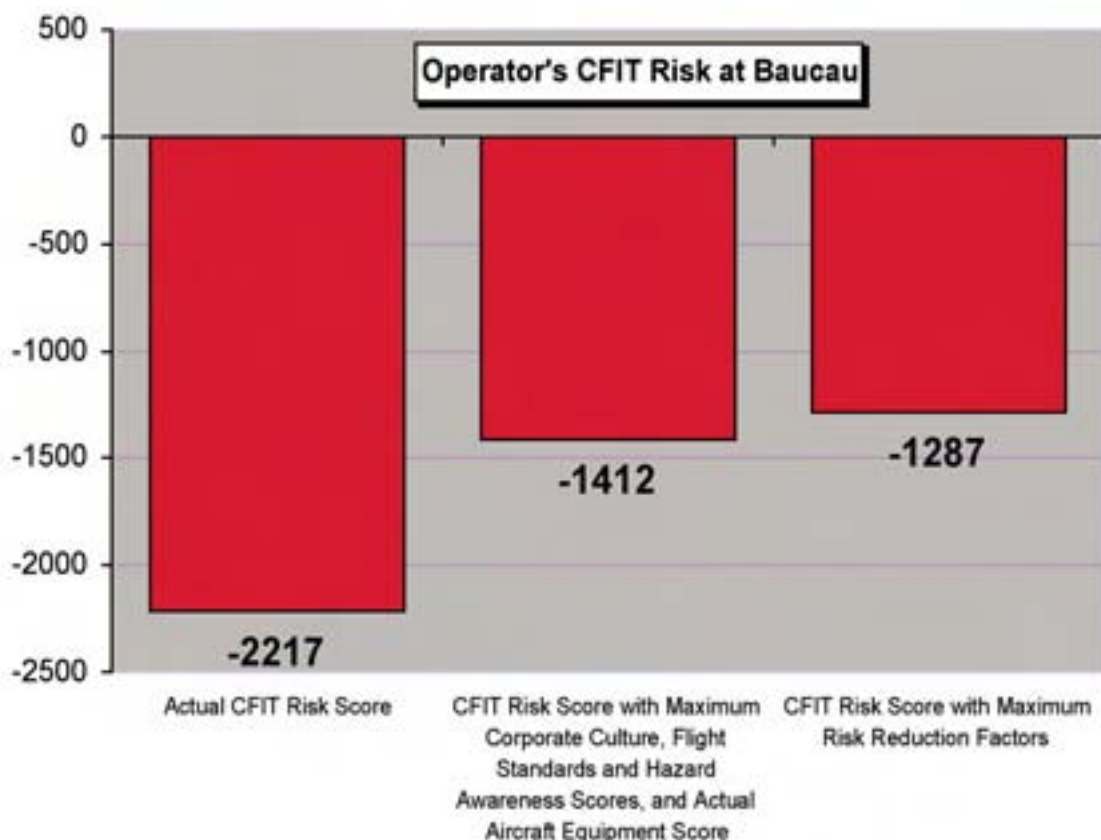
FIGURE 39:
CFIT Risk at Baucau

The alternative CFIT risk scores discussed above are depicted at Figure 39.

CFIT events involving transport-category aircraft will almost certainly result in major to catastrophic consequences involving fatal or life threatening injury, and damage to property and/or the environment, as this occurrence demonstrates. During the second landing approach at Baucau, the likelihood of CFIT increased to the point where it became unavoidable. The flight crew seemed unaware of the severity of the risk until they recognised that impact with terrain was imminent. At that stage, however, the risk could no longer be treated.
