## **TECHNICAL REPORT**

**A-070/2004**

Accident of aircraft  
BOEING B-737,  
registration PH-BTC,  
at Barcelona Airport  
(Spain), on 28  
November 2004

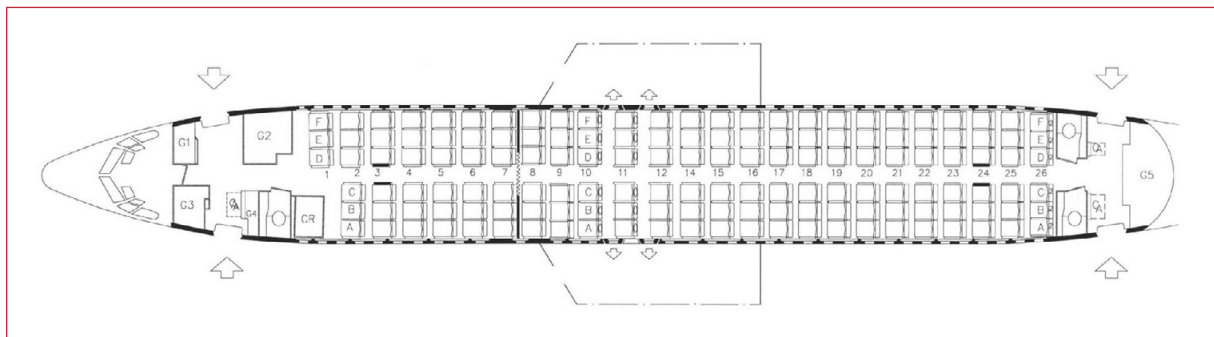
The aircraft has 4 overwing emergency exit hatches, and slides mounted on every door of the airplane. Doors are numbered 1L (forward left), O1L (overwing forward left), O2L (overwing rear left), 2L (rear left) and similarly for 1R, O1R, O2R and 2R.

A malfunction had been identified with deployment of the escape slide of the forward service door (1R). This was the subject of an informative letter («fleet team digest») issued by the manufacturer in December 2002. In some cases the slide became twisted (approximately 90 degrees) during deployment and subsequent inflation. This twisted slide condition rendered the slide and exit unusable for egress. The problem was traced to be probably caused by the escape slide being delayed inside the slide compartment. The manufacturer of the aircraft and the vendor were working on a solution at the time of the PH-BTC accident.

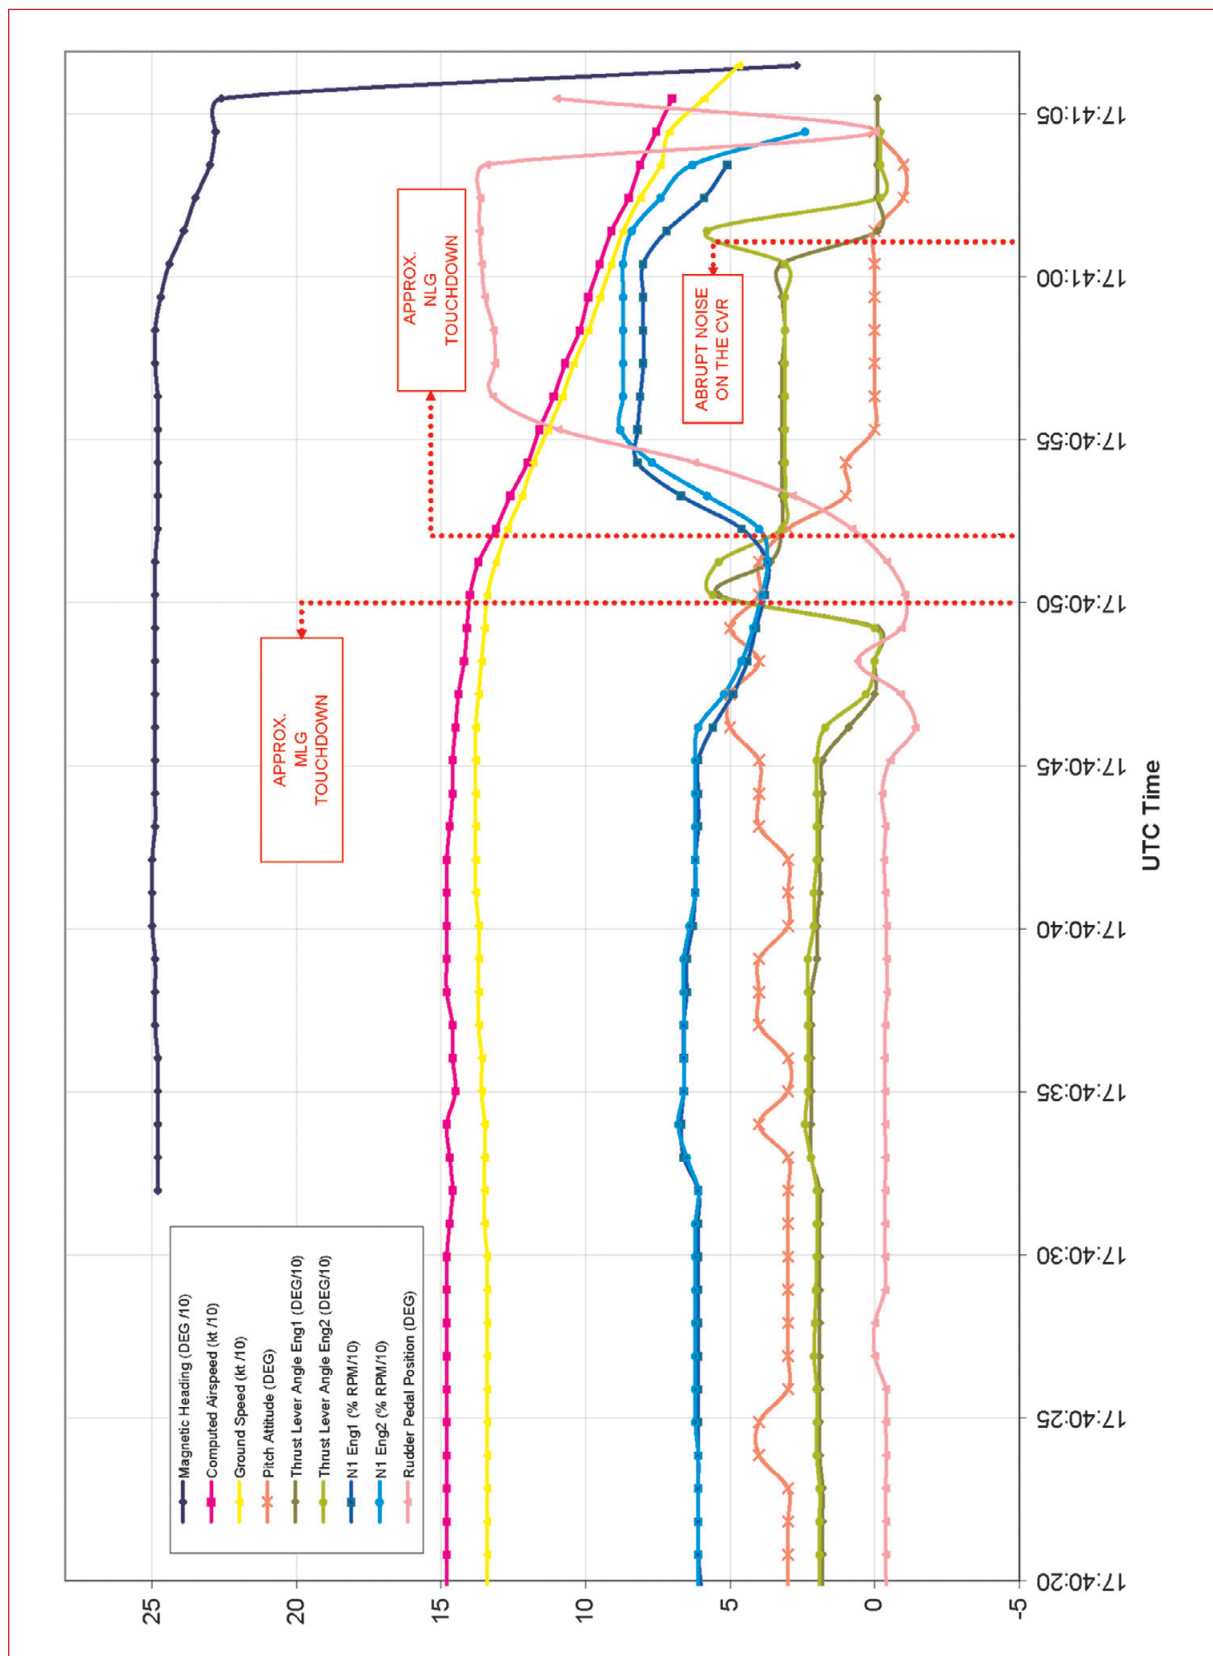
Figure 1.11.2.1. Several parameters during landing

Figure 1.11.2.1 shows the value of some relevant flight parameters during the landing roll on runway 25R of Barcelona Airport. Figure 1.11.2.2 gives the values of the accelerations during that phase. In both cases the data are presented as obtained, without any filtering work to eliminate the possible spurious values.

The deflection of the pedal continued until it reached the maximum with airspeed of 111 kt at 17:40:56 h.

Between 17:41:01 and 17:41:03 h the aircraft exited the paved surface of the runway and noises were recorded on the CVR. At around 17:41:01 h the left and right thrust reversers were stowed. The DFDR showed that the LH thrust lever was moved to idle, and the value of LH N1 (rotational speed of the fan) also decreased. The RH thrust lever was advanced and then also retarded to idle. The maximum lateral acceleration (-0.29 g) was recorded at 17:41:01 h with 91 kt of airspeed (87 kt of groundspeed) while the maximum vertical acceleration (1.49 g) was recorded at 17:41:03 h with 81 kt of airspeed (74 kt of groundspeed).

Since that moment (17:41:03 h), the parameters recorded on the DFDR are no longer reliable, according to the conclusion of the manufacturer specialists. The aircraft suffered heavy deceleration in the unprepared area beside the runway until it came to a stop. Therefore, it was not possible to ascertain the position of the levers or the values of the accelerations during the final part of the off-runway run.
