NATIONAL TRANSPORTATION SAFETY BOARD

AIRCRAFT ACCIDENT REPORT

IN-FLIGHT ICING ENCOUNTER AND LOSS OF CONTROL
SIMMONS AIRLINES, d.b.a. AMERICAN EAGLE FLIGHT 4184
AVIONS de TRANSPORT REGIONAL (ATR)
MODEL 72-212, N401AM
ROSELAWN, INDIANA
OCTOBER 31, 1994

VOLUME 1: SAFETY BOARD REPORT

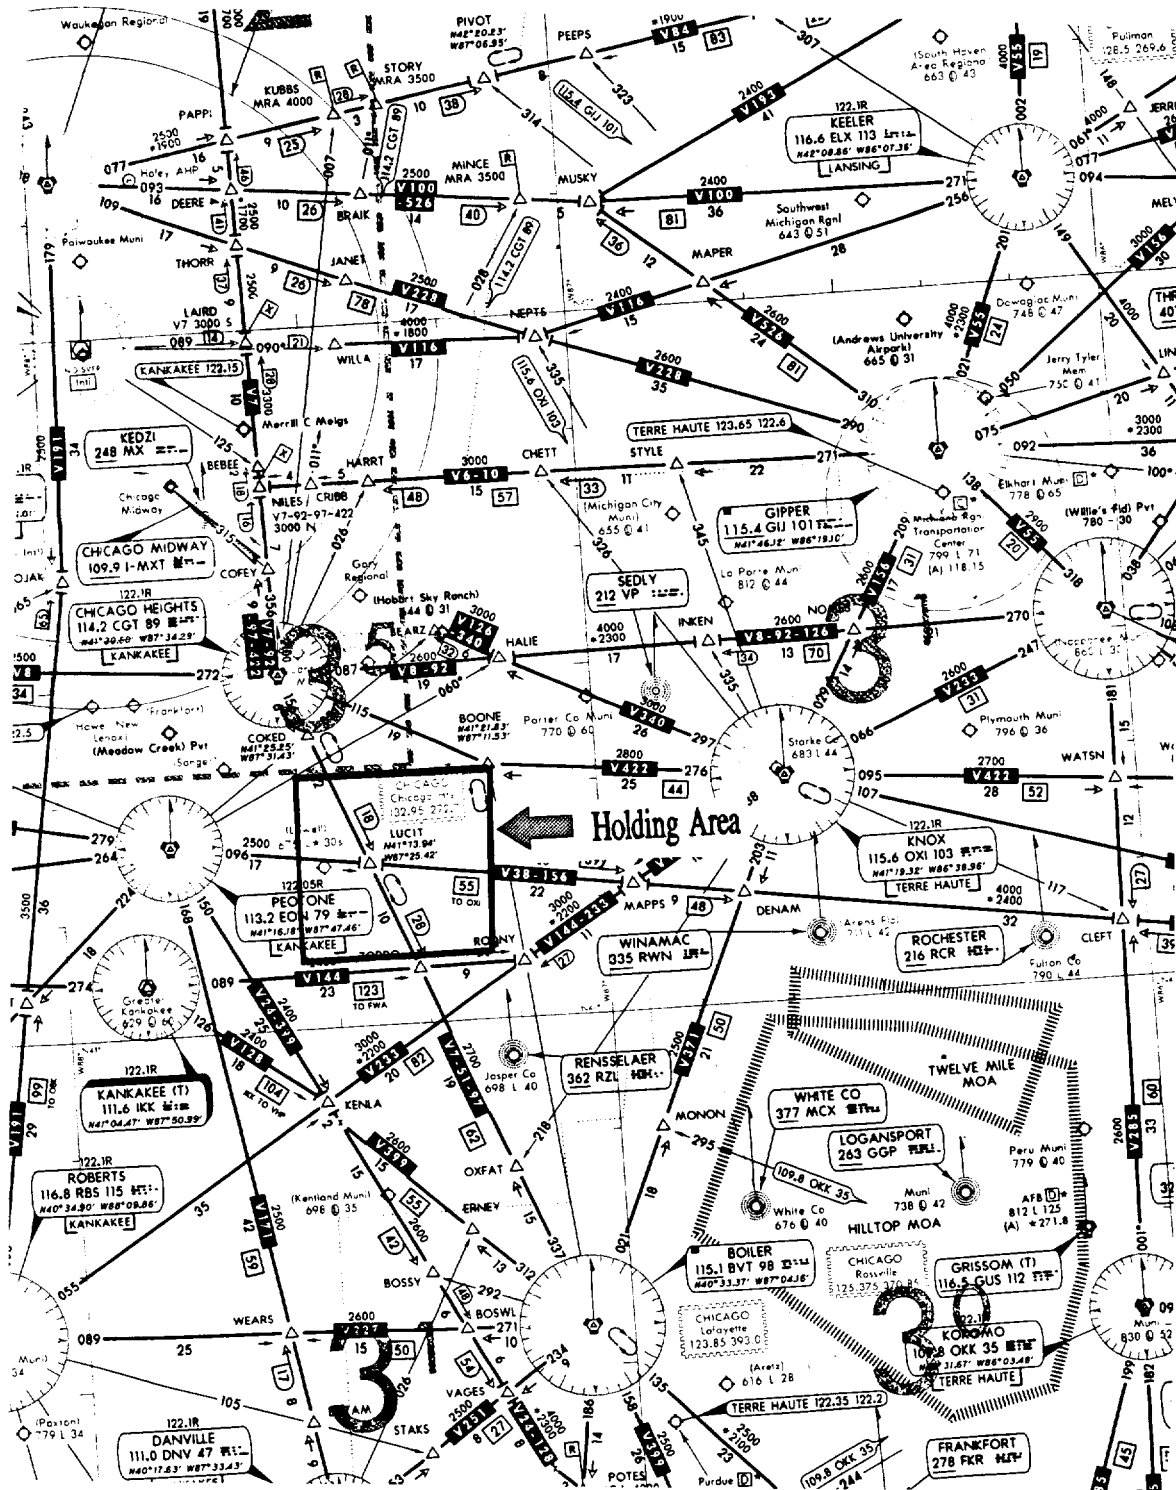
Figure 1.--Holding pattern location; box identifies LUCIT intersection.

ORD.⁷ At 1518:07, shortly after flight 4184 leveled off at 10,000 feet, the crew received a clearance from the BOONE controller that they were, "...cleared to the LUCIT intersection⁸ via radar vectors turn ten degrees left intercept Victor 7 hold southeast on Victor 7 expect further clearance (EFC) two one three zero [Zulu time] [1530 CST]." The captain acknowledged the transmission. About 1 minute later, the BOONE controller revised the EFC for flight 4184 to 1545.⁹ This was followed a short time later by several radio transmissions between the captain of flight 4184 and the BOONE controller in which he received approval for 10 nautical mile legs in the holding pattern, a speed reduction,¹⁰ and confirmation of right turns while holding. (See Figure 1 for holding location.)

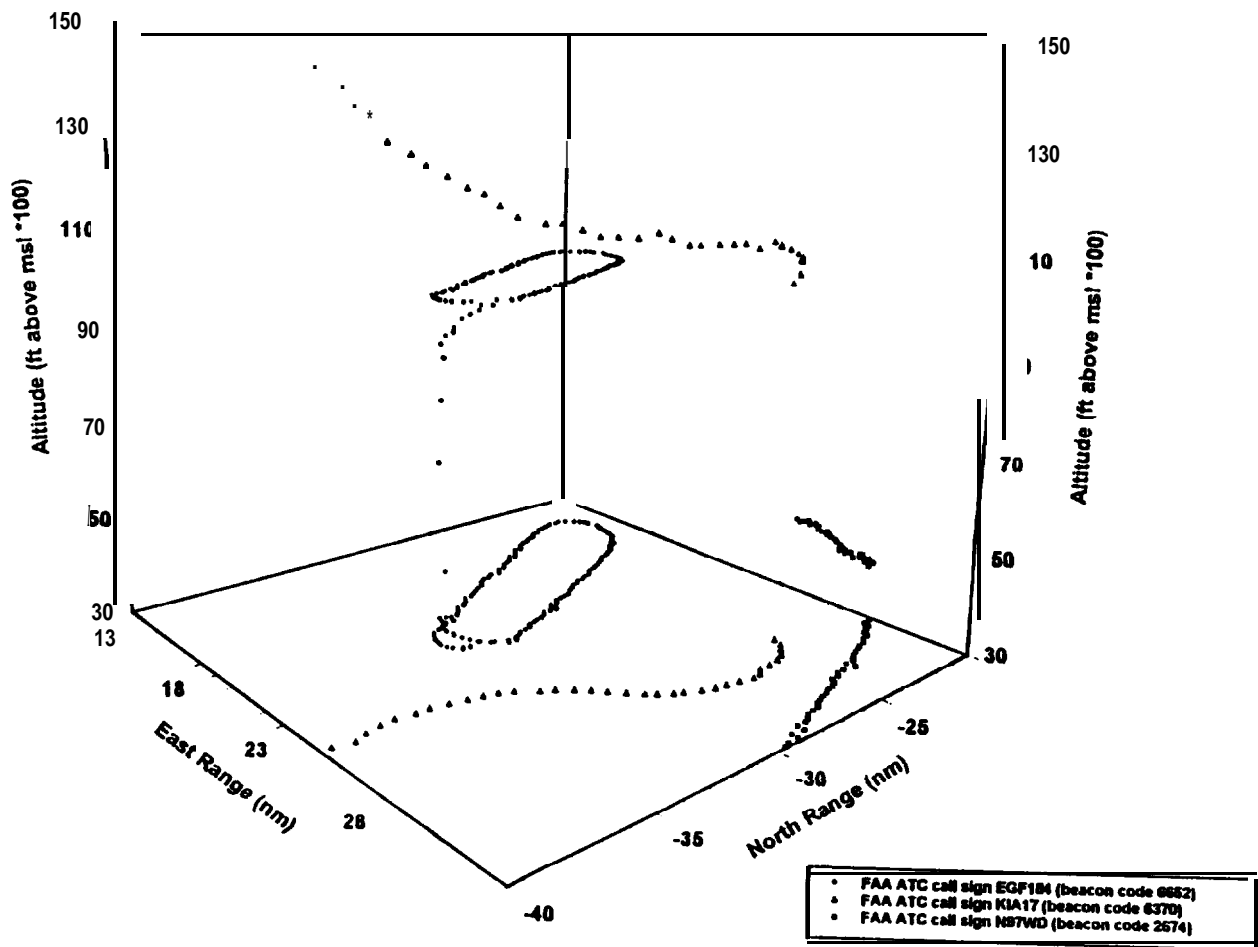
Figure 2.—Flightpath of airplane in holding pattern.

At 1557:33, as the airplane was descending through 9,130 feet, the AOA increased through 5 degrees, and the ailerons began deflecting to a RWD position. About 1/2 second later, the ailerons rapidly deflected to 13.43 degrees RWD,¹⁶ the autopilot disconnected, and the CVR recorded the sounds of the autopilot disconnect warning (a repetitive triple chirp that is manually silenced by the pilot). The airplane rolled rapidly to the right, and the pitch attitude and AOA began to decrease (see Figures 2 and 3 for graphical depictions of the airplane's flightpath and FDR/CVR data). There were no recorded exchanges of conversation between the flightcrew during the initial roll excursion, only brief expletive remarks followed by the sounds of "intermittent heavy irregular breathing."

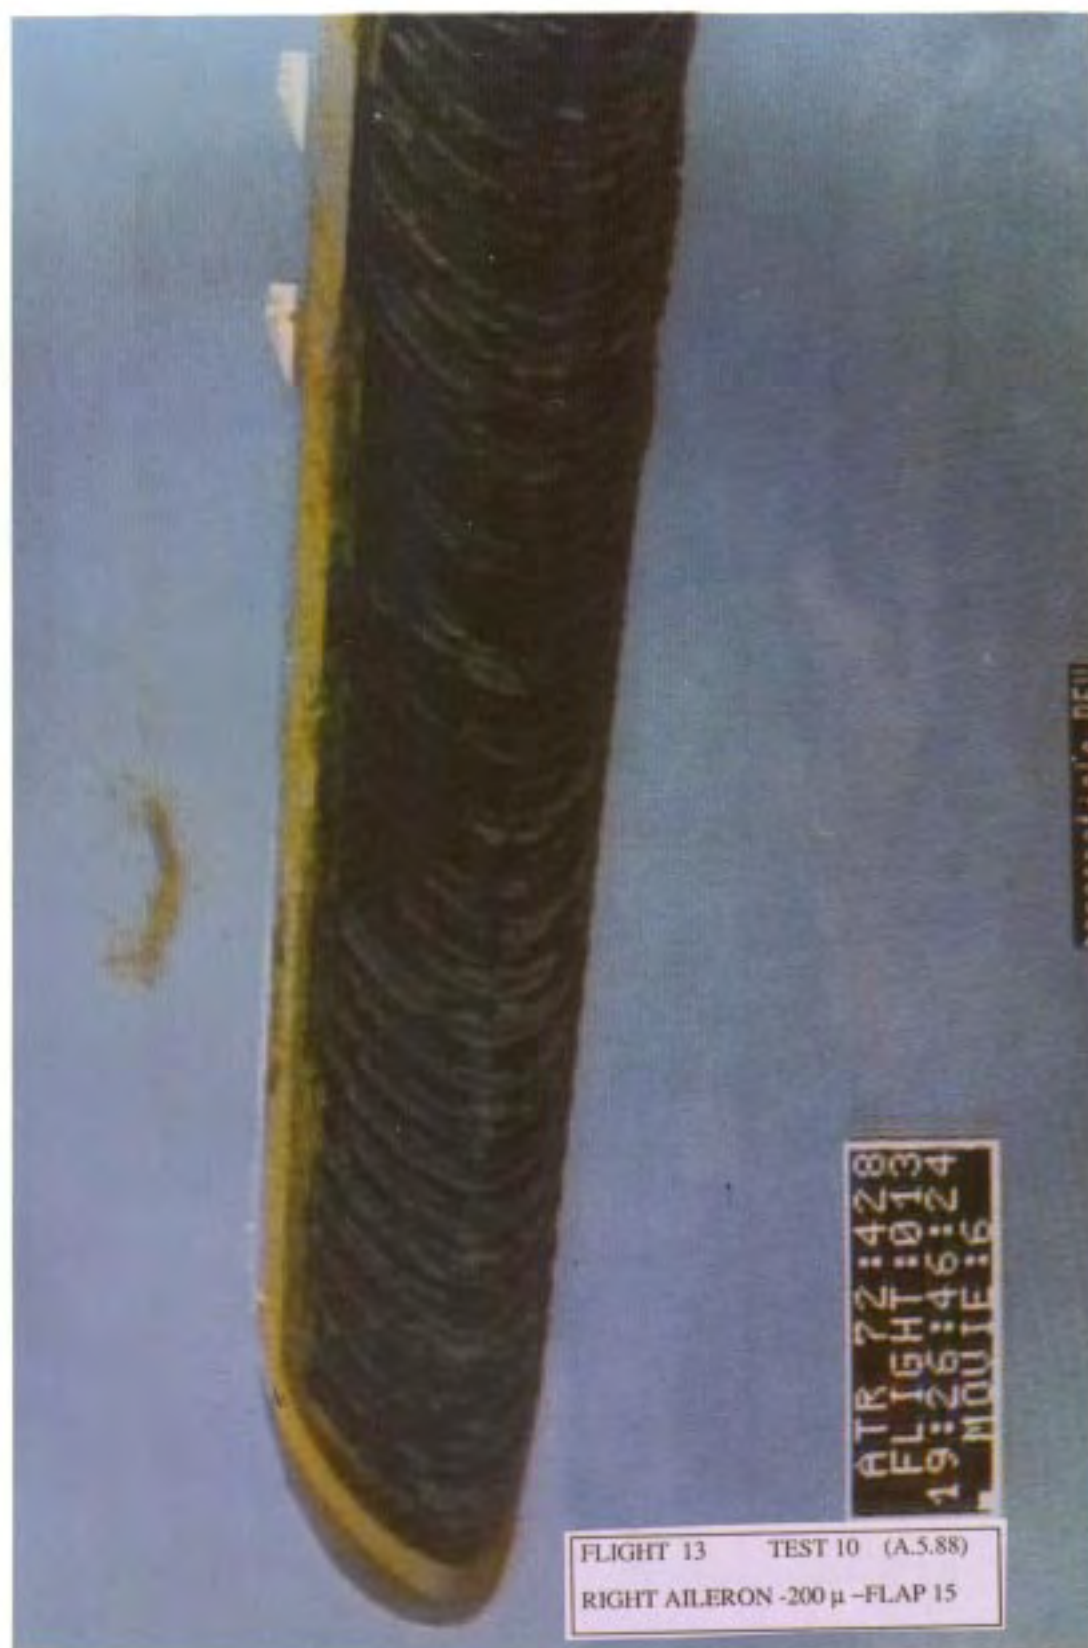
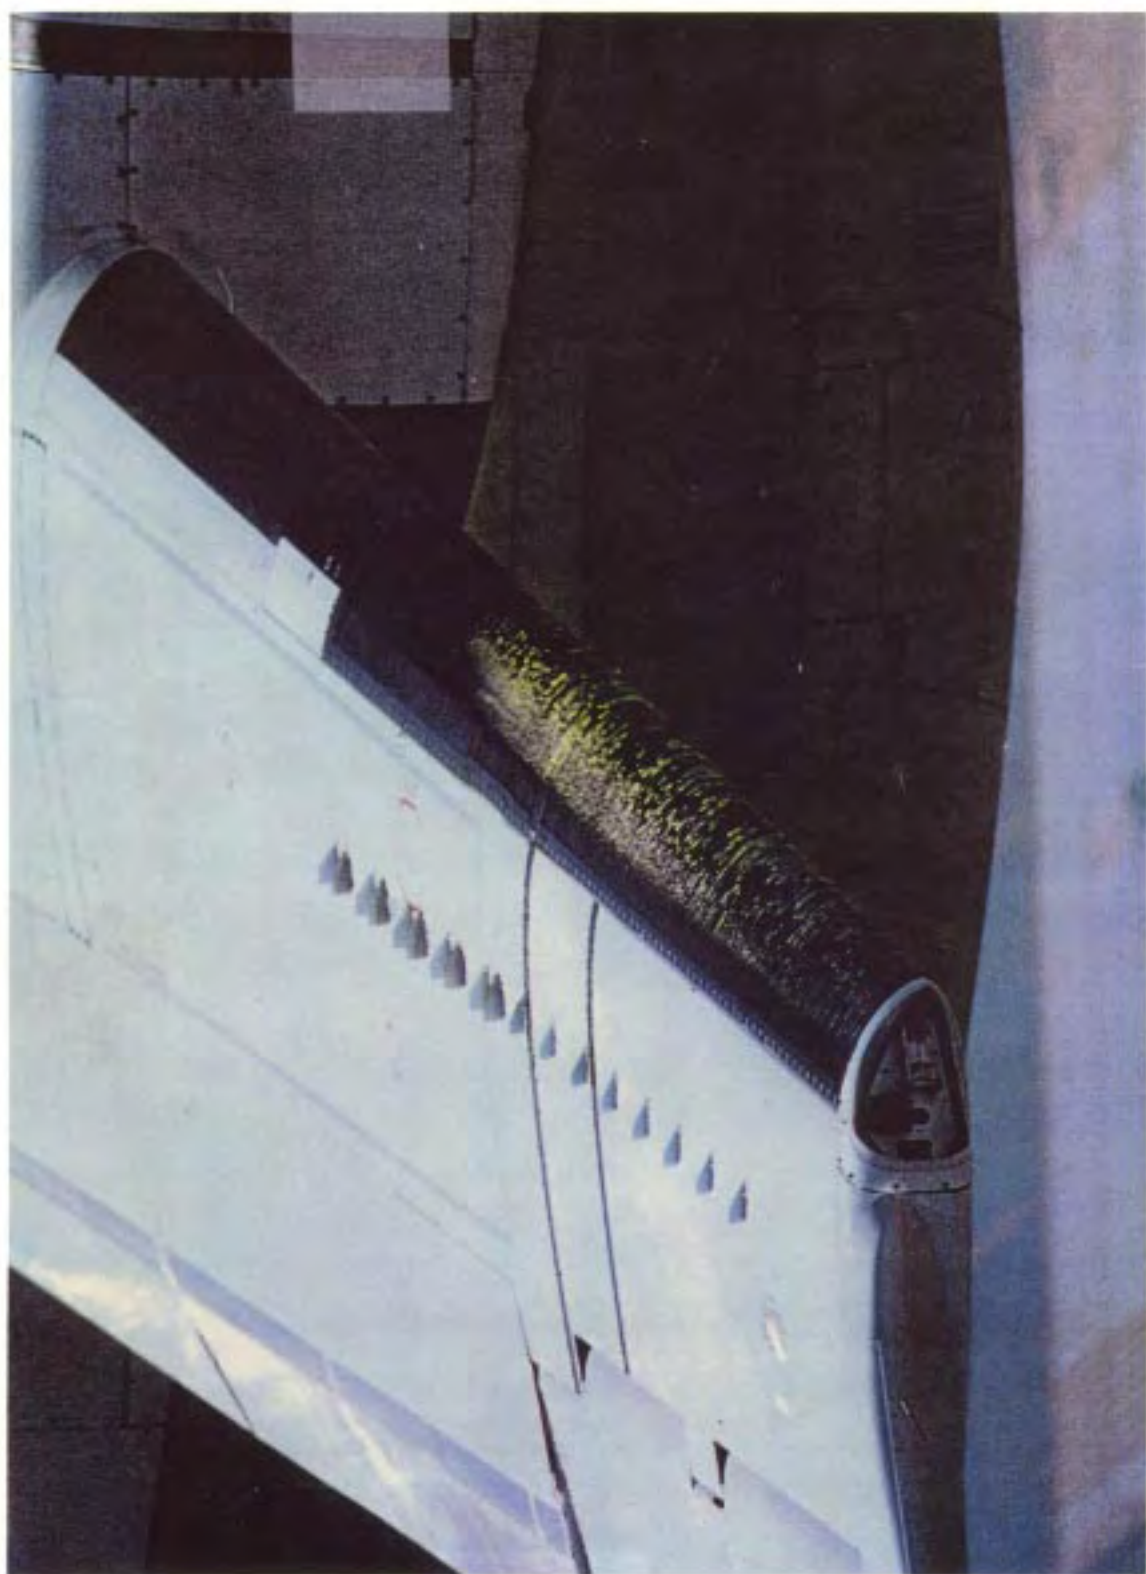
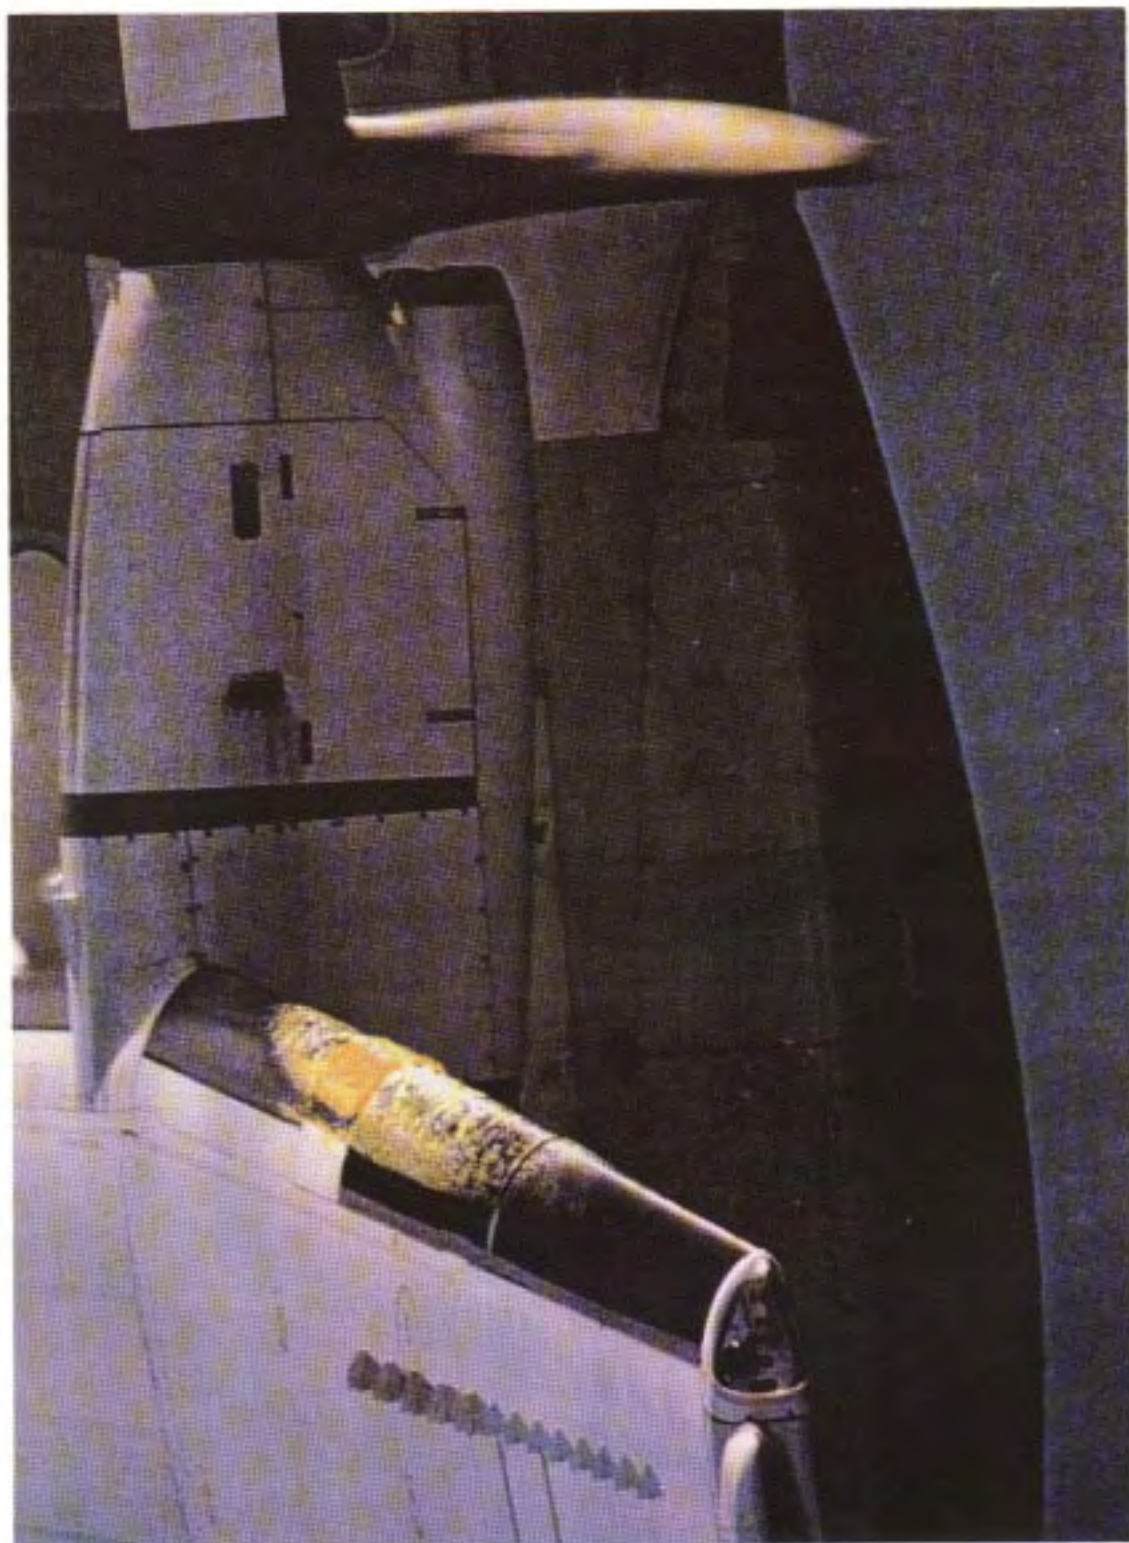
FLIGHT 12 TEST 7 (A.5.45)

LEFT WING -200 μ -FLAP 0

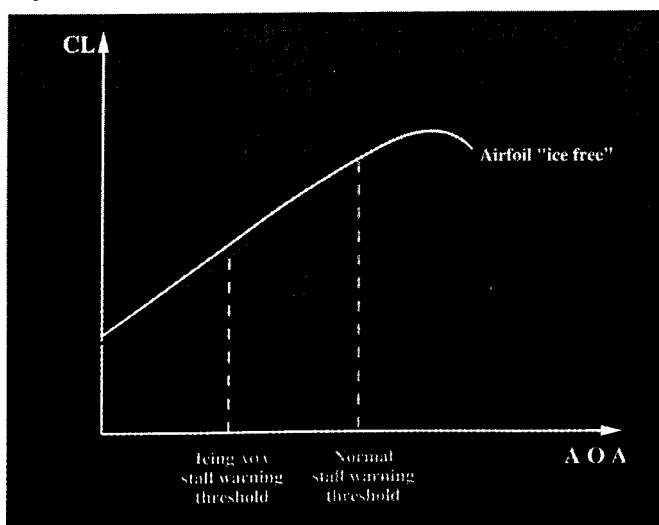
Fig. 12

Stall occurs at higher speeds (fig. 12) when ice accretion spoils the airfoil, therefore the stall warning threshold must be reset to a lower value of angle of attack.

Anti-icing procedures and speed limitations have been developed and must be complied with as soon as and as long as icing conditions are met which may occur even before ice accretion actually takes place. The procedures and speed limitations do apply until the aircraft is clear of ice.

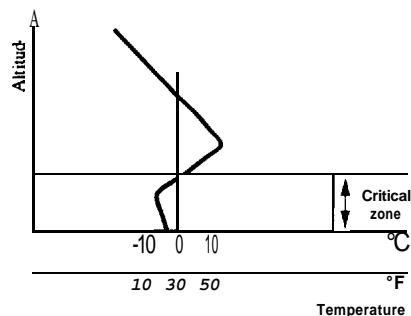
Freezing rain normally occurs as a result of weather conditions where temperature increases with altitude (temperature inversion, ref. fig. 13). Warm rain falls from or passes through this warm layer into a region of subfreezing temperature and typically becomes supercooled. These supercooled large rain drops will then freeze upon impact with an object.

Fig. 13- Temperature in version is a :one where temperature increases with altitude.

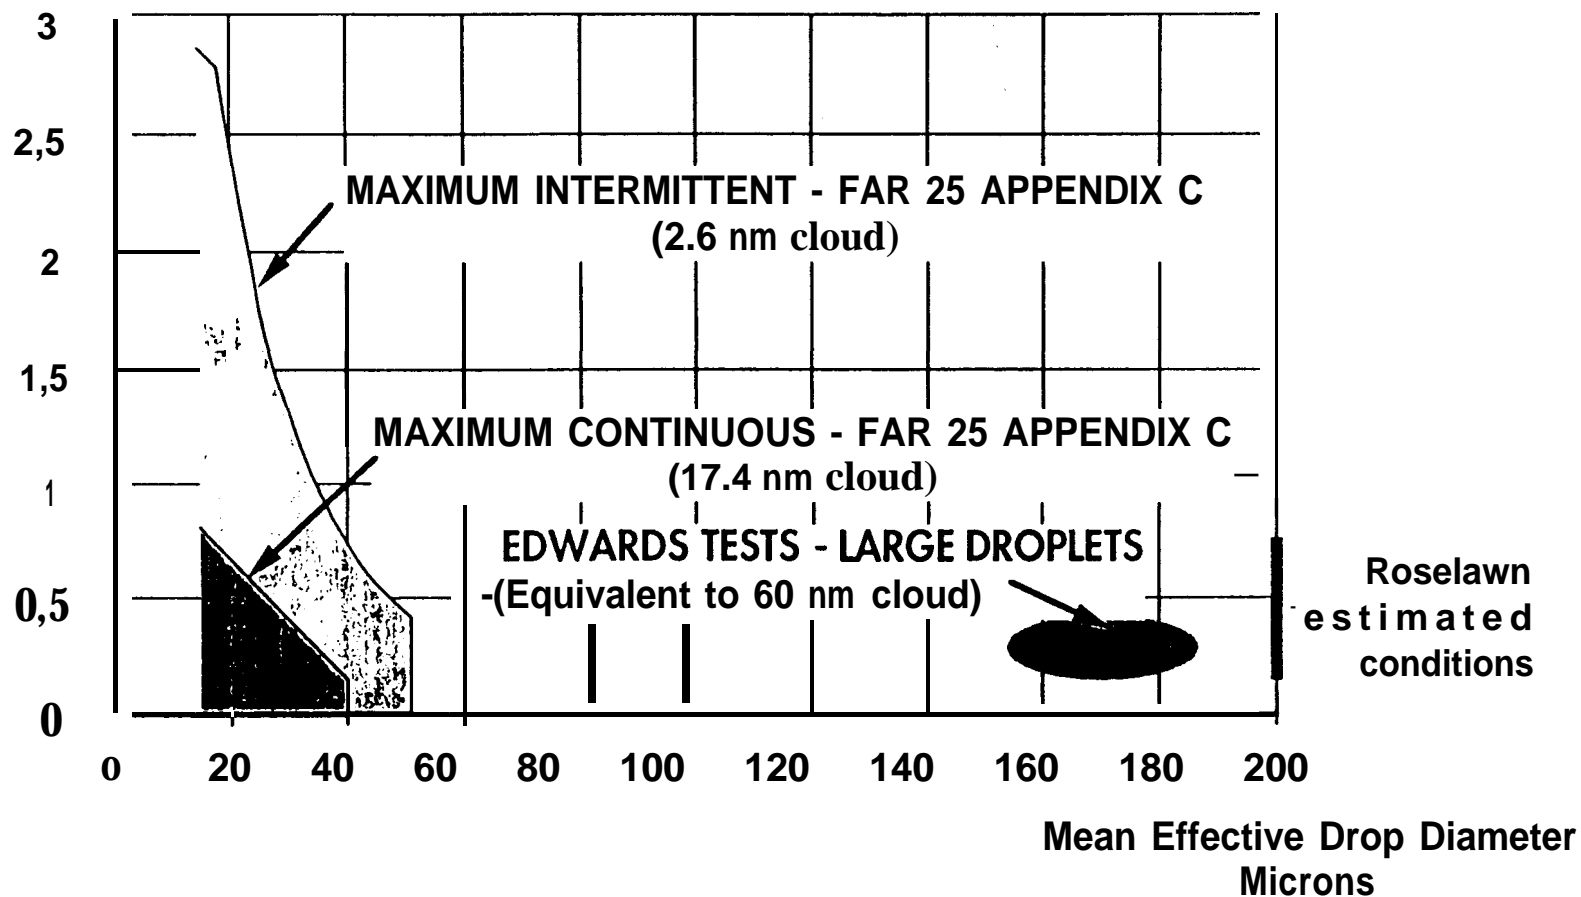
FIGURE 10 : FAR 25.1419 & APPENDIX "C" CERTIFICATION ENVELOPE

ROSELAWN conditions were far outside App "C" certification envelope

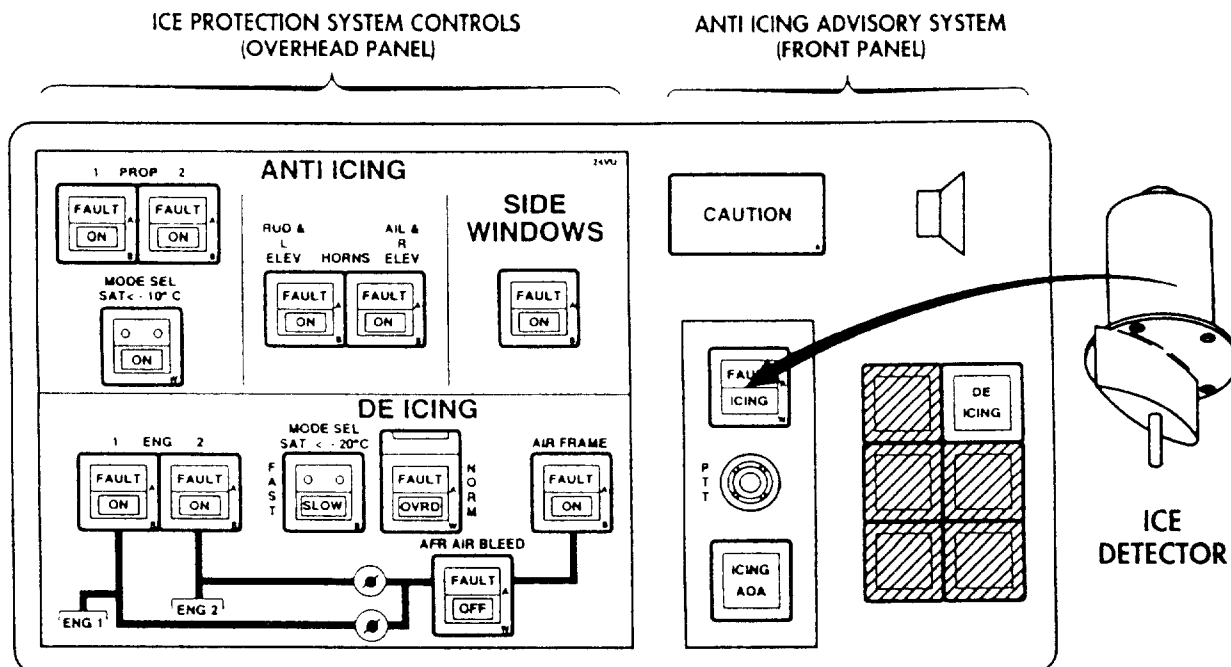
FIGURE 12 : ATR 72 ANTI-ICING ADVISORY SYSTEM (AAS)

ATR 72 ANTI-ICING ADVISORY SYSTEM (AAS) : An effective warning logic to back up crew awareness

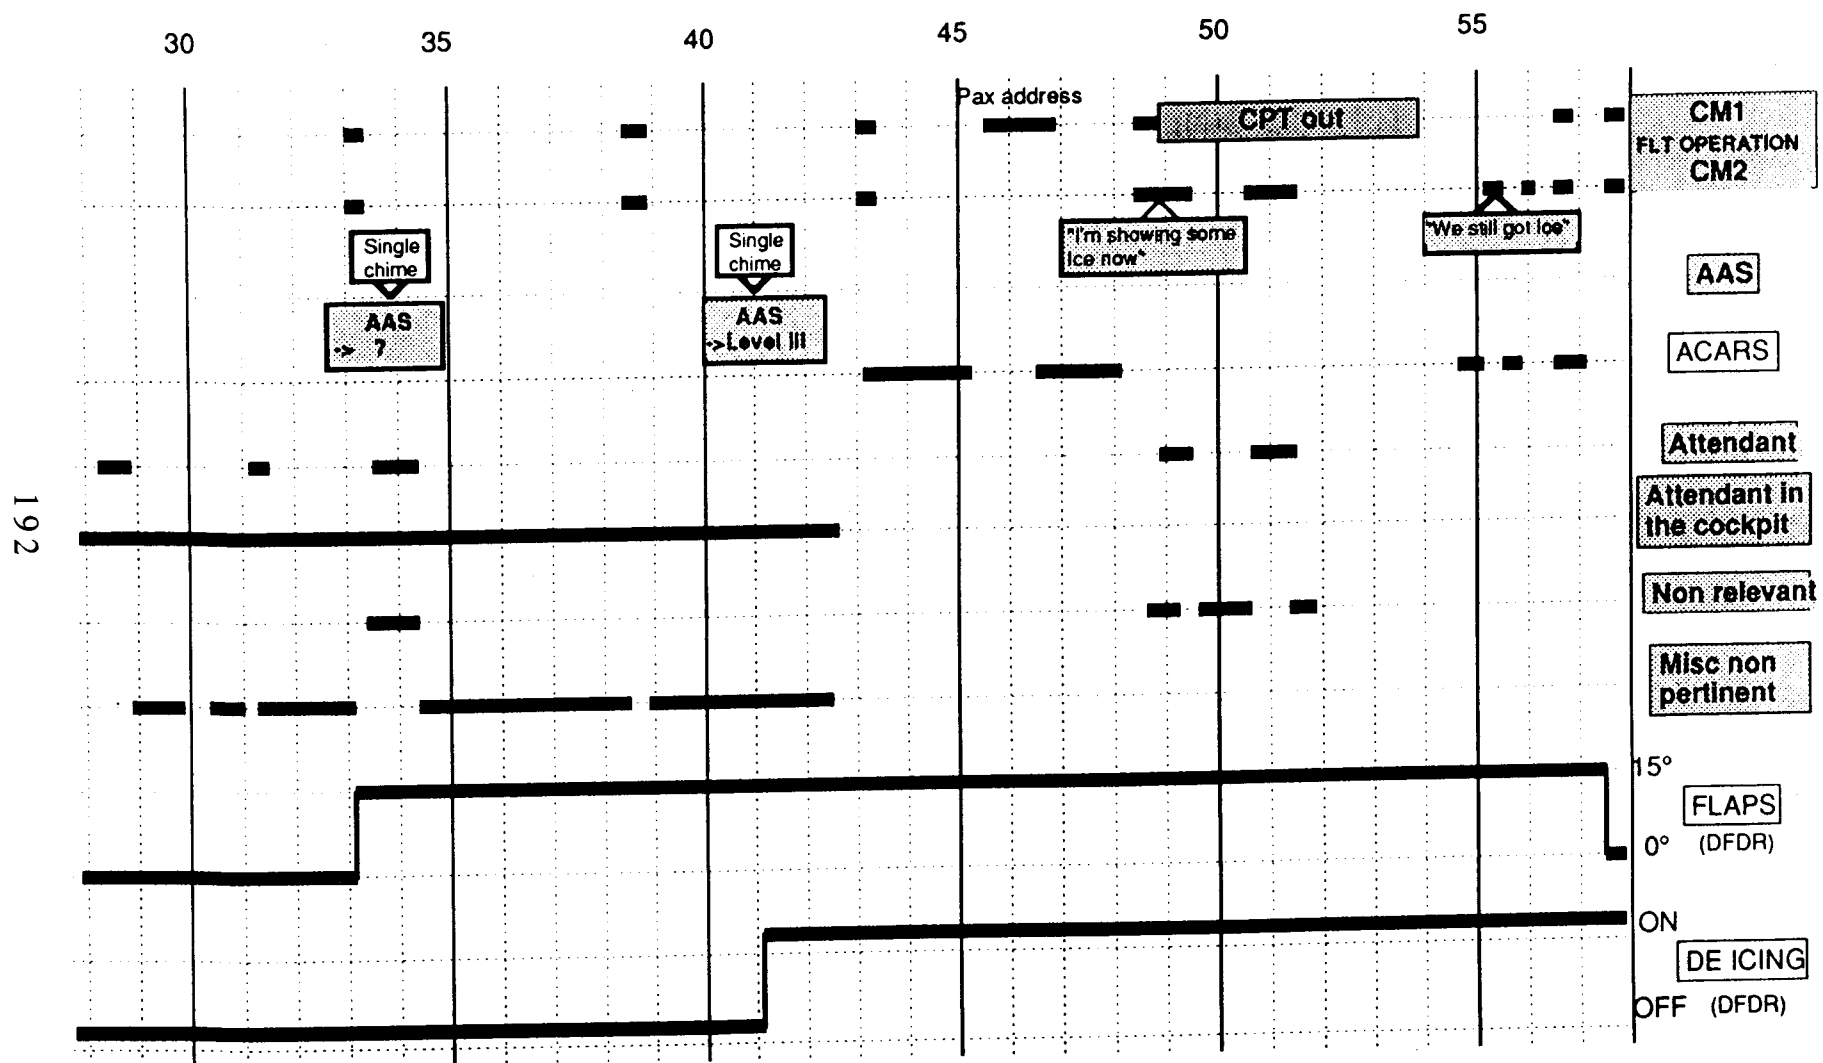
FIGURE 14 : FLIGHT 4184 CVR TIME ANALYSIS

More than 15 mn of Non Relevant & Non Pertinent conversations

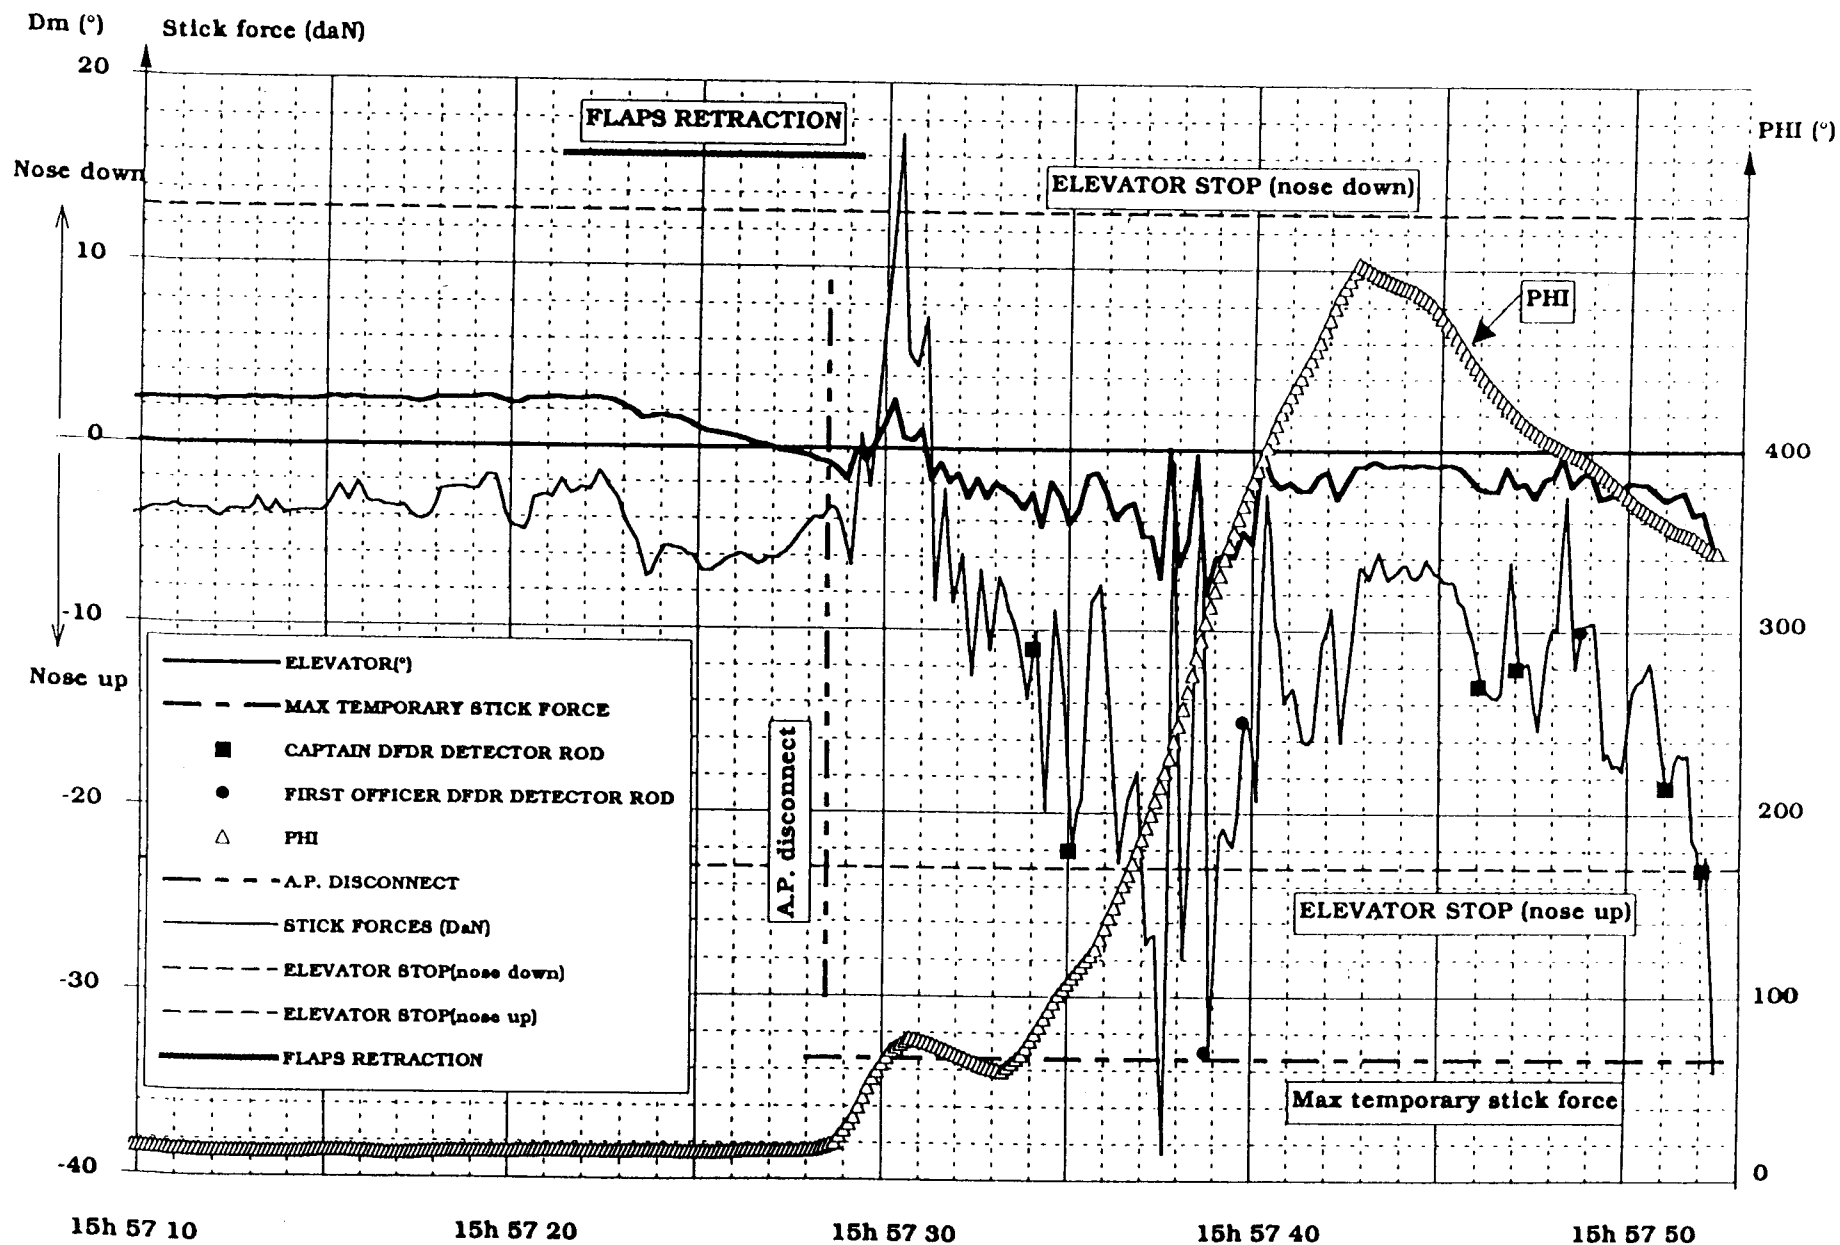
FIGURE 16 : PITCH CONTROL INPUTS / ACTIVITY AFTER ROLL UPSET

A limited control activity mainly during inverted flight

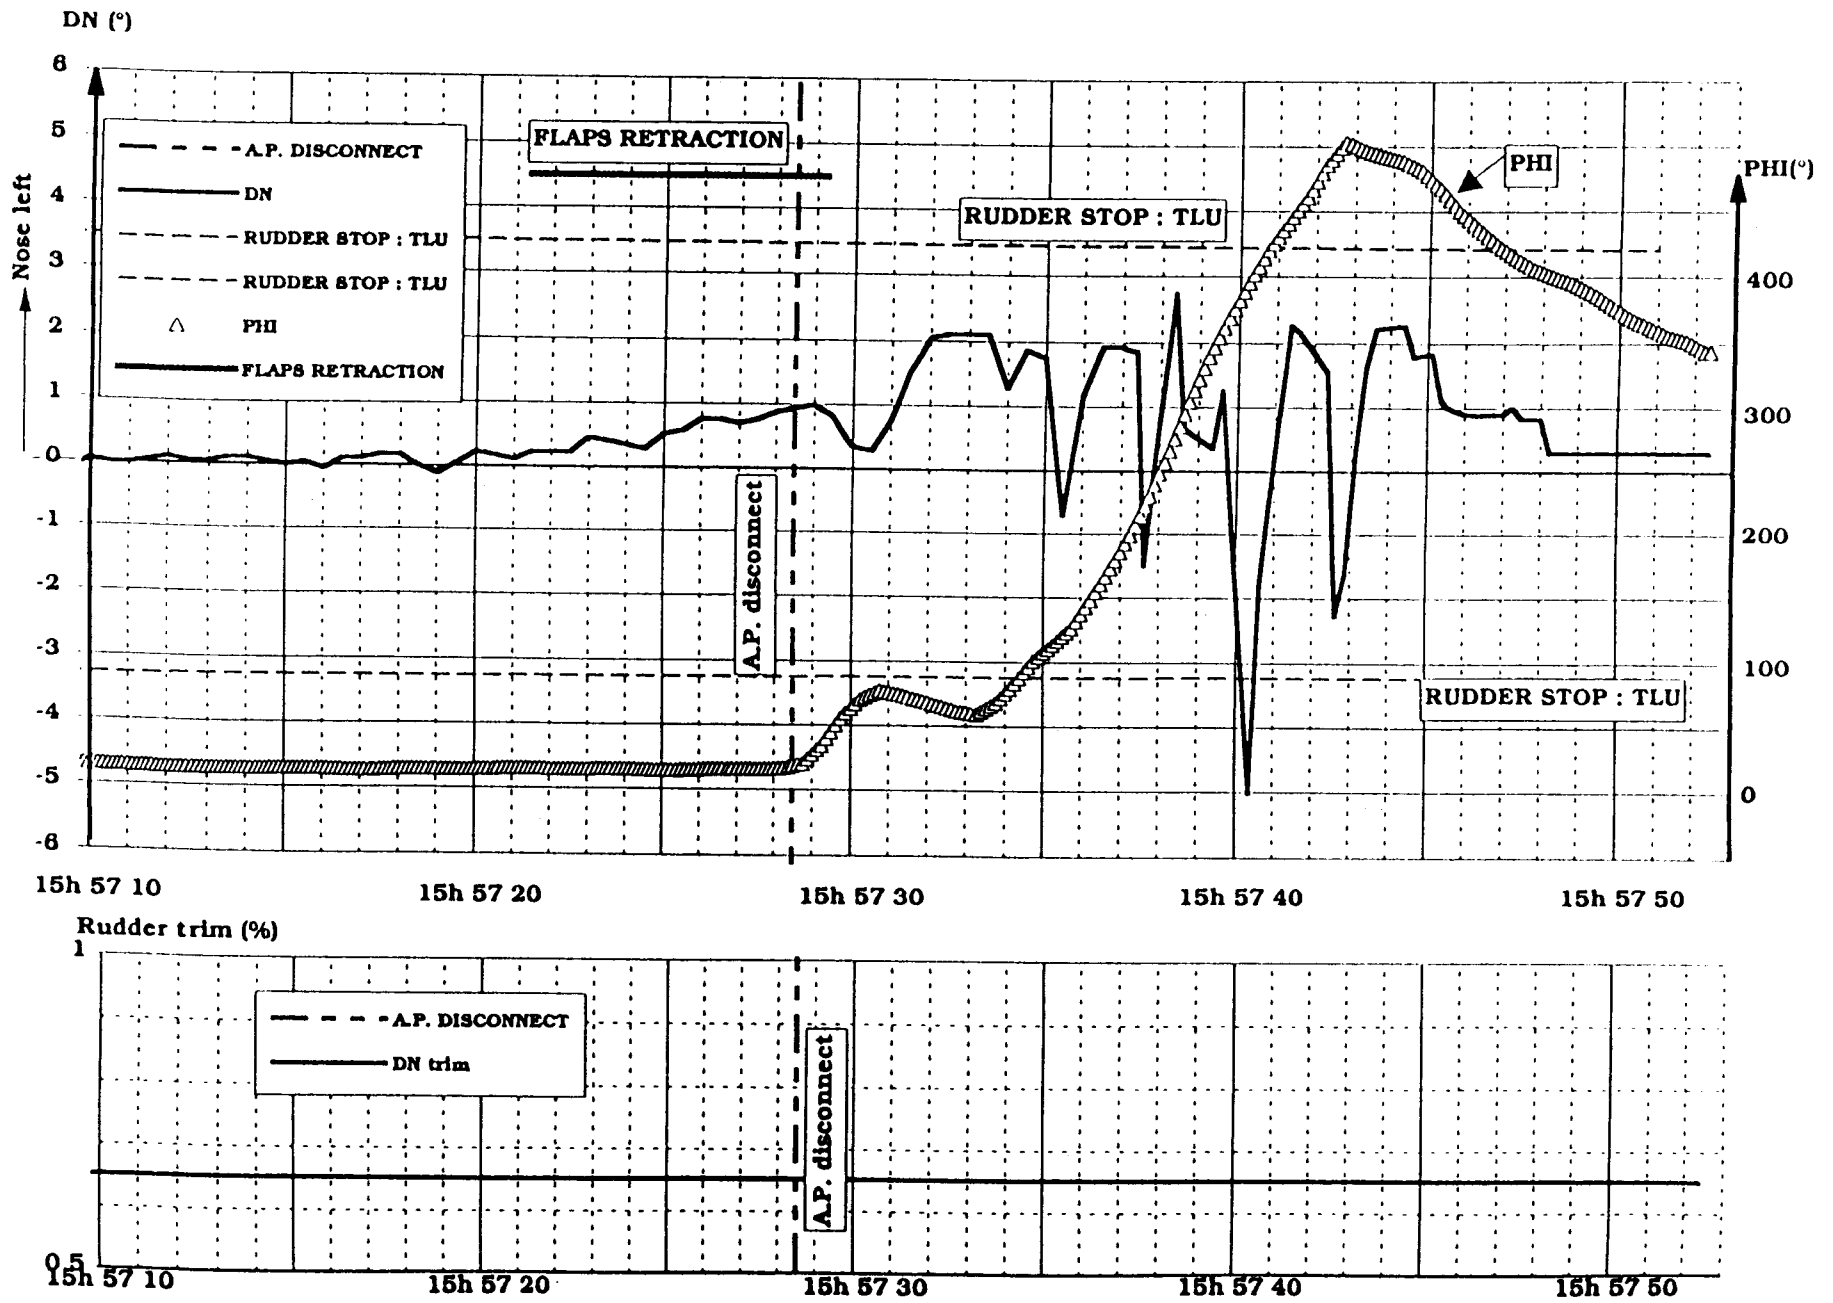
FIGURE 17 : YAW CONTROL INPUTS / ACTIVITY AFTER ROLL UPSET

In addition, the CVR transcript shows that there was almost no discussion between the flight crew in respect to how to respond to the roll upset. Following the initiation of the roll, there was no discussion between the flight crew members regarding the aircraft's attitude or airspeed, nor was there any conversation between them in respect to how to respond to the aircraft's attitude. Further, the First Officer never asked for any help in controlling the aircraft or in responding to the event, nor is there any indication that the Captain exercised his command authority to take over the controls, nor to identify the unusual attitude of the aircraft or to appropriately comment the First Officer's inputs. This shows that the flight crew, probably disoriented, did not identify the unusual attitude nor understood the fast moving evolutions of the aircraft.

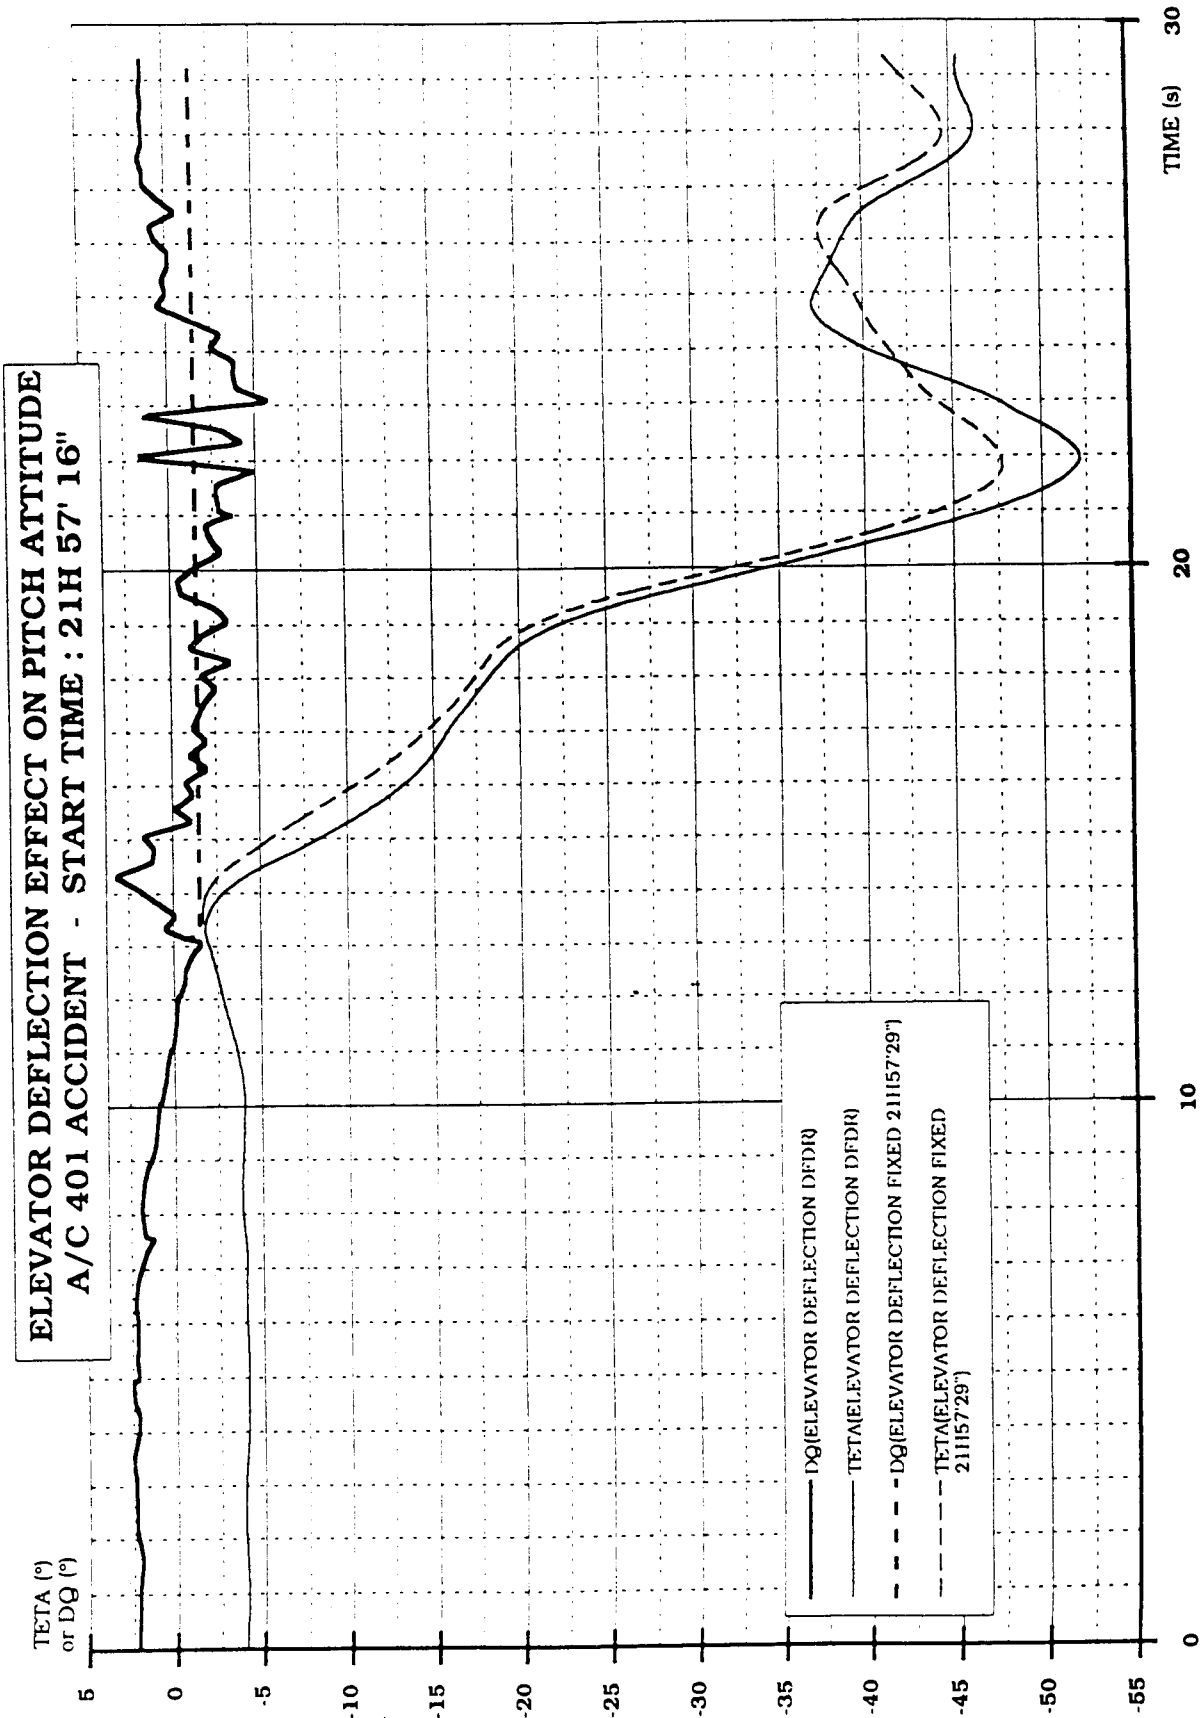
FIGURE 18 : EFFECT OF A CONSTANT PITCH INPUT ON RECOVERY

It also allows to predict the Flight path resulting from different control surface deflections. It is thus possible to determine (fig. 18) that the deflection of the elevators contributes only marginally to the longitudinal movement whose amplitude is mainly due to roll initiation.

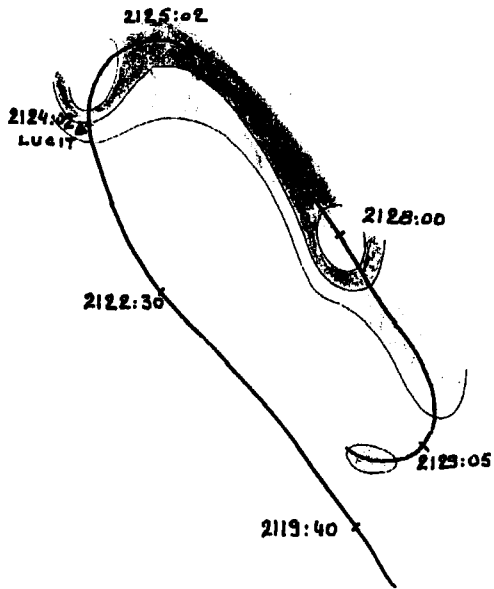
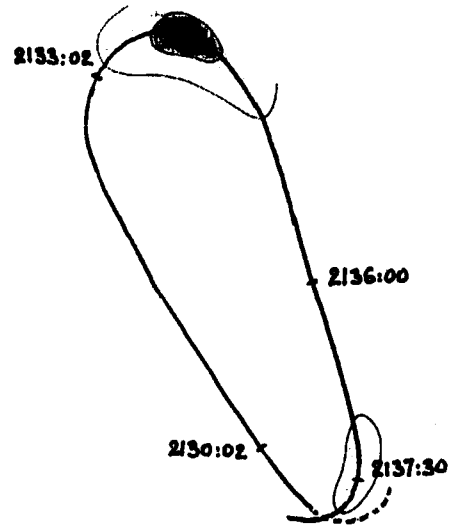
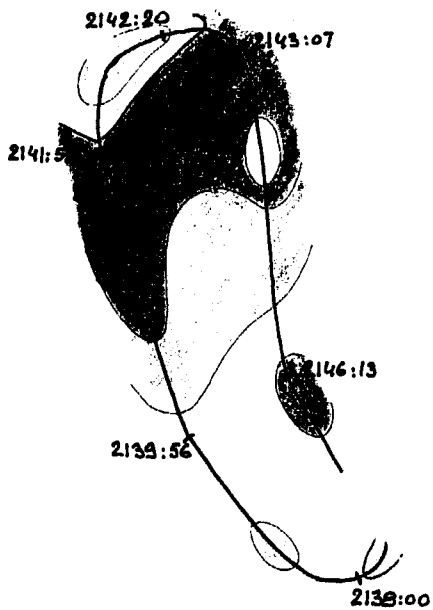
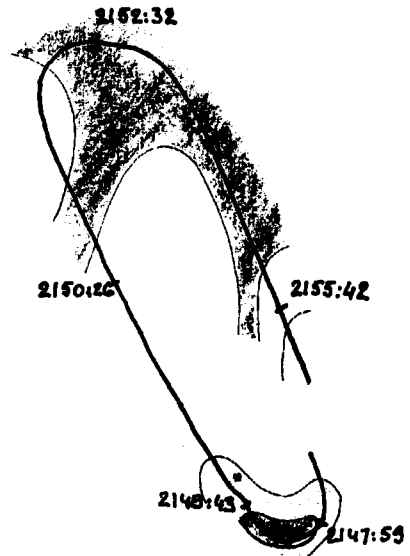
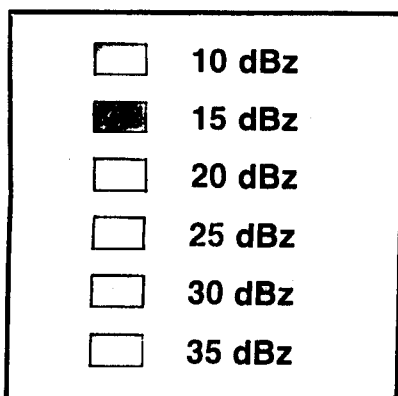
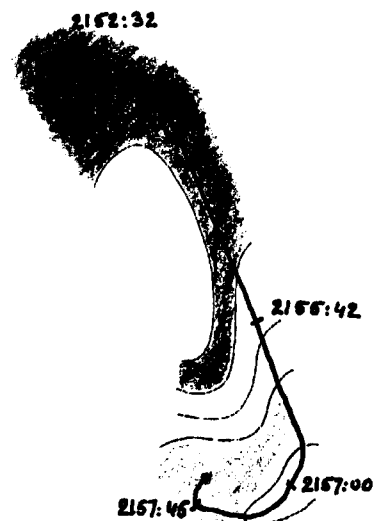
APPENDIX 14

Calculation of the time spent by the ATR 72 in precipitation leads to a cumulative time of almost 24 minutes, out of a total time of more than 30 minutes in such conditions in the holding pattern, with Static Air Temperature varying between -2 and -4 °C (Total Air Temperature between +1.5 and +3.5 °C). This duration is based on precipitation echoes detected on the weather radar in the area of the holding pattern of the aircraft, which means, by deduction, drop size diameters detected of about 100µm or more (see appendices 11 to 14).

PRECIPITATION ECHOES IN THE HOLDING PATTERN (WEATHER RADAR REFLECTIVITIES)
