Accident  
on 25 December 2003  
at Cotonou Cadjèhoun  
aerodrome (Benin)  
to the Boeing 727-223  
registered 3X-GDO  
operated by UTA  
(Union des Transports Africains)

**REPORT TRANSLATION**  
**3x-o031225a**

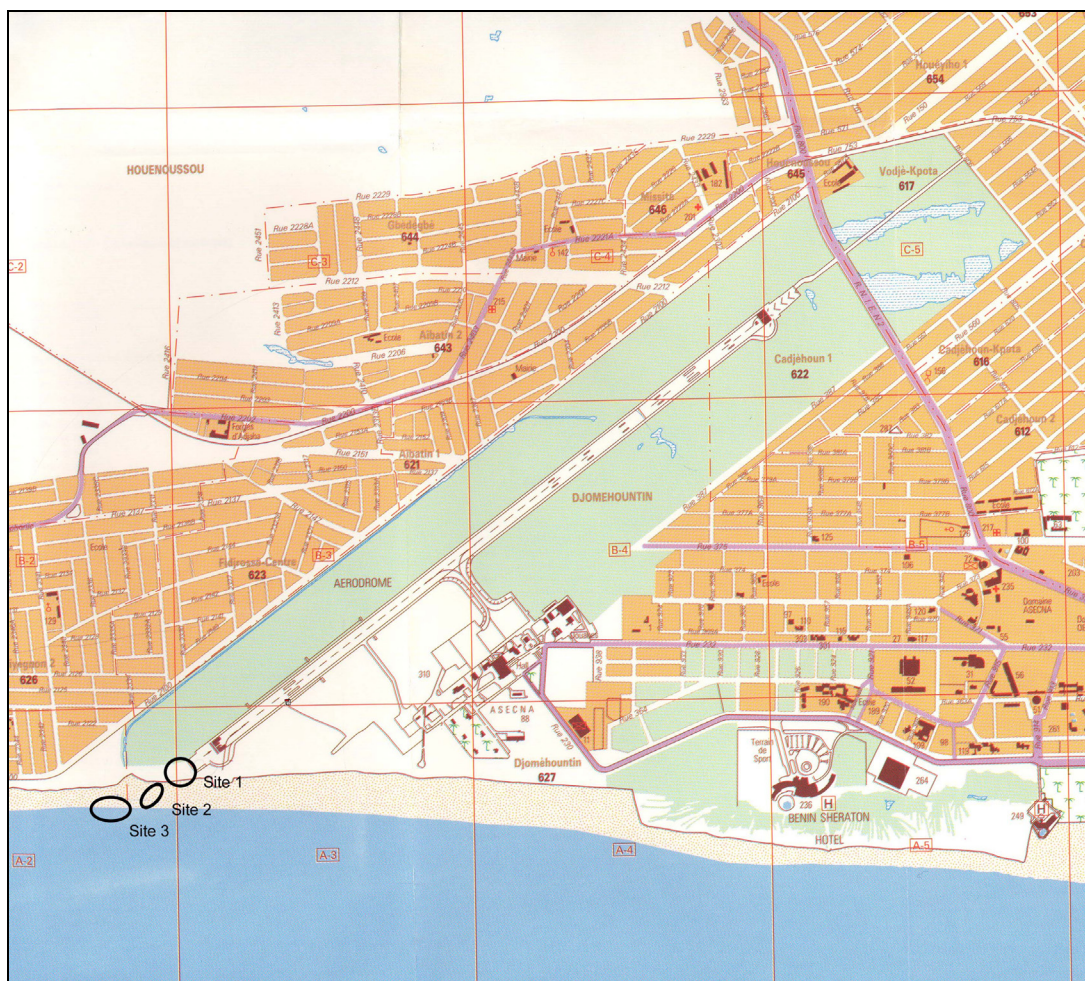
The airplane struck a technical building after the end of the runway (site 1), crashed onto the beach (site 2) and ended up in the ocean (site 3).

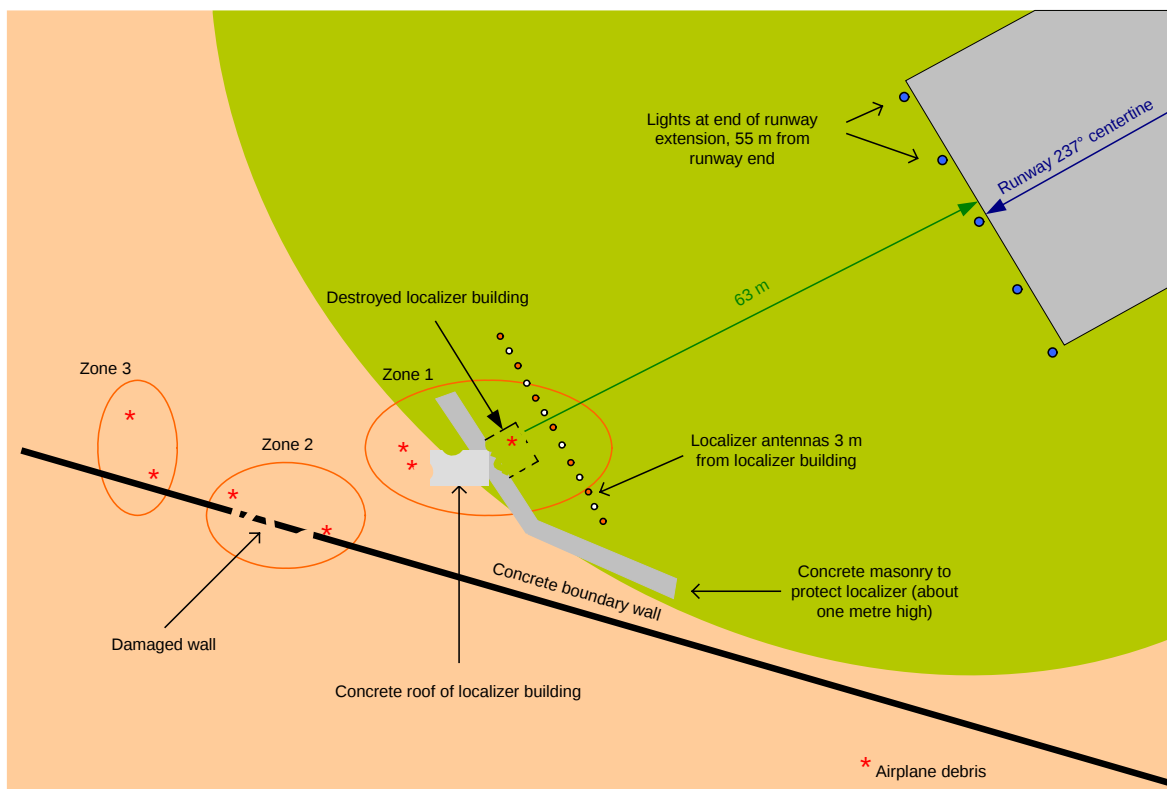
The illustration of site 1 (below) shows the distribution of the airplane debris in three distinct zones, with a total area of about 1,550 m<sup>2</sup>.

## Zone 1

The airplane damaged the localizer antennas, which were about a hundred and fifteen meters from the end of the runway, then destroyed the reinforced concrete building housing the electronic equipment bays.

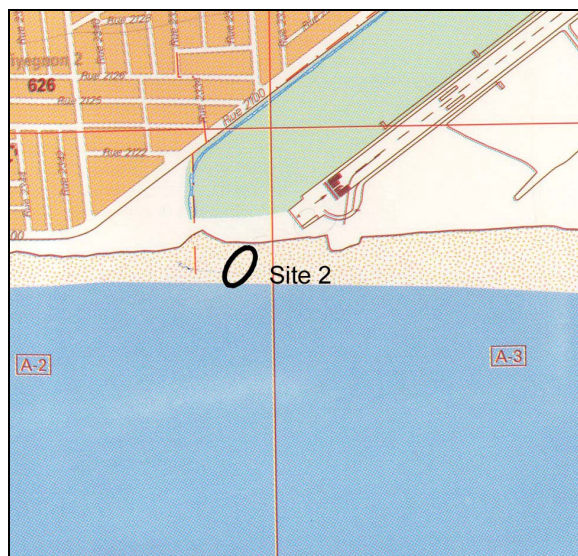
The plan of site 2 shows the position of the parts found in the rain drainage channel that crossed it. The heavy parts, numbered ① to ⑤ indicate the airplane's path after it passed over the aerodrome boundary wall.

The cylinder, the drag strut, the pivot link, parts of the side strut, the lock crank and the right ① main landing gear support beam ① were found in the canal, a hundred and fifty meters from the boundary.

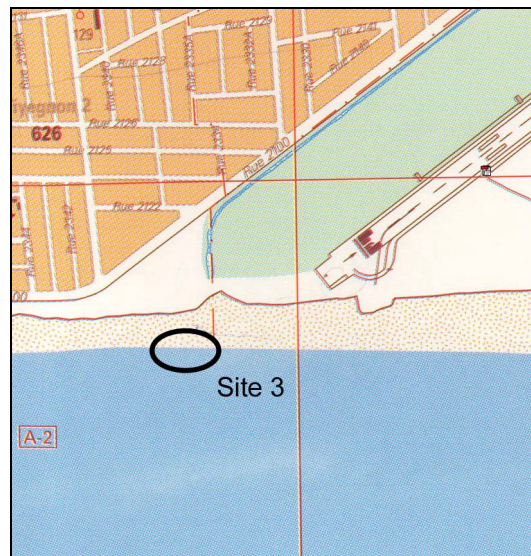
The main parts of the airplane were found in the ocean, in an area where the depth of water varied between three and ten meters. The waves that were breaking about fifty meters out kept the wreckage close to the shoreline.

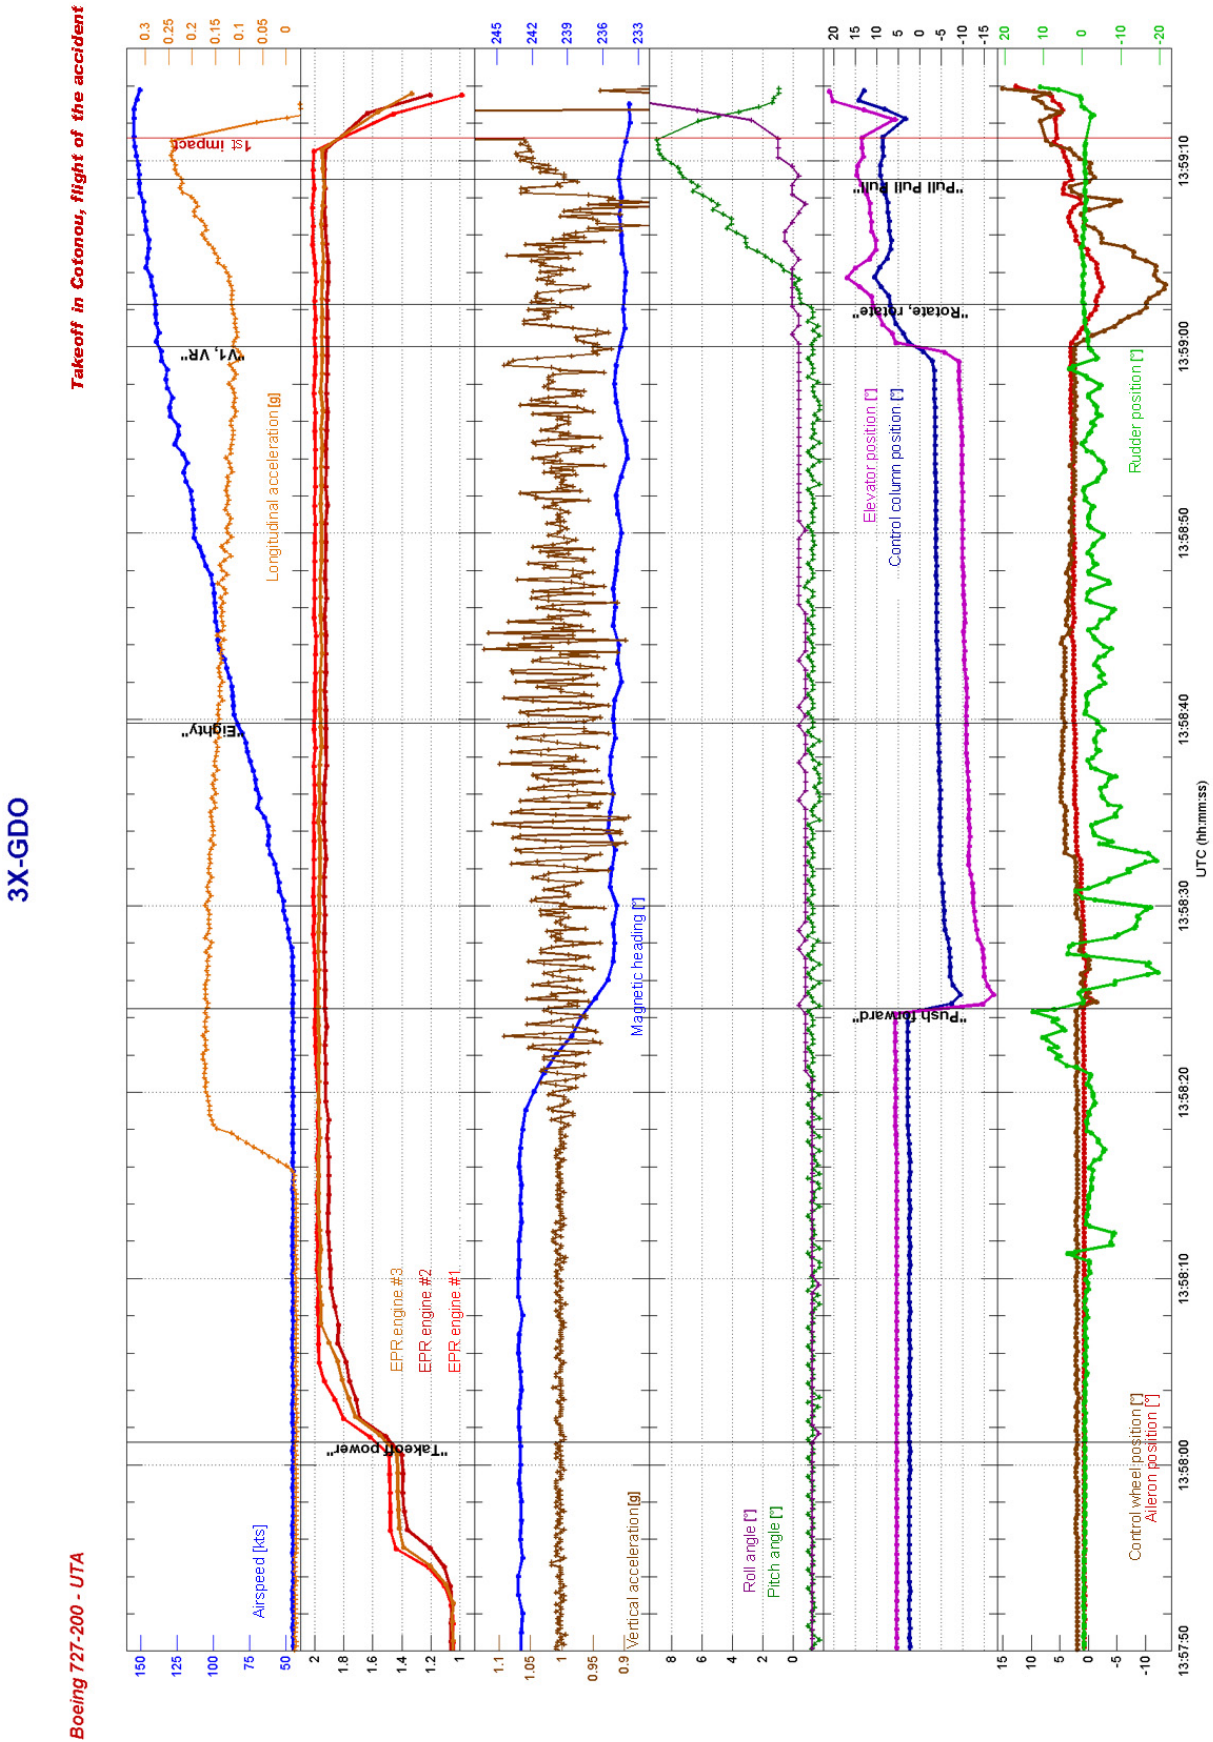
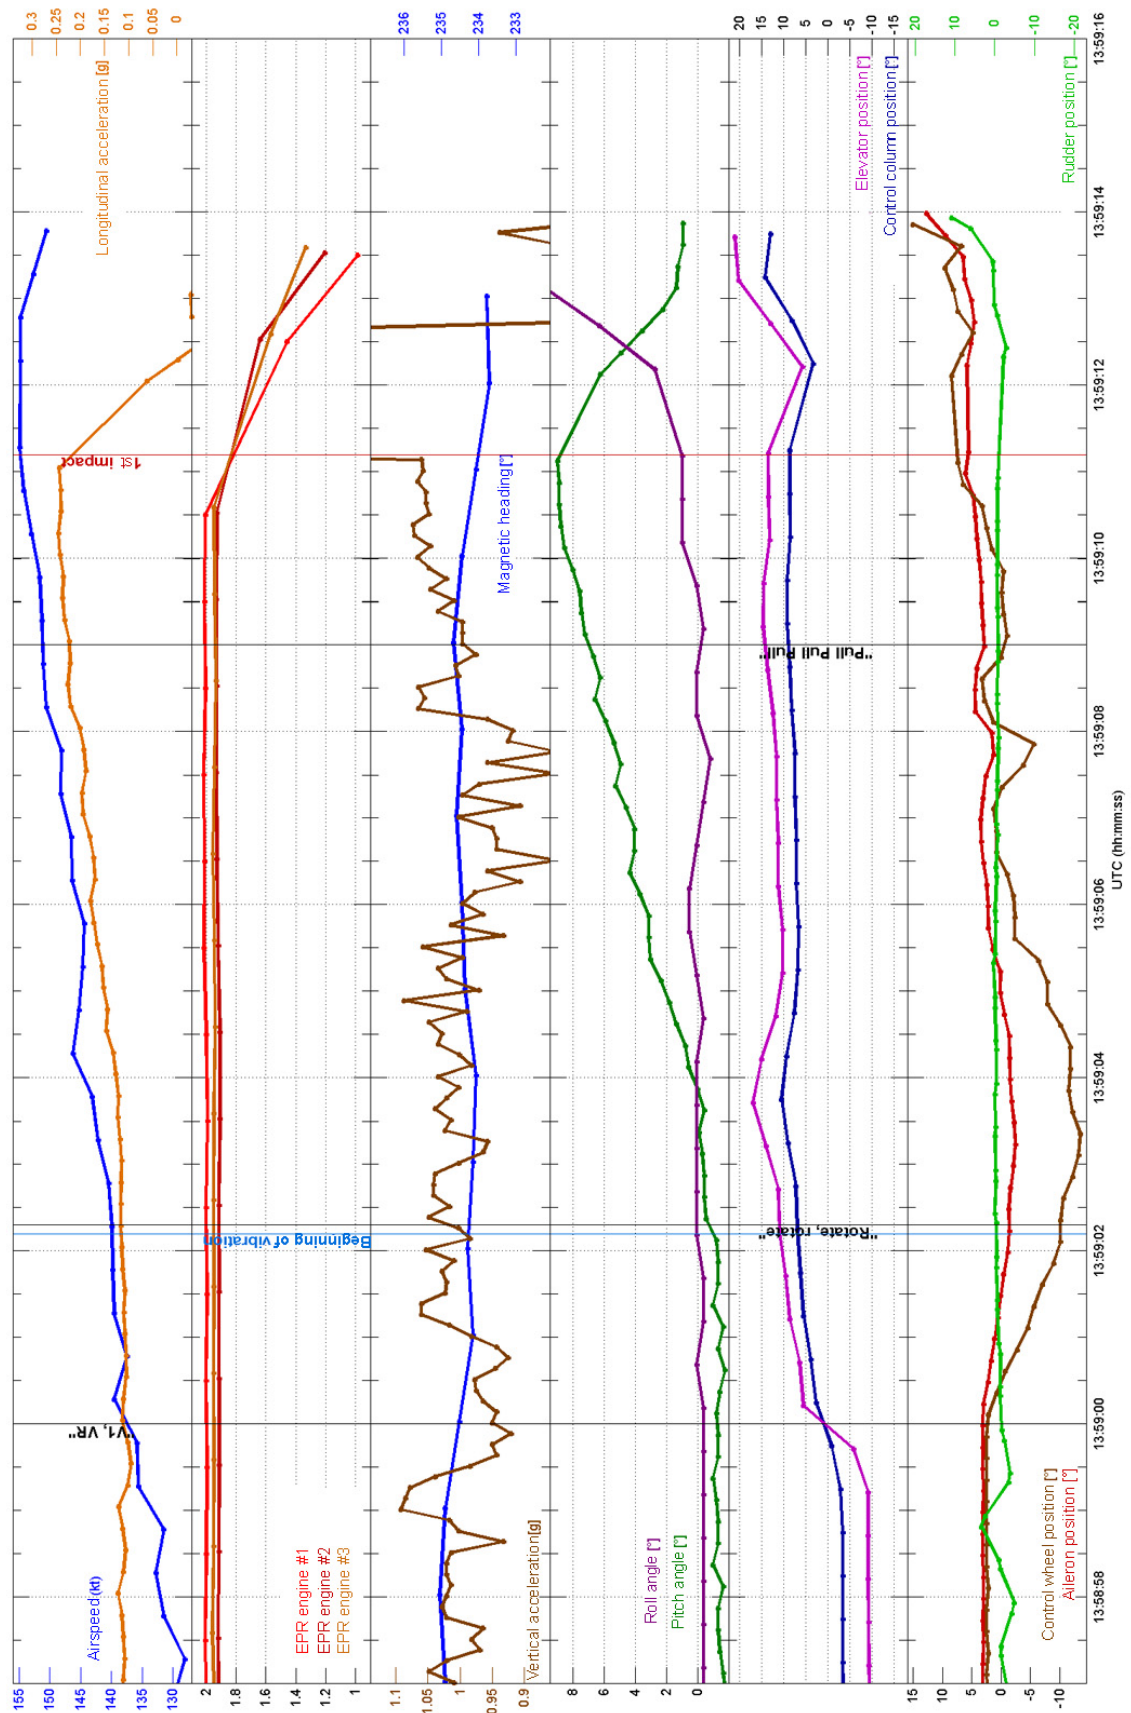
Takeoff in Cotonou, flight of the accident

The graphs obtained from the recorded parameters (see appendix) show that, when the stick was pulled back, the elevator was immediately set in pitch-up position, but that the airplane's response time was very slow compared to the usual time, the nose lifting off late while the acceleration was continuing. Such a situation at the beginning of the climb-out indicates either a limitation in the elevator's operation or an airplane with a center of gravity that is too far forward.
