AIRCRAFT ACCIDENT REPORT

MD-11F, Registration [REDACTED]
King Khalid International Airport – Riyadh
Kingdom of Saudi Arabia

Abnormal Runway Contact (ARC)

15 Sha'aban 1431 H – 27 July 2010 G

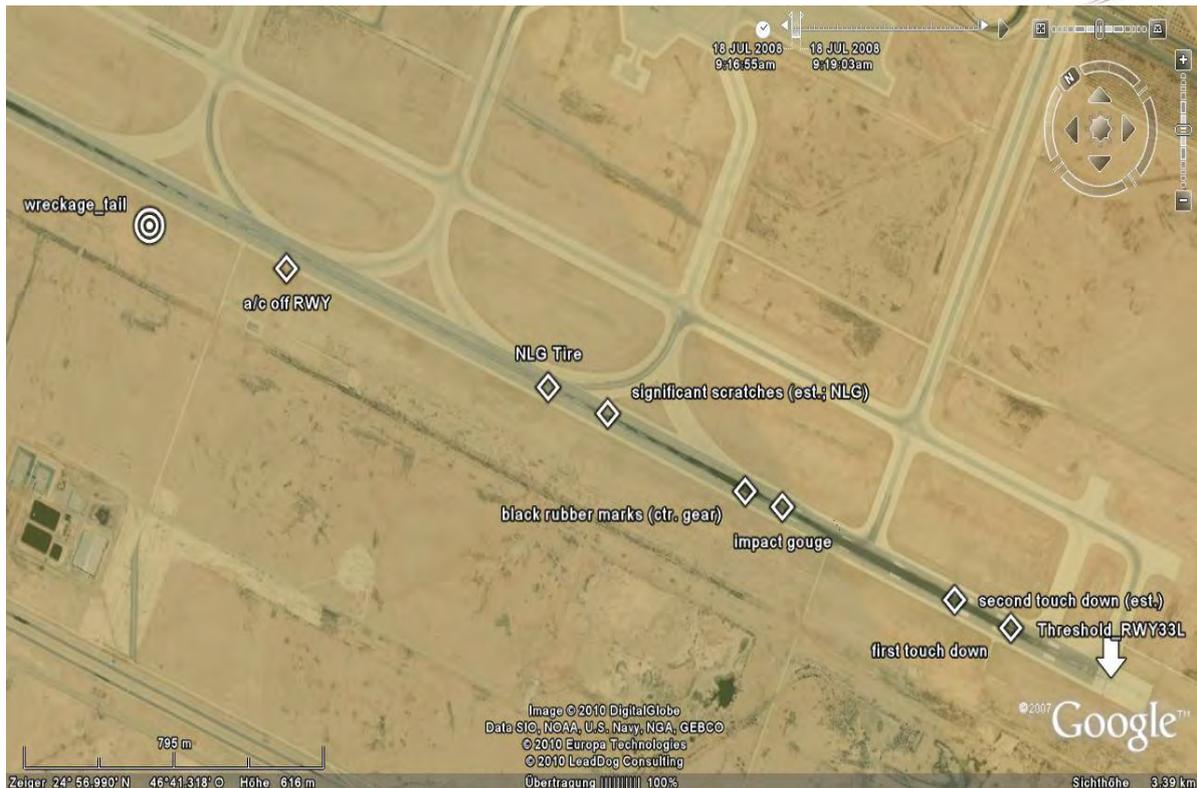
Figure 8: Marks and Debris

The runway and the wreckage trail were observed many times and, the marks and debris were documented and plotted. Significant items along the runway and wreckage path are as follows:

- Six parallel stripes of rubber residue were found 945 ft from the runway threshold indicating that the aircraft touched down with the two main landing gears and the centre landing gear. (Figure 7 - green circle and Figure 9 – green arrows);

- Tail impact at 3200 ft from the threshold. This impact consist of a deep gouge and additional scratches (Figures 7 and 10 – red circle). Beyond this point the number of parts and pieces increased;

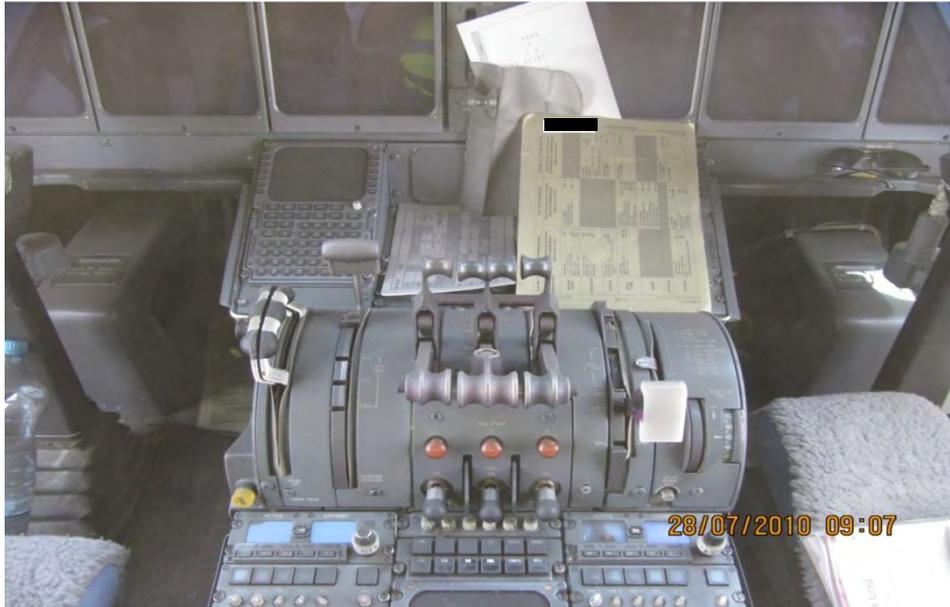
Figure 19: Centre Pedestal

The list of the circuit breakers which were found opened is at Appendix A.

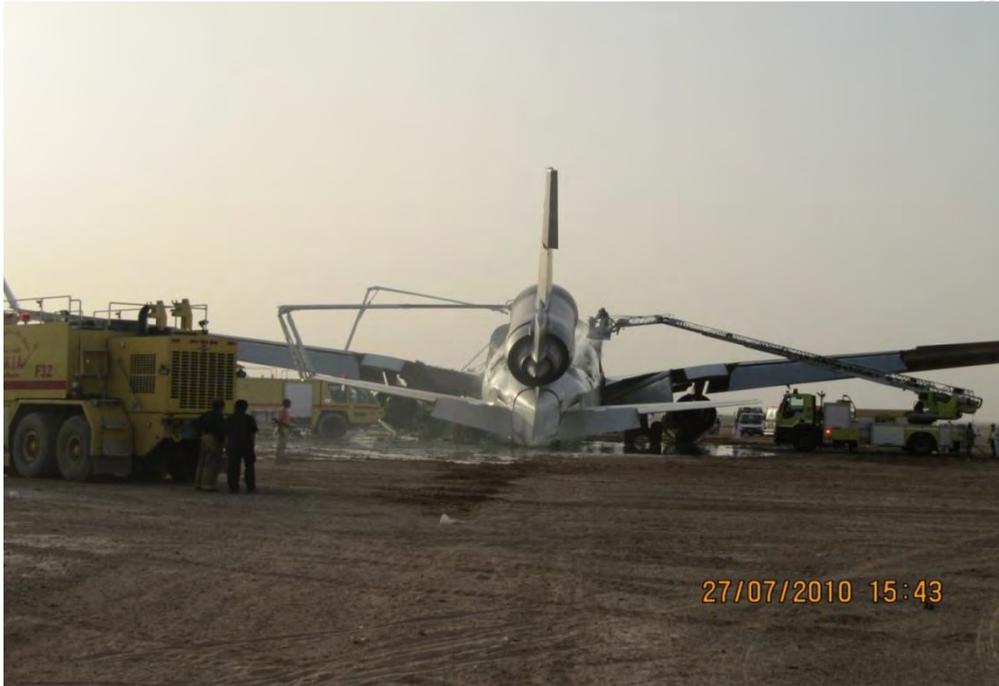
Figure 26: Fire Fighting Operations

The fire fighting operation continued until 04h30 the next day, 28 July 2010 (Figure 26). The accident site was released to the Investigator-In-Charge (IIC) at 10h30 on 28 July 2010.

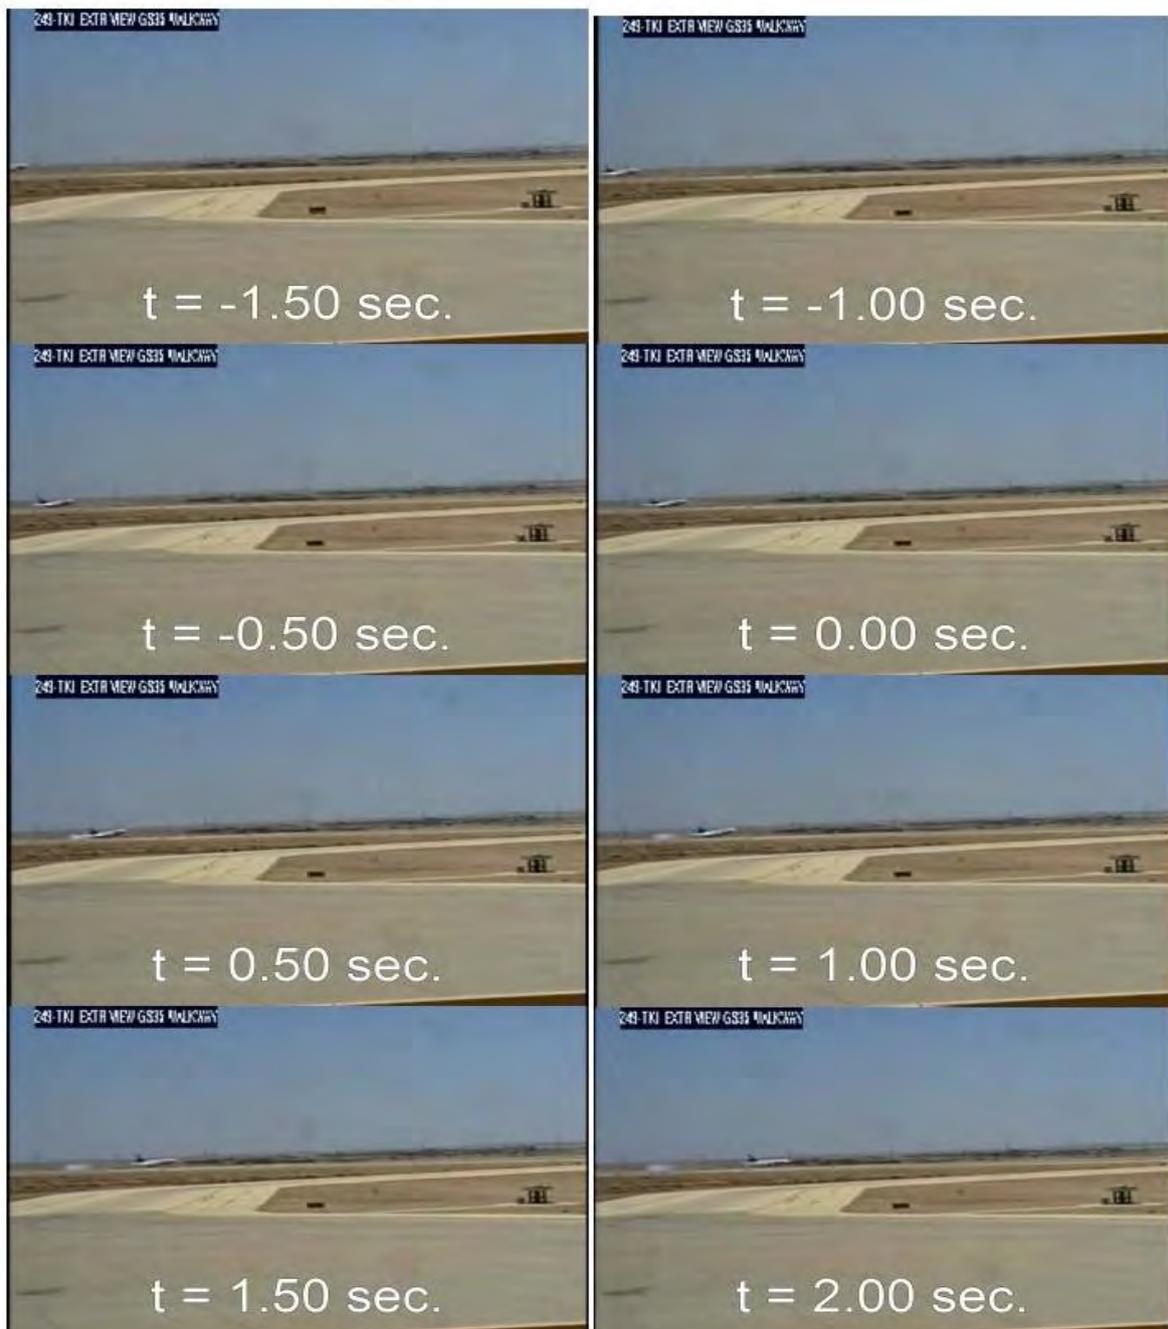
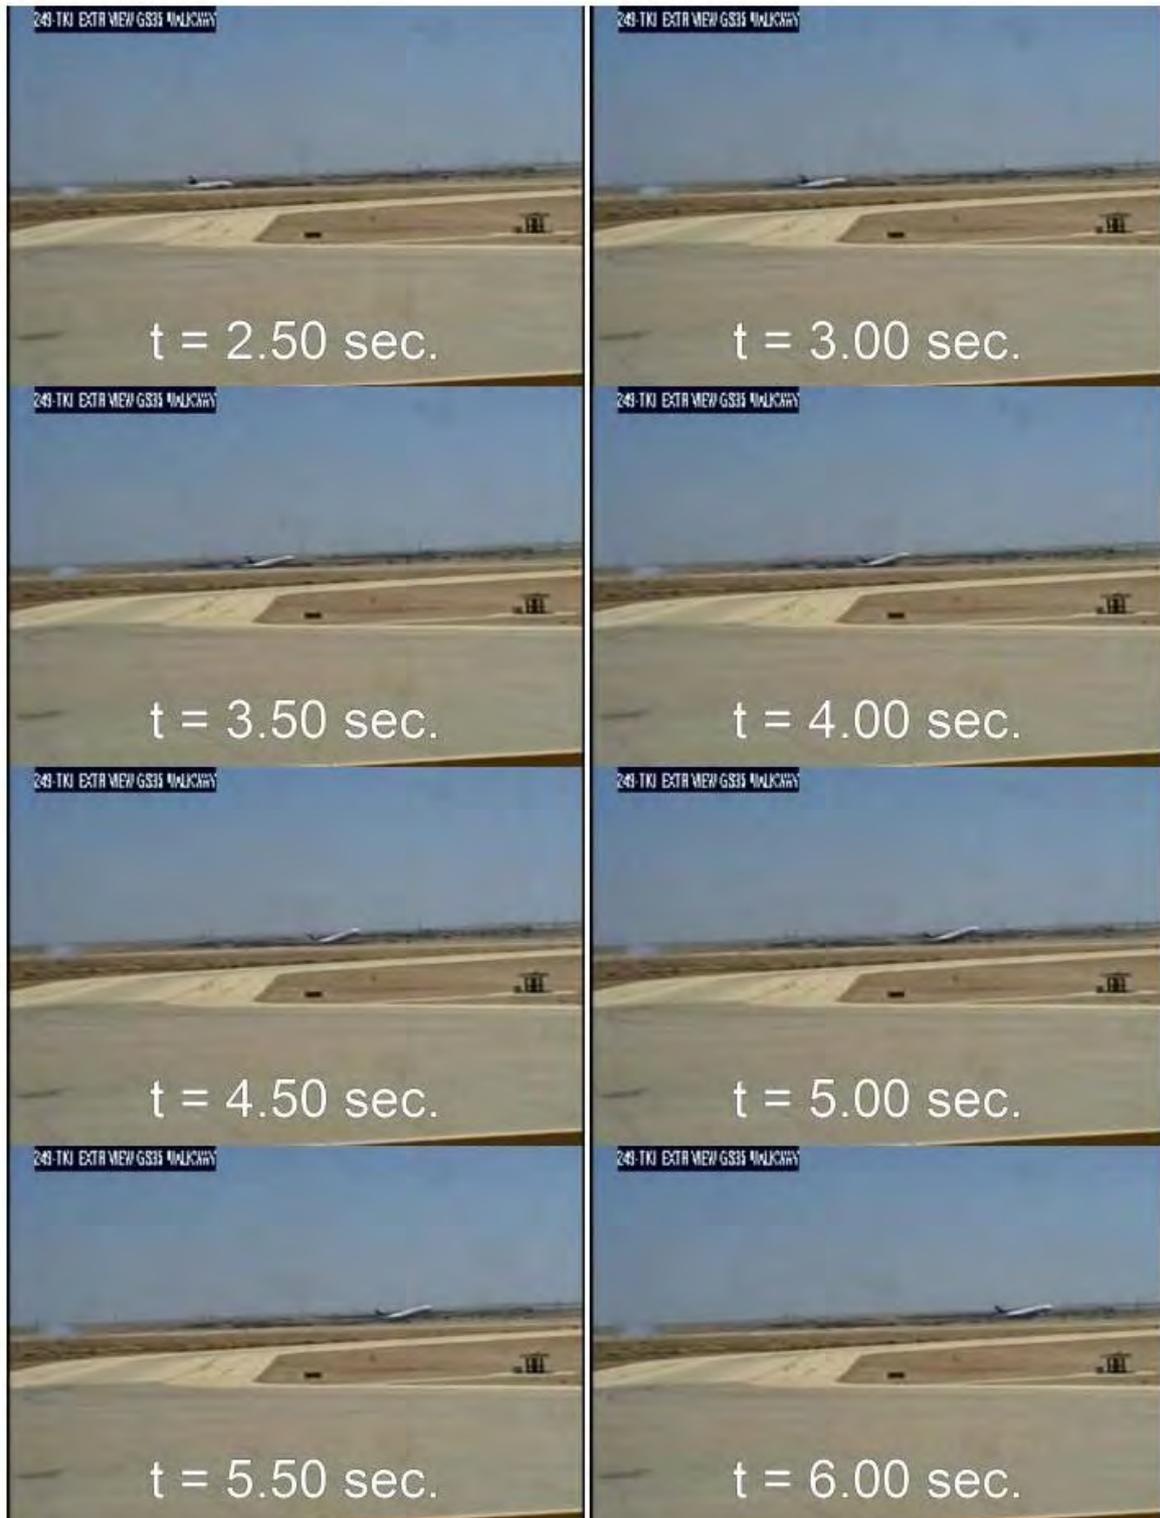
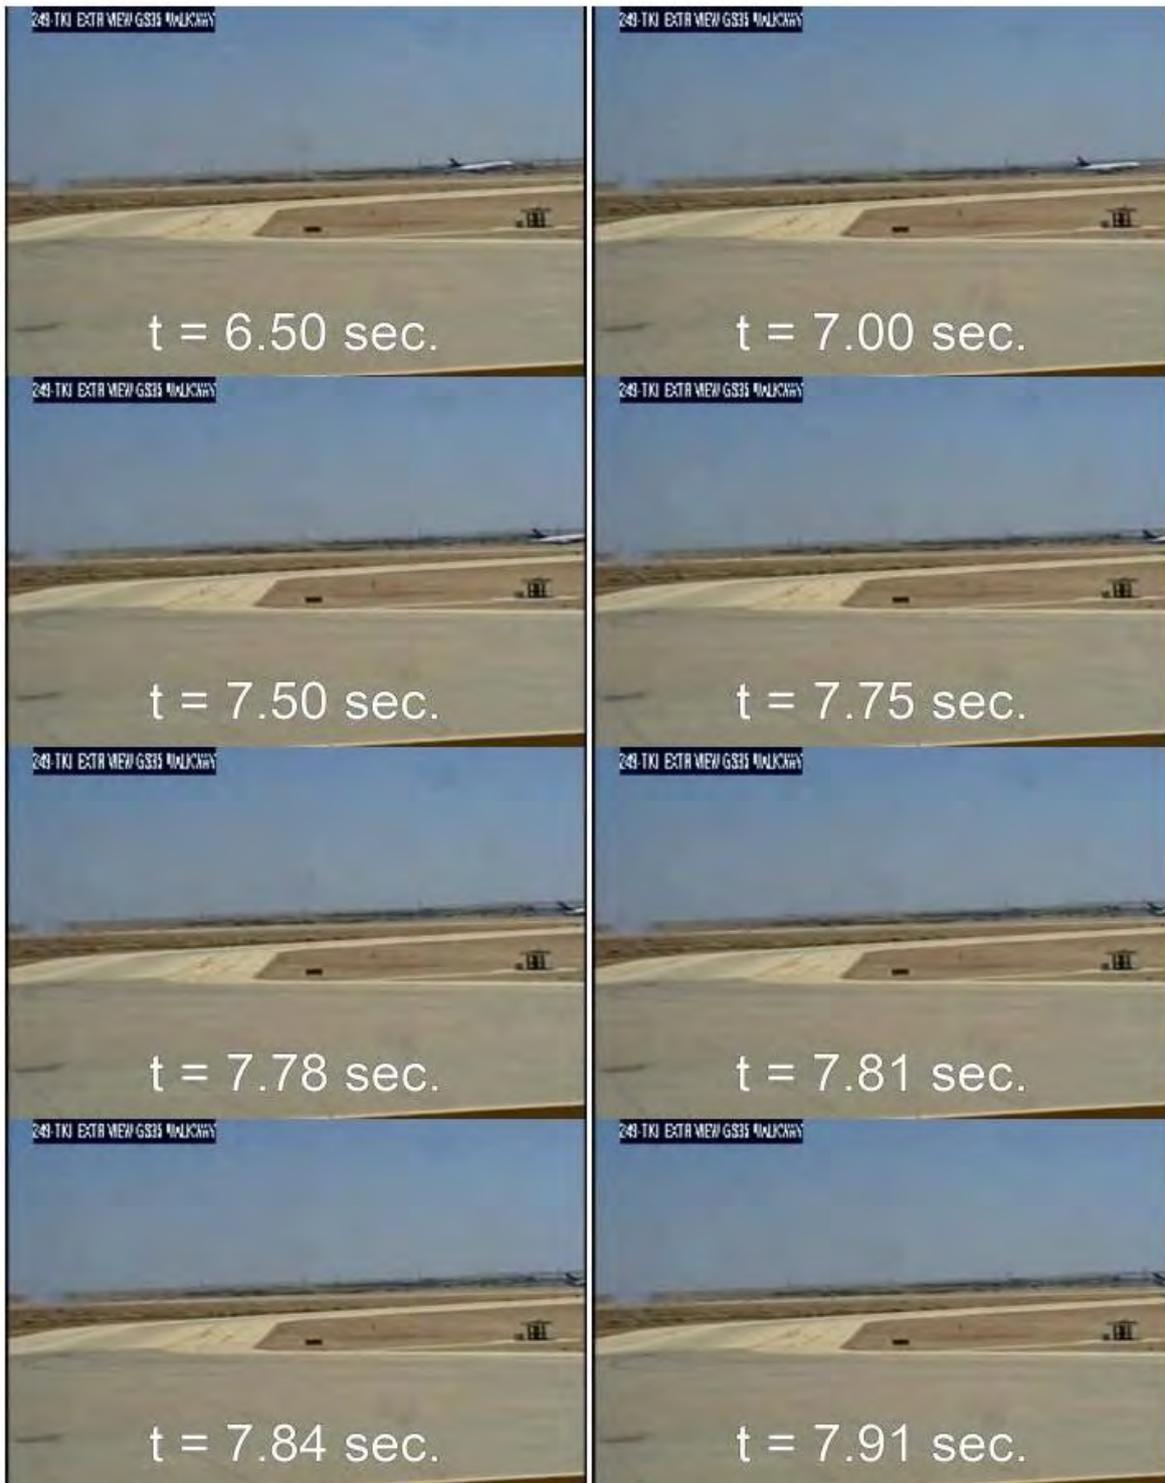
Figure 1 (page 1 of 3). Still frames from first security camera.

The video recording of the landing captured by the airport security camera (Appendix C- Figure 1) showed that after the first touchdown of the main gear, the aircraft bounced back into the air and then touched down a second time with both the main gear and nose gear in a nearly flat pitch attitude. The aircraft bounced again with the nose rising rapidly. This second bounce was much higher than the first. The aircraft again pitched over and returned to the runway. Following this third touchdown, the aircraft exited the field of view of the security camera.

Figure 1 in Appendix C contains a series of still frames from the video recording of the airport security camera from a point on final approach at $t = -1.5$ seconds (sec.) before the first touchdown to the exit of the aircraft from the camera field of view following the last touchdown at about $t = 7.9$ sec. after the first touchdown. The first touchdown occurs at $t = 0.0$ sec.

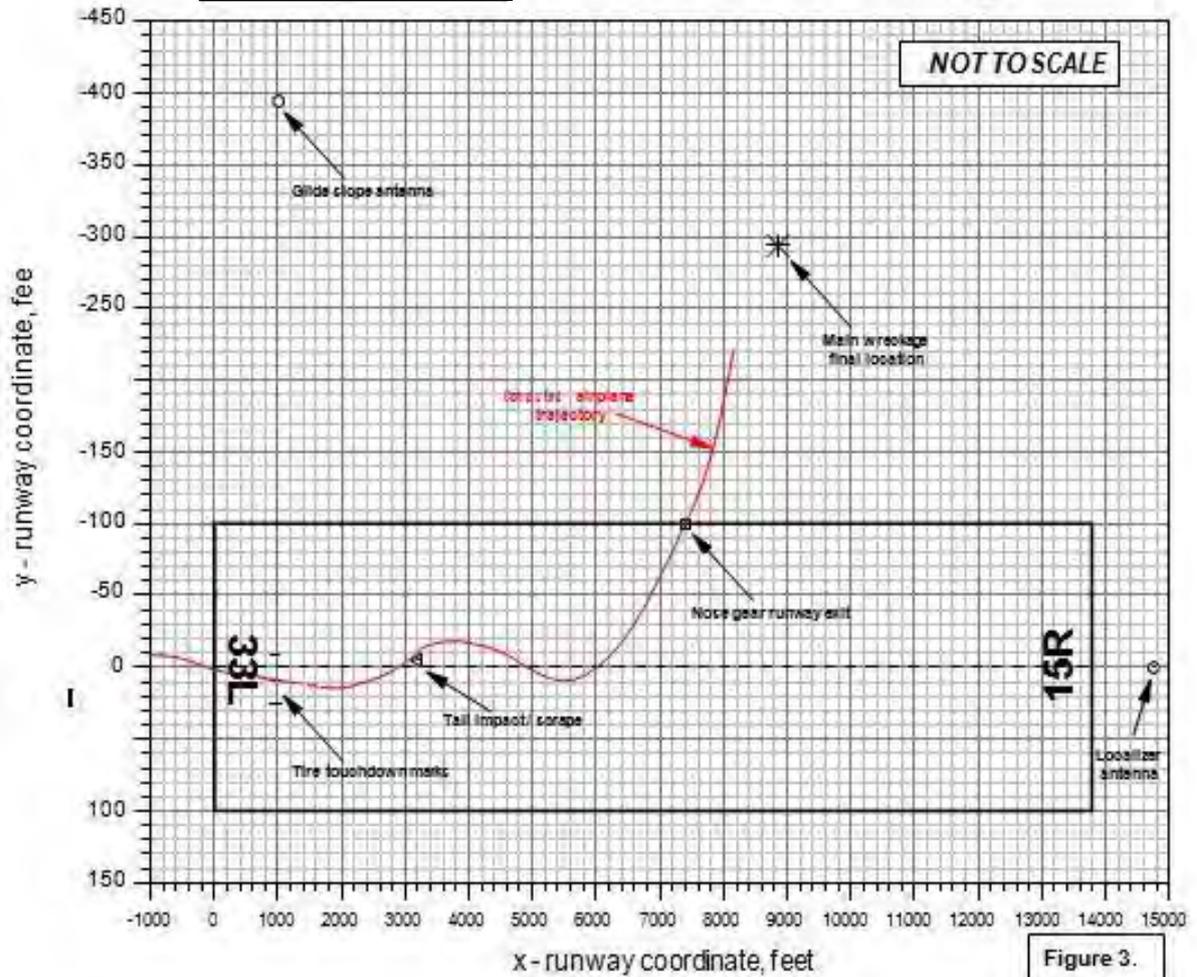
Ground scars and markings

Several ground scars and markings provided evidence of the aircraft trajectory following the first touchdown. (Figures 7 to 12 and Appendix C - Figure 3)

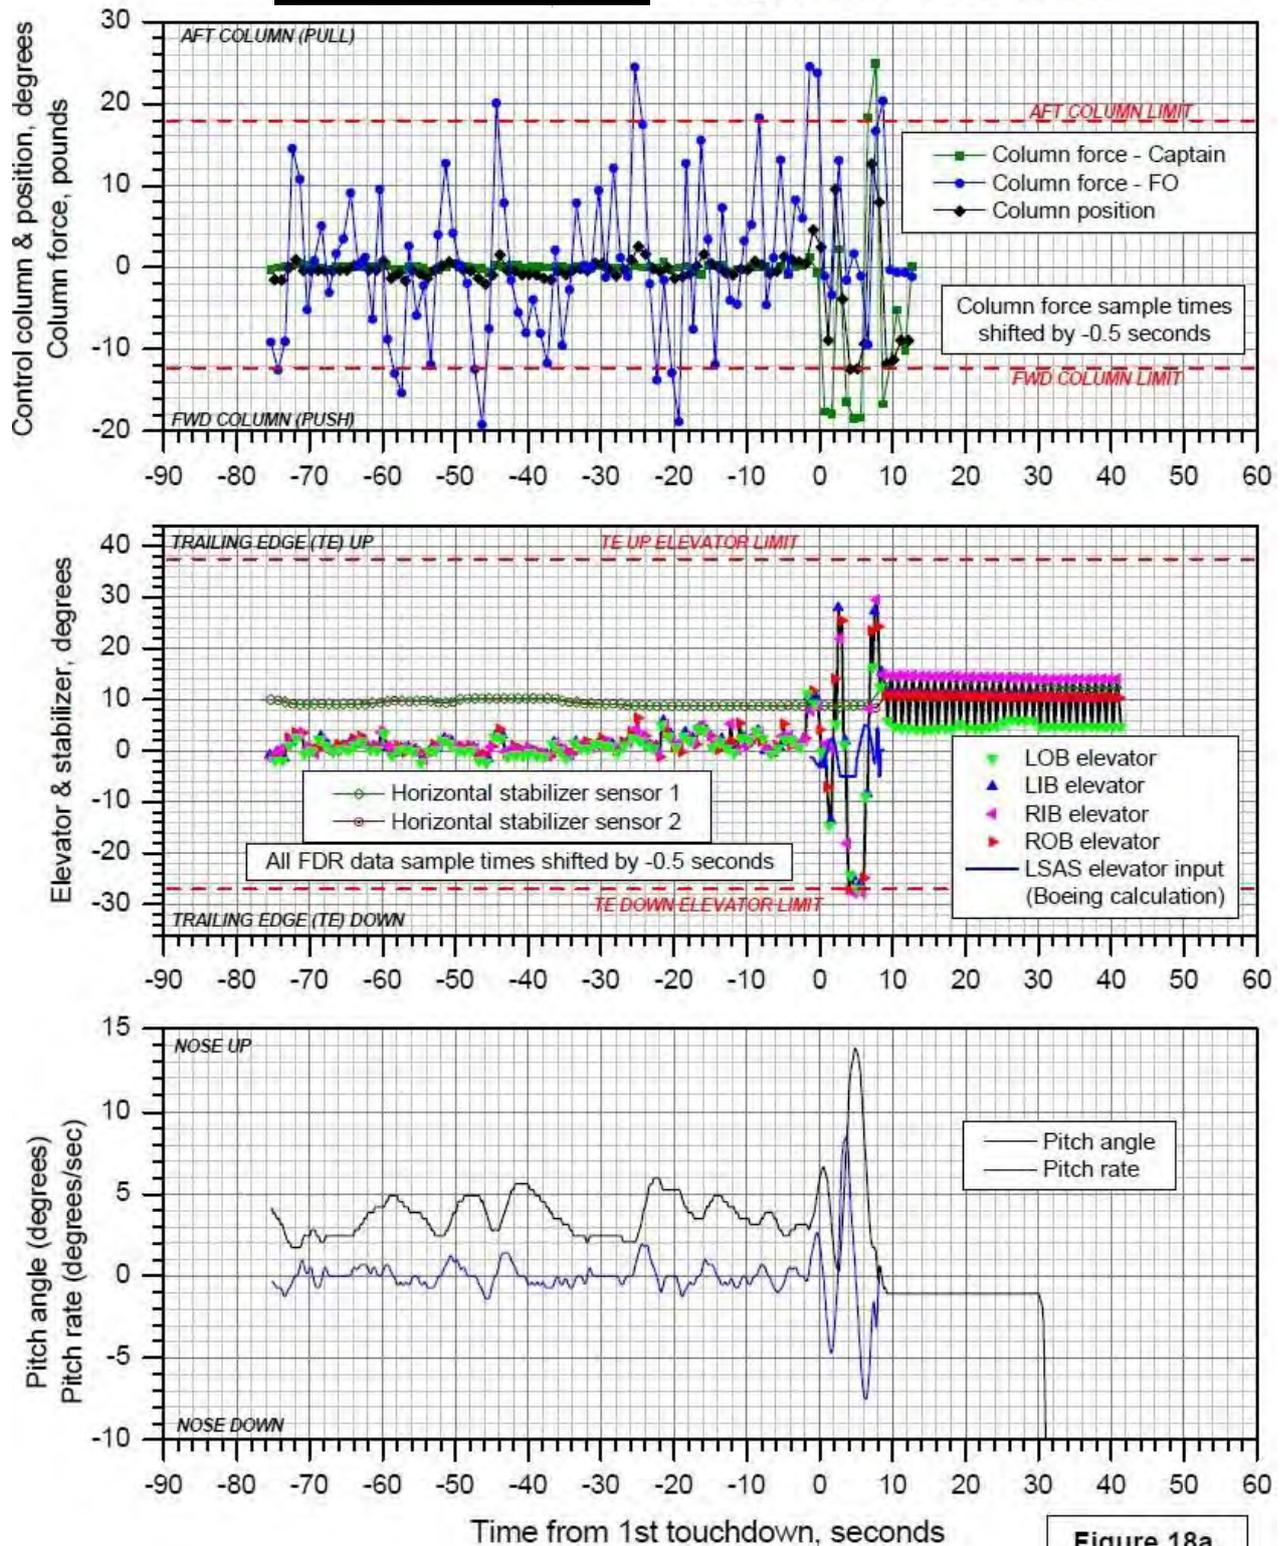
Figure 18a.

The first touchdown (main gear) at a *nlf* of 2.1g and a sink rate of -13 ft/sec resulted from a late flare initiated by the FO between 1.7 and 2.0 sec/23 to 31 ft above the runway before touchdown. This is indicated by the start of the upward movement of the elevators and the increase in pitch angle (Appendix C – Figure 18b). While the first touchdown resulted in a bounce, the landing was recoverable. The severity of the subsequent touchdowns was not a consequence of the first touchdown, but primarily a result of the pitch angle during the bounces, which resulted from the actions of both flight crews on the control column.
