# Aircraft Accident Report

**Operator:** Sita Air Pvt. Ltd.

**Aircraft Type and Model:** Dornier 228-202(K)

**Registration:** 9N-AHA

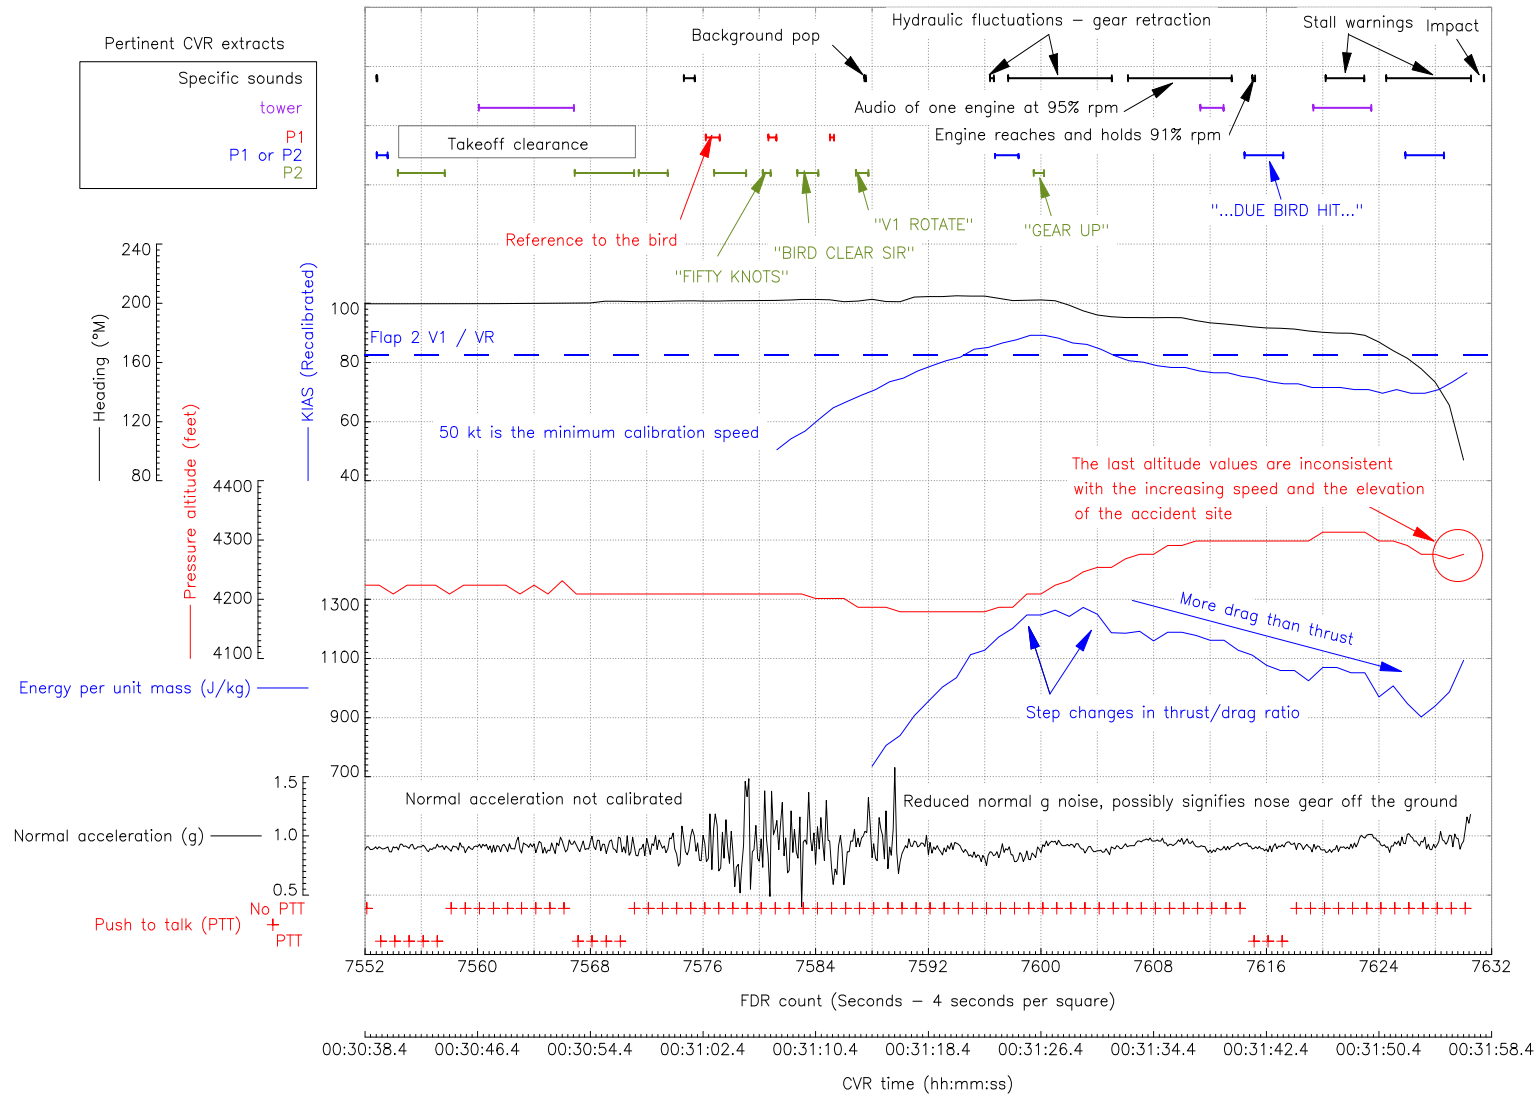
**Figure 1.11-1** Pertinent extracts from recordings and calculated total energy per unit mass, zeroed at the airfield elevation.

The recorded data for the takeoff is shown in Figure 1.11-1 along with the calculated energy per unit mass for the aircraft. Energy is calculated by adding the aircraft's kinetic energy ( $\frac{1}{2}m.V^2$ ) to the aircraft's potential energy ( $m.g.h$ ), but because the aircraft's weight was not accurately known, the energy per unit mass was calculated ( $\frac{1}{2}.V^2 + g.h$ ).

The recorded pressure altitude dipped during the takeoff roll. A short duration dip in pressure altitude is normally associated with rotation just prior to lifting from the ground. In this case the dip was prolonged, indicating a long period with the aircraft pitched up but whilst still on the ground. This is corroborated by a reduction in noise recorded by the normal acceleration parameter that is likely to be associated with nose gear interaction with the runway. This is further

Corroborated by the “VEE ONE ROTATE” call just prior to these parameter changes. However, the rotate call and the observed effects of rotating the aircraft occurred before the aircraft reached the correct rotate speed.

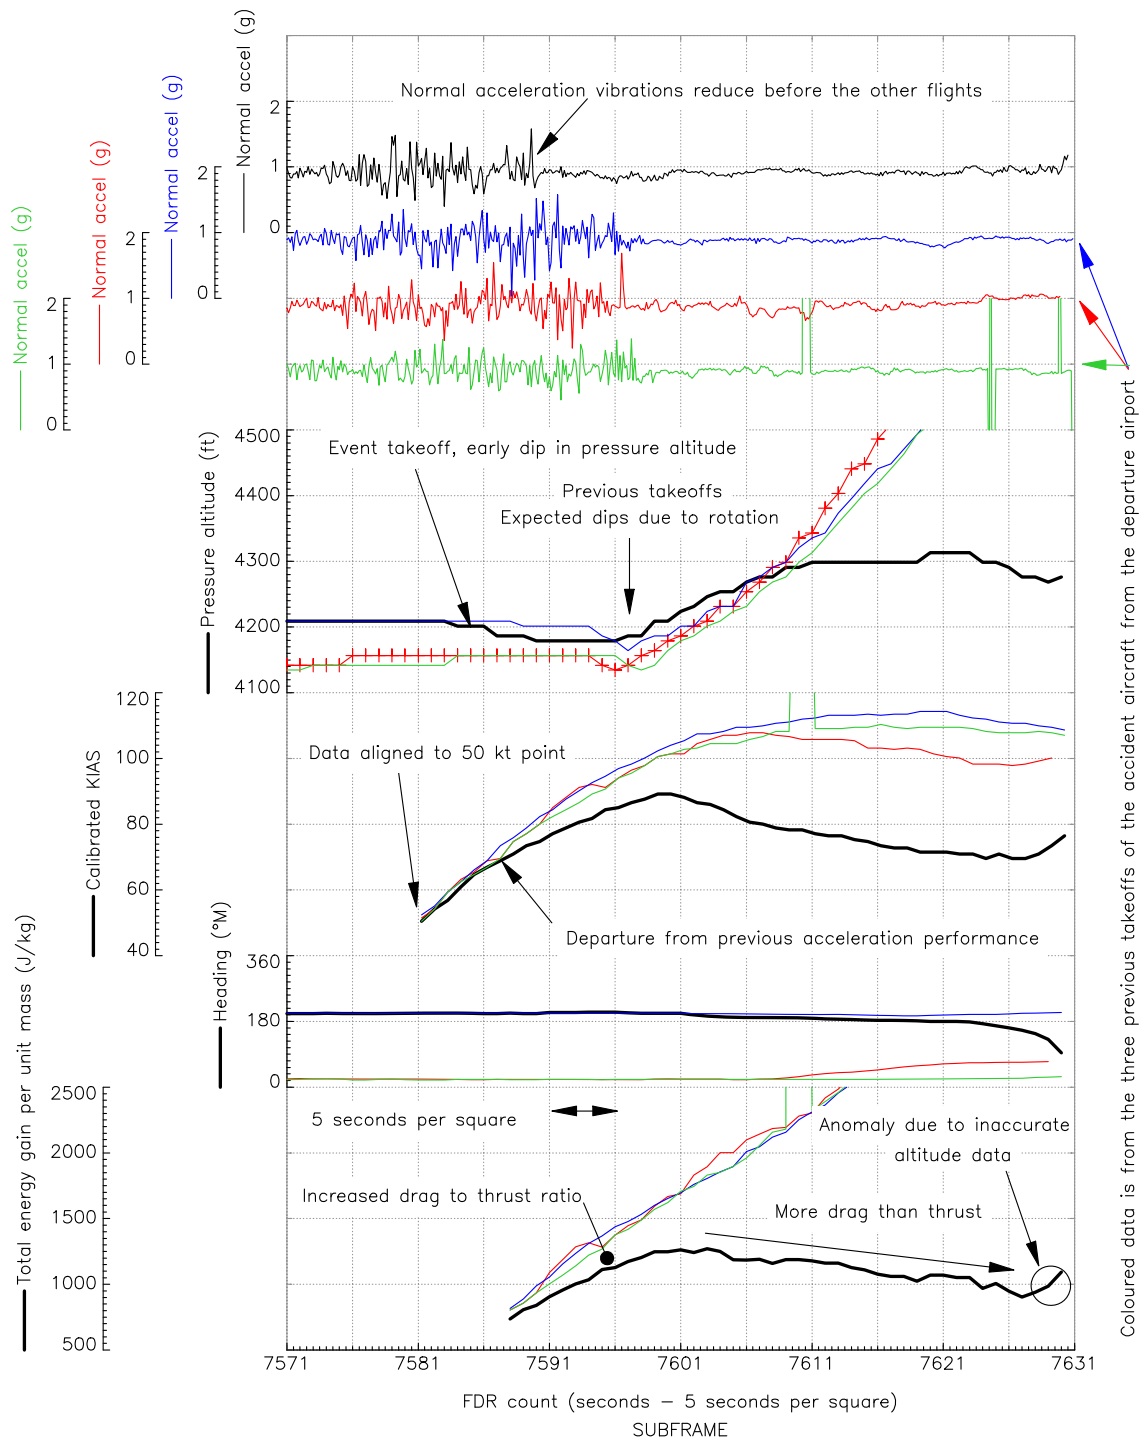
**Figure 1.11-2**

The accident takeoff was compared to the previous takeoffs from the same airfield, one in the same direction and two in the opposite direction (Fig. 1.11-2). The loadsheet weights for these flights were the same as for the accident flight and it is clear that the acceleration for the initial part of the takeoff roll matches that of the previous flights up to approximately 70 kt, after which the speed profile becomes slower than the previous takeoffs. Despite this reduced speed, the behaviour of the altitude data and the vibration sensed by the normal accelerometer indicate that the aircraft rotated earlier in time and therefore at a lower speed than the previous flights.

Comparison of the accident flight (black lines) with the previous take offs from the same airfield.

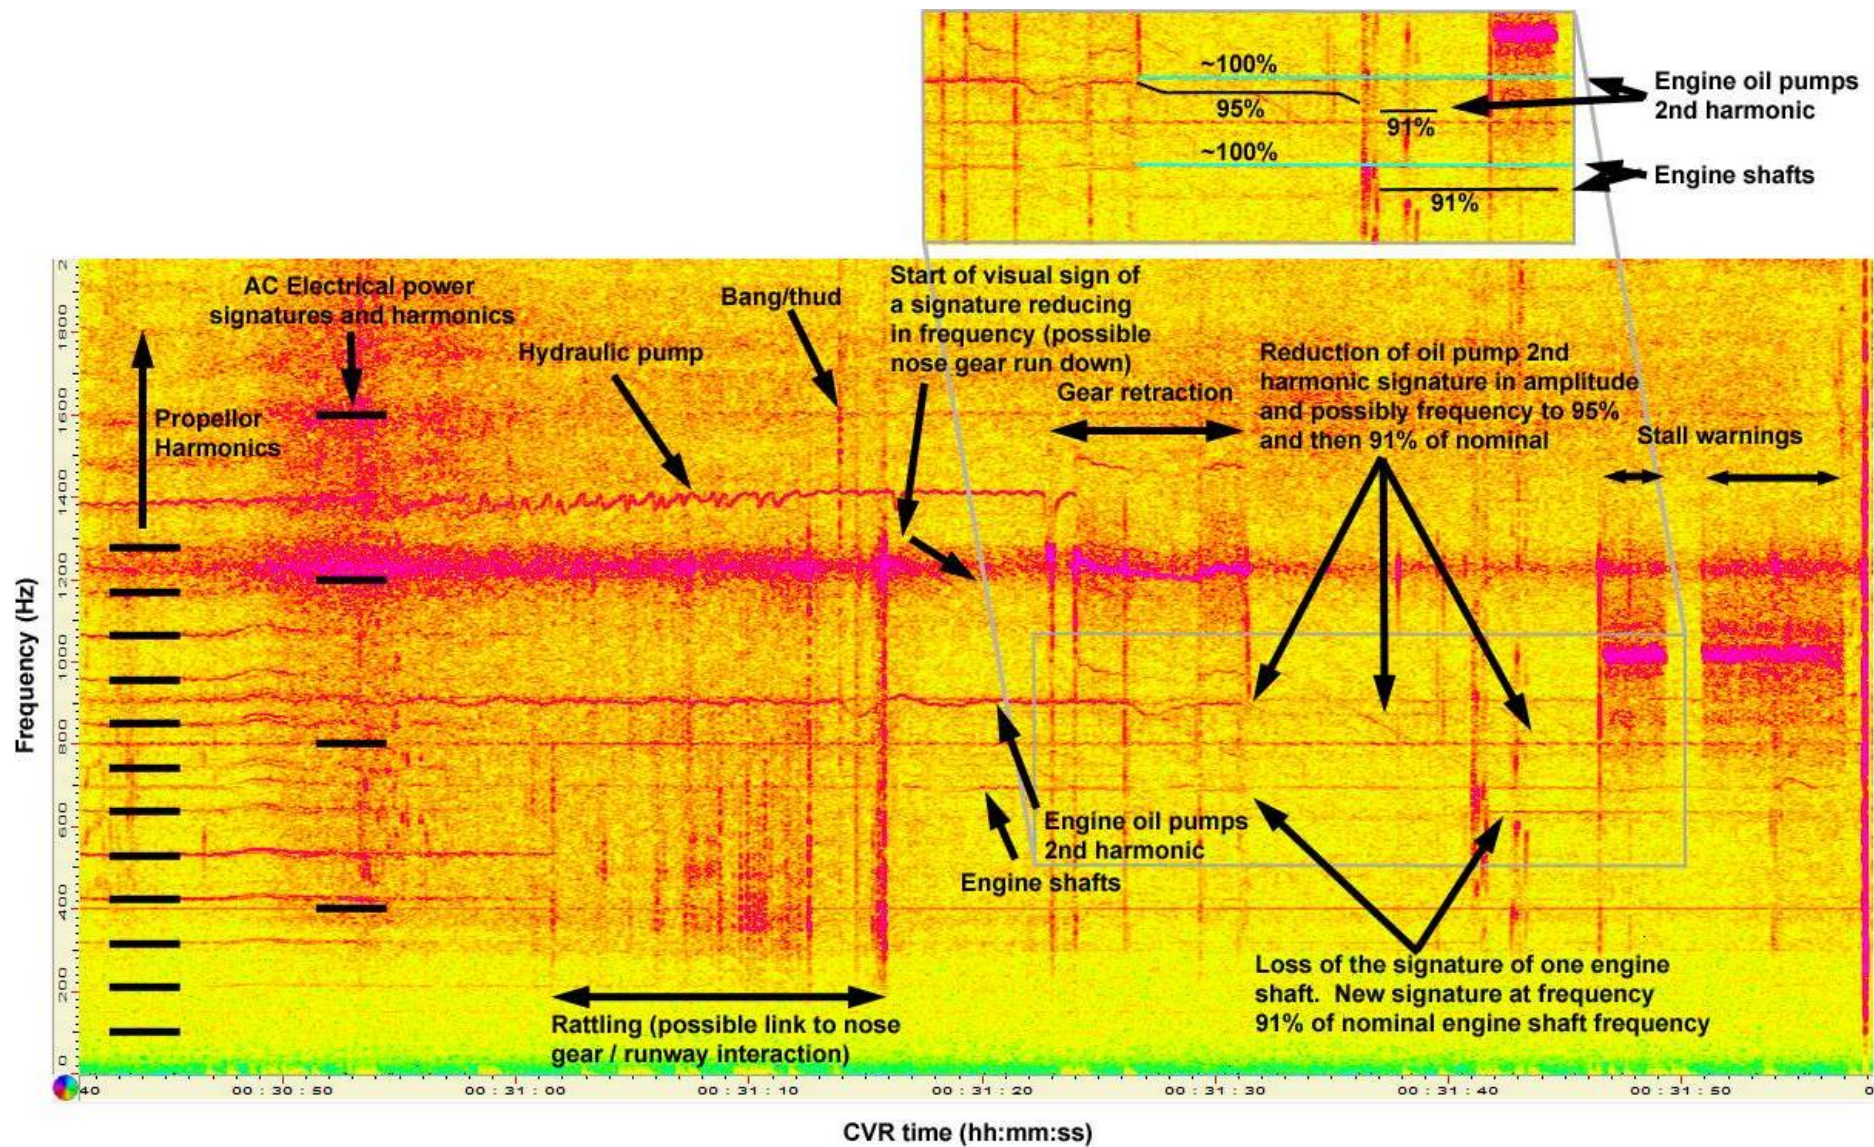
**Figure 1.11-3.**  
Spectrum analysis of the CVR CAM channel

Spectrum analysis of the CVR CAM channel highlighted prominent features that have been associated with rotation rates, blade pass frequencies and gear teeth meshing frequencies of various propeller, engine or system parts during different phases of the accident flight. The key features are shown in Figure 1.11-3.

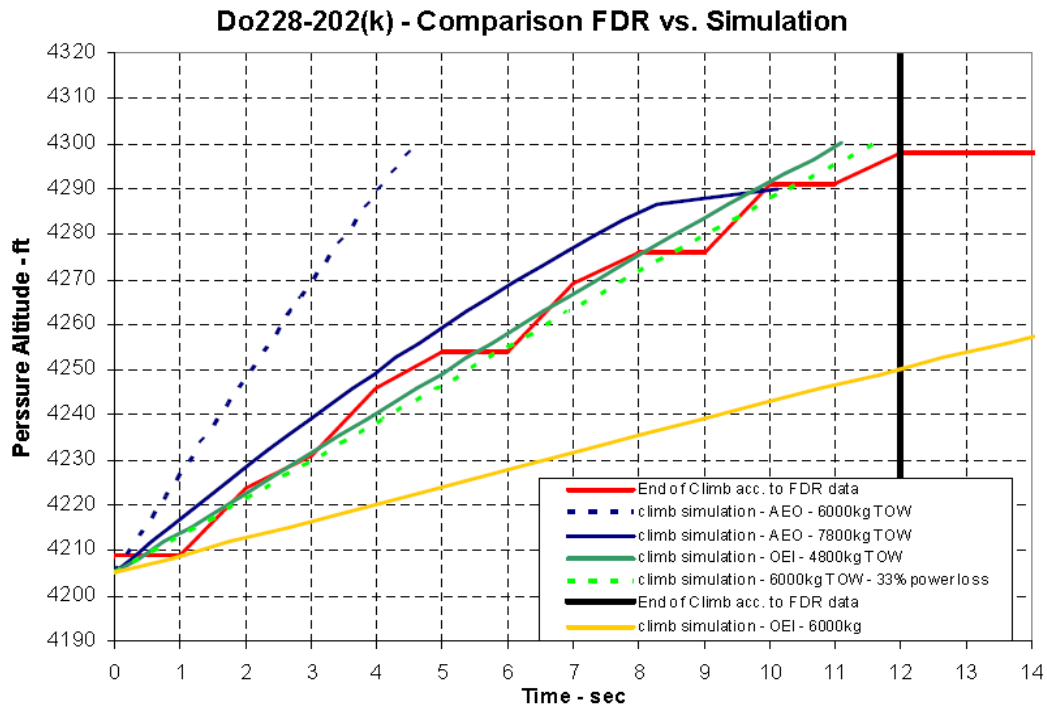
**Figure 1.16-1**

Climb situation considering altitude (red line is the actual performance of the aircraft)

Using a takeoff weight of 7,800 kg, the maximum weight that could be entered into the software and a figure representing a grossly overweight aircraft, the simulated aircraft AEO would have been able to out-perform the actual speed-altitude profile: in Figure 1.16-1, the simulated aircraft would have reached a given altitude in less time than the actual aircraft while maintaining the observed speed profile; and in Figure 1.16-2, the simulated aircraft would have reached a given speed earlier than the actual aircraft while maintaining the observed altitude profile. Therefore, overloading alone was not the cause of the lack of performance in the climb phase.

Following a single engine failure, an aircraft would be expected to maintain a speed of  $V_2$  and follow a lower climb rate than the one observed. The yellow lines in Figures 1.16-1 and 1.16-2 show the expected climb profile of an aircraft at 6,000 kg OEI. The lines show that the simulated aircraft would have reached a given altitude at a later time than the actual aircraft while matching the speed profile, and would have reached a given speed at a later time than the actual aircraft while matching the altitude profile. The solid green lines show that the takeoff weight of the simulated aircraft had to be reduced to 4,800 kg before it had the power available OEI to match the observed speed-altitude profile of the accident aircraft. Given the assumed takeoff weight of between 5,800 and 6,100 kg, this shows that the aircraft had more power during the climb phase than would have been the case under OEI conditions.

Had the aircraft maintained  $V_2$  during the climb, it would have attained an altitude greater than that shown by the yellow line in Figure 1.16-1, because the yellow line assumes the total loss of power from the operative engine, and it would have had a speed of  $V_2$  (83 kt) at the beginning of the level flight phase. At this speed, less power would have been required to maintain level flight than was required at 77 kt. The investigation could not determine whether the power available would have been sufficient to maintain speed during the level flight phase had  $V_2$  been maintained during the climb phase.

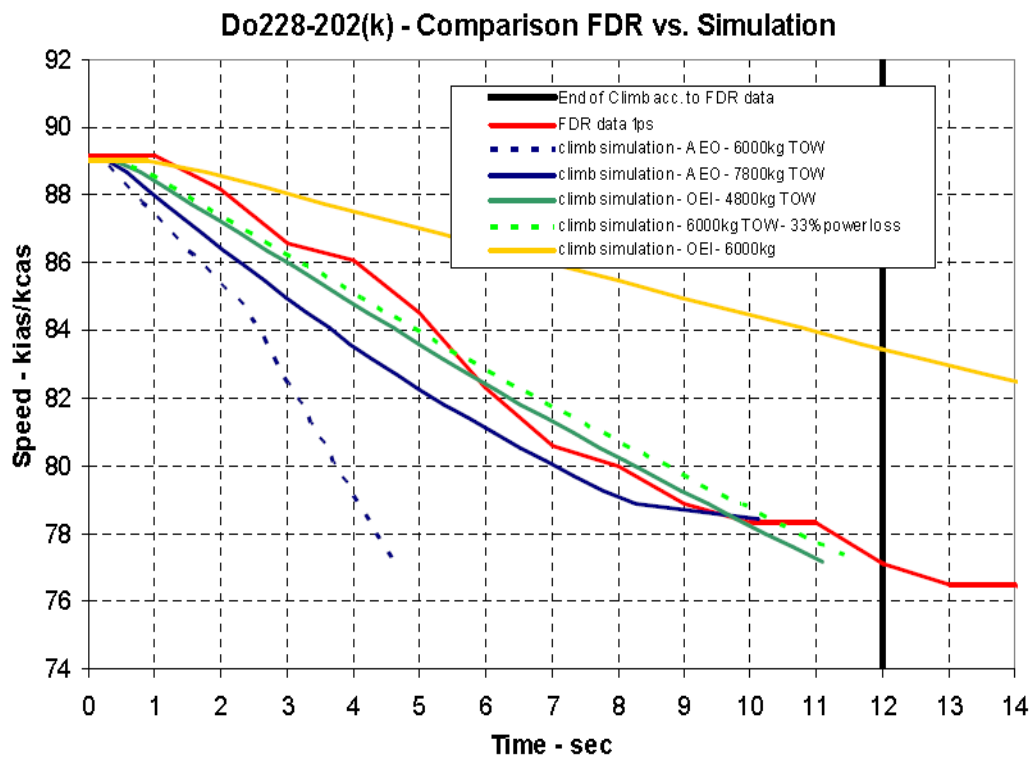
**Figure 1.16-2**

Climb simulation considering speed (red line is the actual performance of the aircraft)

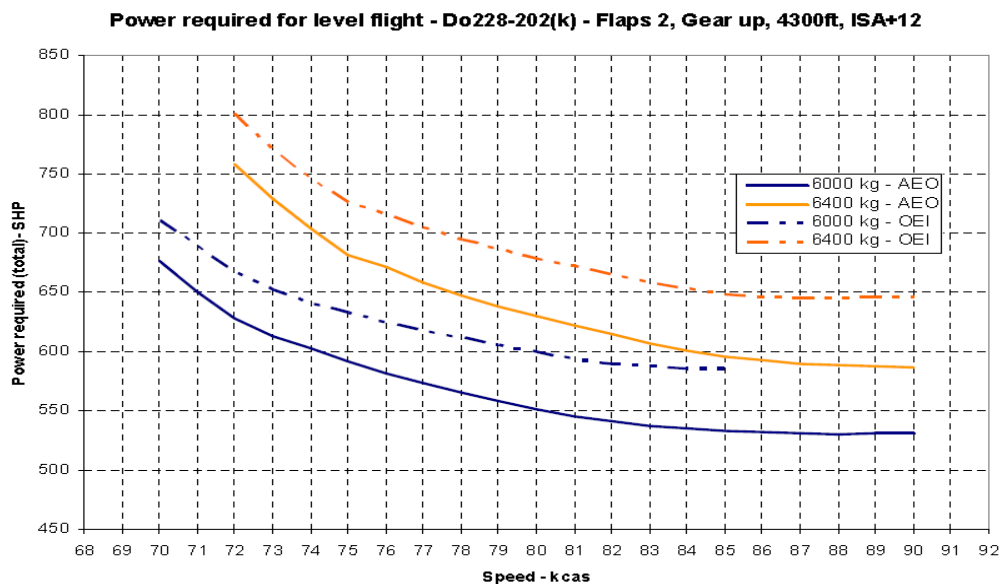
**Figure 1.16-3**

The TC holder was unable to model the level-flight deceleration phase of the aircraft after it reached 100 ft AAL, so it calculated the steady-state power required to maintain level flight at different weights and the results are shown in Figure 1.16-3.

Power required curve for level flight at different weights

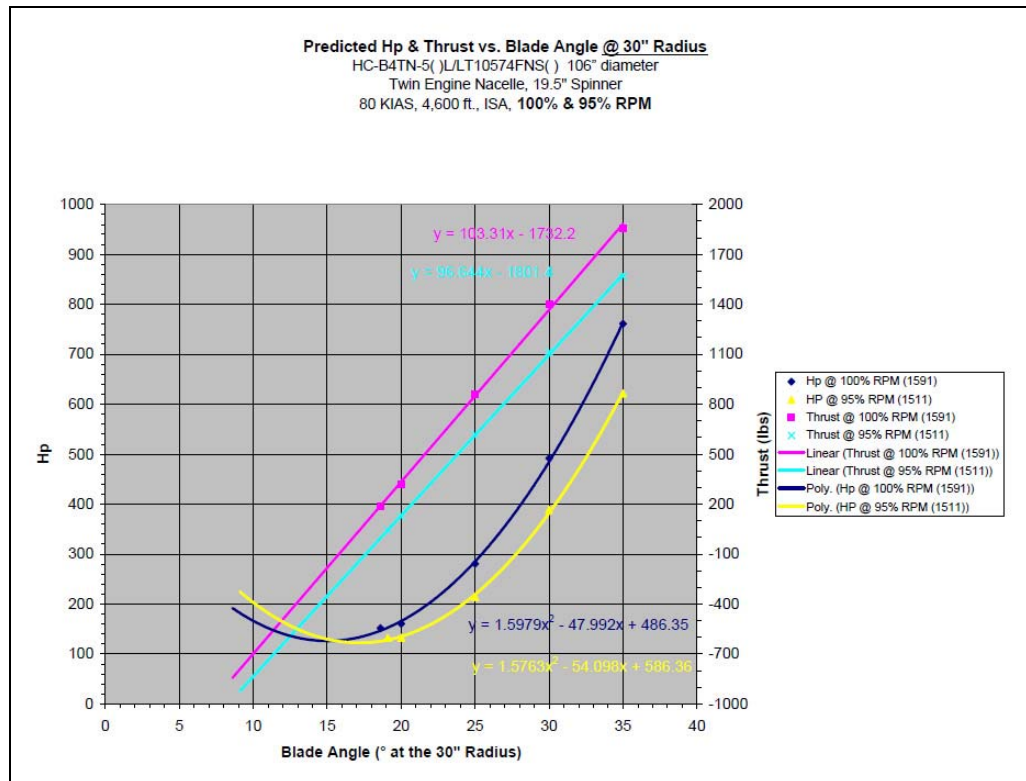
**Figure 1.16-4**  
 Hartzell predicted Hp and Thrust Vs Blade Angle and rpm

The propeller manufacturer was asked to calculate how much power was required to turn the propeller at 100% rpm and 95% rpm in the same conditions. The propeller manufacturer's calculations are shown in Figure 1.16-4. Hp is the power required to turn the propeller. Thrust is the thrust delivered by the propeller and negative values of thrust mean that drag is being produced. Propeller blade angle is presented on the x-axis and the minimum in-flight blade angle is 15°.

this speed only 72 hp is available at flight idle which means that 95% rpm would not be maintained either at flight idle.

The results show that because of the low idle fuel flow setting on 9N-AHA, if flight idle had been selected at airspeed of 80 kt, the rpm would have reduced below 95% rpm and the drag produced by the propeller would have been greater than 350 lb.

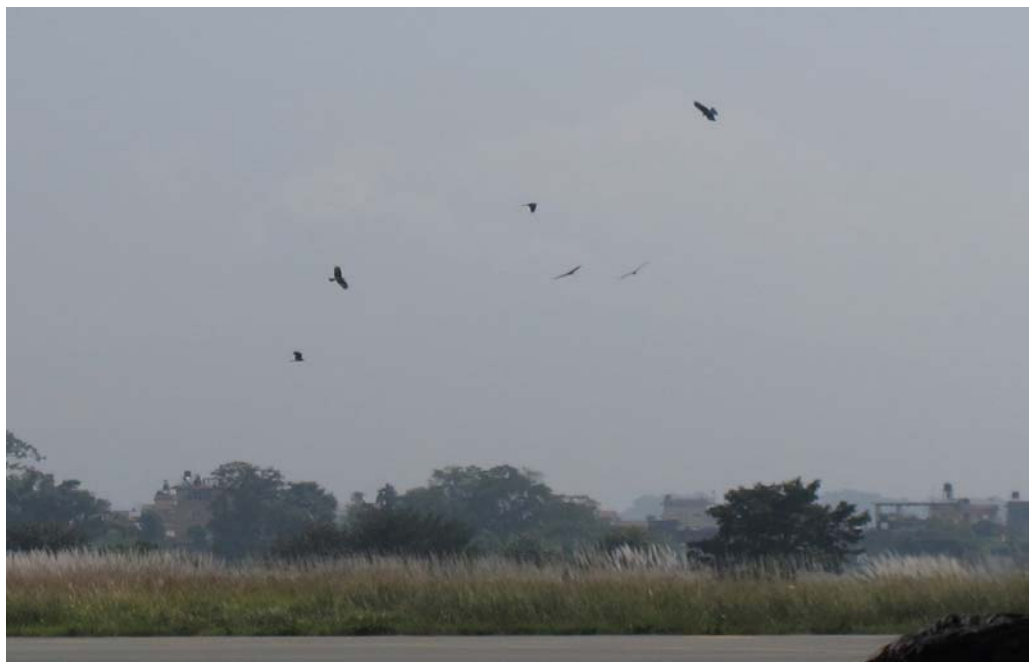
**Figure 1.18-1**  
Birds over the runway at TIA on 3 October 2012

There are some bird dispersal techniques being applied at TIA to scare birds away from airports: ‘wailer’ units producing sonic and ultrasonic sound; ‘quad blaster’ ultrasonic units; gas cannons; scare crow visual equipment; patrols with personnel armed with weapons; earthworm control techniques; cleaning of the runway and taxiways; issuing of NOTAMs about bird activities; and a public awareness program. Despite applying these measures, bird activity remains an issue at TIA (Figure 1.18-1).
